Condition Report – Lower Farm

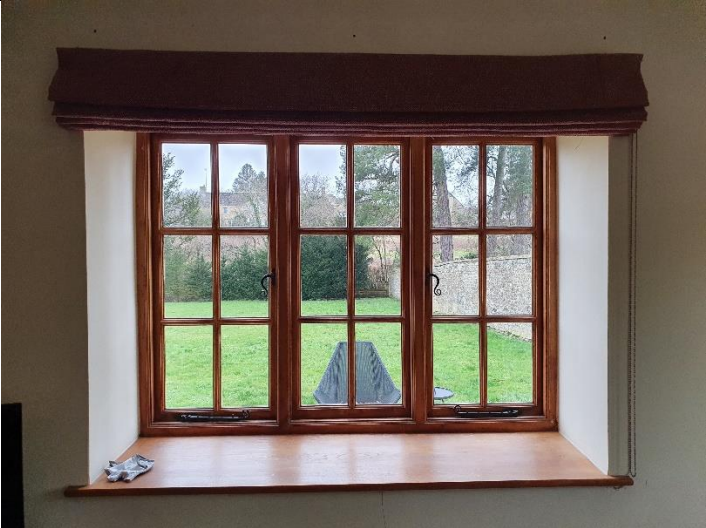
Window Reference & Description	External Image
<p>W.01</p> <p><u>Existing</u></p> <p>Triple light Timber casement</p> <p><u>Proposed</u></p> <p>Steel Casement w/ 12mm double glazed unit</p> <p>Opening Window Sightline – 45mm</p> <p>Fixed Sightline – 32mm</p> <p>The timber windows have not been treated over a significant period of time allowing water to get into the framework and making it soft in places, so starting the wood to rot.</p>

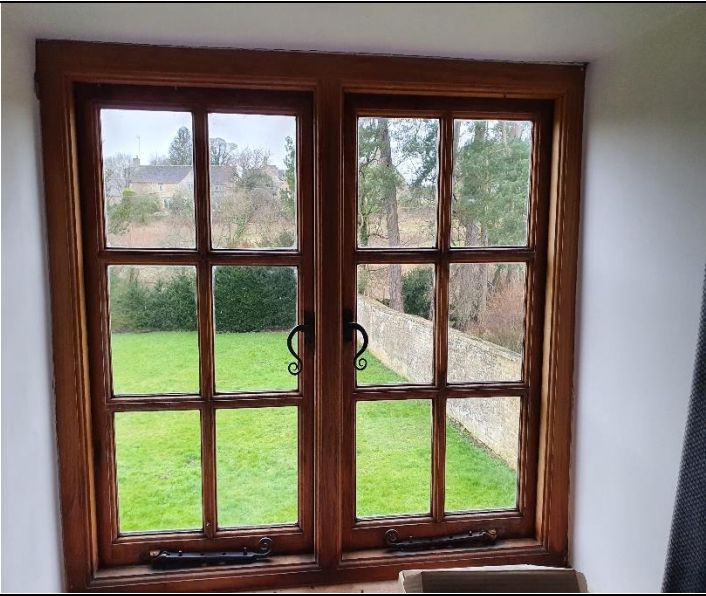
<p>W.07</p> <p><u>Existing</u></p> <p>Double light Timber Casement</p> <p><u>Proposed</u></p> <p>Steel Casement w/ 12mm double glazed unit</p> <p>Opening Sightline – 45mm</p> <p>Timber casement manufactured to fit into stone openings. Windows are not original to the property and no historic glass is present. Timber casement is starting to rot in the lower areas and is also swelling on the openers.</p>

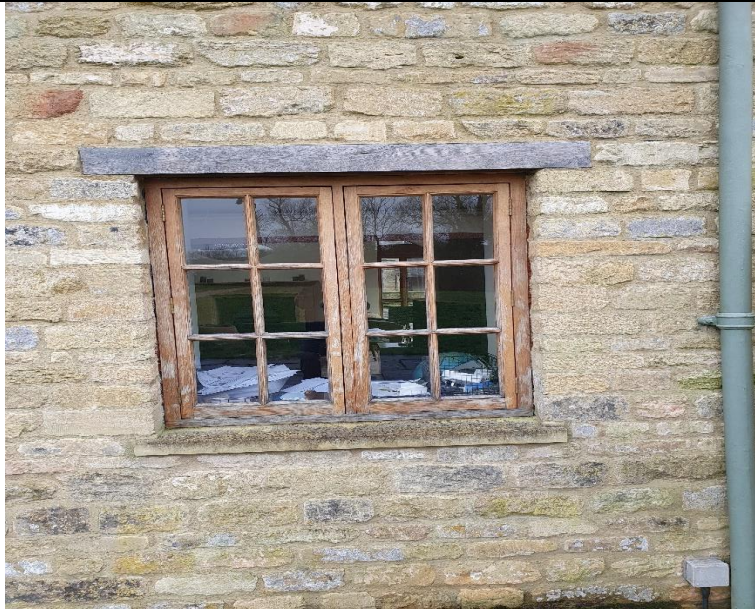
W.02

The timber windows have not been treated in a long time, so water has got into the frame which has made areas soft, this has caused long term damage.

Steel Casement w/ 12mm double glazed unit

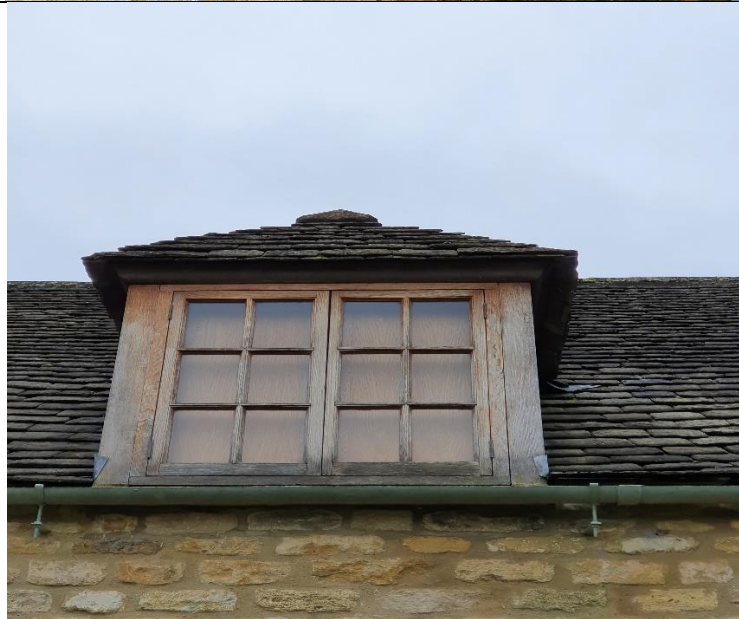
W.03

The dormer timber windows have gone soft at the cills and the bottom of the openers which has started them to rot as they have not been treated sufficiently over a period.

Steel Casement w/ 12mm double glazed unit

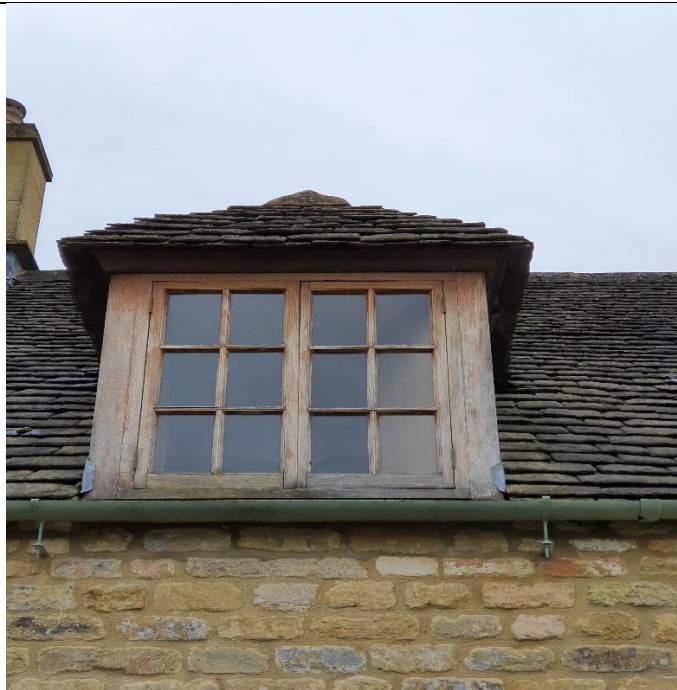
W04

The dormer timber windows have gone soft at the cills and the bottom of the openers which has started them to rot as they have not been treated sufficiently over a period. The opener was very difficult to open and close as swelling of the timber.

Steel Casement w/ 12mm double glazed unit

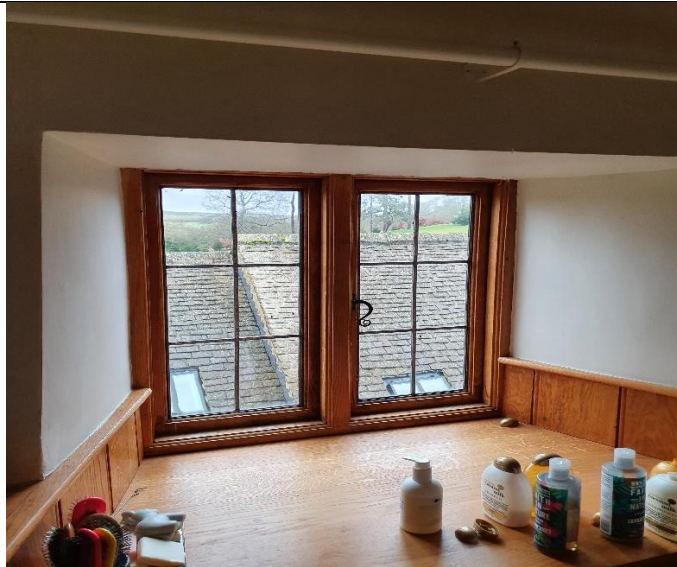
W05

Timber casements with a leaded design which is not in keeping, they are very difficult to open and close due to moisture swelling of the frames, this has caused lasting damage.

Steel Casement w/ 12mm double glazed unit

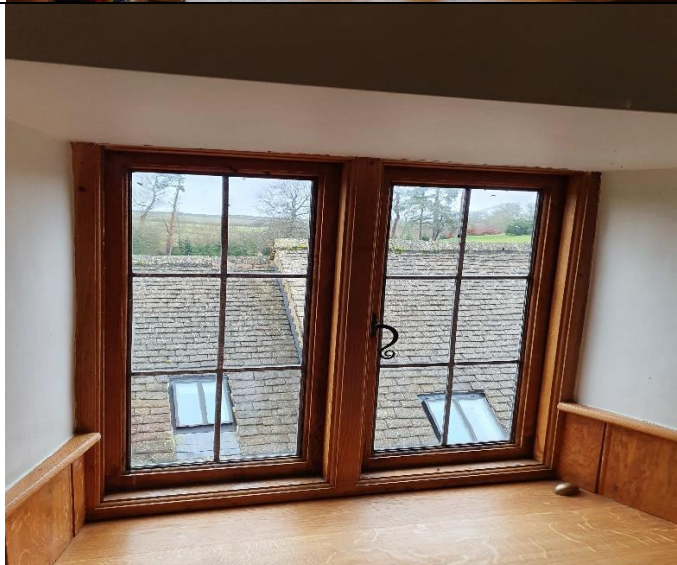
W06

Timber casements with a leaded design which is not in keeping, they are very difficult to open and close due to moisture swelling of the frames, this has caused lasting damage.

Steel Casement w/ 12mm double glazed unit

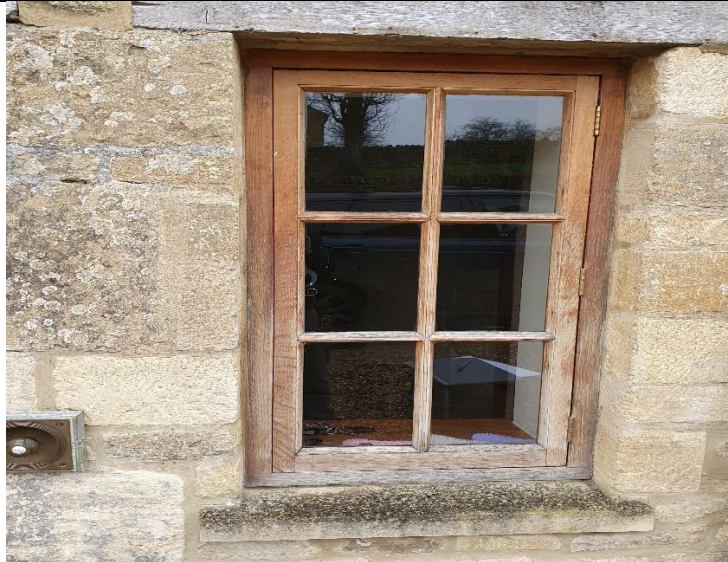
W08

Timber window in need of treating as signs of moisture in the frame, which may bring long term issues with in the frame causing it to not operate as it should.

Steel Casement w/ 12mm double glazed unit

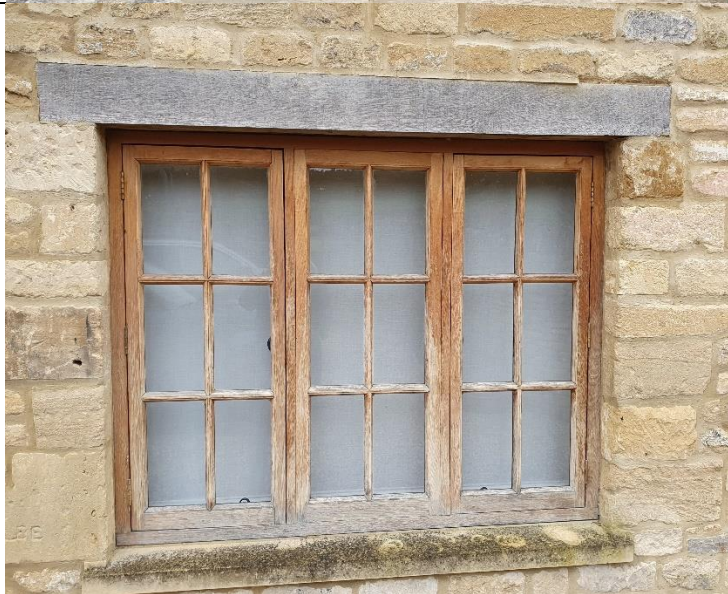
W09

The timber windows have not been treated over a significant period of time allowing water to get into the framework and making it soft in places, this causing long lasting damage.

Steel Casement w/ 12mm double glazed unit

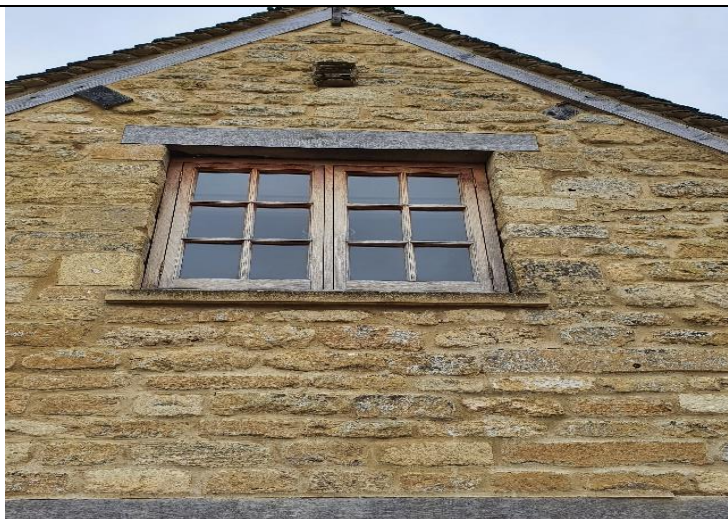
W10

Timber window has gone soft in places at the bottom of the outer frame due to lack of treatment of the wood, this has caused long term damage.

Steel Casement w/ 12mm double glazed unit

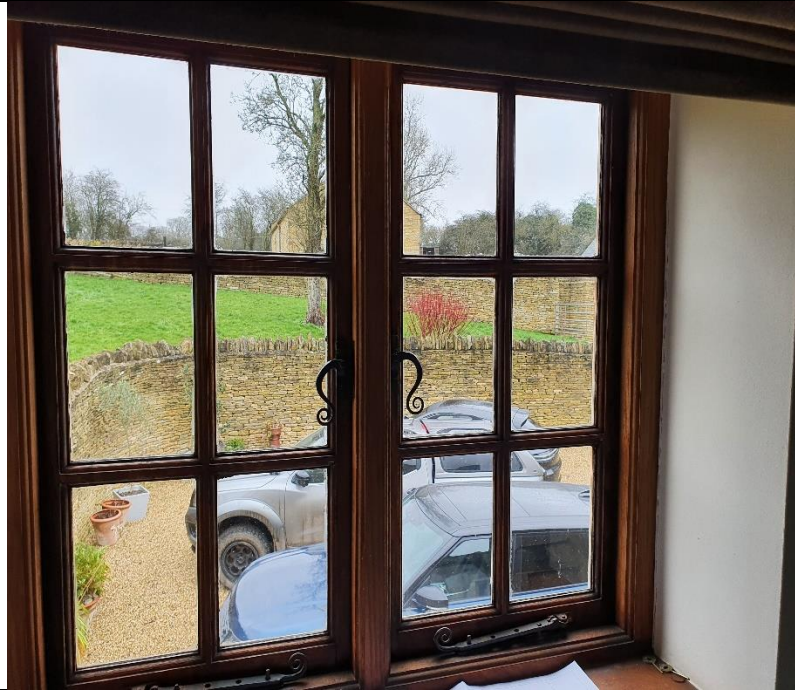
W11

Timber window has signs of water ingress at the cills causing swelling to the frame, this needed to be treated at an early stage to stop this happening.

Steel Casement w/ 12mm double glazed unit

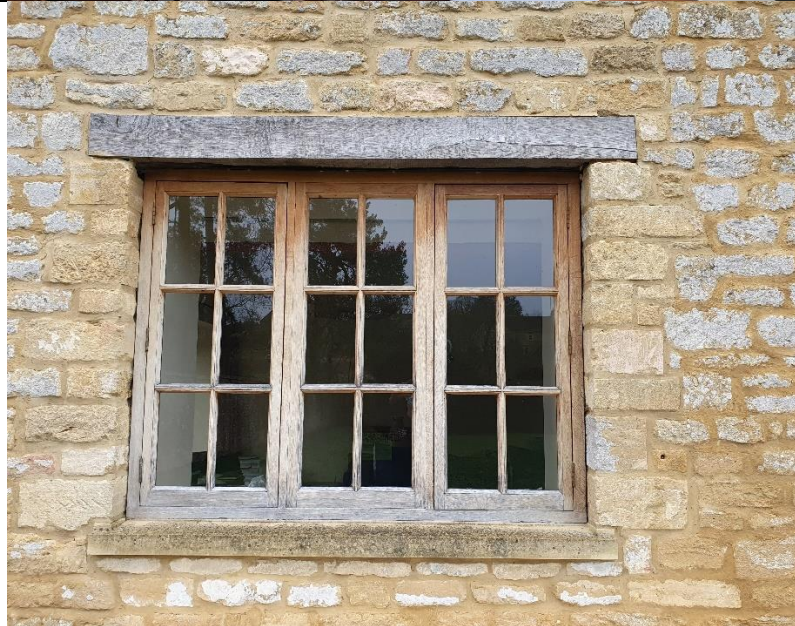
W12

Timber window has gone soft in places at the bottom of the outer frame due to lack of treatment of the wood, this has caused long term damage. The opener has difficult to open/close as lost shape.

Steel Casement w/ 12mm double glazed unit

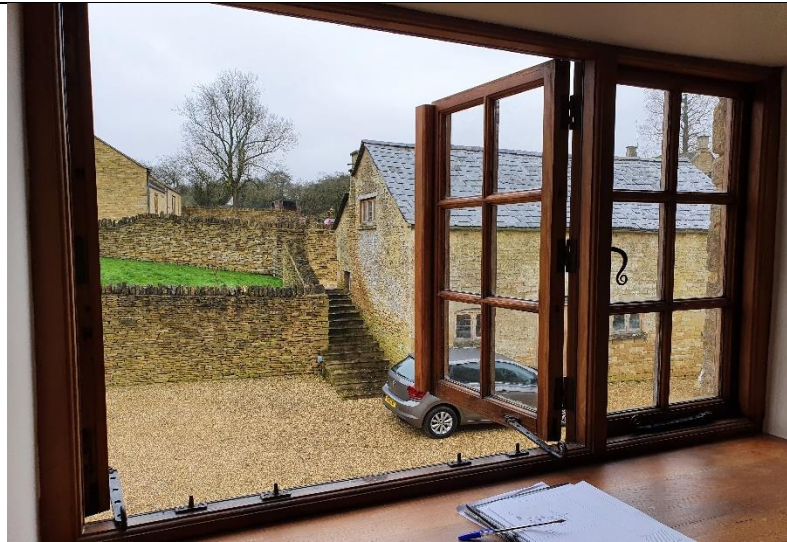
W13

Timber window shows signs off water ingress on the cills due to lack of treatment of the wood. The opening window was also swollen and very difficult to shut once opened.

Steel Casement w/ 12mm double glazed unit

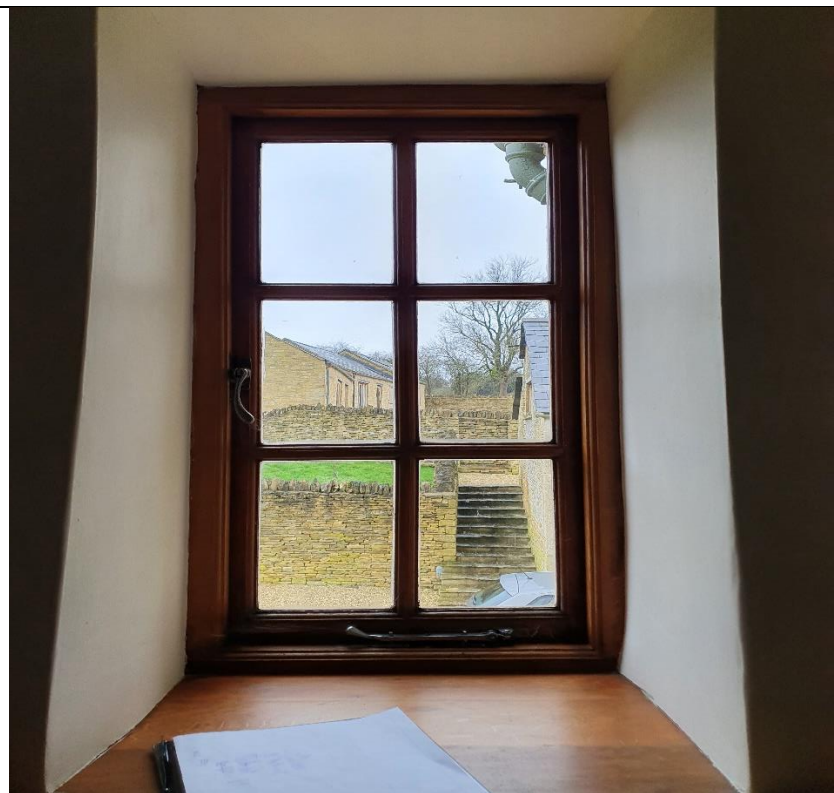
W14

Non original timber casement which has been added to the property at a later date. No rotting apparent but window is not original to property, no historical glass is present within the window.

Steel Casement w/ 12mm double glazed unit

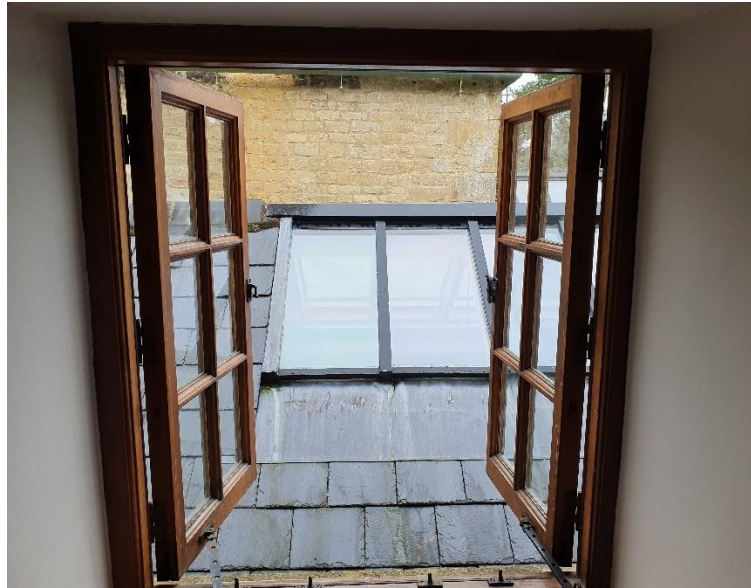
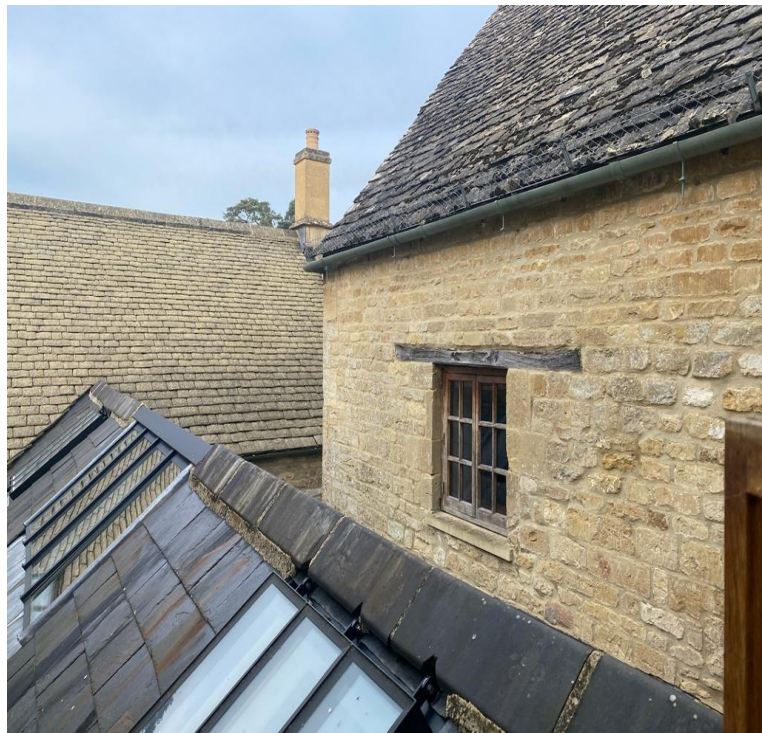
W15

Non original timber casement
which has been added to the
property later. Rotting apparent at
the cills and also swelling is
affecting the function, no historical
glass is present within the window.

Steel Casement w/ 12mm double
glazed unit

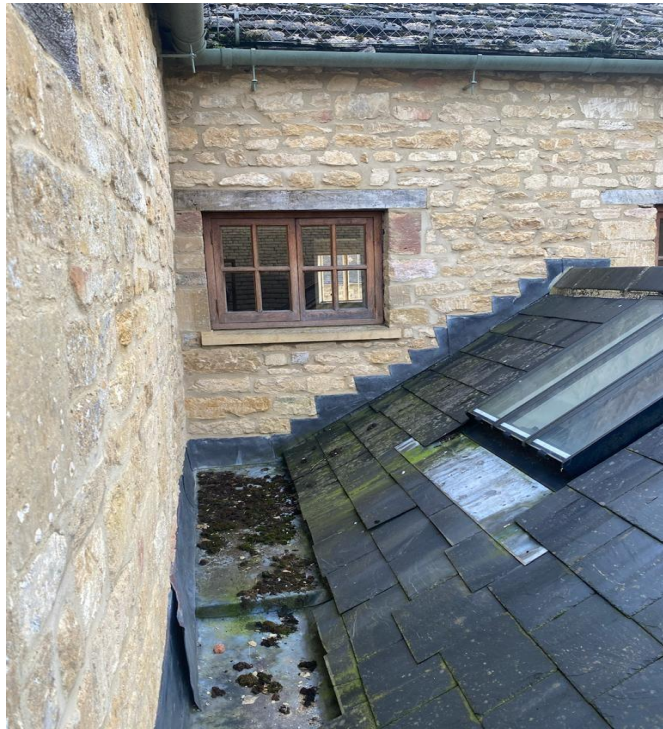
W17

The dormer timber windows have gone soft at the cills and the bottom of the openers which has started them to rot as they have not been treated sufficiently over a period, which has led to irreversible damage.

Steel Casement w/ 12mm double
glazed unit

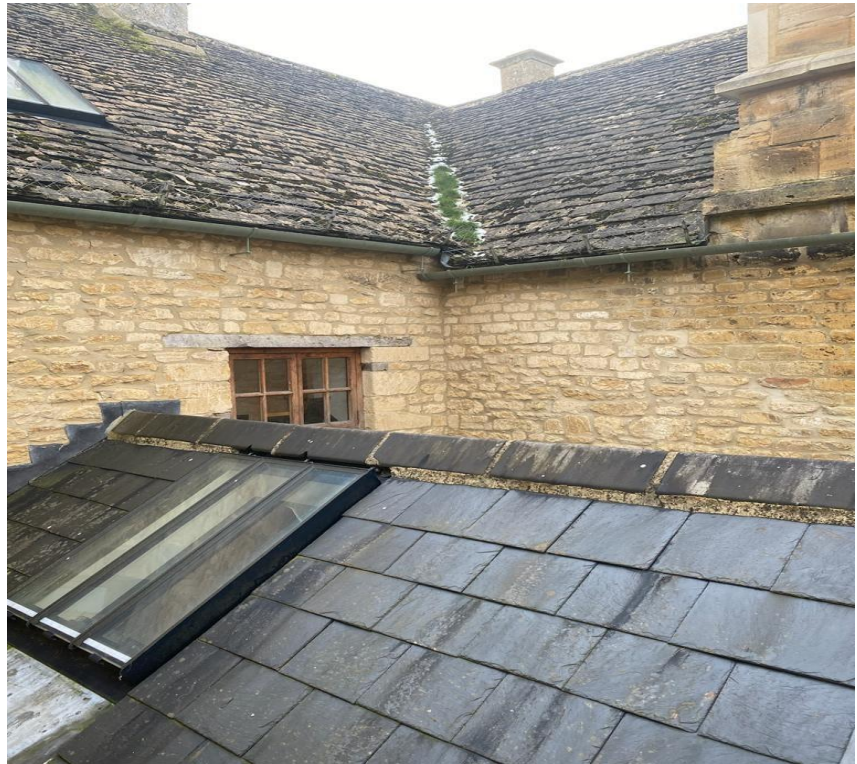
W18

The dormer timber windows have gone soft at the cills and the bottom of the openers which has started them to rot as they have not been treated sufficiently over a period, which has led to irreversible damage.

Steel Casement w/ 12mm double
glazed unit
