Report on condition
Cedar House
Church Avenue
Clent
Worcestershire DY9 9QT

Inspected on 11th February 2021

I have been instructed by Mr & Mrs A Yates of Cedar House to report on the condition of their property, Cedar House, to include maintenance and repair requirements associated with this type of property.

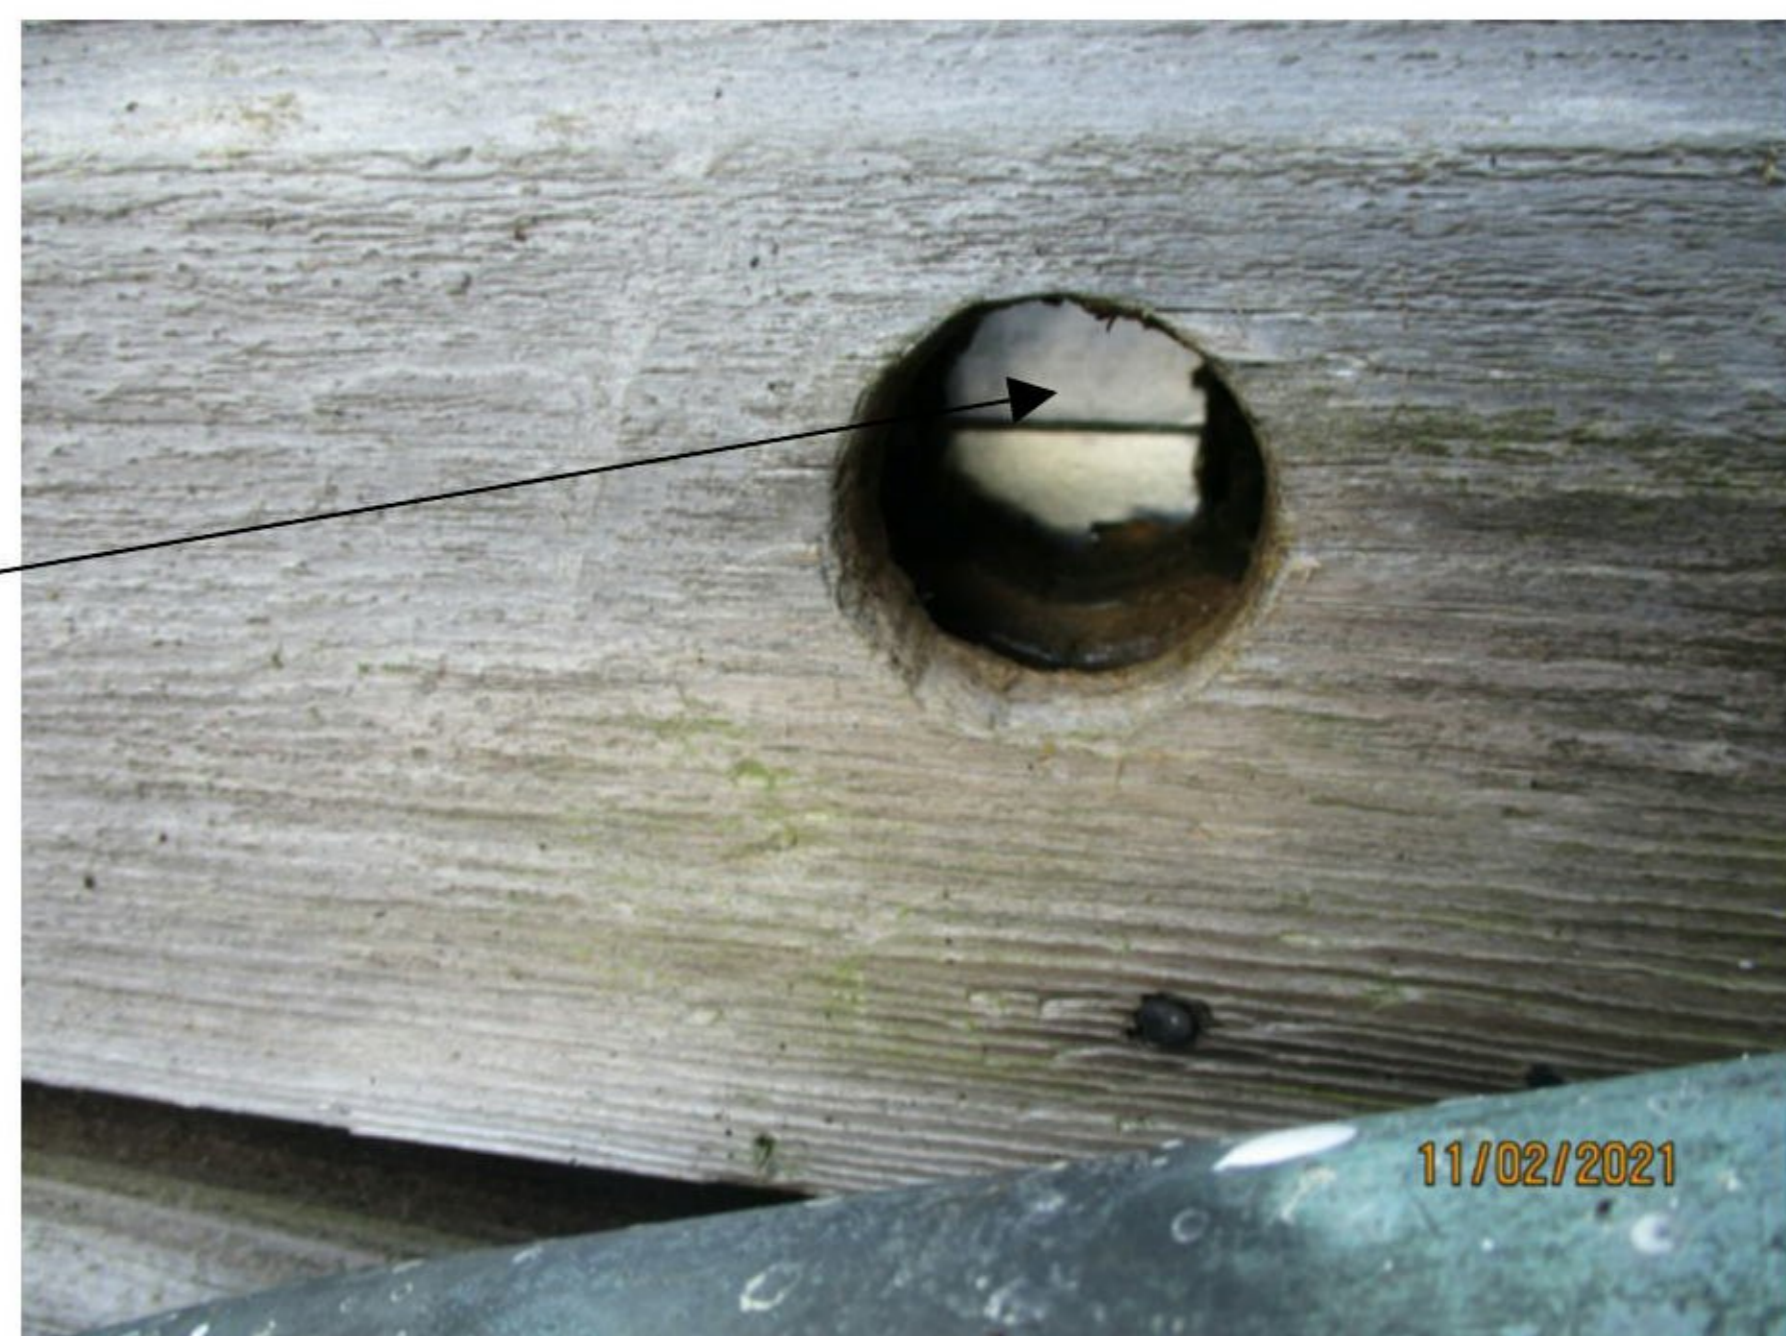
On the right-hand gable wall there is a hole in the external cladding where a waste pipe or similar has been removed. From this point it is possible to see through to the foil backed insulation boarding installed by the owners. I understand that it is in this one particular bedroom only. There is no intervening insulation.

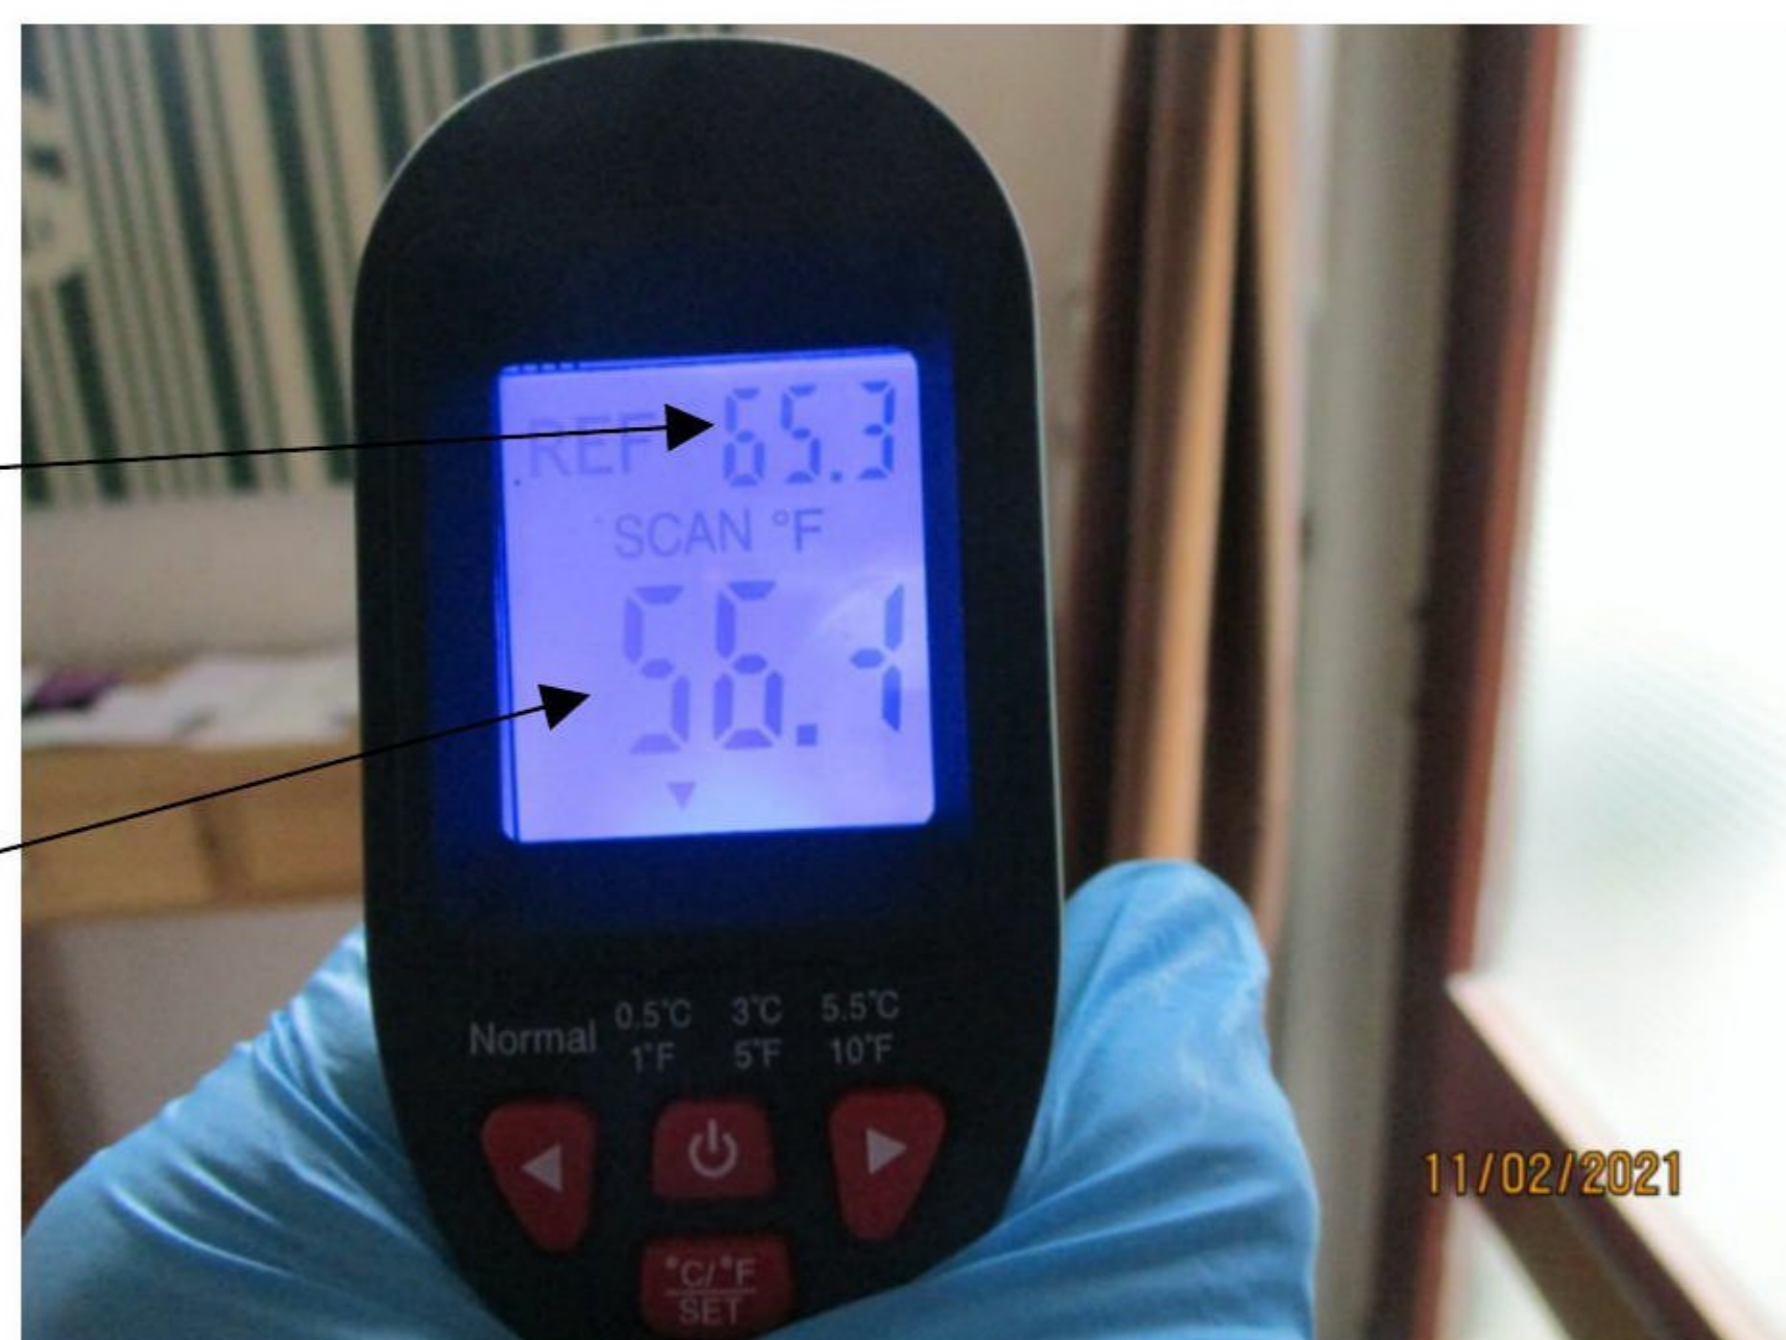
I checked the temperature of several walls using a laser thermometer. The first step is to take a reference temperature from an internal wall. This can be seen as the top reading on the adjacent photograph. The lower reading is the surface temperature of an external wall in the same room. Differences of 5° to 7° were noted in a number of rooms throughout the property.

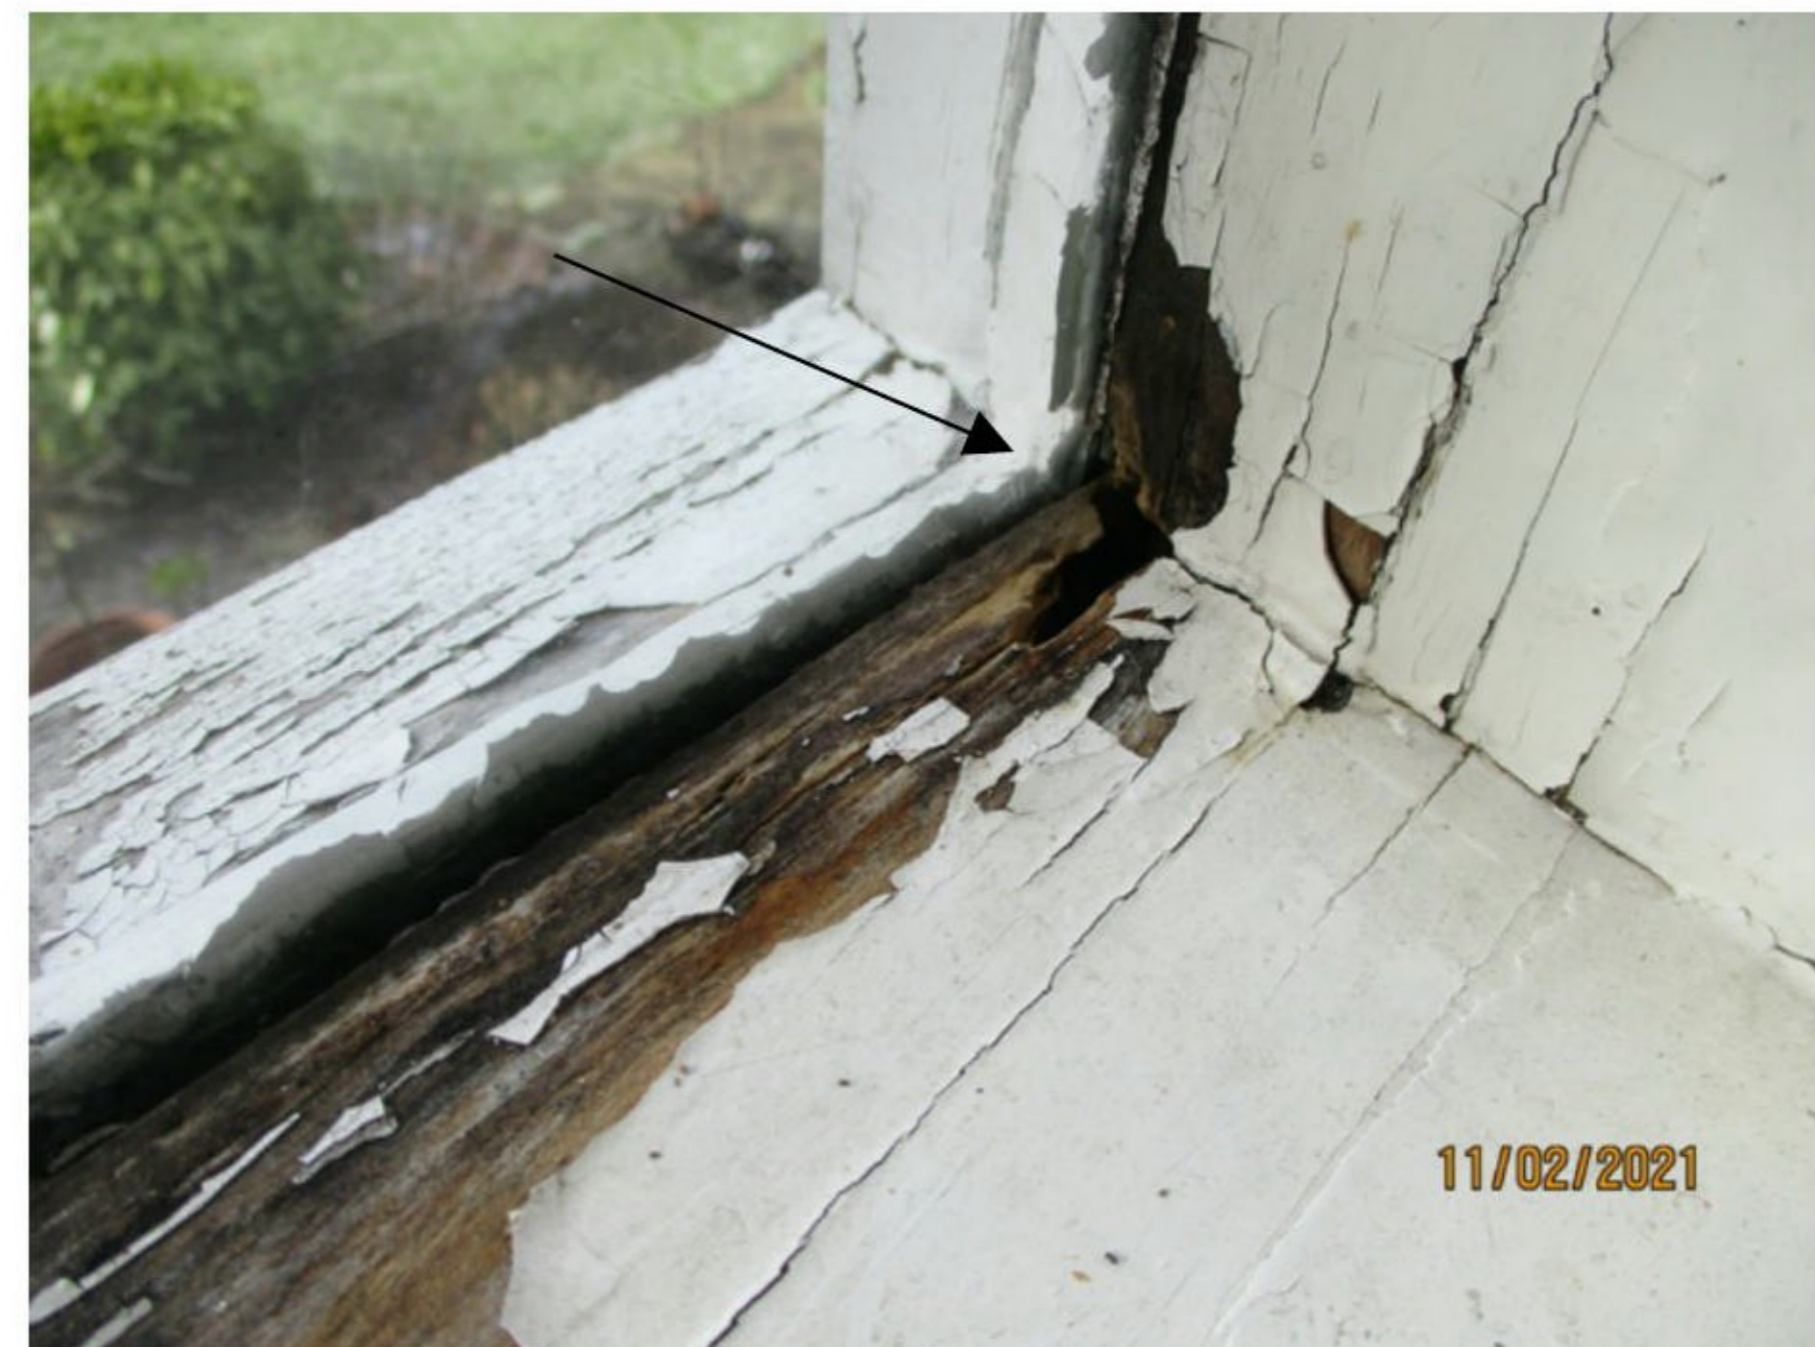
Condensation problems go hand-in-hand with poor insulation. In this case the original metal window casements, which are notorious for producing condensation, are still in place. I understand they have to be wiped down every morning to remove condensation although this was still visible in one room at the time of my inspection. Despite the owner's efforts the condensation has rotted the internal frames in a number of areas.

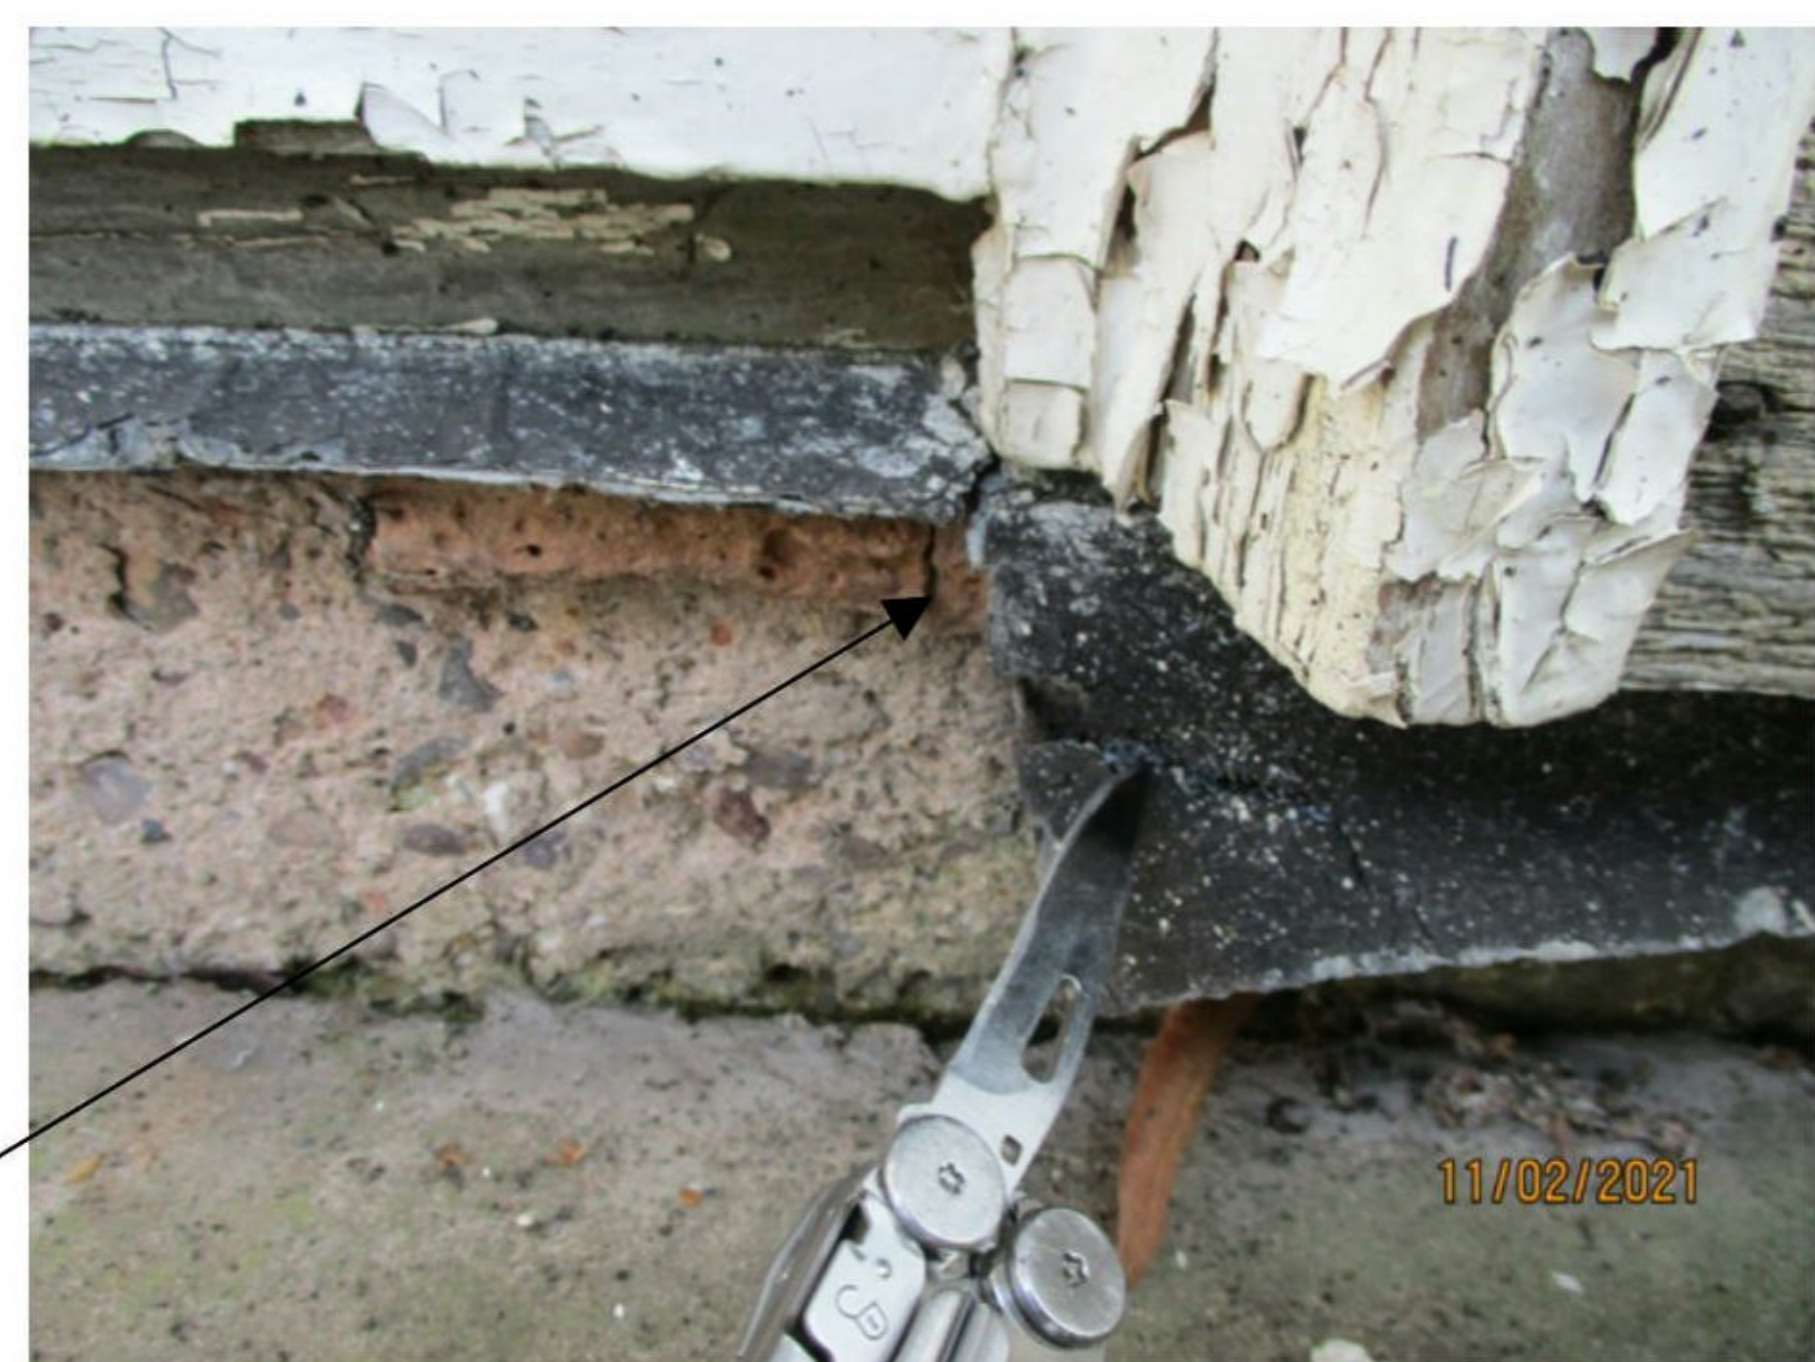
Working drawings for the property and my own inspection indicate that the timber panels are set onto brick footings with a layer of bitumen material providing a damp proof course. In this case the exposed bitumen has become brittle with age making it easy to break down. As a result its effectiveness is limited. Because it projects beyond the timber it is holding moisture on the exposed upper surface and is allowing deterioration of the lower timber panels.

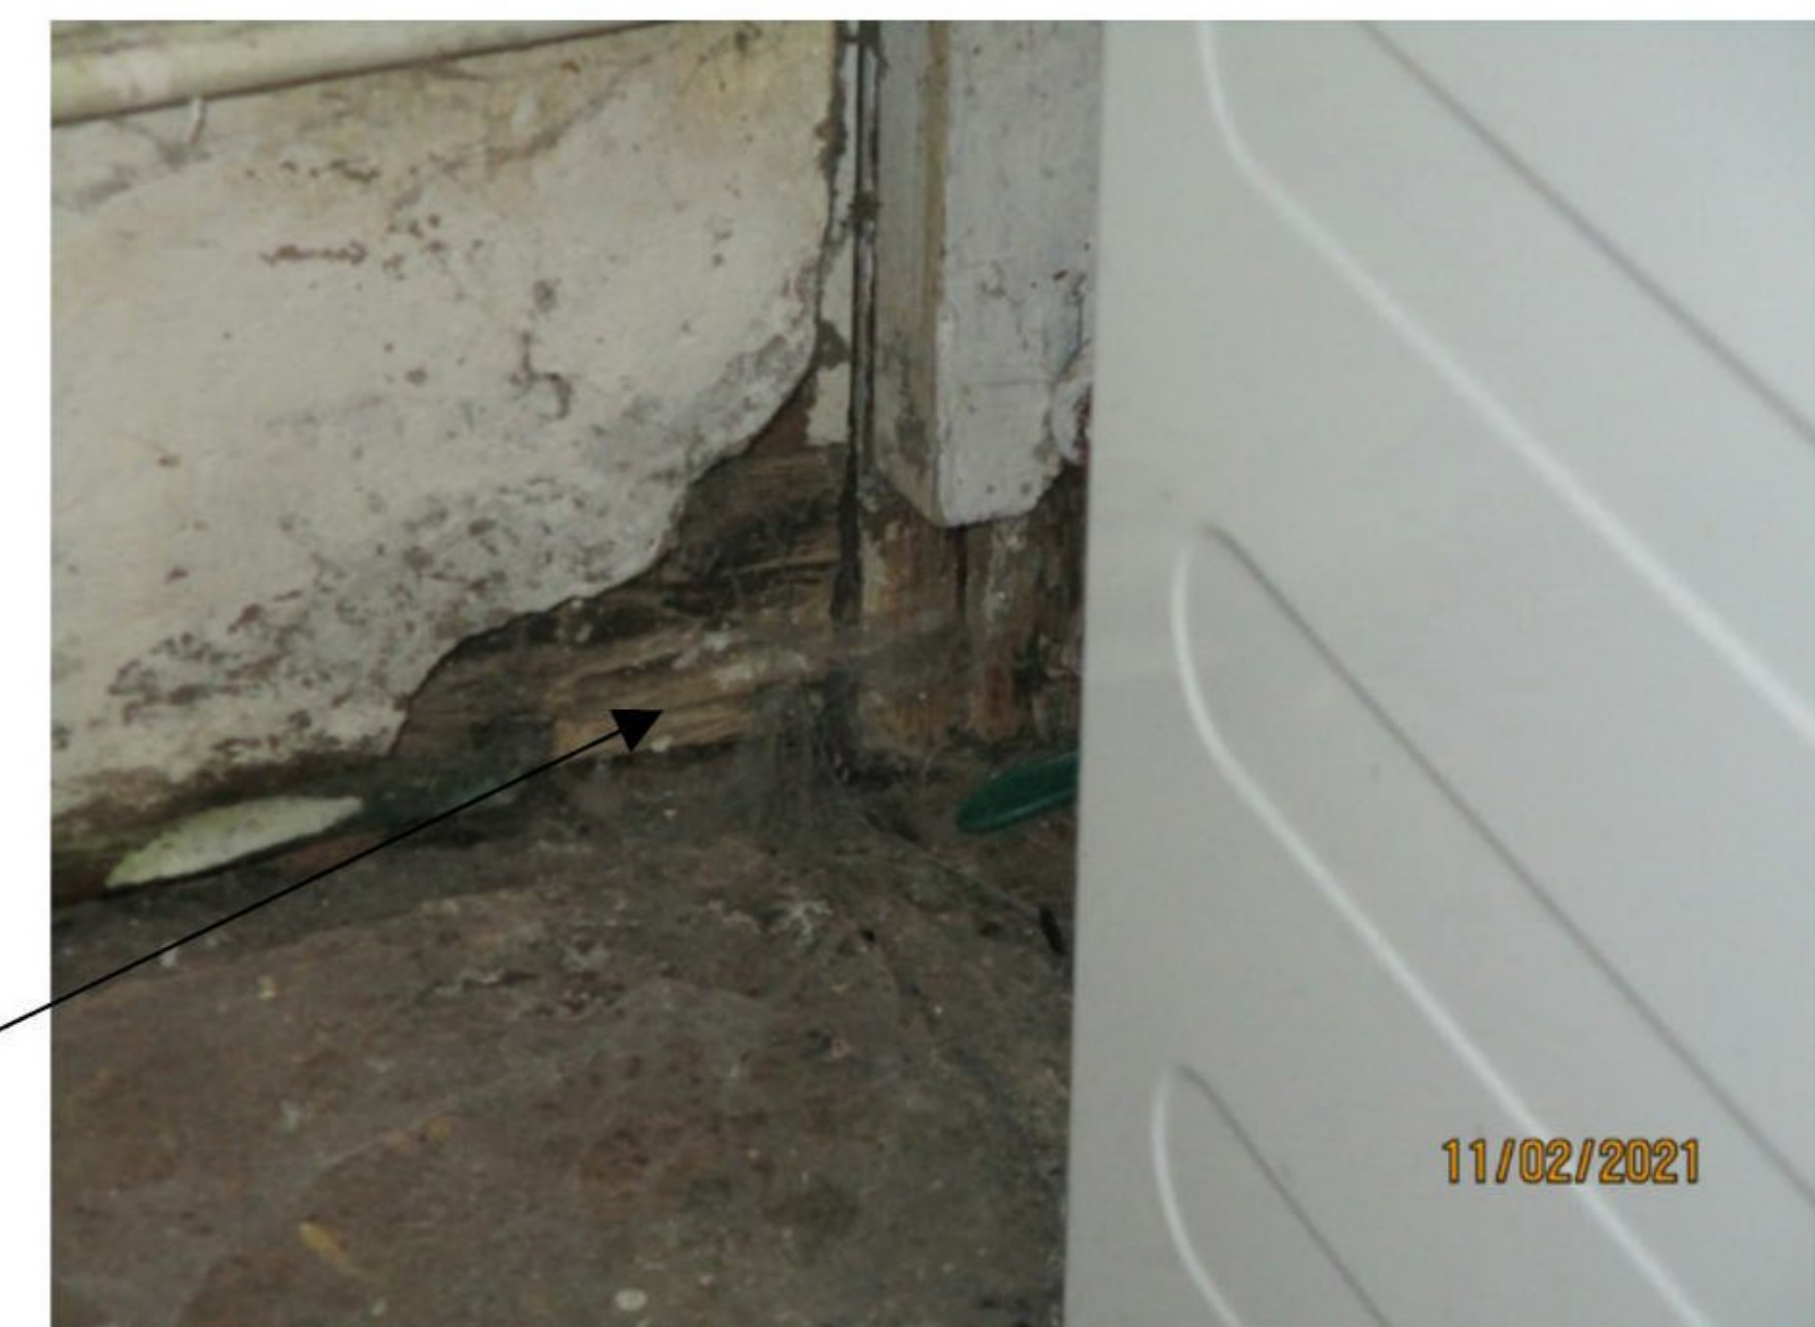
Internally there is also evidence of deterioration to the lower timbers.

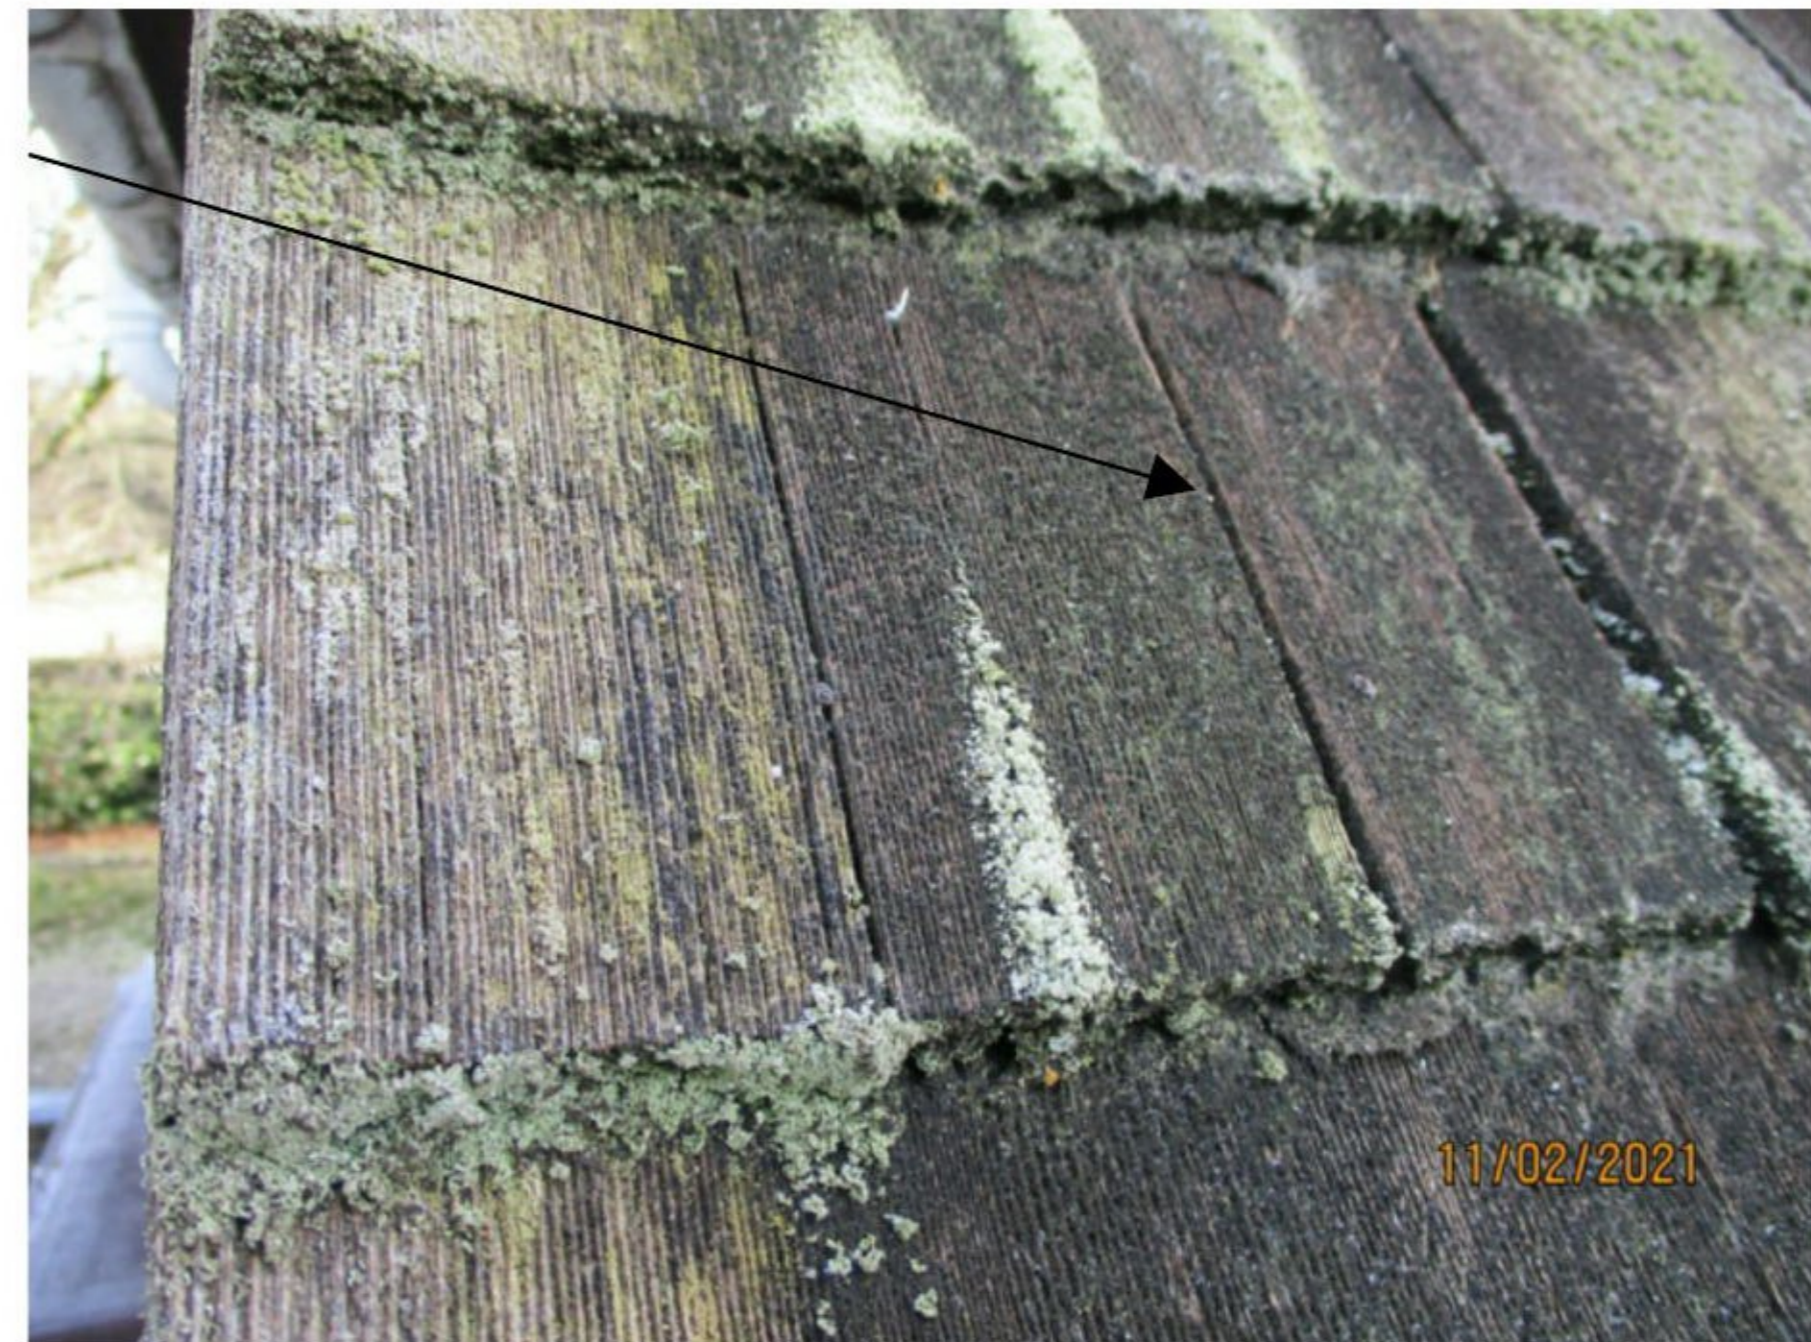
Cedar roof shingles of this type have a normal life expectancy of between 30 and 40 years. They will then need extensive overhaul to include replacement.

The shingles on this particular roof have warped and are beginning to split along the grain. There is also mildew where the shingles are in shadow particularly adjacent to the dormer windows. Similar symptoms are evident on the garage roof.

As referred to earlier the roof shingles have deteriorated and I consider that they have reached the end of their effective lifespan and need to be replaced.

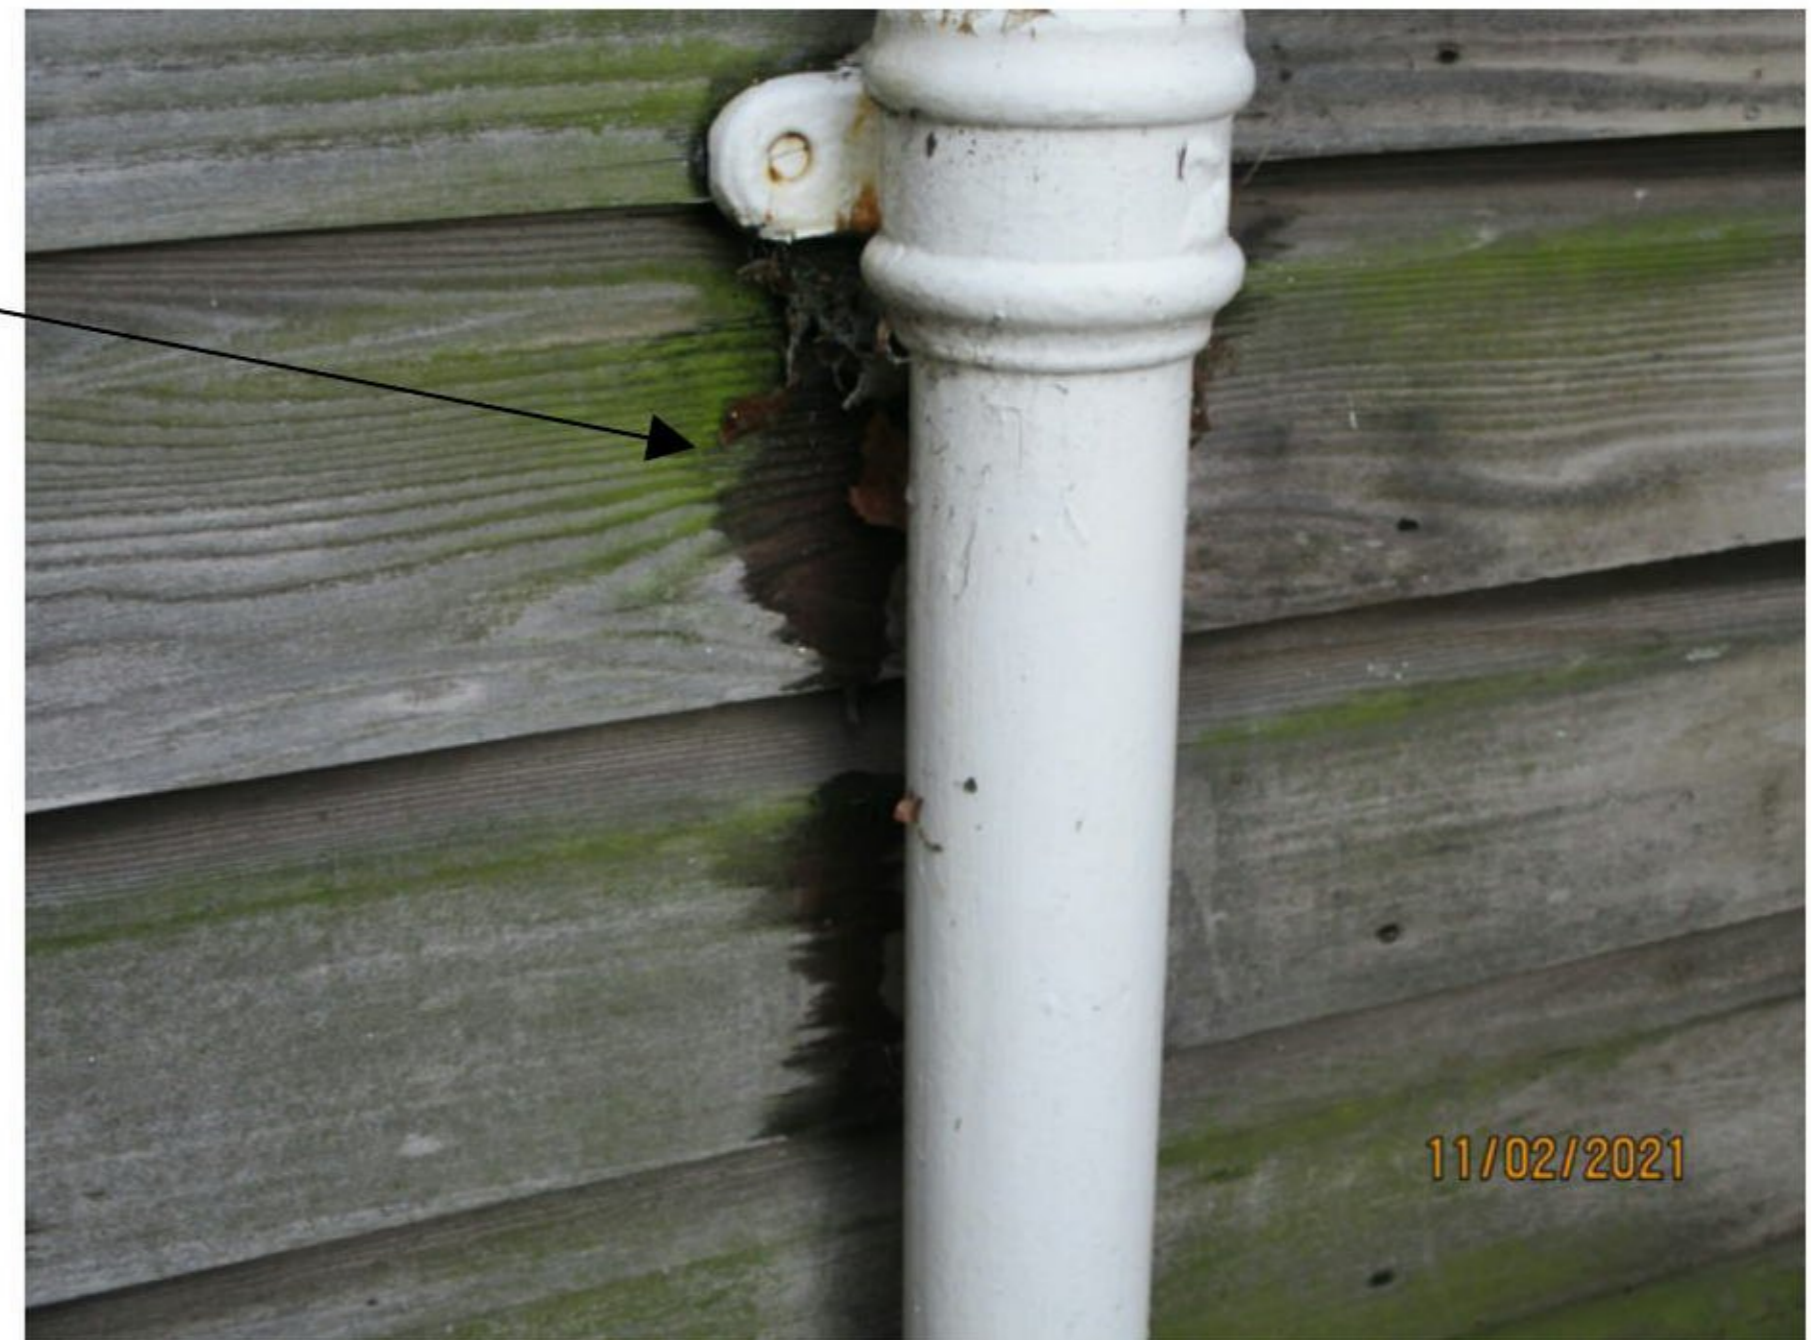
The rainwater goods are showing evidence of corrosion. Where one downpipe joint has started to leak it is allowing water onto the timber cladding which will result in deterioration.

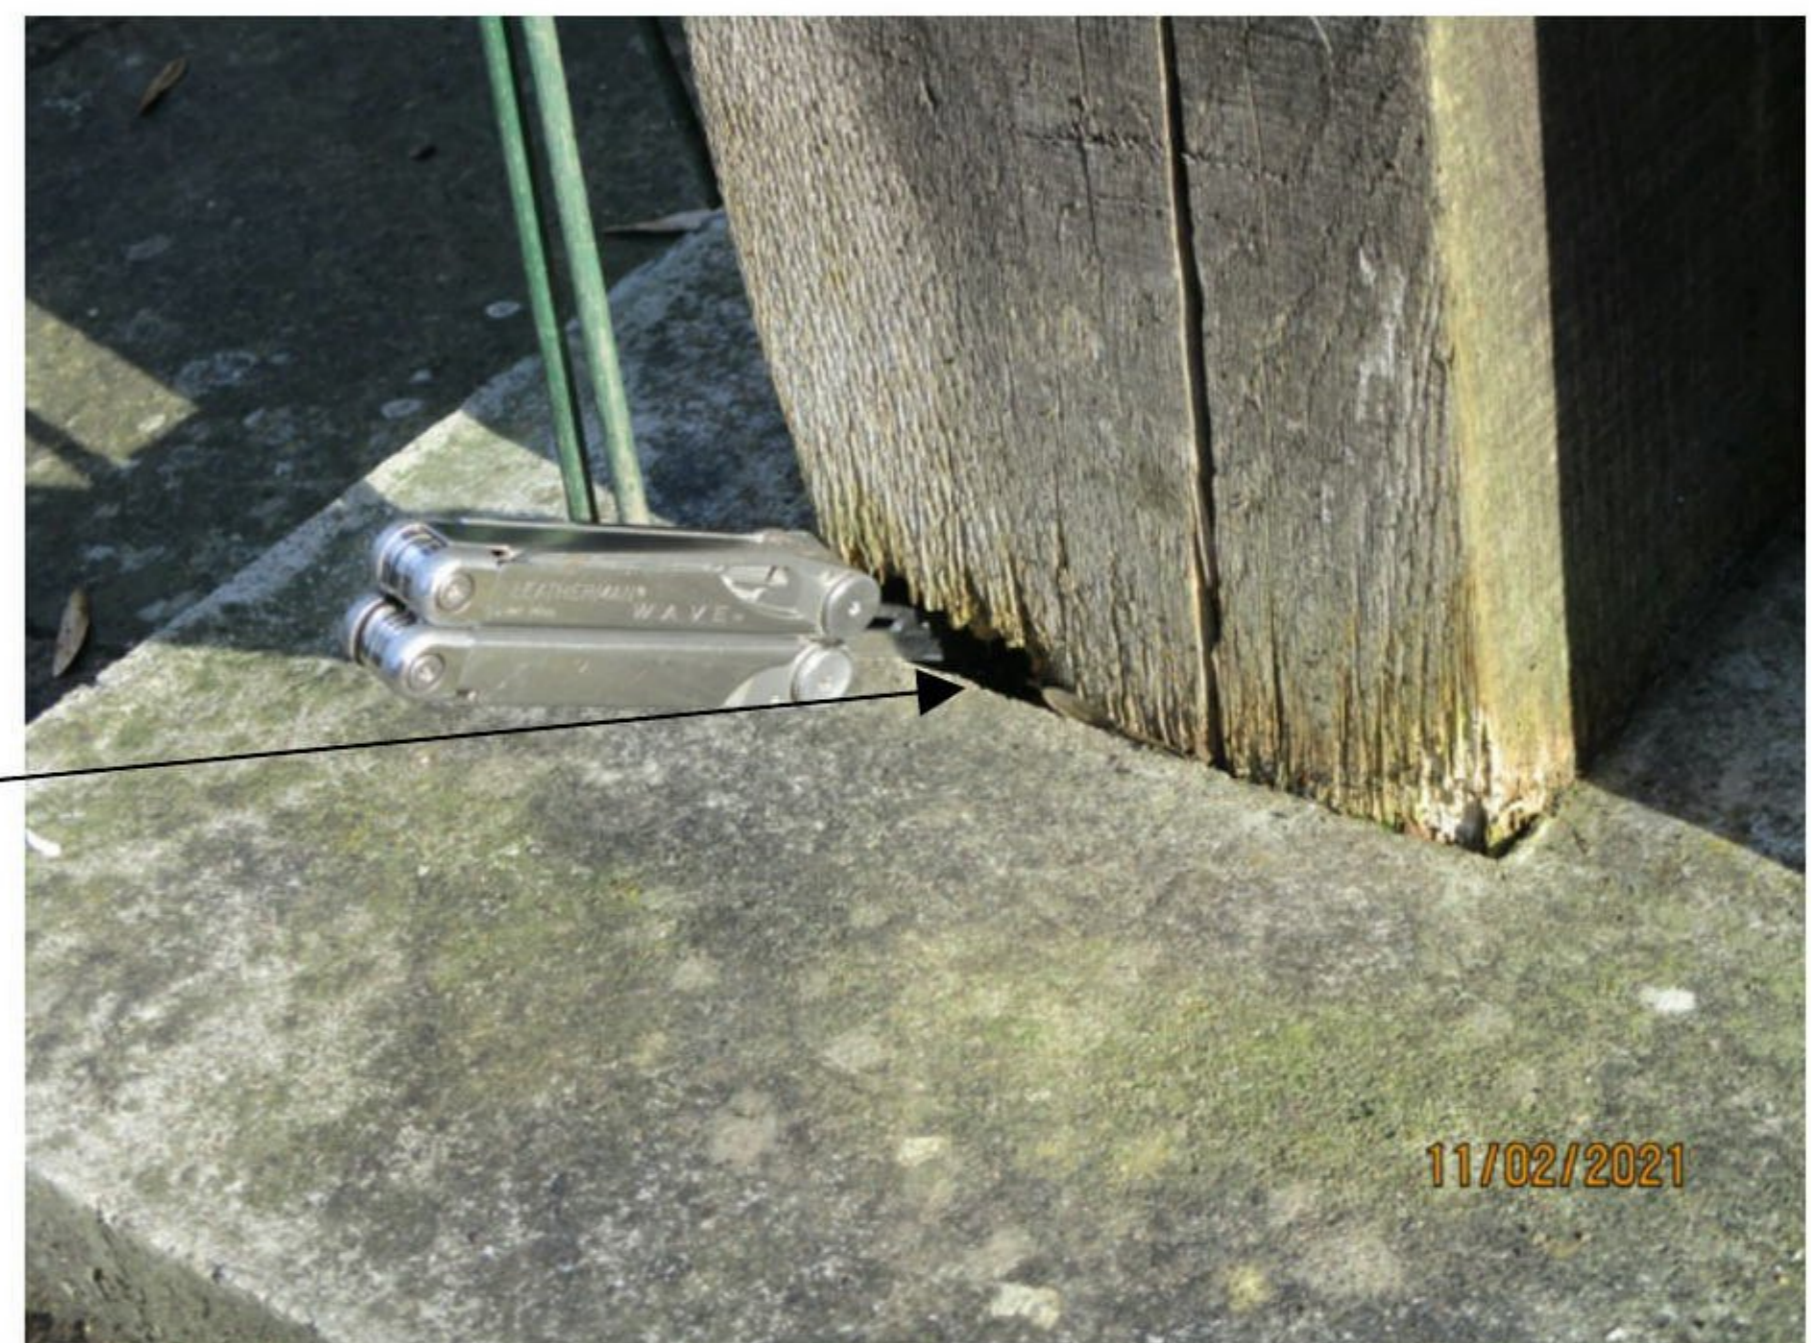
Deterioration is evident to the wall panels as referred to earlier. At the rear of the property is a first floor projection supported on timber posts. One of the posts is rotten which will cause the projection above to subside.

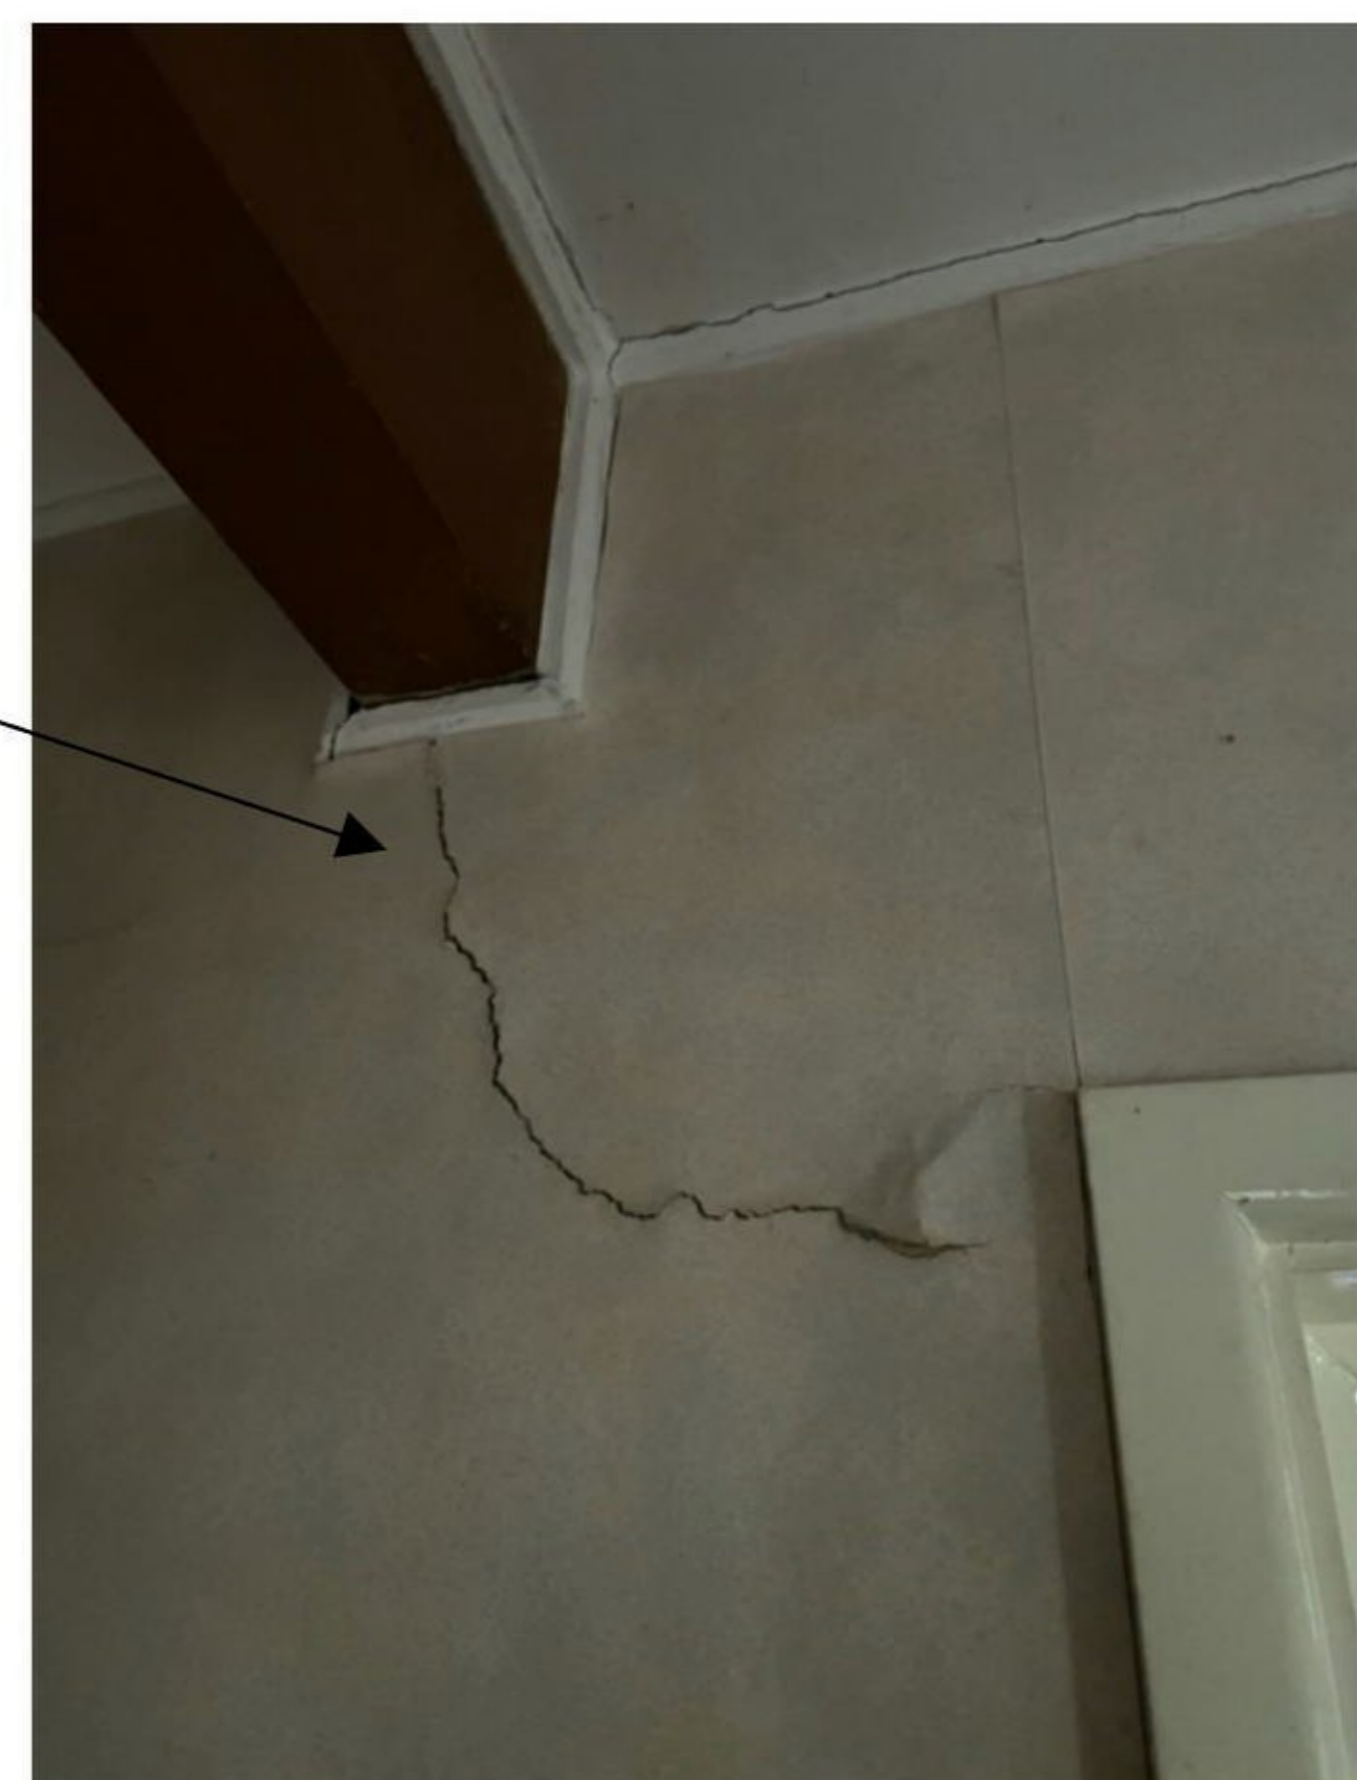
Internally there is also evidence of movement with cracks at the panel joints. A further invasive inspection is require to diagnose the extent of damage.
