Report on condition
Cedar House
Church Avenue
Clent
Worcestershire DY9 9QT

Inspected on 11th February 2021

I have been instructed by Mr & Mrs A Yates of Cedar House to report on the condition of their property, Cedar House, to include maintenance and repair requirements associated with this type of property.

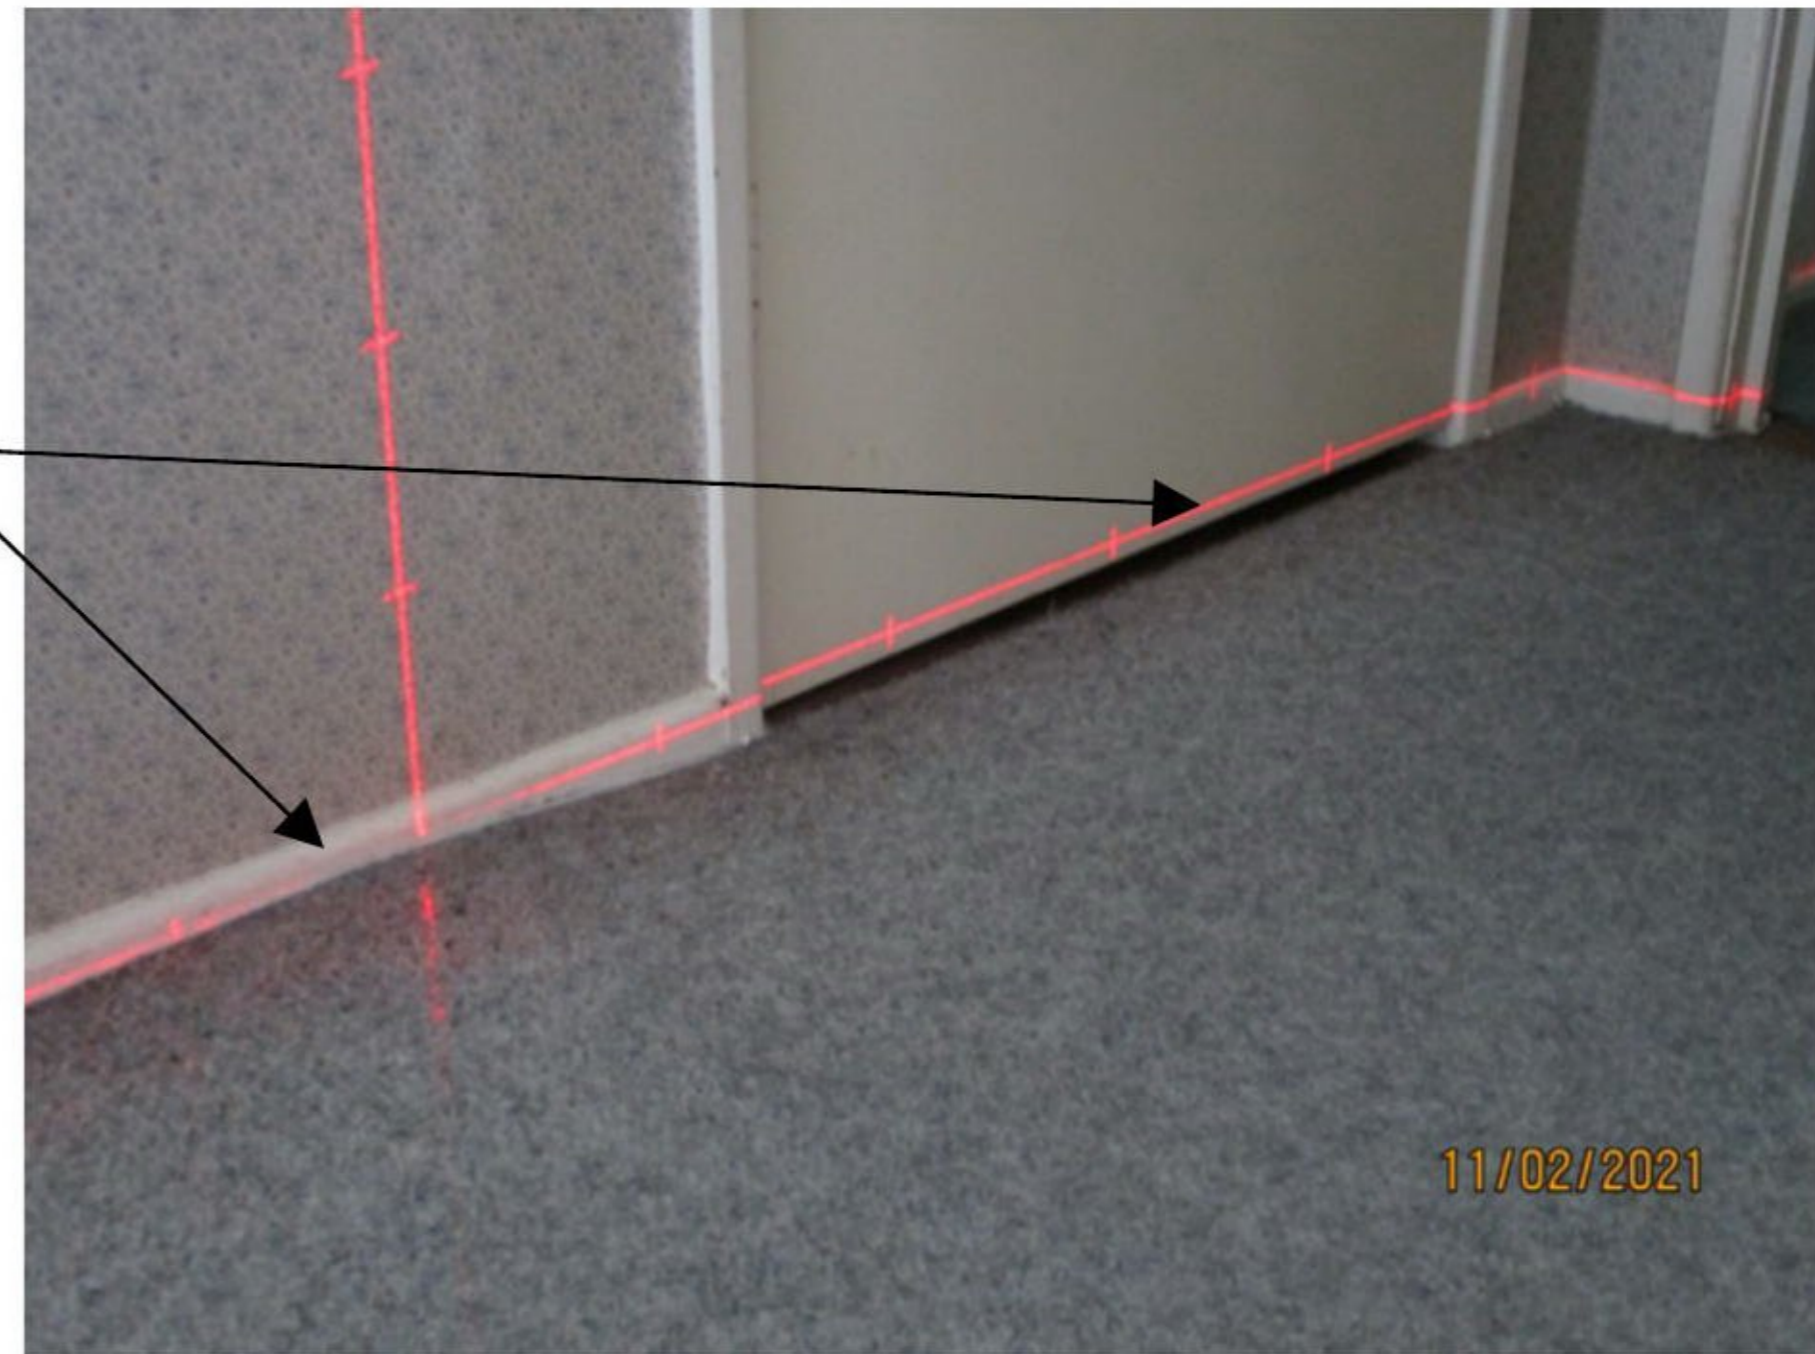
The left-hand section of the house is an extension which I understand was constructed a little over 50 years ago. There is a marked change in floor level on entering the extension at first floor level. It is most unlikely that it was constructed in this manner and I formed the opinion that the change is the result of movement within the timber frame.

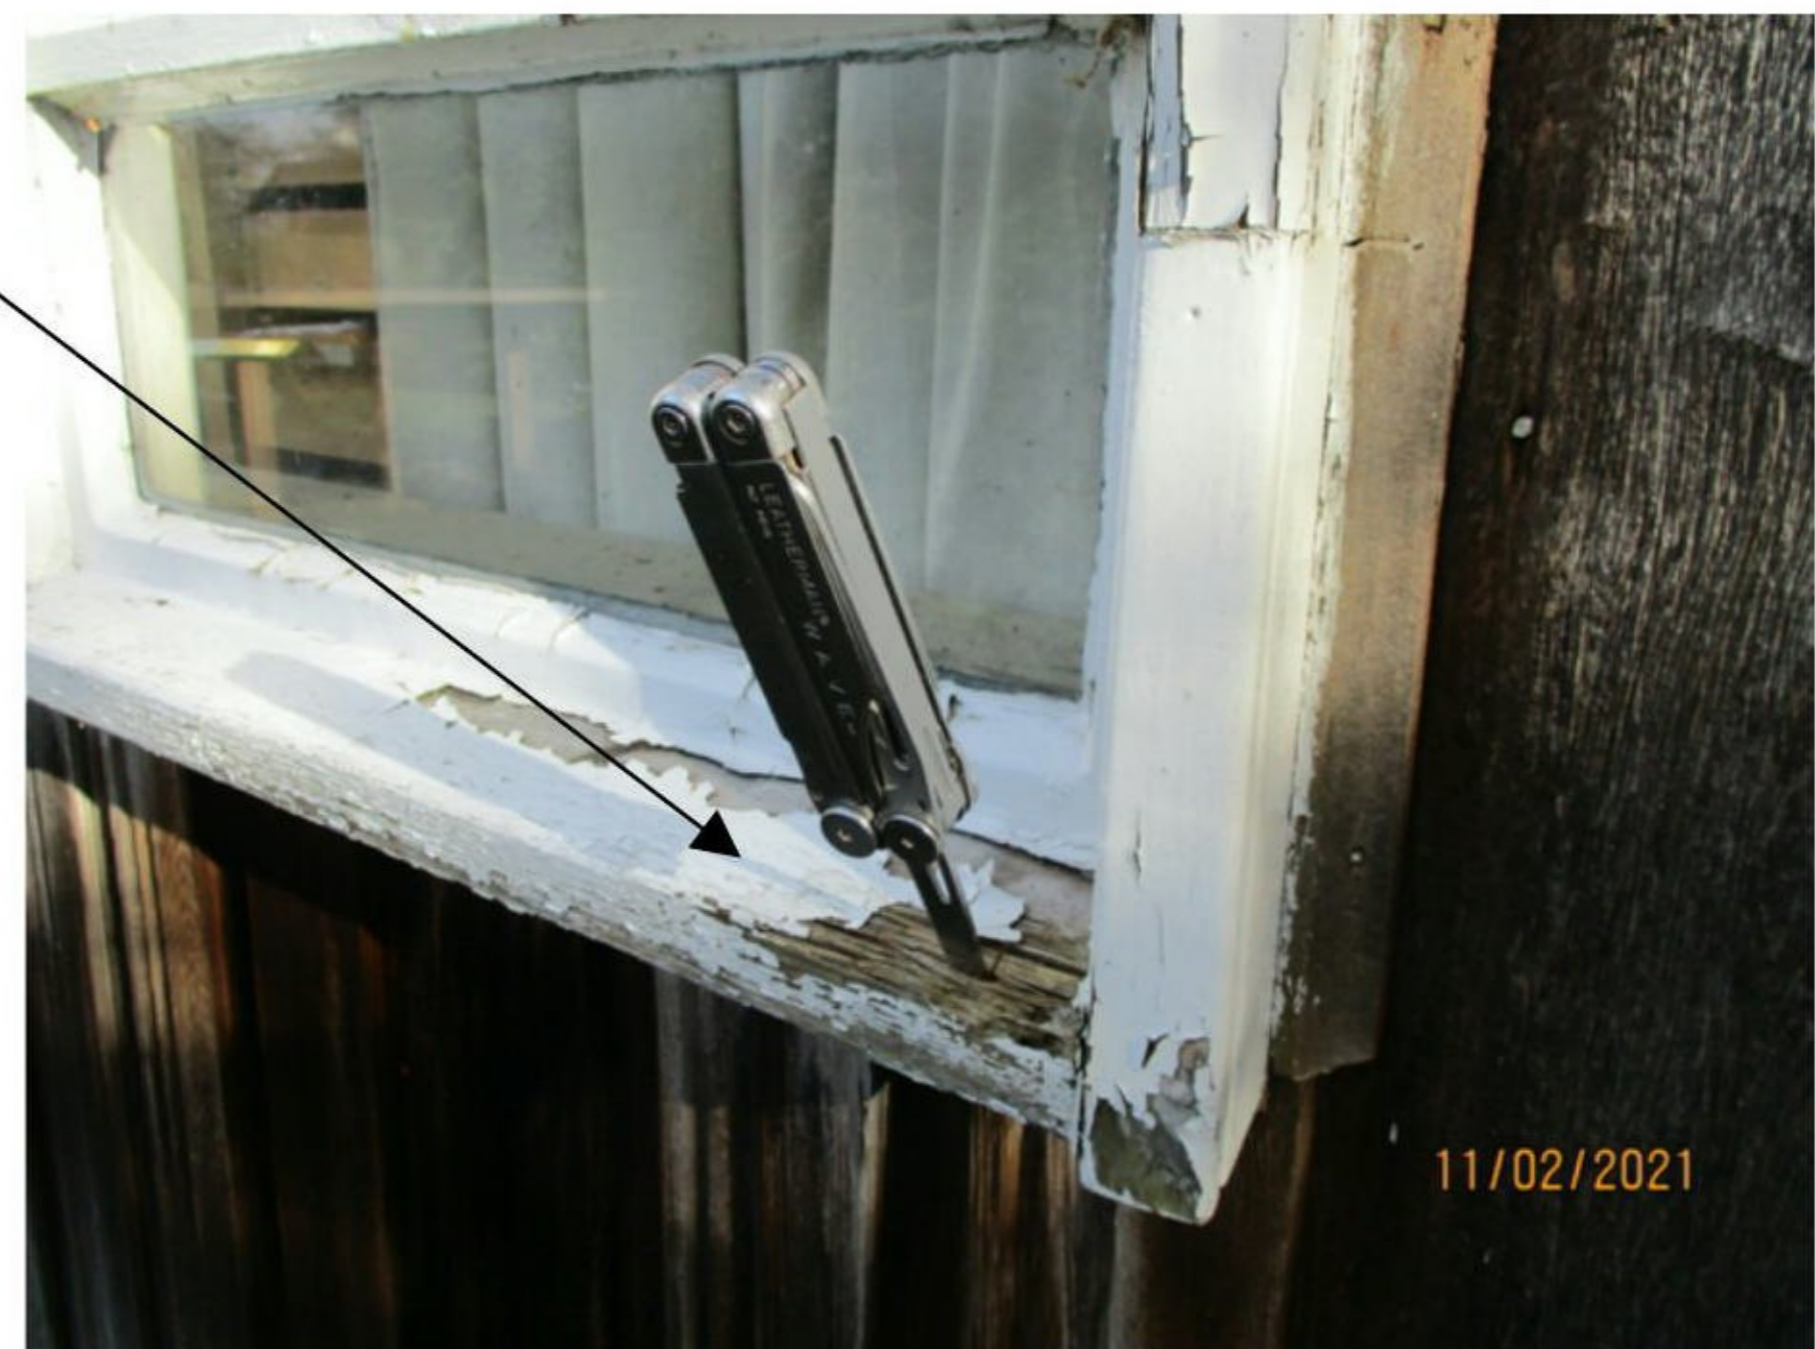
The windows are heavily corroded and beyond repair. They have caused damage to the wooden frames internally and externally.

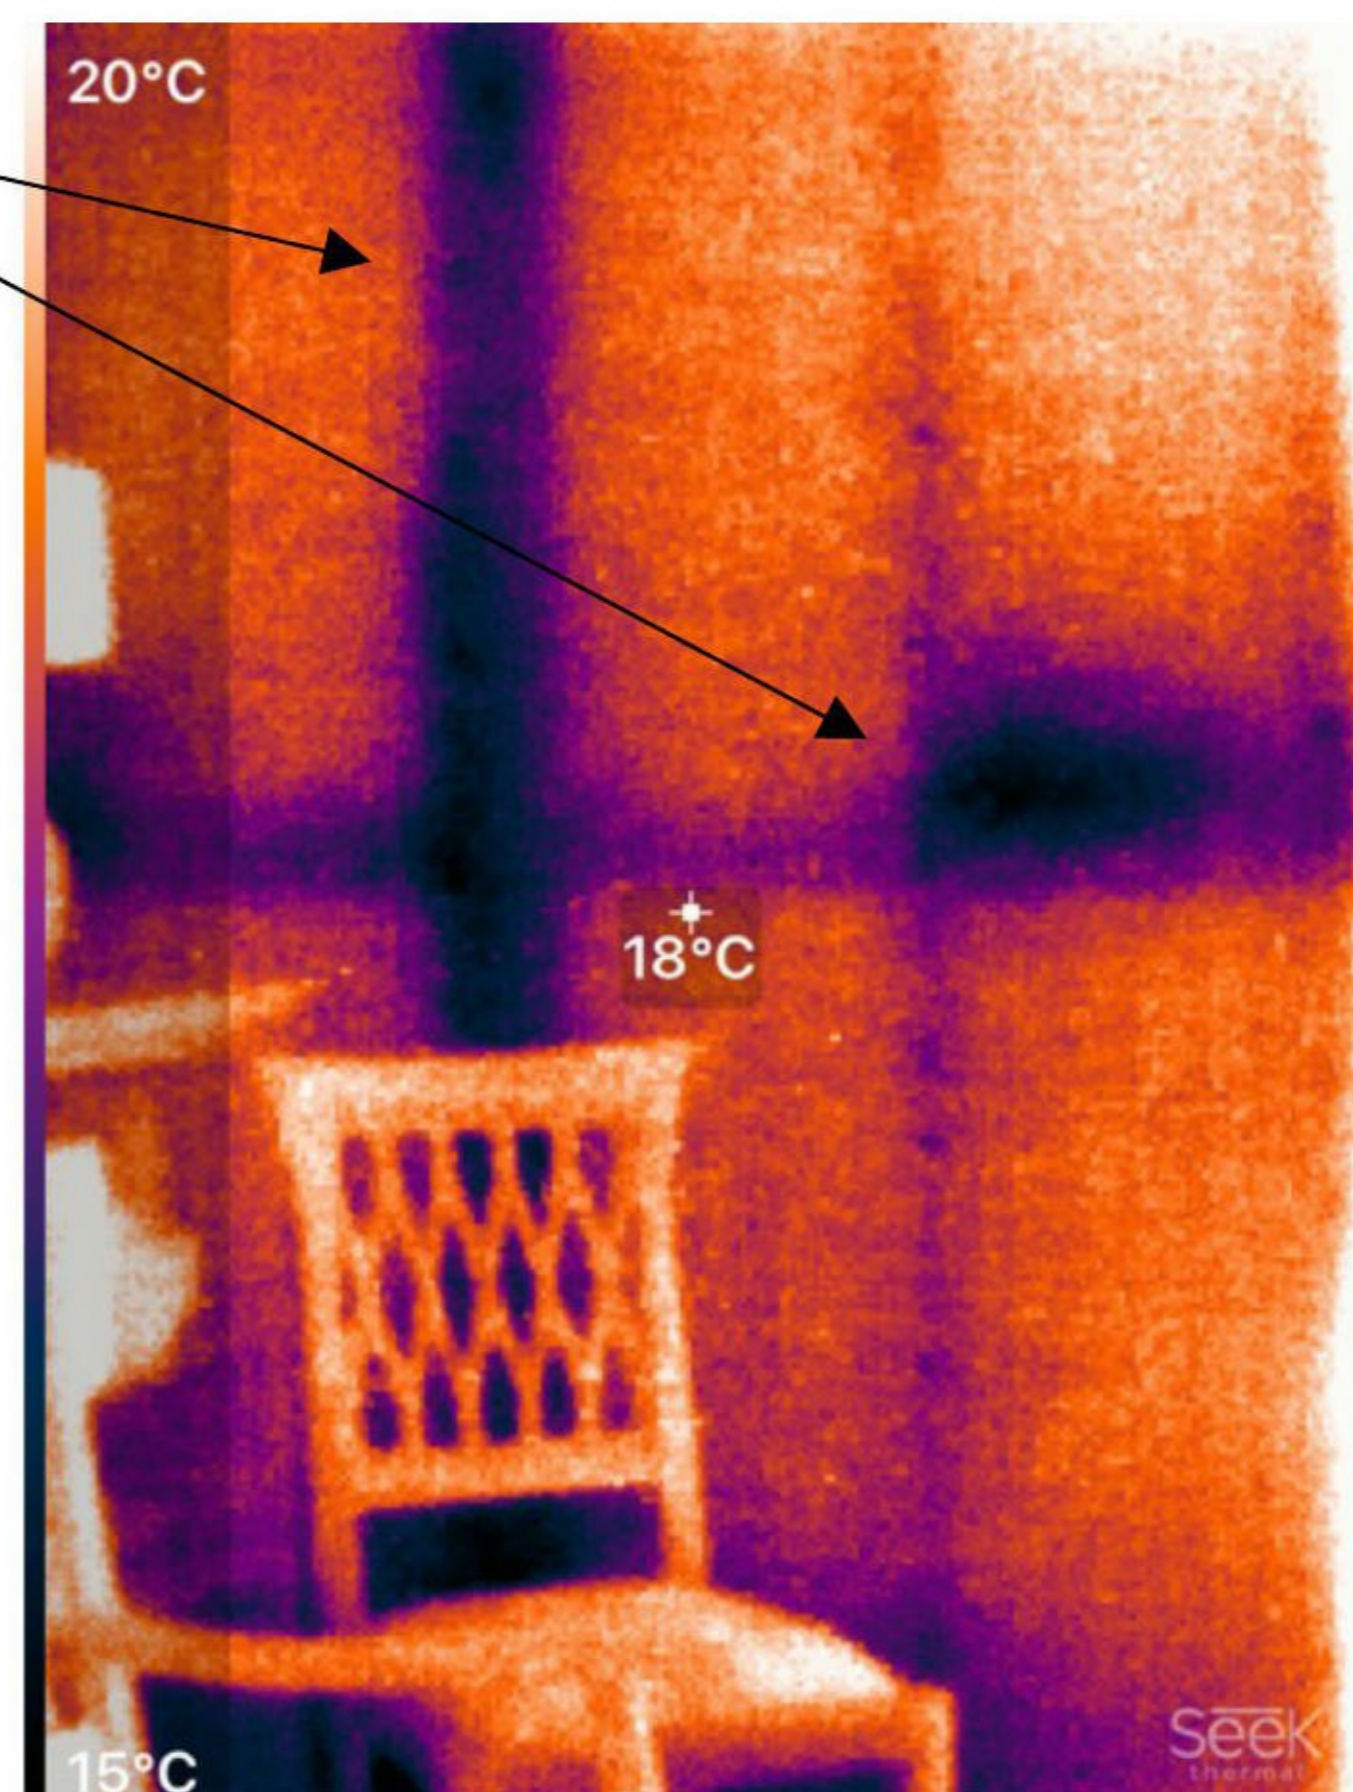
Using a thermal imaging device it is possible to detect the timber frame members which cause a 'cold bridge' allowing heat to escape and cold to penetrate.
