Photographic Schedule of condition

Project 1922

Units 116 & 119

Cannon
Workshops

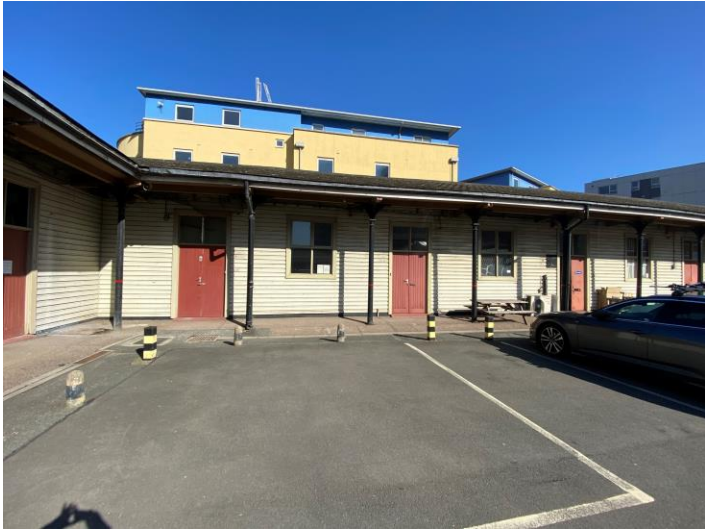
Image (1)

1. The building is in poor exterior decorative order, there are numerous penetrations to the façade because of previous tenant fixtures (evidenced by images: 1, 2, 9, 10, 11, 12 and 13).

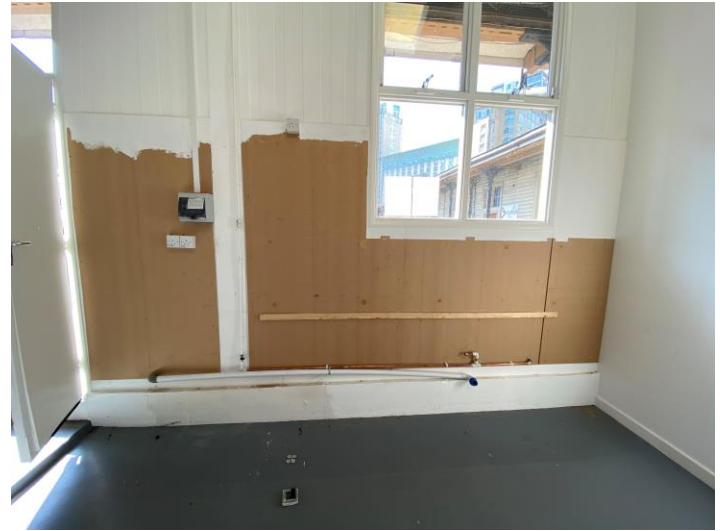
Image (4)

2. Interior walls and ceilings are in poor condition with damaged surfaces following previous occupier fit out removal (evidenced by images: 4, 5, 20, 21, 23, 24, 25, 26, 27, 28, 29, 30, 31, 32, 33, 34, 35, 36, 37, 38, 39, 40, 44, 45, 46, 47 and 48).

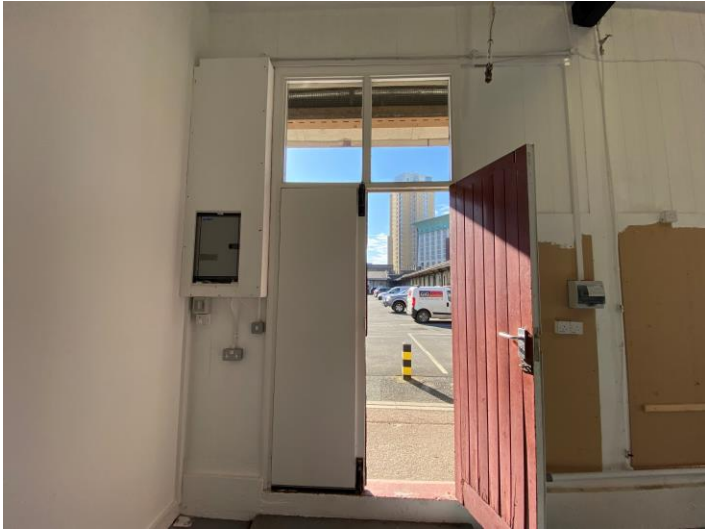
Image (5)

3. The door sets are in poor condition, (evidenced by images: 5, 6, 7, 8, 9 and 24).
4. Part of the roof structure is exposed, timber is in poor decorative order, it has been painted black and between wood/metal supports the roof panels have been clad in plasterboard: (evidenced by images: 17, 18, 19, 20 and 21).

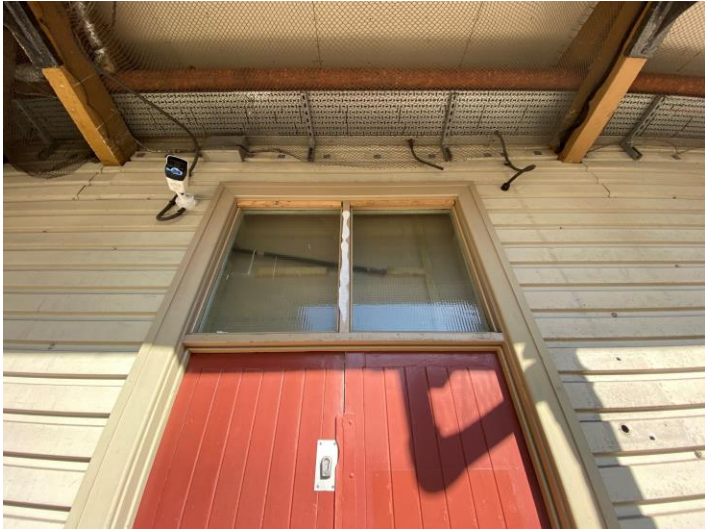
Image (9)

9. Central supply services are external to the unit, these have been run on exposed cable tray: (evidenced by images: 9 and 12).
10. The wall surfaces are in poor general condition, ceilings and walls are cracked in numerous locations: (evidenced by images: 30, 35, 45, 46, 49, 50 and 51).

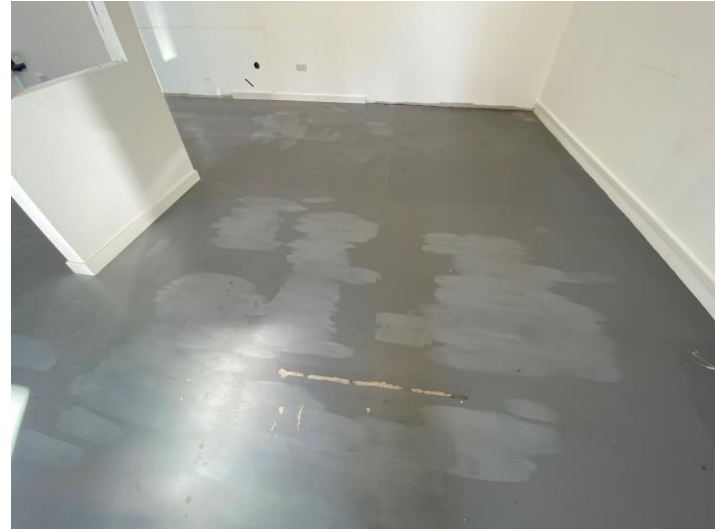
Image (14)

5. Floor surfaces are in poor condition, ceramic tiles are damaged, the painted floor is damaged, and the floating wooden floor material is incomplete and damaged (evidenced by images: 14, 15, 16, 18, 19, 22, 23, 24, 25, 26, 27, 30, 31, 32, 38, 39 and 40).

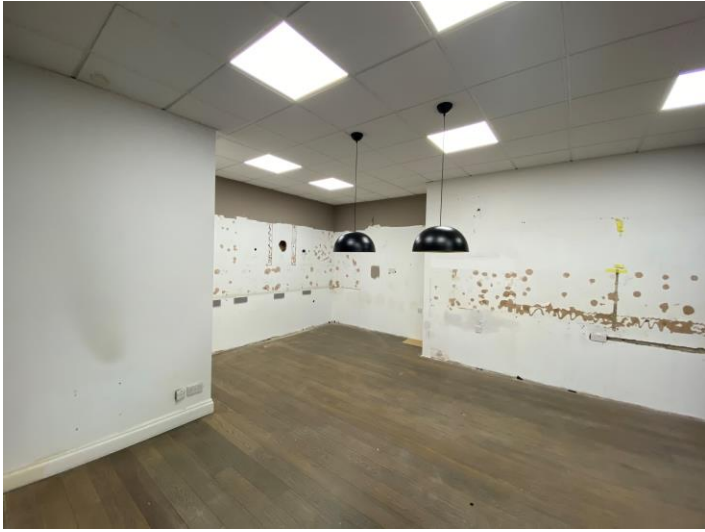
Image (25)

6. There are no tea point fixtures or fittings.
7. The suspended ceilings are in poor condition; (evidenced by images: 25, 26, 28 and 29).
8. There is evidence of a roof leak: (evidenced by images: 47 and 48).
