CE 229 Fibrous report WDC 01

The Globe Theatre
Willmott Dixon Site office
Cordell building
159-160 High St
Stockton-on-Tees
TS18 1PL

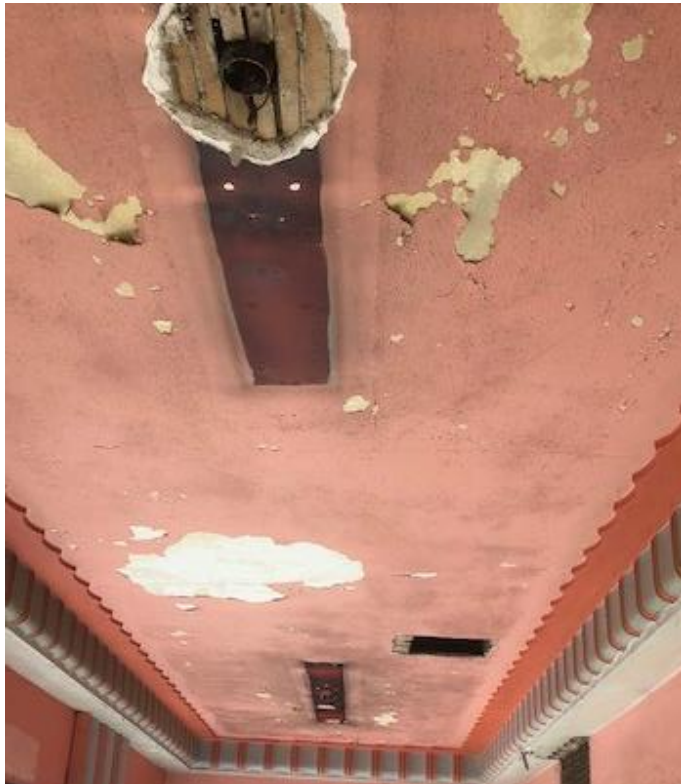
Timber Lath & Plaster Ceiling fixed to timber joists with nails. Approx 12mm thick. 2 number light fixing points removed & 1 number access hole. Condition of plaster inspected via the access hole good & stable. Localised making good where redundant services removed.

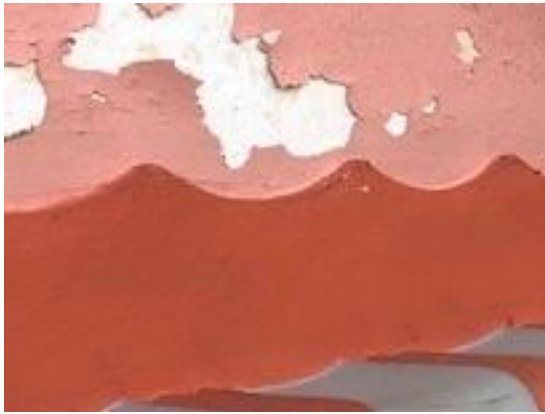
Horizontal Ceiling Moulding – Wave – Approx 150mm projection. Manufactured off site & applied to the face of lath & plaster ceiling at perimeter of entrance lobby ceiling. Good stable condition, very minor repairs. Small chips.

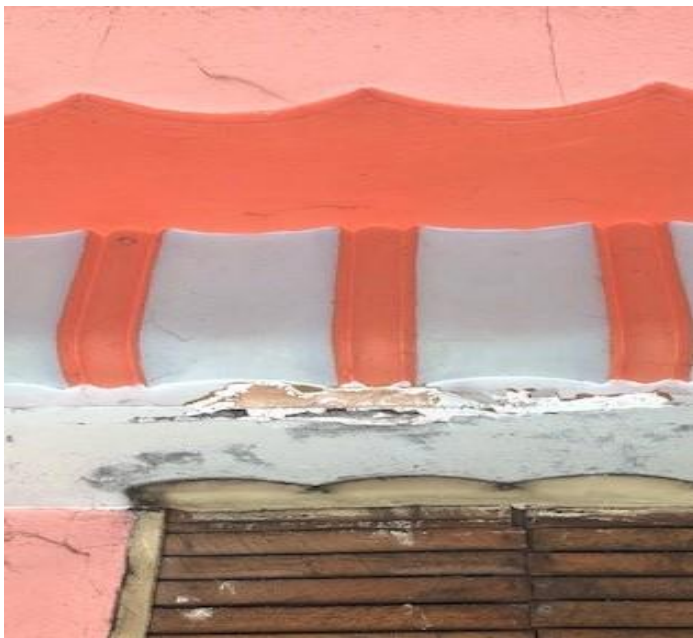
Vertical down stand Moulding – 230mm. Fixed on cantilever timber frame work. Manufactured off site. Slight damage to one section , repairable on site. General good condition in other places.

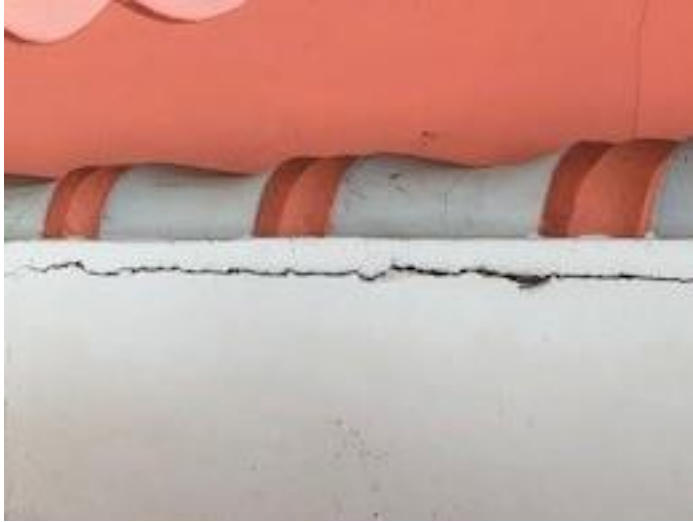
Plasterboard soffit below above moulding, abutting bottom edge of the above moulding. No scrim cloth apparent. Cut back / knife out fill & make good.

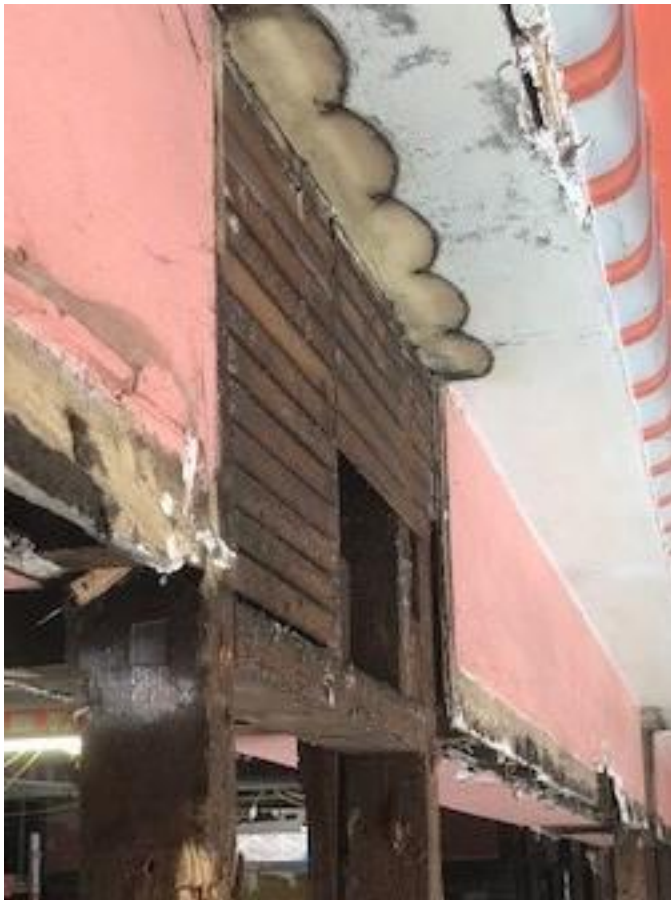
Downstand / Bulkhead between entrance lobby & Foyer. Approx; 1100mm girth. Poor condition as it appears that a screen or partition which was previously attached to it has been removed. Majority of the bulkhead is in 9mm plasterboard with a skim finish. Fixed to timber. One section (as shown above) is constructed with timber laths. It would appear that a moulding of some sort has been previously attached in this location. The overall condition of the bulkhead would suggest it need removing & replacing.

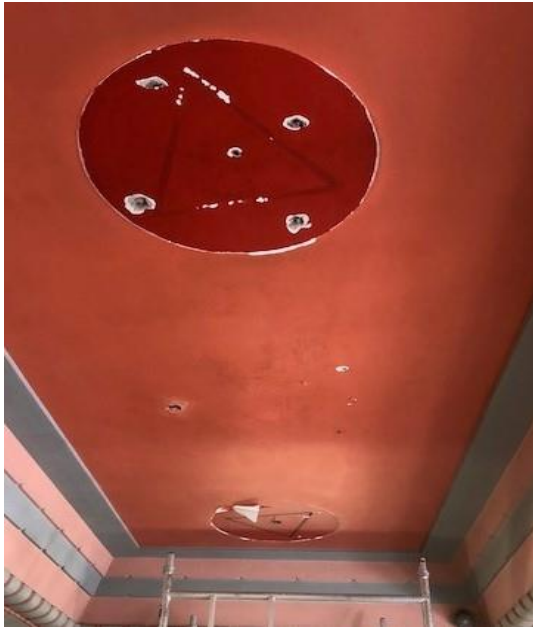
Main Lath & Plaster ceiling, view from Foyer.

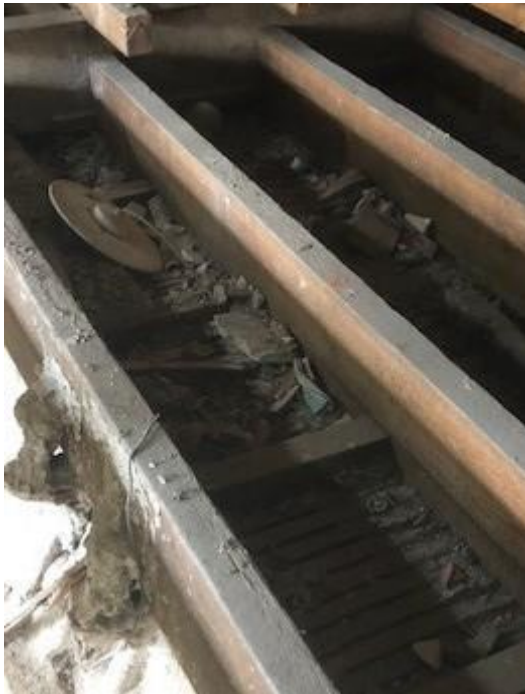
Main Lath & plaster ceiling – view from behind

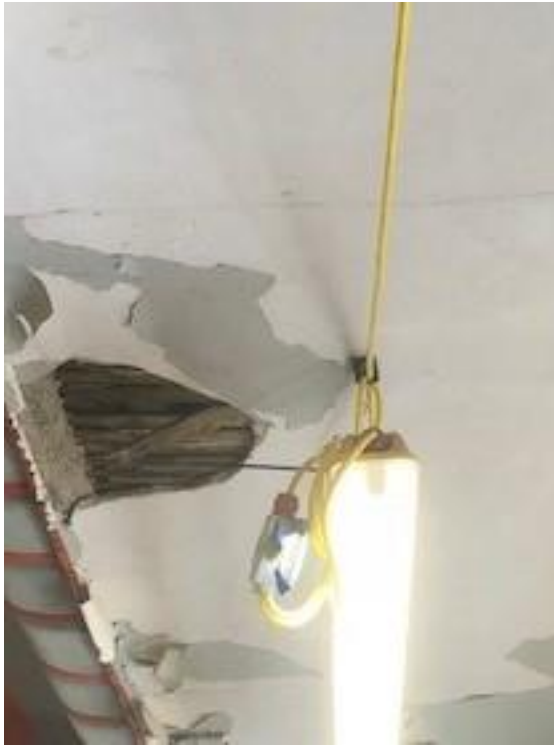
The ceiling running around the four sides of the higher-level foyer ceiling. Lath & plaster construction. The key viewed from above is solid – refer to comment above. The face has a small amount of damage & there are a small number of lateral cracks, these are not superficial & local repairs will be needed. There is cracking between the mouldings & the lath & plaster ceiling. This can be repaired locally.

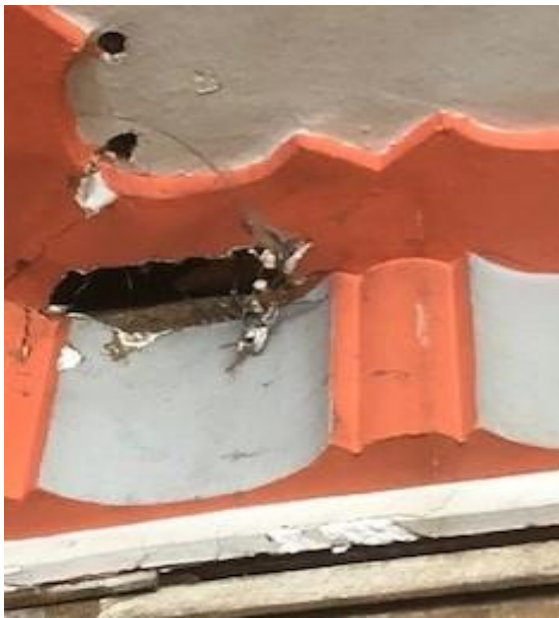
Rear view of Foyer mouldings – Wad.

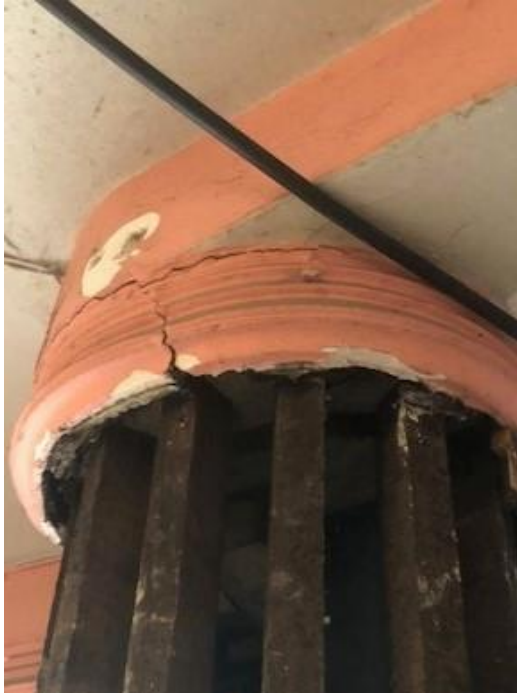
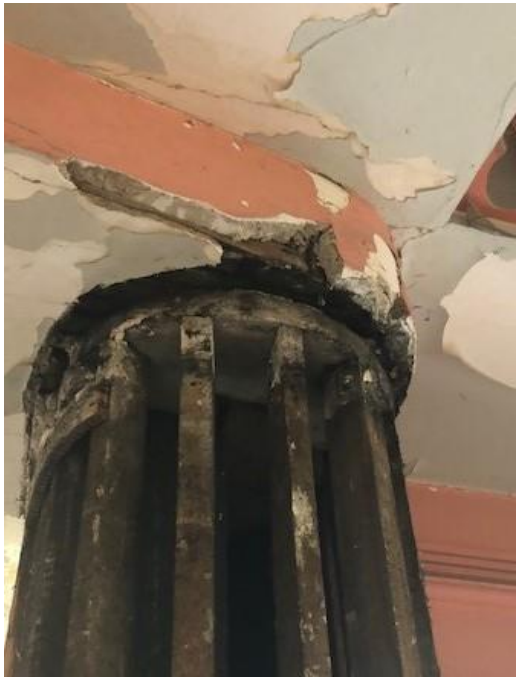
Top photo shows moulding which is severely damaged & needs replacing. A section from this can be used to replace as original. The bottom moulding is missing in its entirety. This can be made new & fixed on site to match the opposite side.

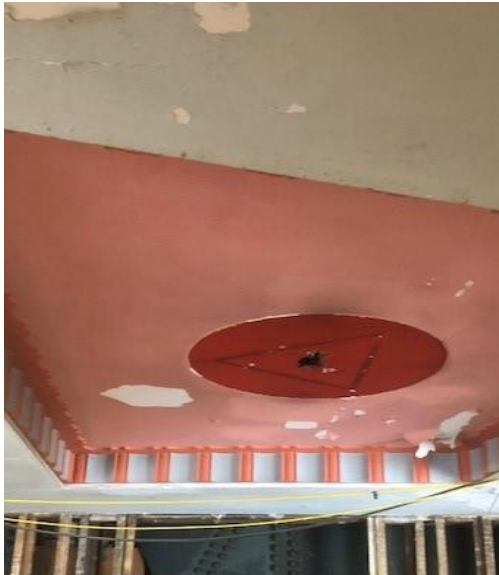
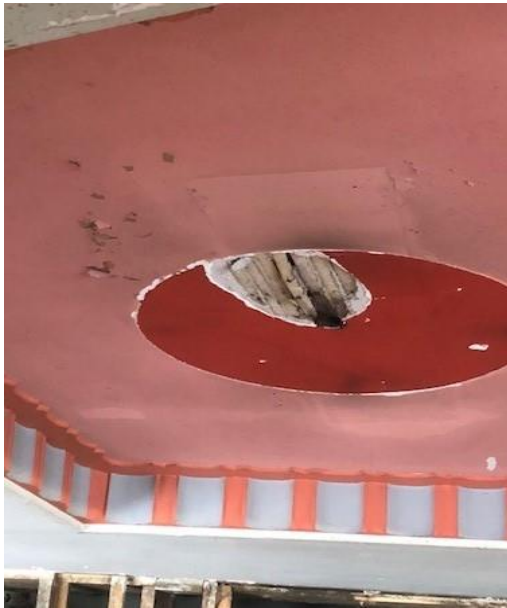
Lath & Plaster ceilings. Overall stable condition. One ceiling has damage where plaster has come away, more than likely due to the removal of the light fixture. The moulding that surround the flat ceiling are in a good condition generally with only minor repairs required.

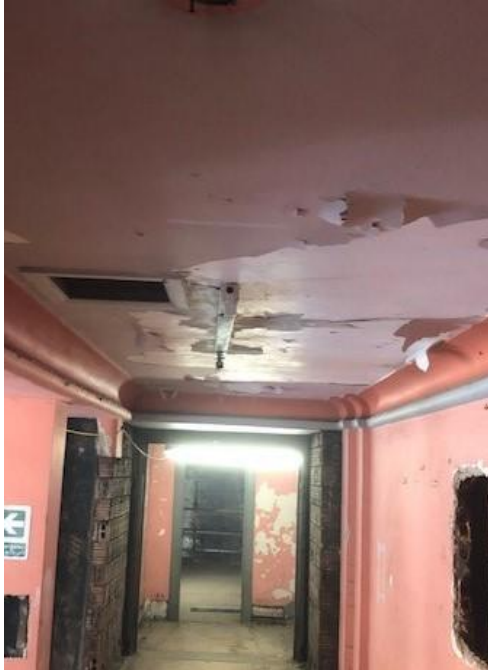
Lath & Plaster flat ceiling. Fibrous plaster plain radius cornice to four sides. There are a few minor chips & damage where items have been fixed to it in the past. Localised repairs.

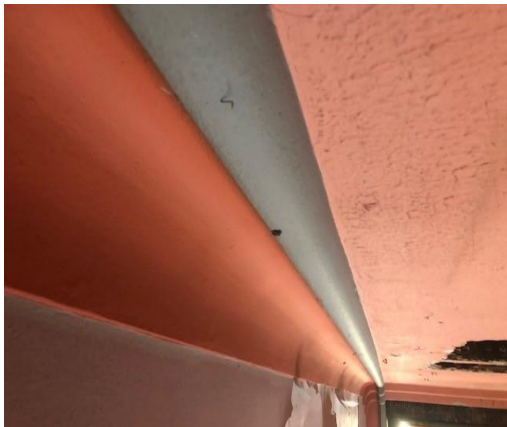
Cornice with minor damage.

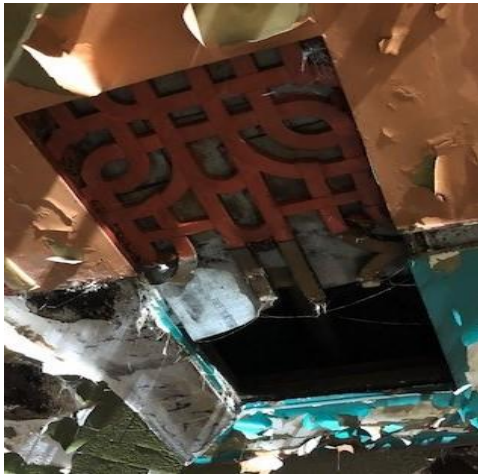
Damaged grille. Can be reproduced off site & replaced.

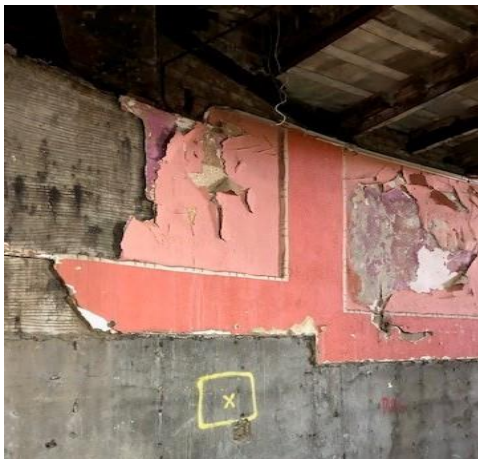
The traditional , Lime putty plaster to the walls is missing in all locations except the small amount shown. This loose & crumbling. It should be removed. It can however, be replaced to match existing with the panel mouldings reproduced off site.

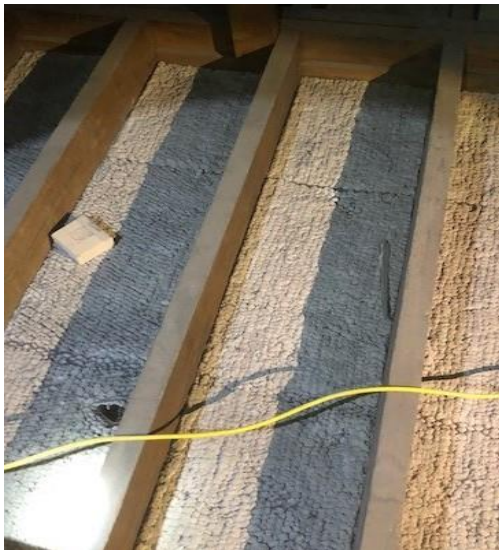
Rear of Main Flat Bed Ceiling – Sound Plaster Key.

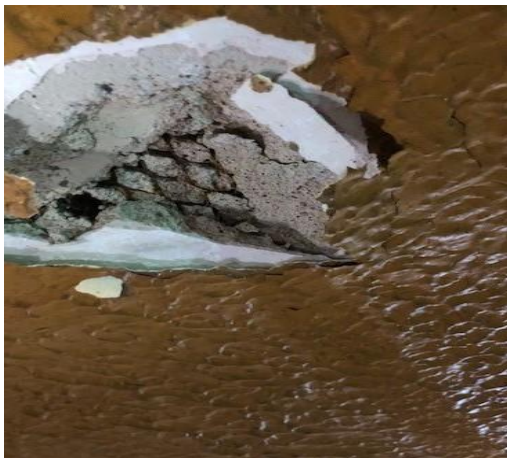
Face of Main flat bed ceiling – Localised damage.

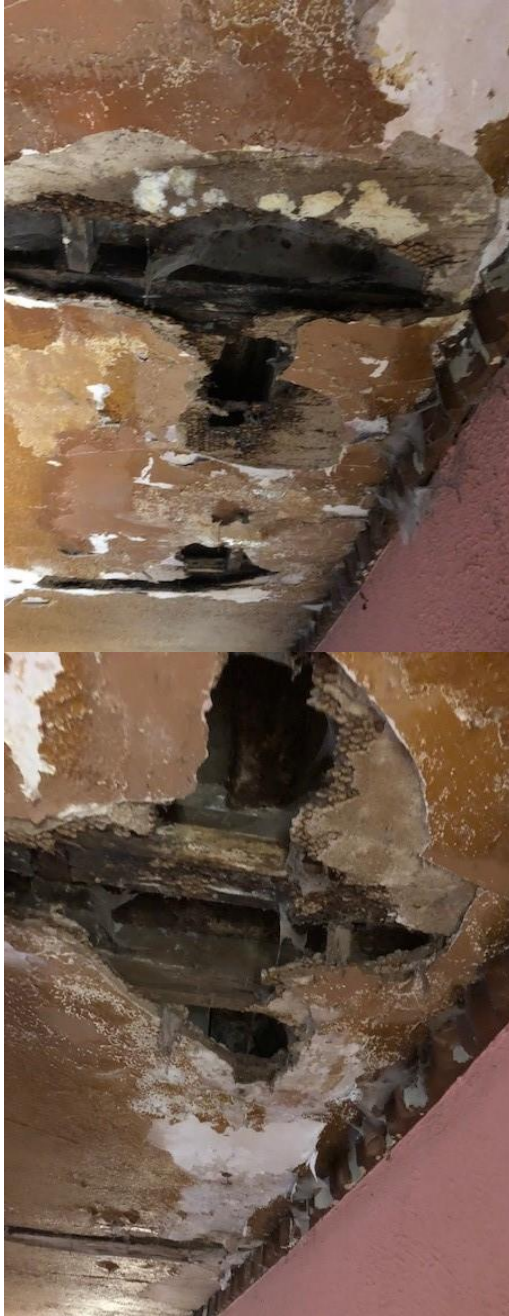
Ceiling to rear of stalls

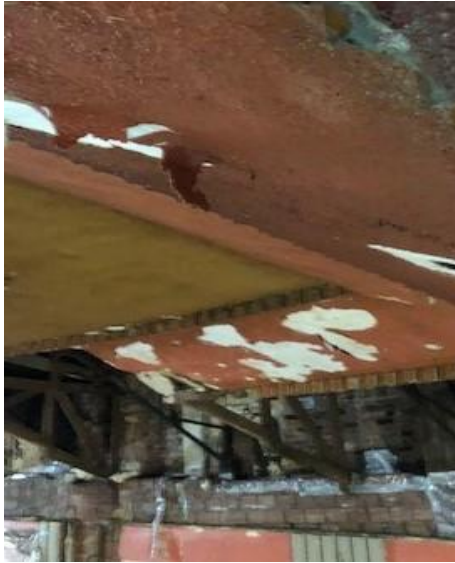
Missing Sloping Sections

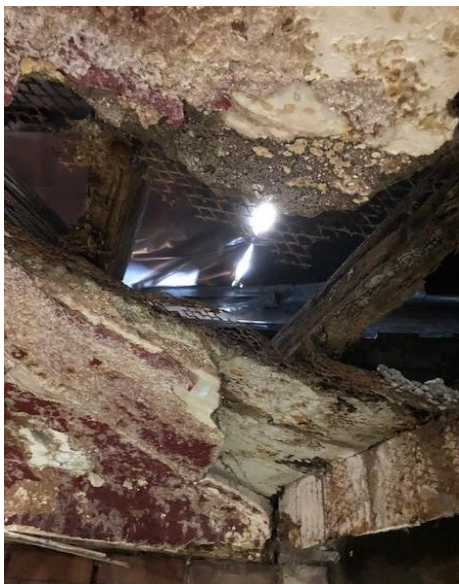
Close up section of badly damaged sloping ceiling. Rotten timber & corrosion to metal lath.
Stage right GL4

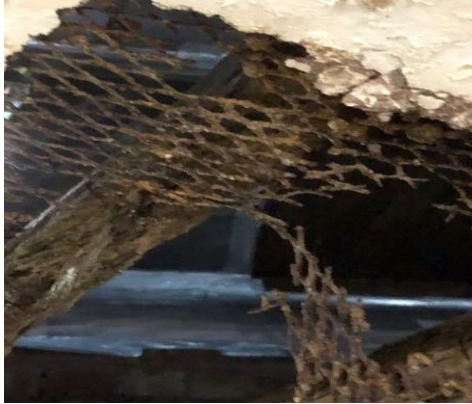
Rotten timber & corroded metal lath.

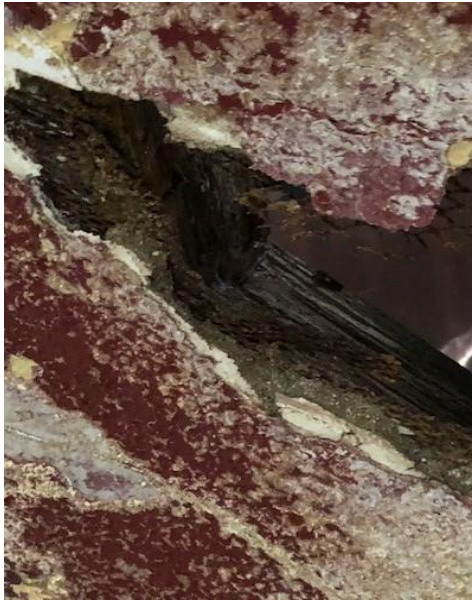
Rotten & corroded section, stage left GL 7-8

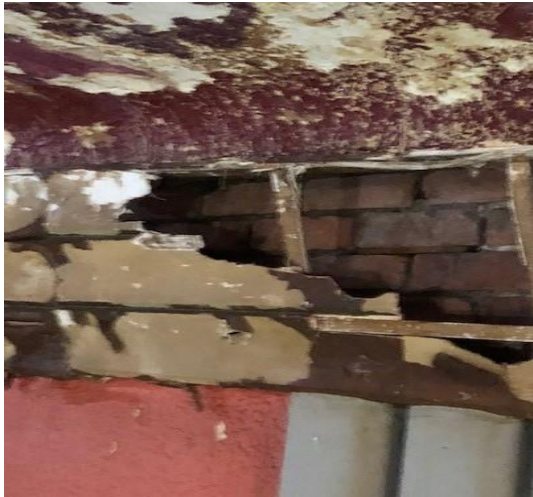
Cornice showing exposed timber lath

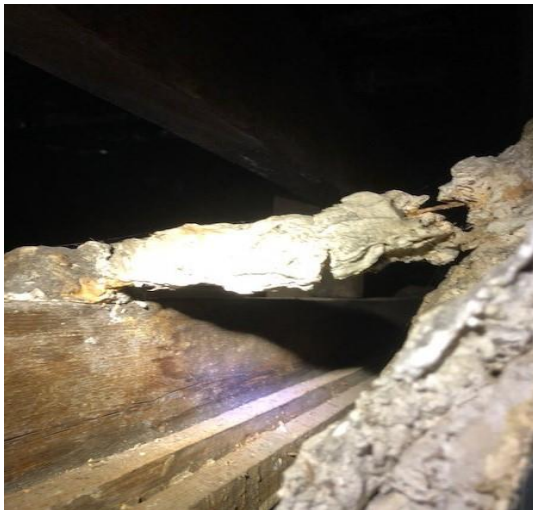
Wad holding cornice rotten & wire corroded.

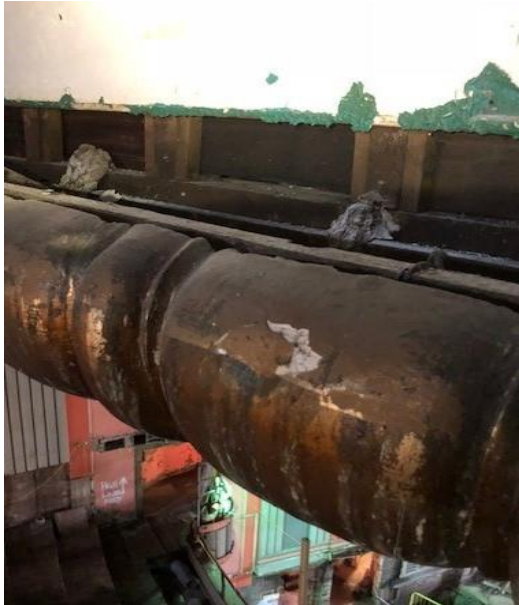
Bead & Reel- Minor chips to faces.

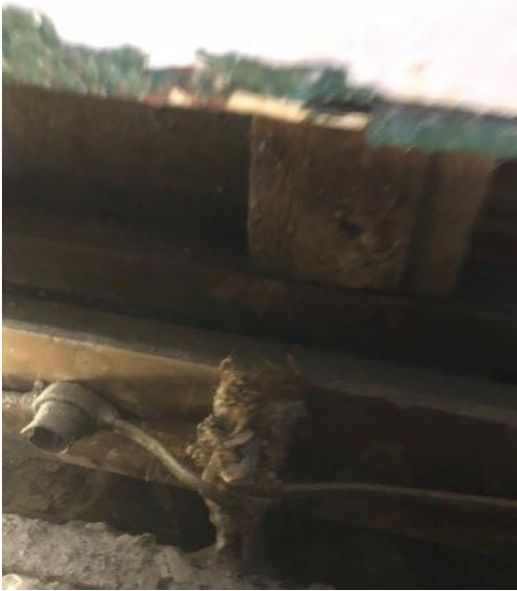
Hessian degradation of wads

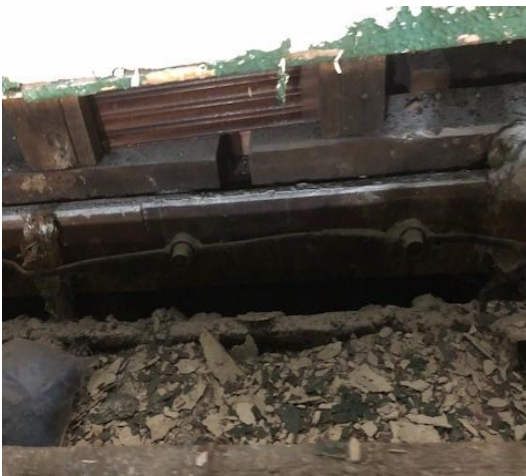
Debris in bead & reel trough

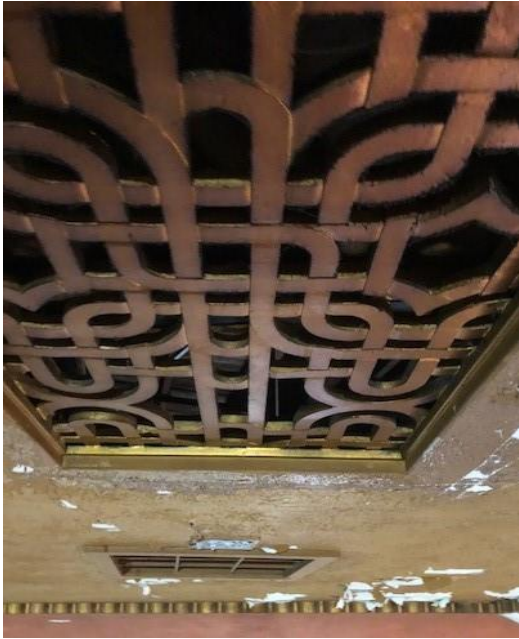
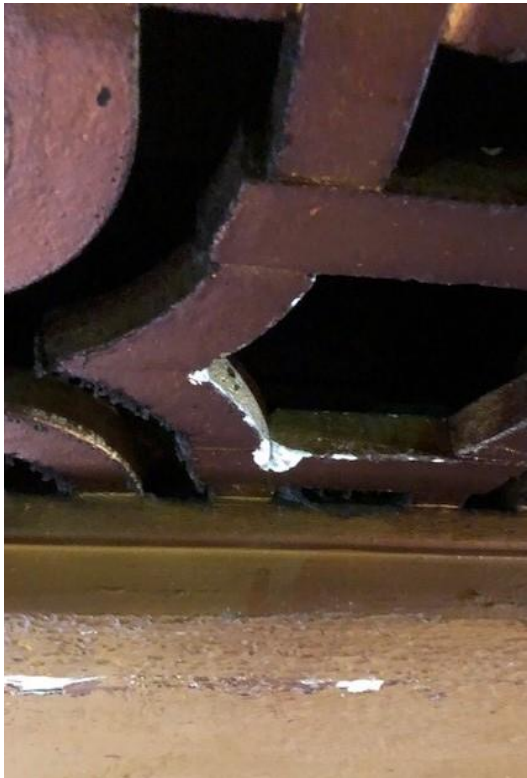
There are **Four feature Grilles** in the main flat ceiling. Only three are still in situ & have over time suffered minor damage, which can be repaired locally. There is one missing, this can be reproduced off site & replaced.

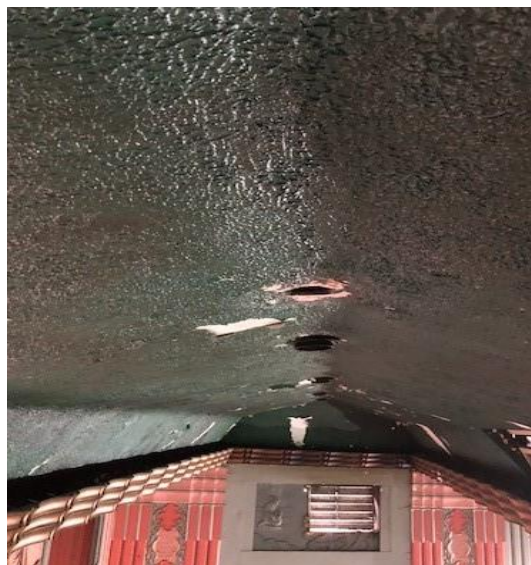
Face of vaulted ceiling – Minor localized repairs

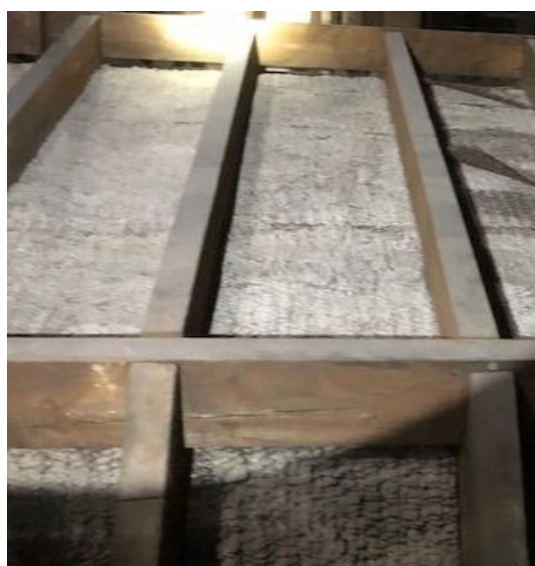
Rear of vaulted ceiling – Key in sound condition.

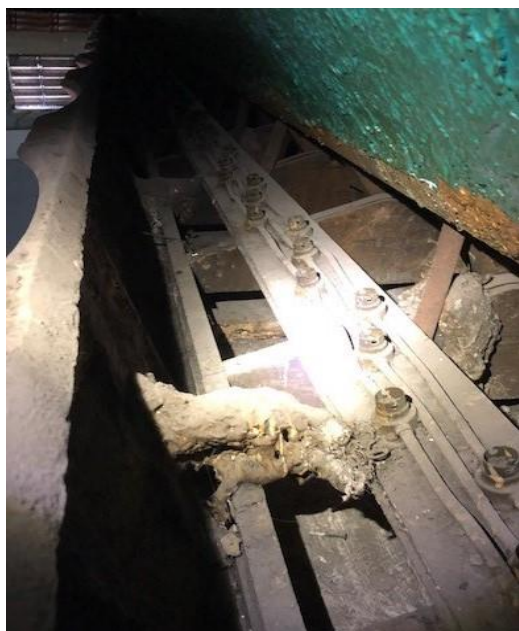
“Wad” rotting in lighting trough

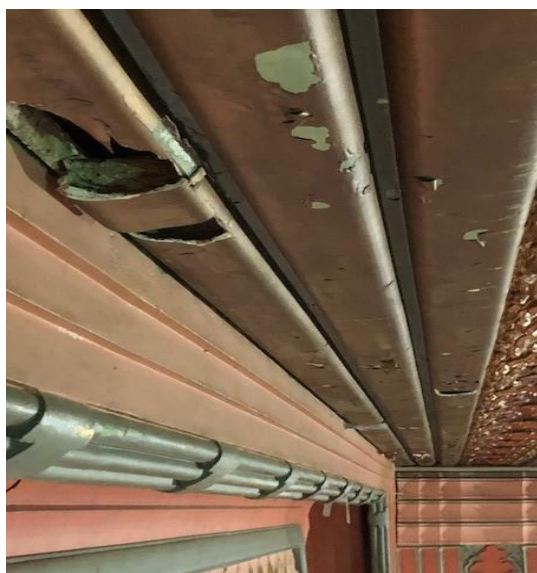
Local repair required.

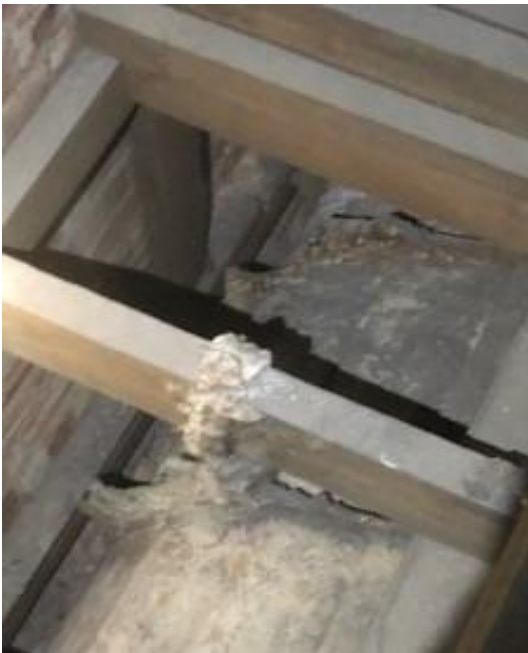
Wad to stage moulding – sound condition.

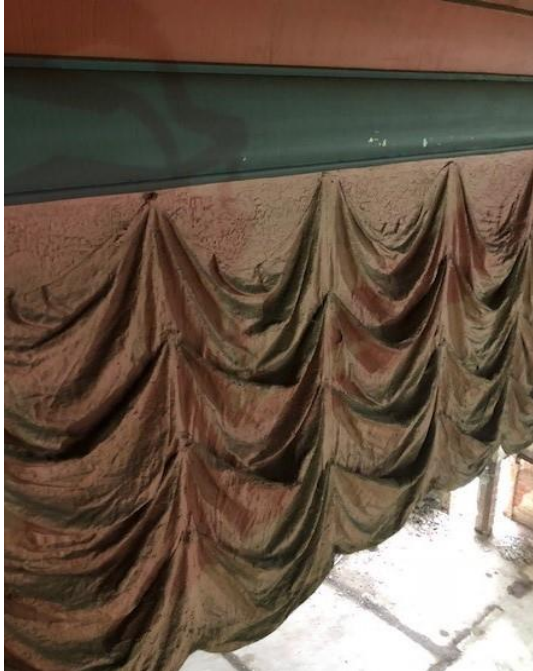
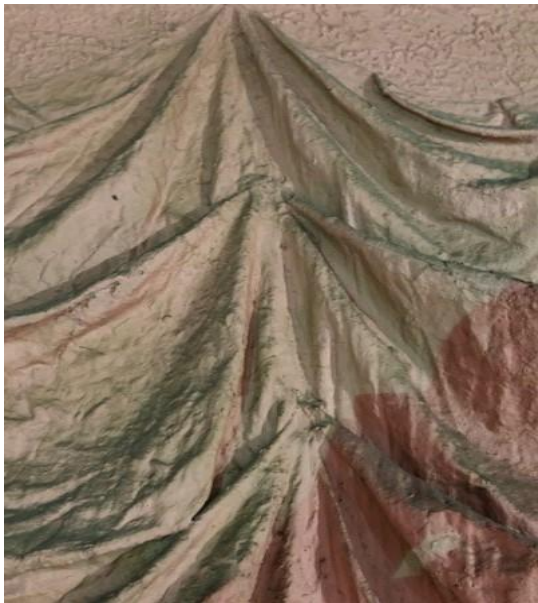
Stage Left Plasterwork Mouldings to the flank wall.

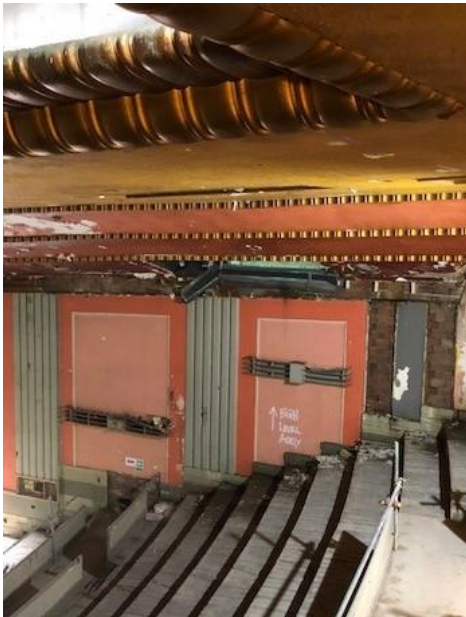
Panel 1 – missing, Panel 2 – rotten, Panel 3 – Minor damage.

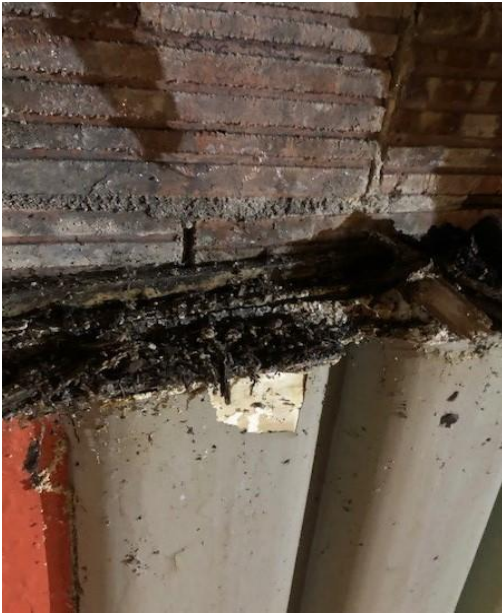
Panel 2, water has got into the back of the ribs & caused the hessian & timber to rot.

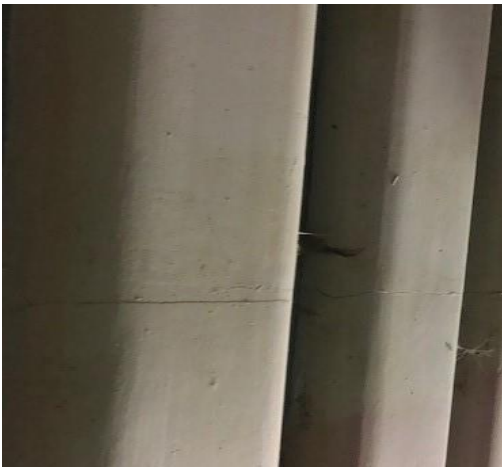
Panel 3 – Crack along casting joint

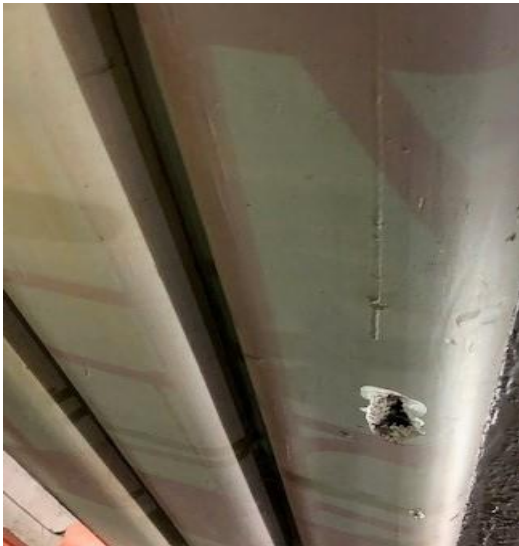
Panel 4a & 4b have minor damage repairable on site.

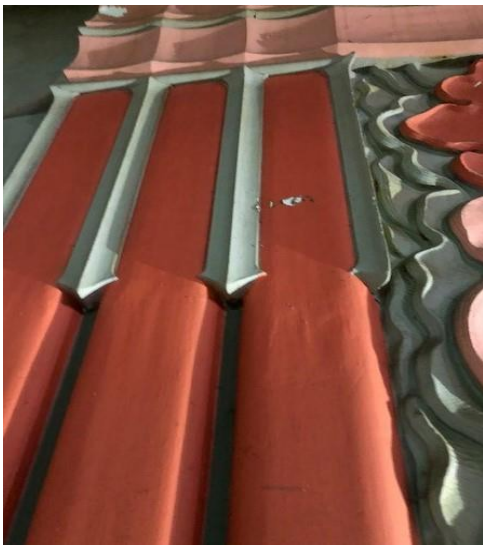
The freize detail & paneling around, as well as the capital to the flank wall have minor superficial damage which can be easily repaired on sight. There appears to be no damaged caused by water ingress. There are metal intrusions within the ribbed section which have been poorly made good in the past. These can be attended to onsite, along with the other minor damage in this area & made good.

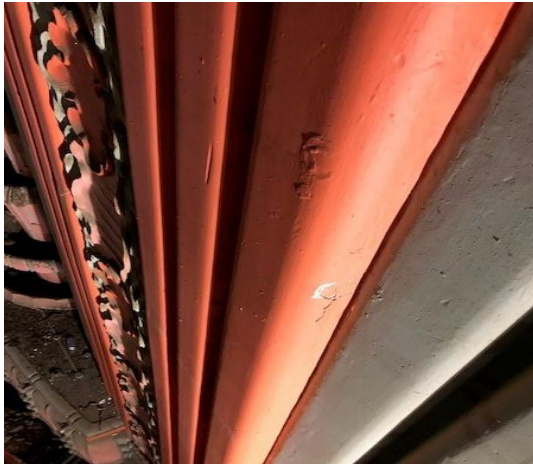
Minor damage to ribs.

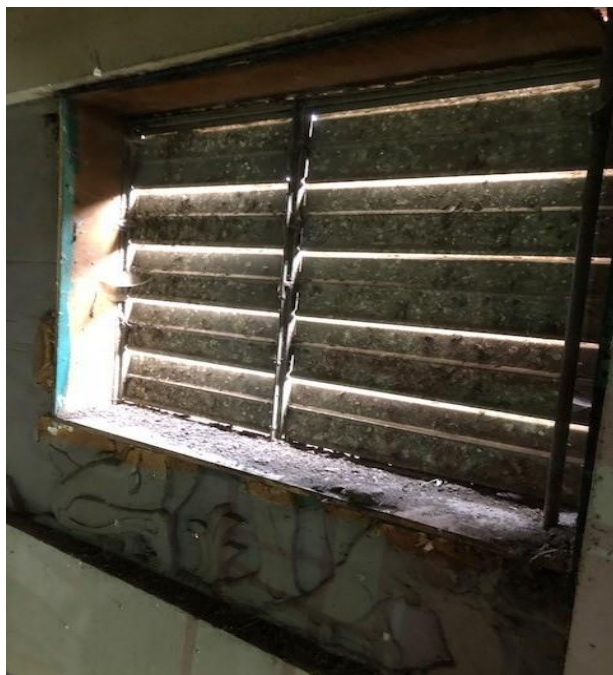
Grille in the Entablature

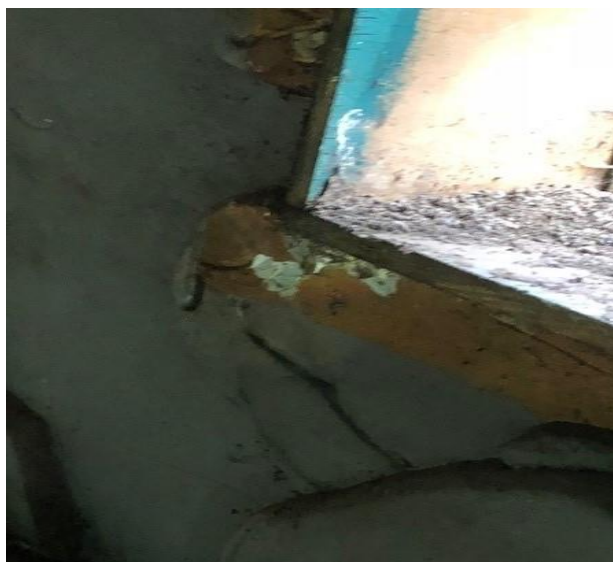
Damage to Entablature Panel

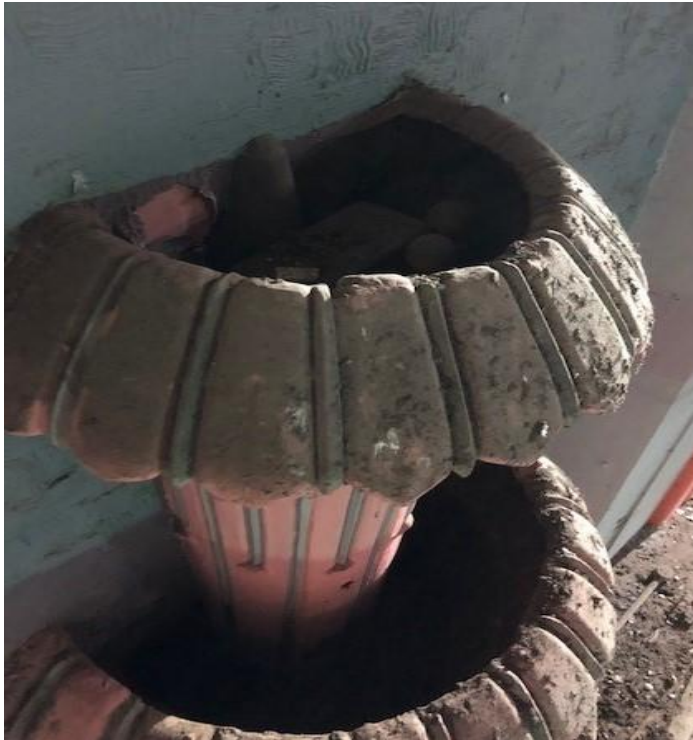
Fountain cover in dirt.

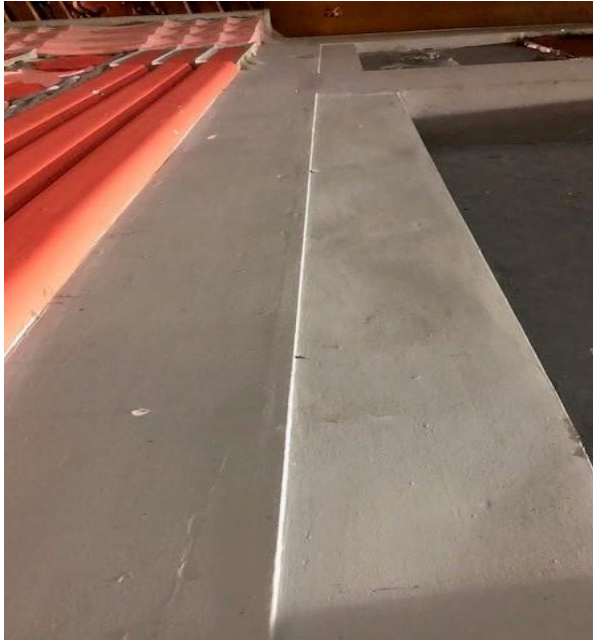
Panel with minor damage

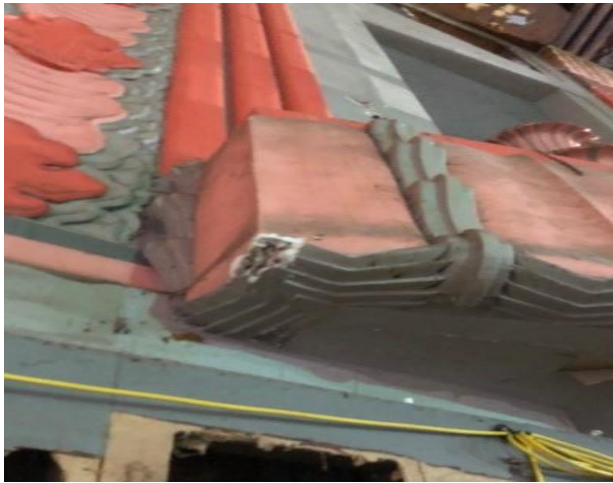
Chipped corner to base moulding

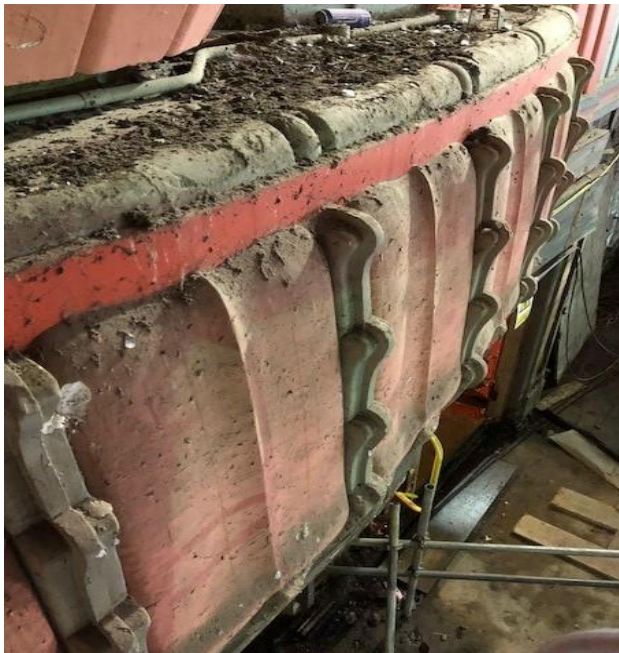
Damage to bead & reel detail on top edge & chipping of face mouldings.

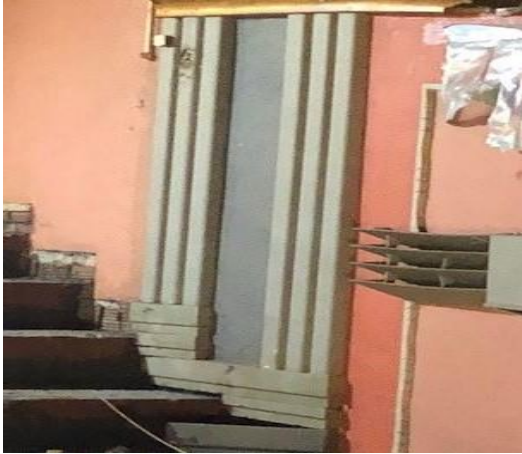
- 2) Panel number 2 is in a very poor condition, there has been excessive water ingress, the hessian & timbers forming the mouldings have rotted beyond repair. It's recommended that they be removed & replaced.

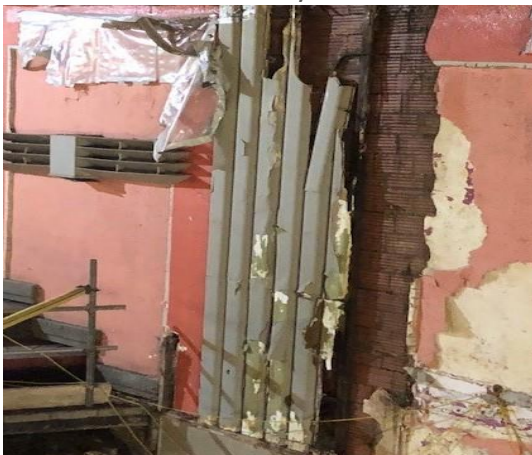
- 3) Panel number 3 there has been excessive water ingress, with water running down the back of the mouldings. This has caused the hessian & timber laths to rot beyond repair.

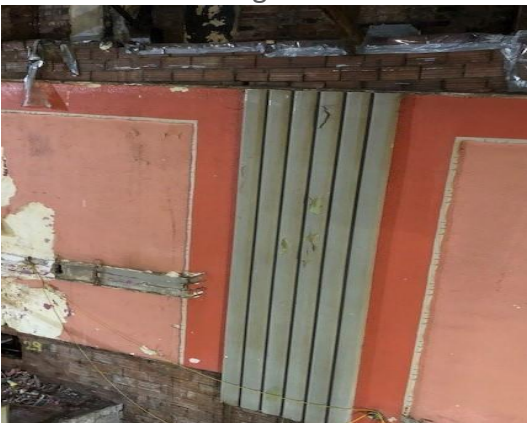
- 4) Panel number 4a & 4b, frieze mouldings & panels either side of the fountain, as well as the base to the fountain.

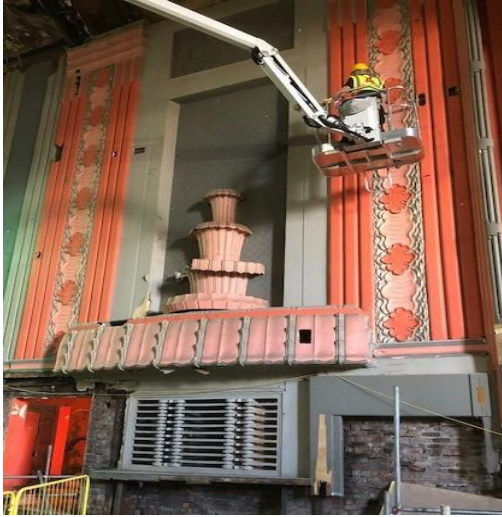
Having cut out a number of inspection holes to all of the above areas it was evident on inspection that water ingress over the years has caused the hessian & timbers to rot to a condition that the mouldings are not repairable. It would also appear that the main timbers which hold the cast in place are also rotten beyond repair. The timer report need to confirm this.

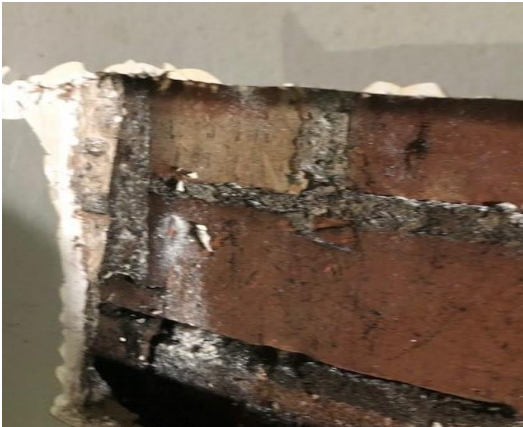
Rotten timber caused by water running down the back.

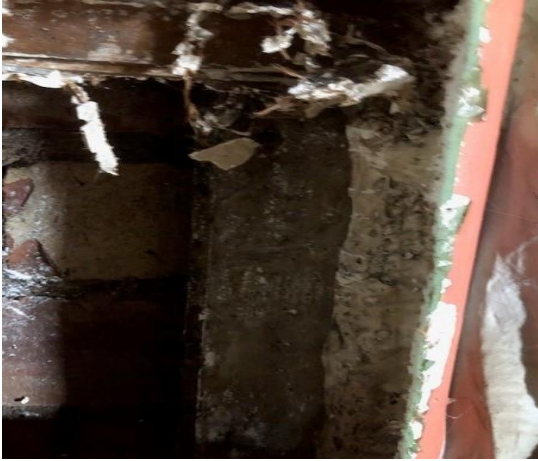
Decayed hessian in back of cast caused by water ingress.

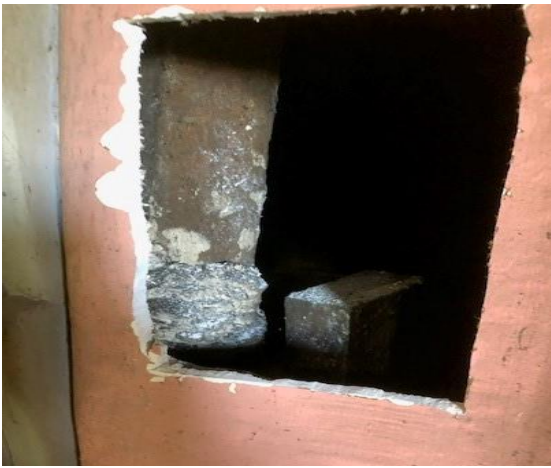
Rotten wad viewed through inspection hole.

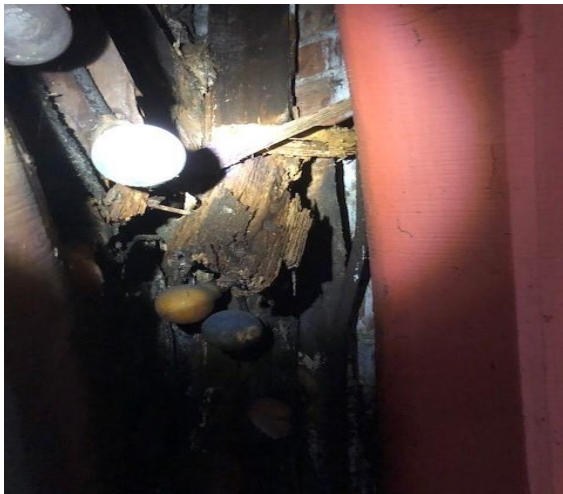
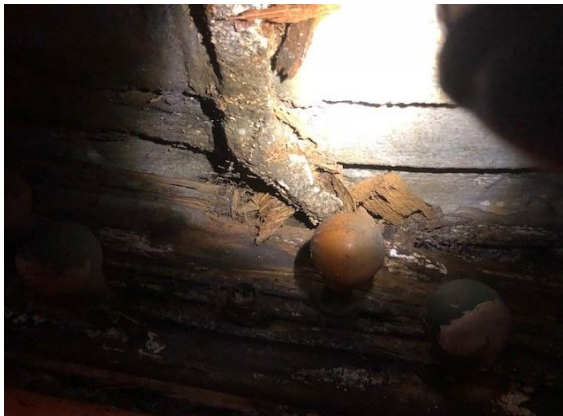
Evidence of timber degradation & failure. Rotting wads & hessian.

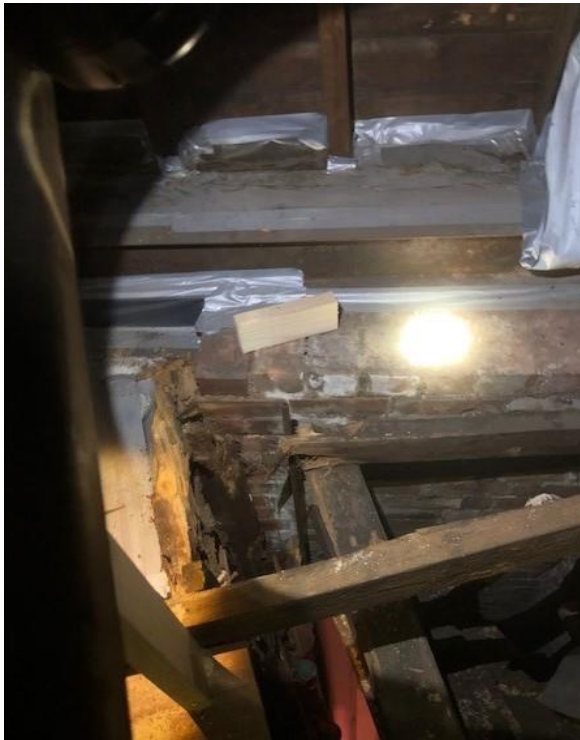
Rotting timber joists.

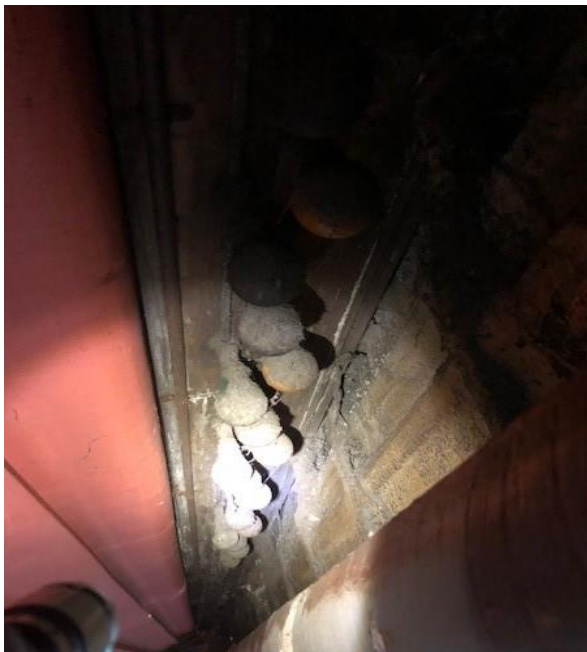
A view down the vertical arch lighting feature. Evidence of water running down it & damage to wads.

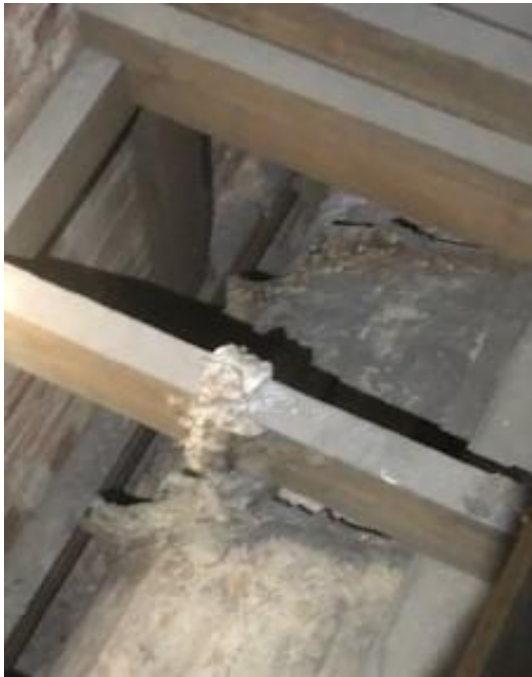
Wads inspected on the mouldings running across the front the Proscenium check & in good condition.

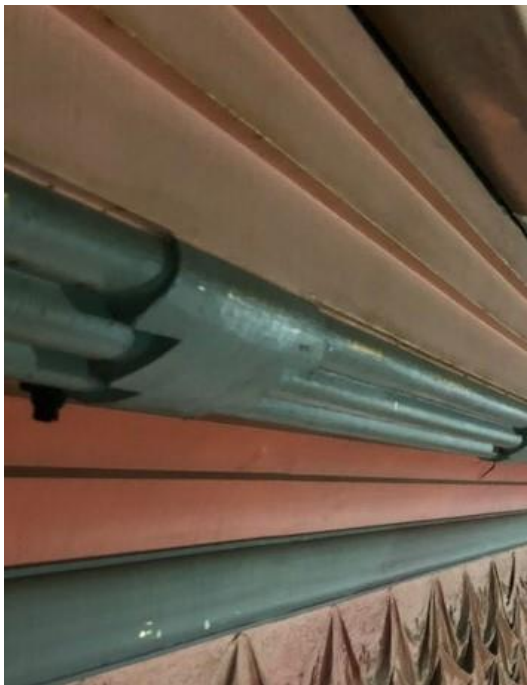
Front Pic. Good condition.

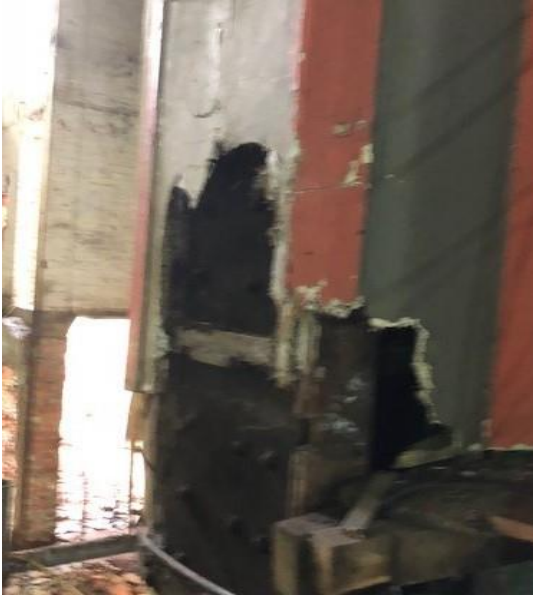
Damage to base of Arch Stage Left

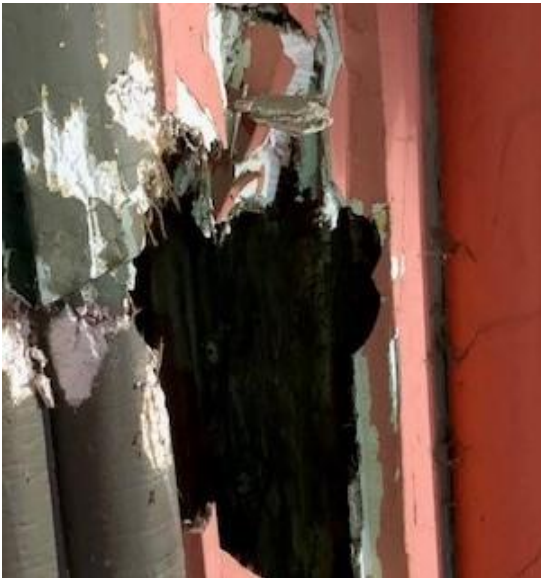
Damage to sides of Proscenium Arch stage left.

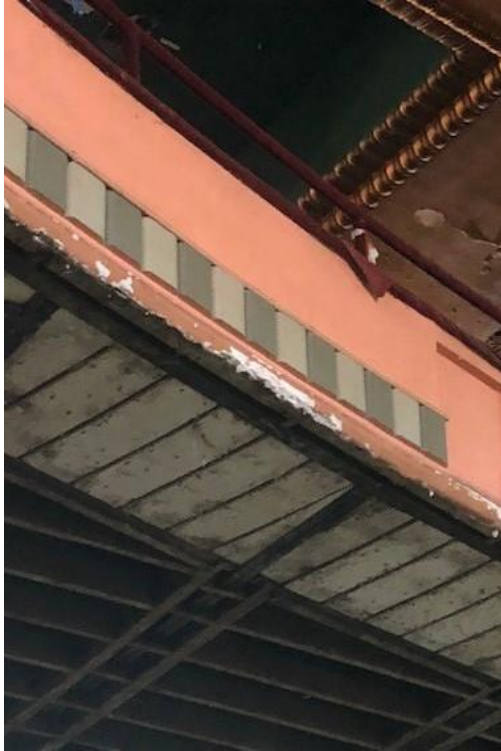
Minor chipping to the front which can be repaired on site. Three sections missing which can be manufactured & replaced.
