CE 229 Fibrous report WDC 01

The Globe Theatre
Willmott Dixon Site office
Cordell building
159-160 High St
Stockton-on-Tees
TS18 1PL

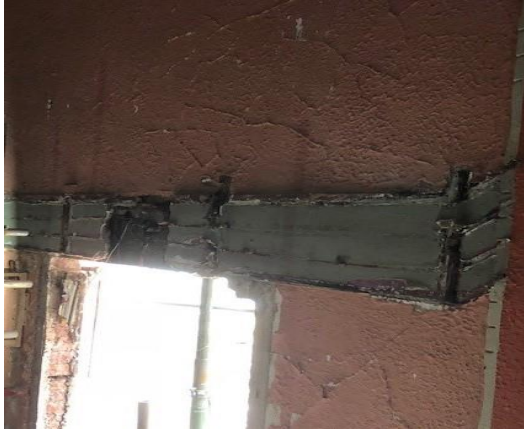
The majority of these have been damaged beyond effective repair , a number are also missing. These which are stable can be repaired on site, whilst those missing & damaged beyond repair can be made as new & fixed in situ.

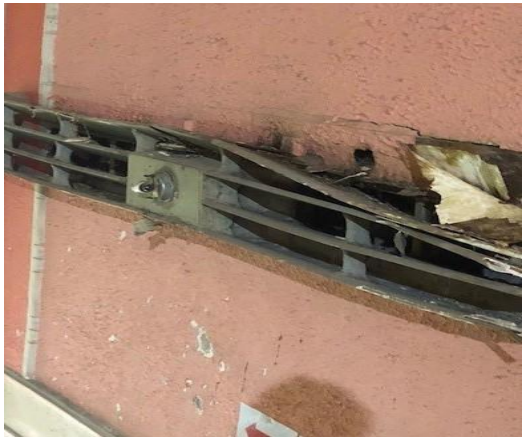
Grille damaged beyond repair
