## **Preliminary Structural building appraisal**

November 2020

### **Agricultural barn at :**

Windy Cross Farm  
Thornbury  
EX22 7BZ

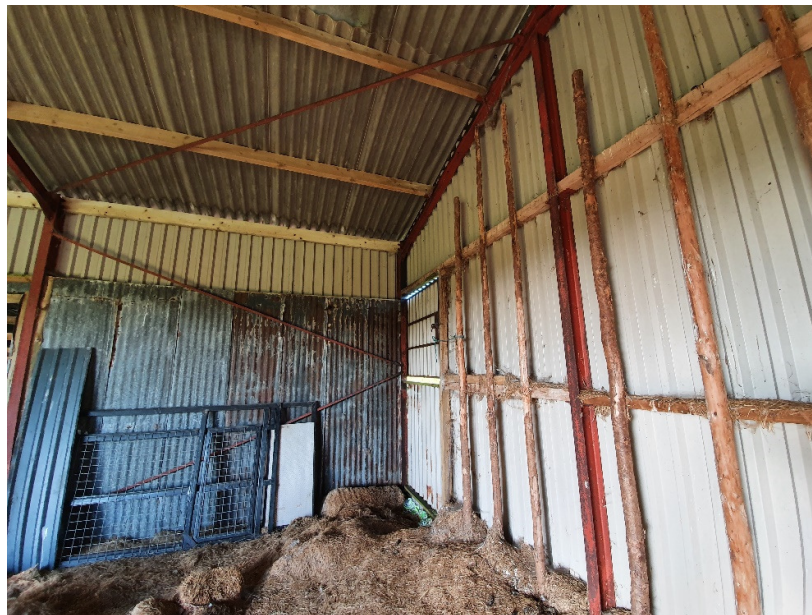
Diagonal steel restraint bracing was noted to the northern aspect of the portal structure, providing additional structural integrity to the portal frames.

The northern most portal frame is braced back to the central frame with steel wind bracing, at diagonal juncture, bolted to each portal to provide lateral restraint to the main structure.

Steel portal frames, sheet cladding, lateral structural restraint strapping to roof and wall elements of portal frames
