Stonewest Ltd

**CAREW MANOR
SALVAGED BRICKS &
PROPOSED SAMPLE PANELS REPORT**

Report No: 67751/Rep

Dated 31.03.2021

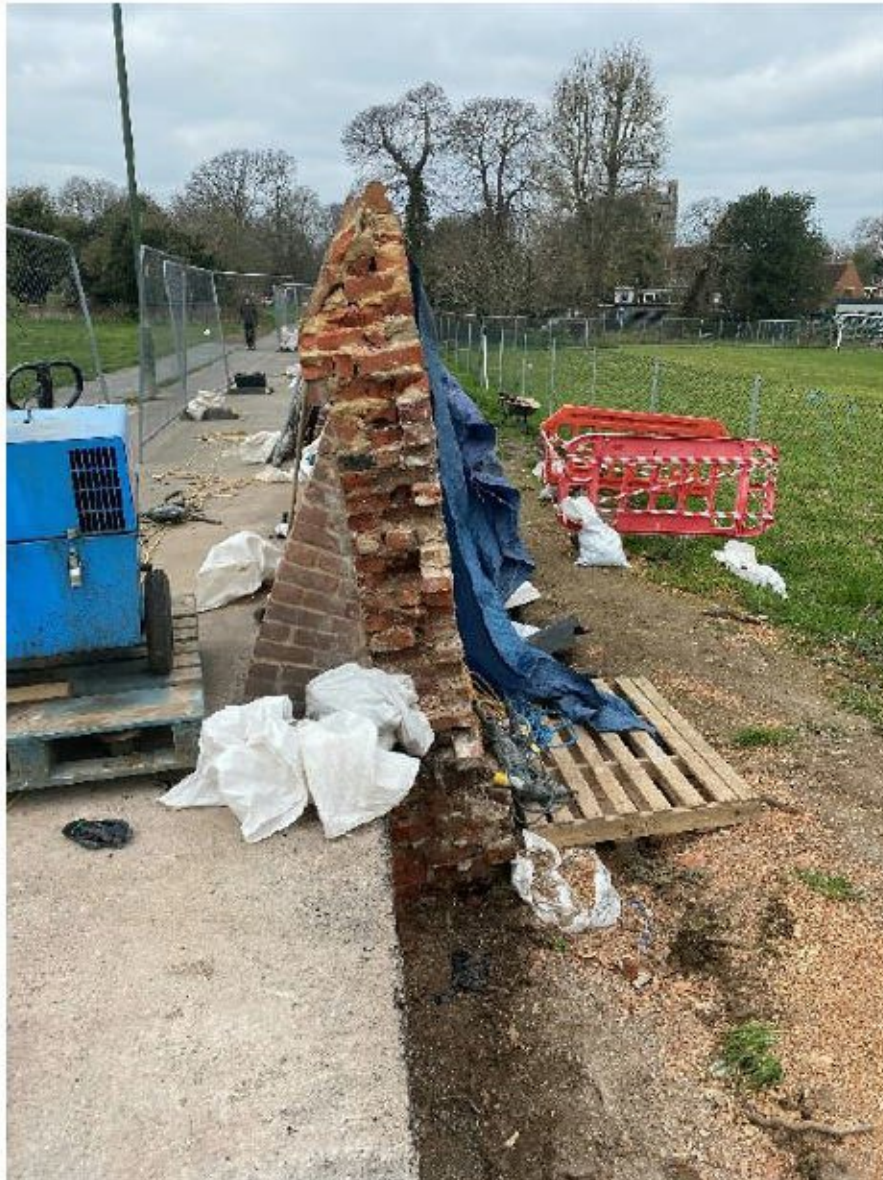
Stonewest	Location:	67751 CAREW MANOR	
E: info@stonewest.co.uk T: 020 8684 6646	CHURCH LANE	Careful Dismantling and Salvage all Masonry	Sample :
Description: <p>The East end of the wall scheduled for careful dismantling and rebuilding has been successfully dismantled by hand, whilst ensuring as much original masonry is salvaged for re-use as possible. Many existing bricks are found to be very soft and friable and disintegrated during the dismantling process.</p>			Comments:

**Dismantled to Buttress 8
Looking West**

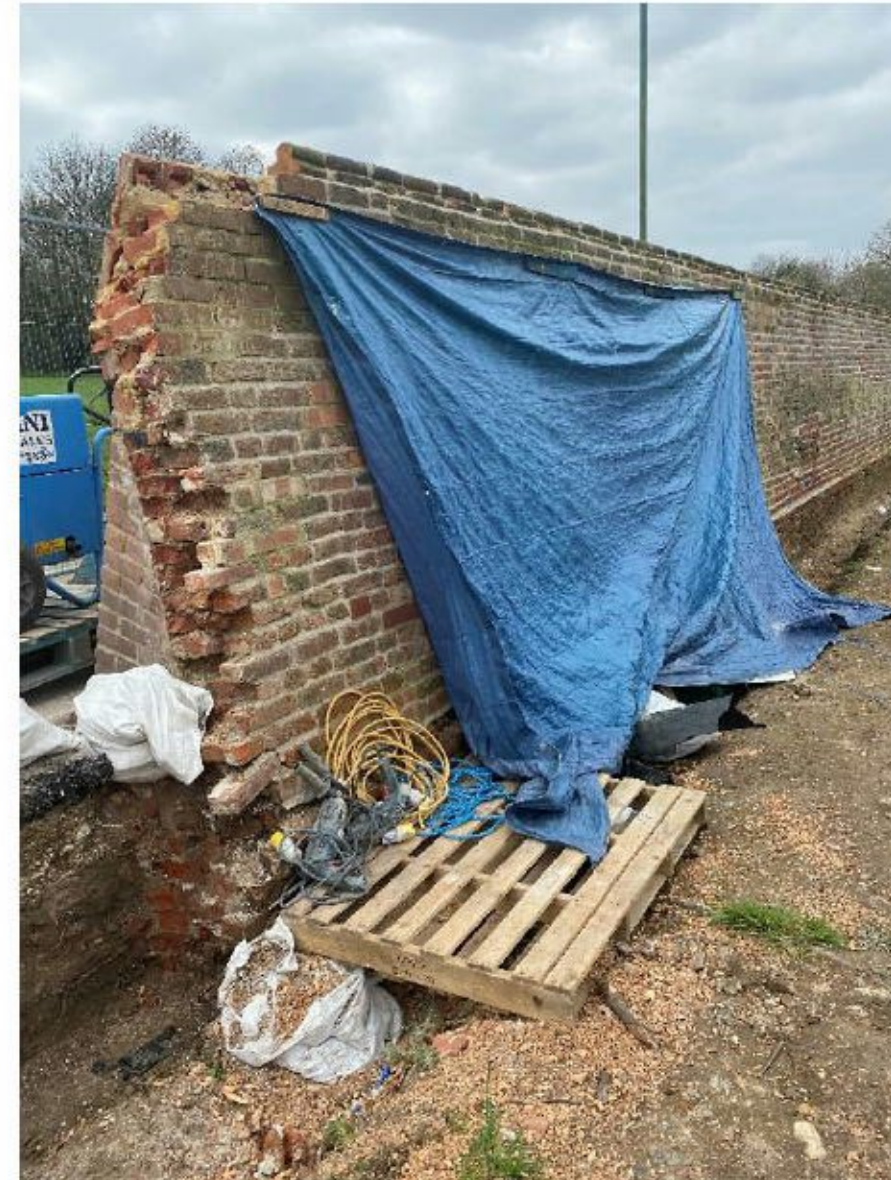
**Ready to be toothed out and new
wall starter per the specification**

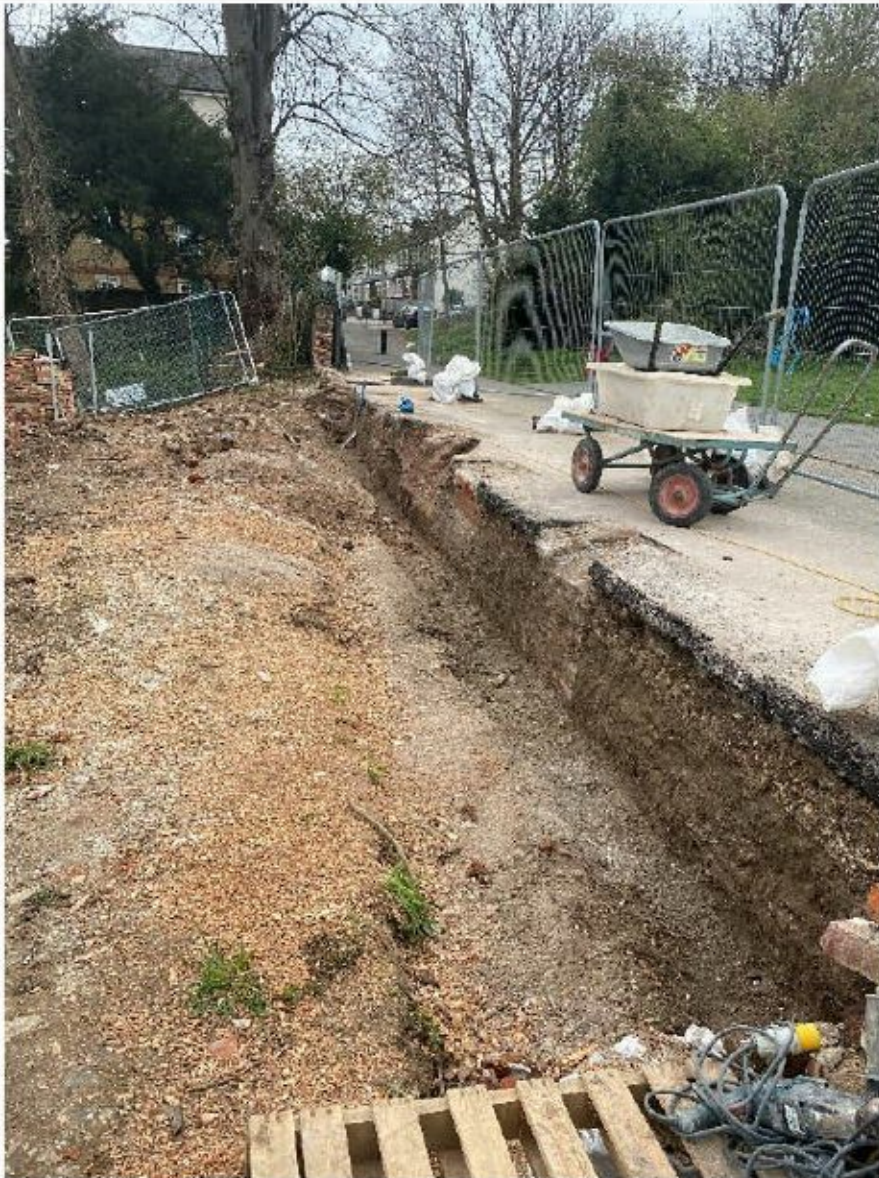
Stonewest	Location:	67751 CAREW MANOR	
E: info@stonewest.co.uk T: 020 8684 6646	CHURCH LANE	Cleared Walling Down to Foundation Level.	Sample :
Description:		Shows both tree stumps successfully removed and all bricks dismantled/removed. Bricks below pavement level have become contaminated/soiled so have been set aside should their use become essential. Now the masonry is removed our team pulled a string line through and its apparent the existing wall is not straight. Therefore the new foundation will need to curve to follow the existing line. If built straight, true and plumb the resultant construction would end up too far away from Buttress 8.	Comments:

Looking East all bricks carefully removed

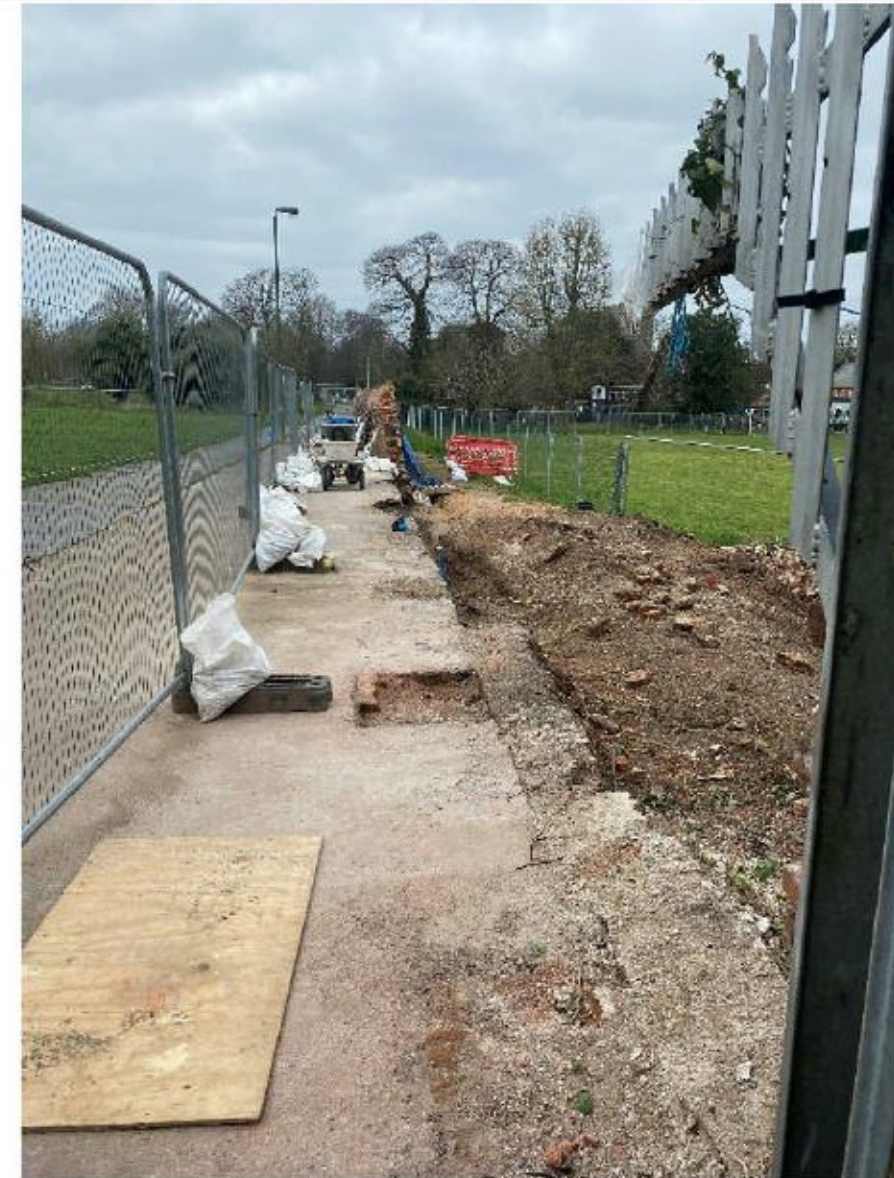
Looking West along the dismantled section

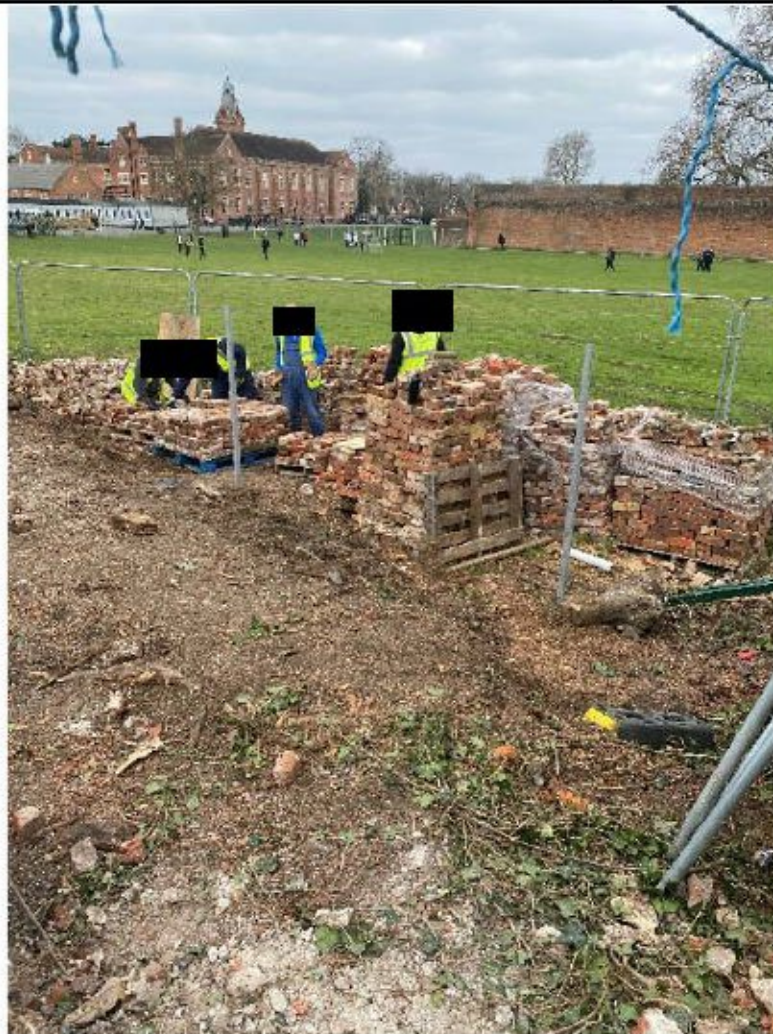
Stonewest	Location:	67751 CAREW MANOR	Sample :
E: info@stonewest.co.uk T: 020 8684 6646	Church Lane	Salvaged Bricks Sorted into Pallets and Counted Accurately.	
Description:	<p>2000 headers were salvaged (vast majority due to many full bricks crumbling during the dismantling process). 1500 stretchers were salvaged. All cleaned free of redundant mortar ready for re-use. With these quantities confirmed, we will propose the following arrangement as set out on the next page.</p> <p>The contaminated/soiled bricks salvaged from below ground level will be kept/set aside for the time being should their use become essential.</p>		Comments:

Salvaged bricks

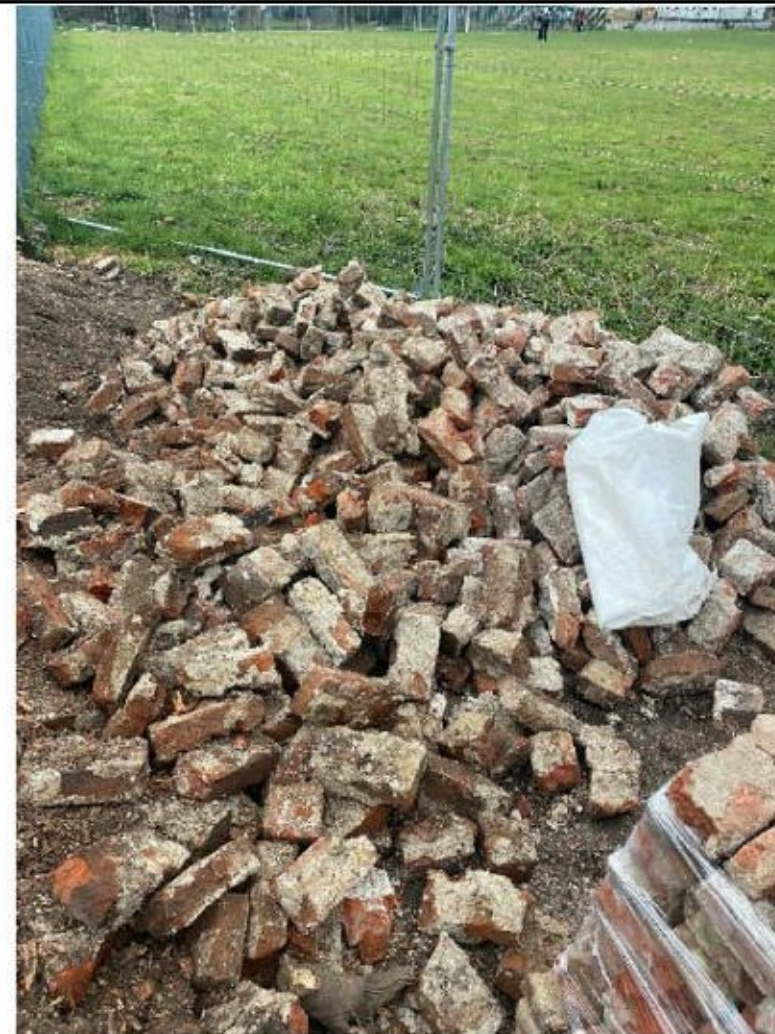
Below ground contaminated bricks

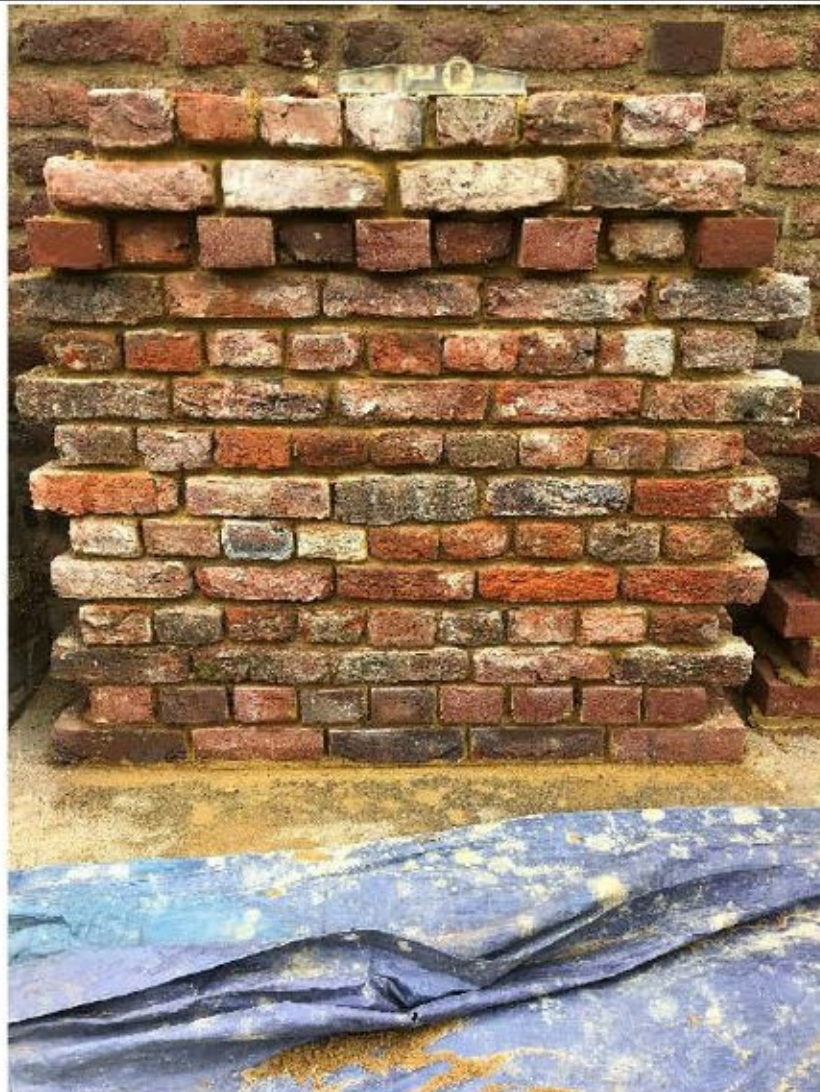
Shows the proposed sample panel for the Church Path elevation which primarily consists of salvaged bricks. **NOTE** The first two courses above pavement level will be **NEW** Goodwood blend bricks, then salvaged bricks above. The Corbelled course to be built using **NEW** Goodwood blend bricks due to the salvaged bricks fragility making them unsuitable. Then salvaged bricks used above the corbelled course. With **NEW** for the Coping bricks as detailed below. We consider all salvaged bricks are too fragile for the structural elements. We also propose the four new Buttresses will be constructed using the new Goodwood blend.

Sample panel construction

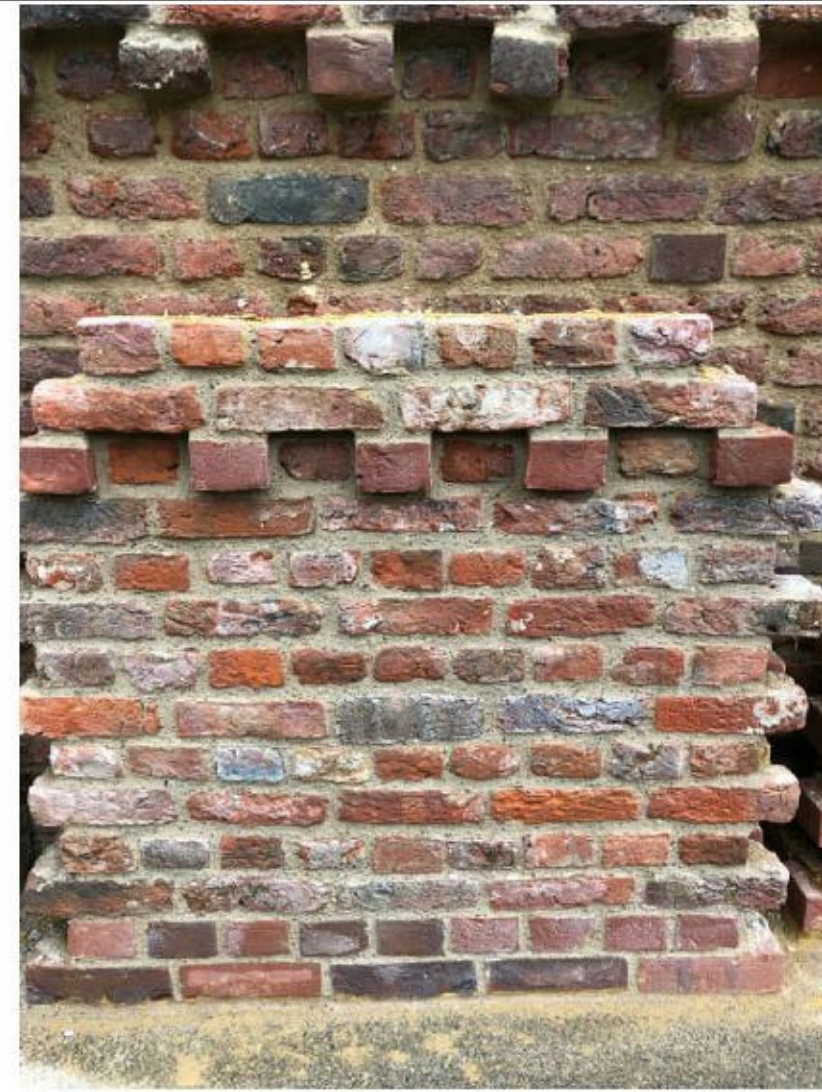
With Lime mortar pointing completed

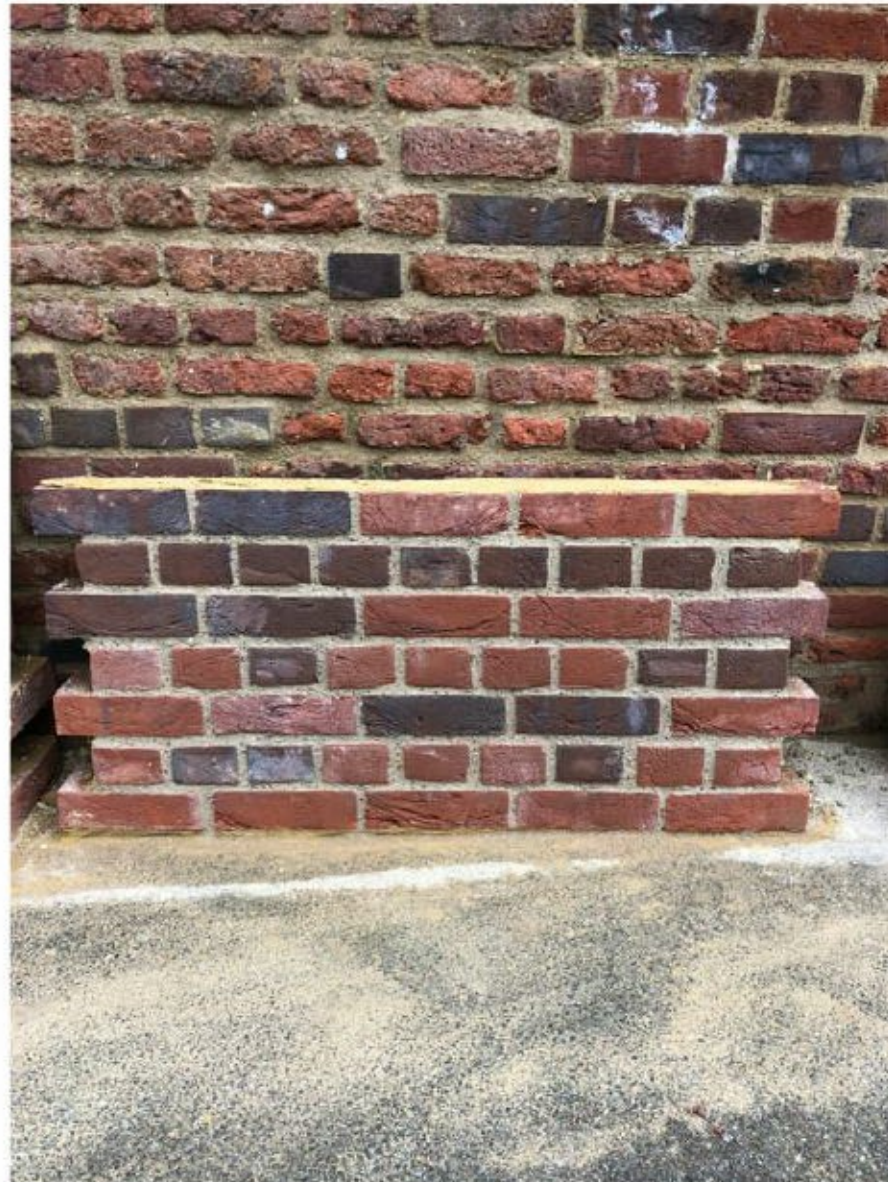
Stonewest	Location:	67751 CAREW MANOR	
E: info@stonewest.co.uk T: 020 8684 6646	CHURCH LANE	Sample Panel Showing Proposed School Elevation	
Description:		<p>To the School (rear) elevation where the ground levels are different we propose to use a semi engineering brick below ground level (unseen).</p> <p>To use the Goodwood blend to the outer face/skin (where seen) and up to the top of the wall on the School/rear elevation.</p> <p>We also propose to use new bricks for Church Path elevation four new buttresses, corbelling and first two courses out the ground (all structural elements).</p>	Comments:

Proposed School (rear) elevation using the Goodwood Blend

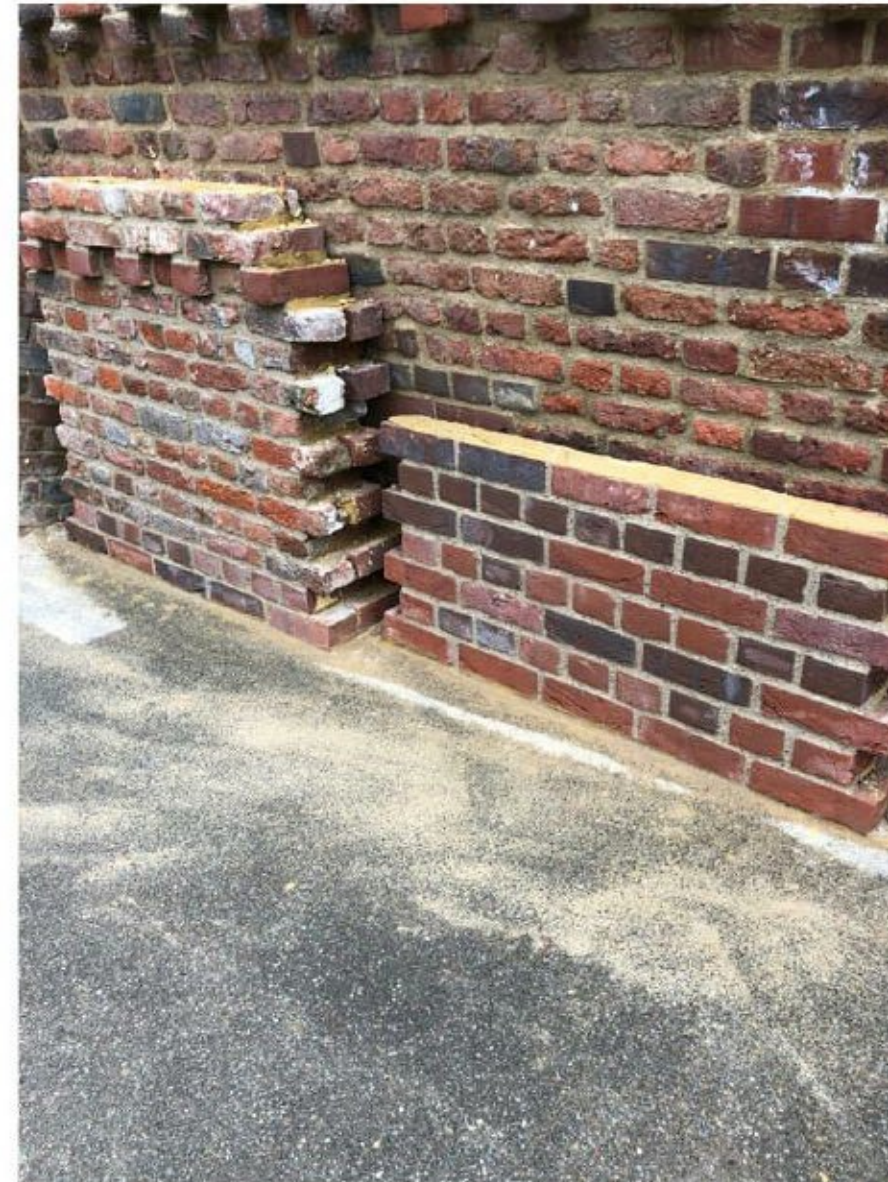
Shows proposed front and rear elevations

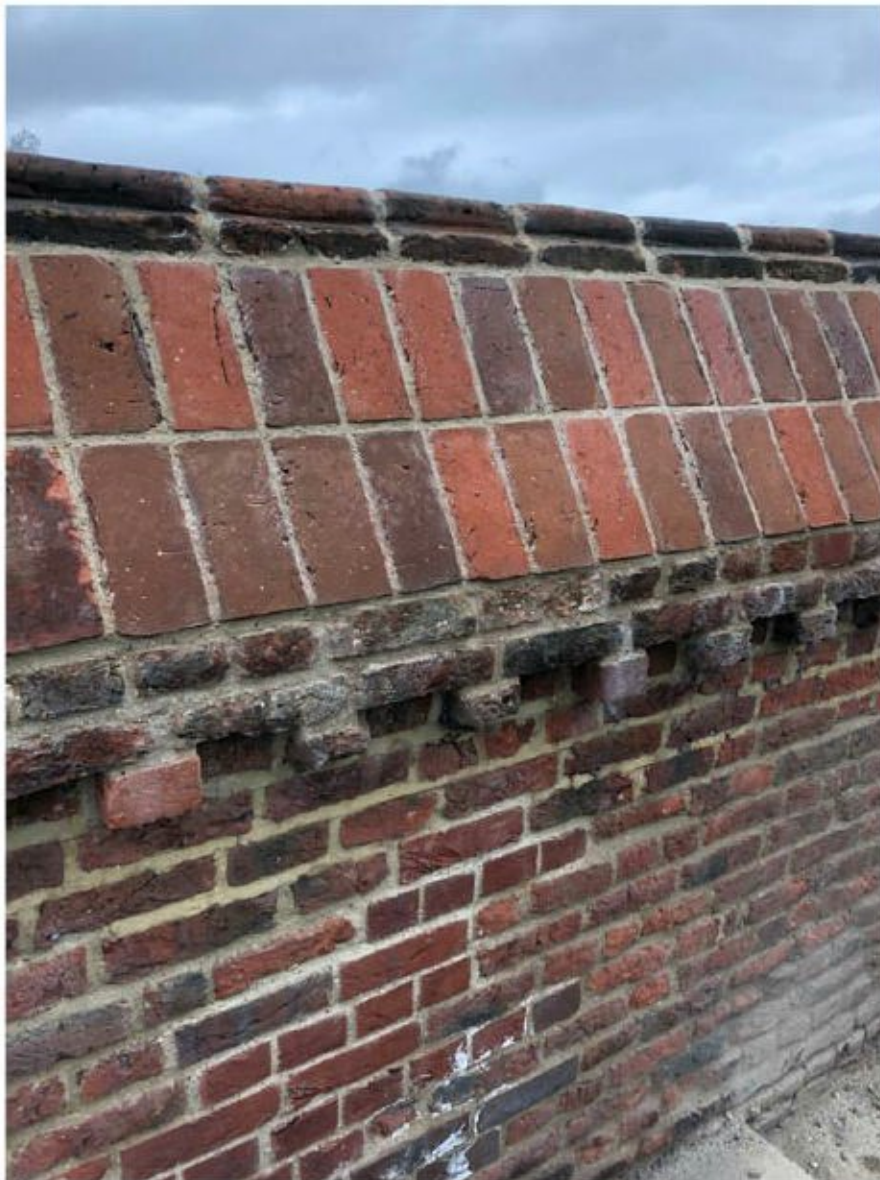
Stonewest	Location:	67751 CAREW MANOR	Sample :
E: info@stonewest.co.uk T: 020 8684 6646	CHURCH LANE	Proposed Use of Combination to NEW & Salvaged Bricks	
Description:			Comments:
The skewed Coping bricks with their bottom beds facing skyward, we propose/recommend will be in the NEW Goodwood Blend bricks for longevity.

Shows the Goodwood brick to the skewed capping

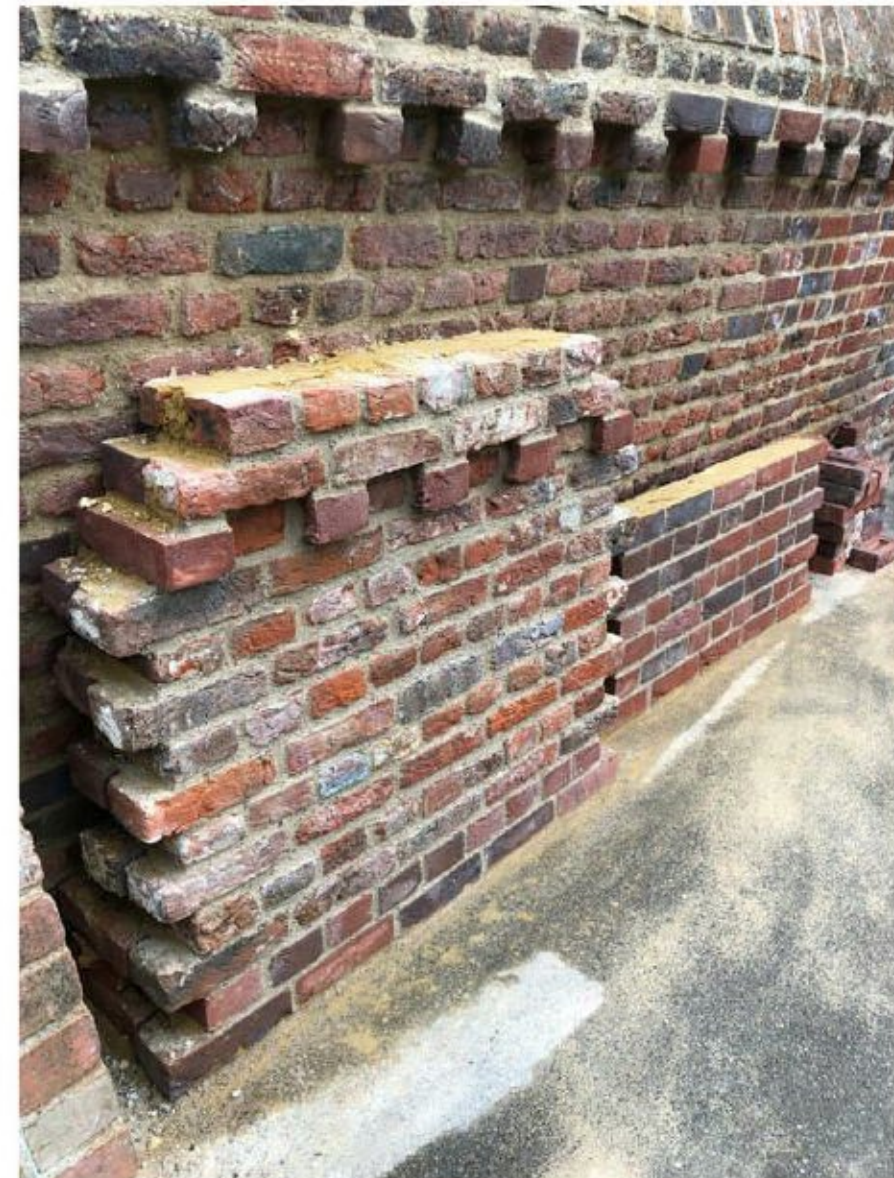
Shows church path and school elevations proposed samples panels

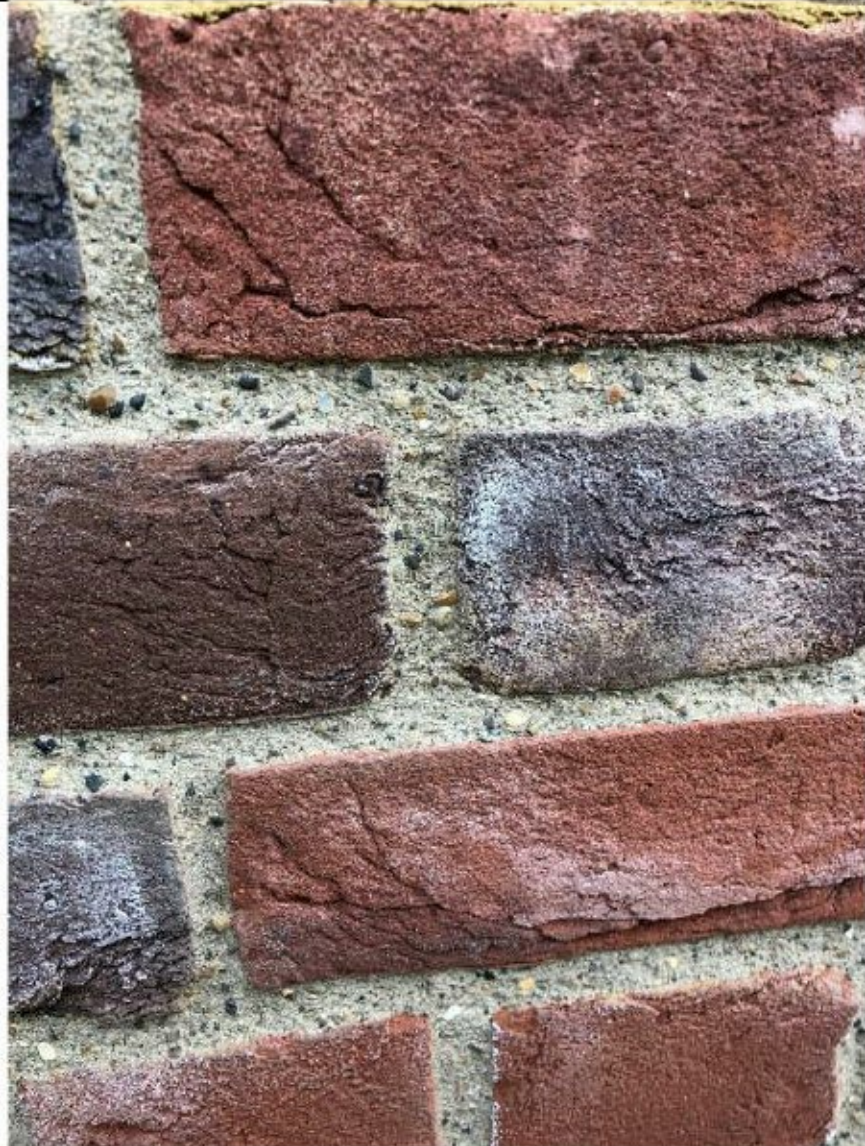
Stonewest	Location:	67751 CAREW MANOR	
E: info@stonewest.co.uk T: 020 8684 6646	CHURCH LANE	PROPOSED LIME MORTARS	Sample :
Description:	For Building, 2 parts Westerham fine graded washed building sand and 1 part washed plastering sand and one part NHL 3.5 Hydraulic Lime (3:1). Raked Back to a depth that's twice the width of the joint. For Pointing, 3 parts Chalk Down Lime Sharp Washed sand 4mm aggregate (Greenhithe) to 1 part NHL 3.5 hydraulic lime (3:1).		Comments: Very close colour match to the original lime mortar with a good sized binder at 4mm.

Shows Hydraulic Lime Mortar Proposed Pointing to New Bricks

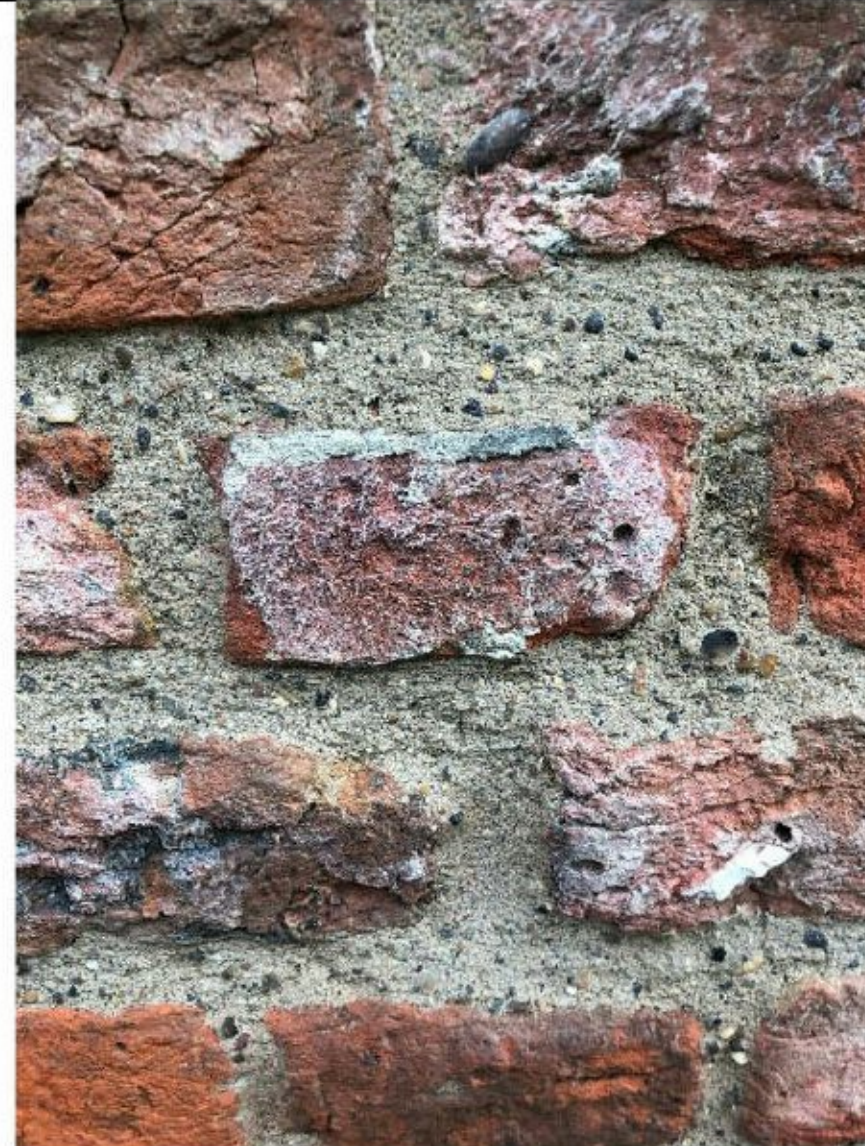
Shows Hydraulic Lime Mortar Proposed Pointing to Salvaged Bricks
