# SLOPE STABILITY REPORT

Fort Halstead, Kent

February 2015

**Client Name:** Armstrong (Kent) LLP  
**Document Reference:** EED12715-102-R-8.1.8-RD  
**Project Number:** EED12715

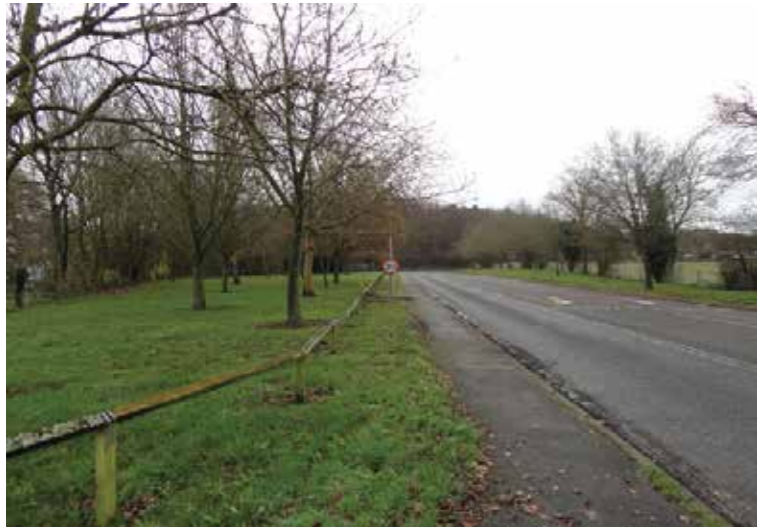
Plate 1 – Entrance to Crow Drive (looking south).

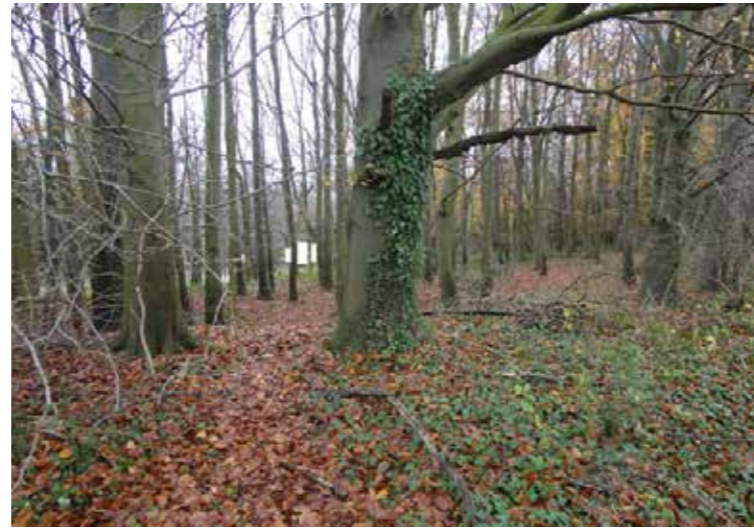
Plate 2 – Slope to the east of Crow Drive (looking south east).

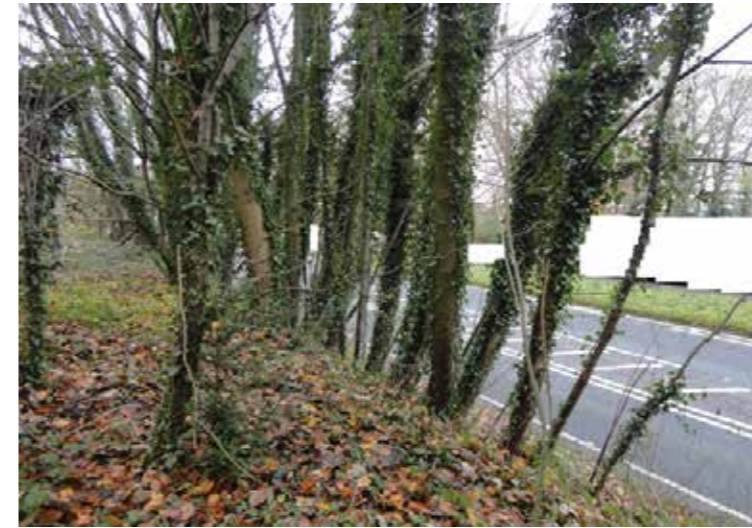
Plate 3 – Slope towards A224 (looking north east).

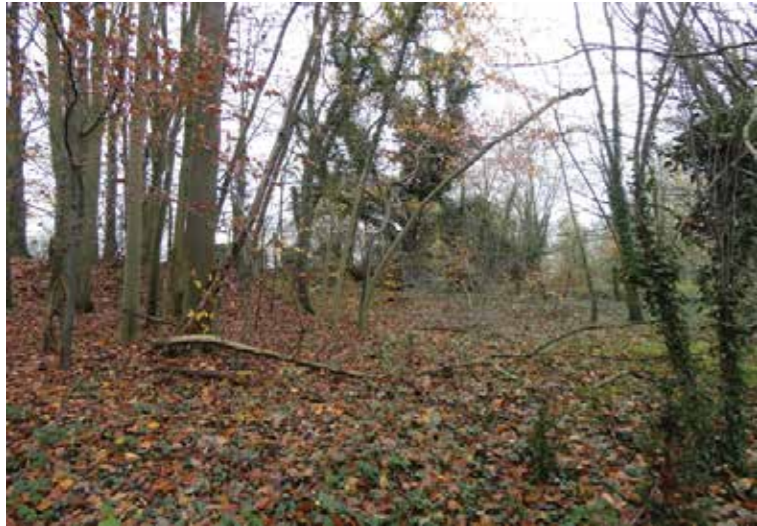
Plate 4 – Slope to the east of Crow Drive (looking south east).

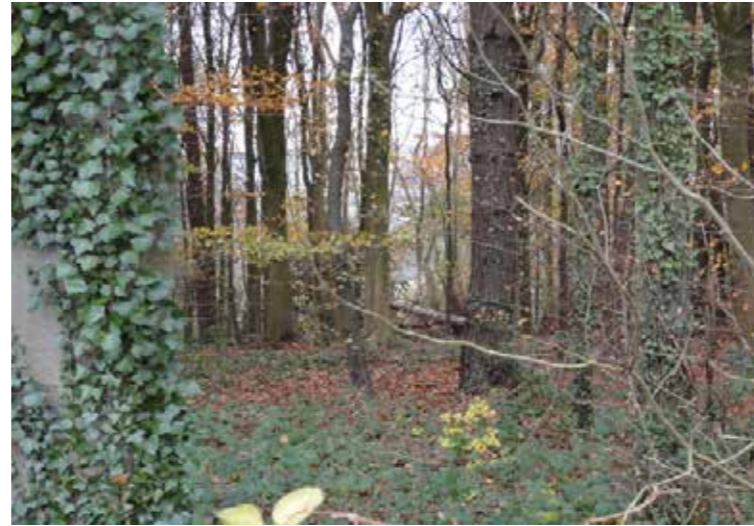
Plate 5 – Slope to the east of Crow Drive (looking south east).

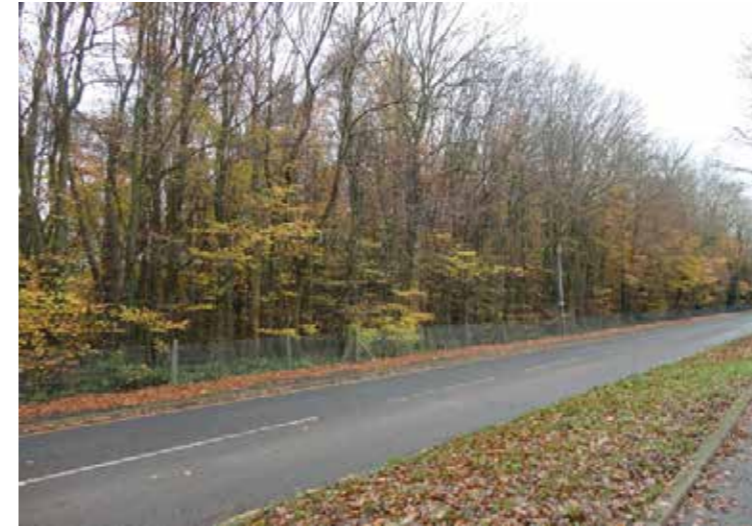
Plate 6 – Crow Drive (looking south east).

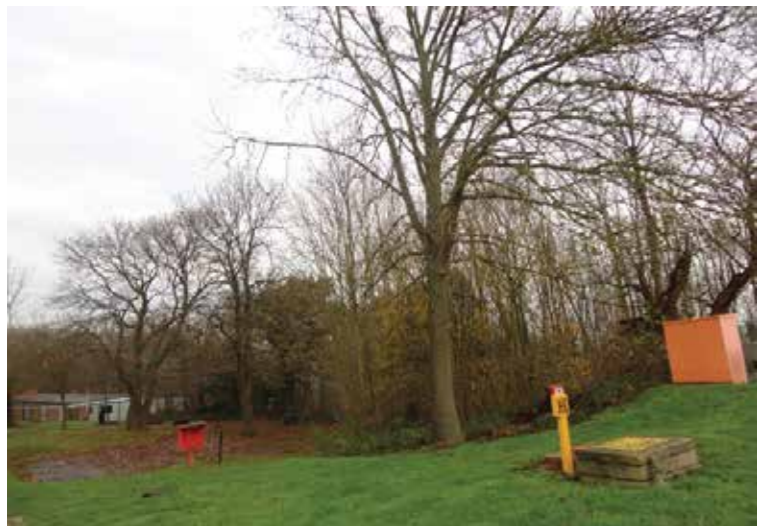
Plate 7 – Slope to the east of Crow Drive (looking north east).

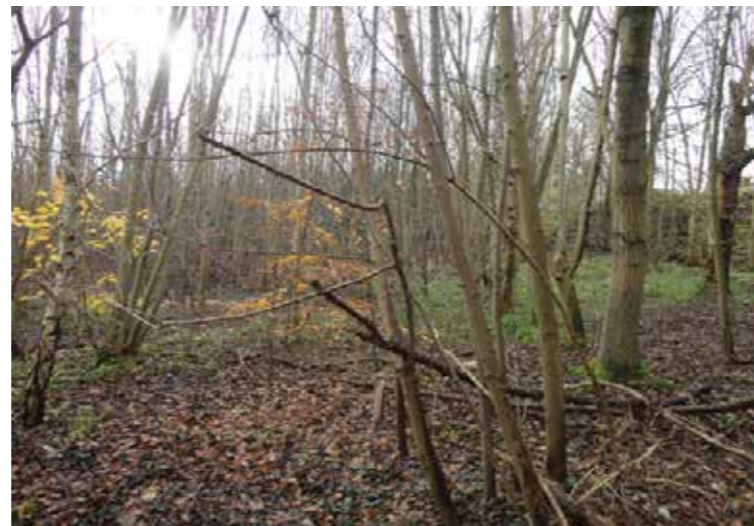
Plate 8 – Slope to the east of Crow Drive (looking south east).

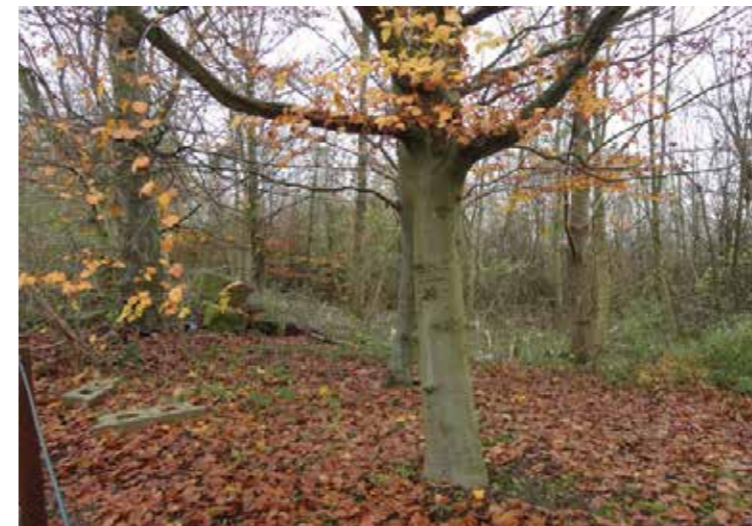
Plate 9 – Slope to the east of the car park (looking east).

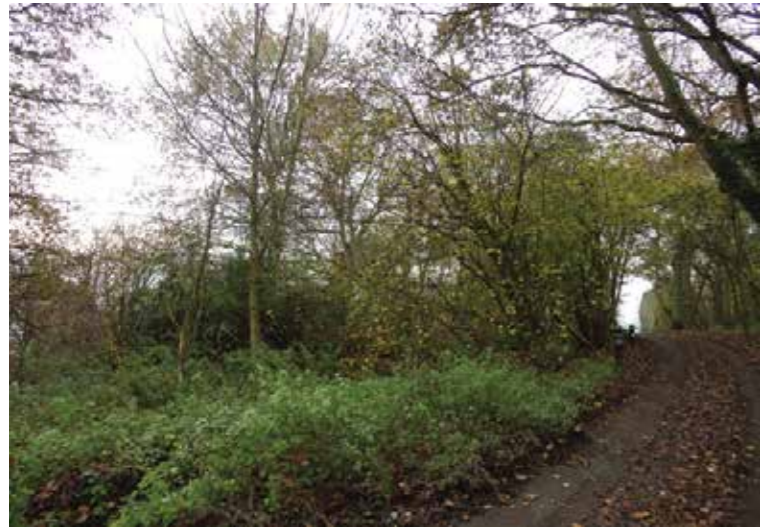
Plate 10 –Footpath to the east of the fort (looking south).

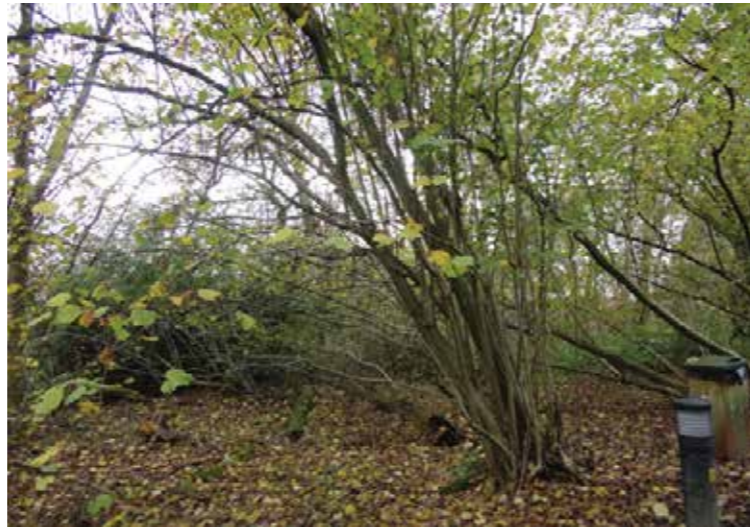
Plate 11 – Inclined trees towards the downslope direction (looking south).

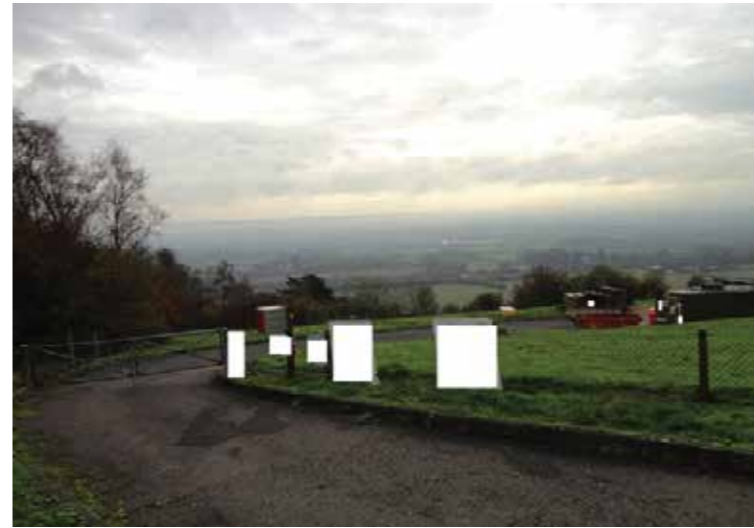
Plate 12 – Towards the practice firing range area (looking south).

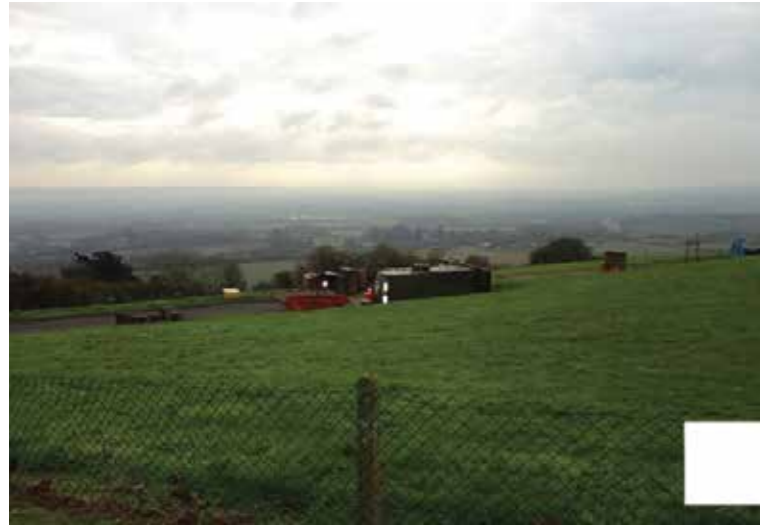
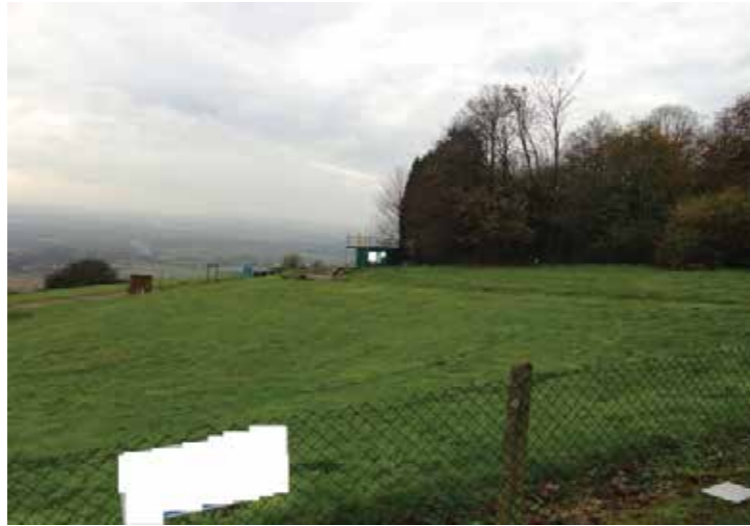
Plate 13a – Slope towards the practice firing range area (looking south).

Plate 13b – Slope towards the practice firing range area (looking south).

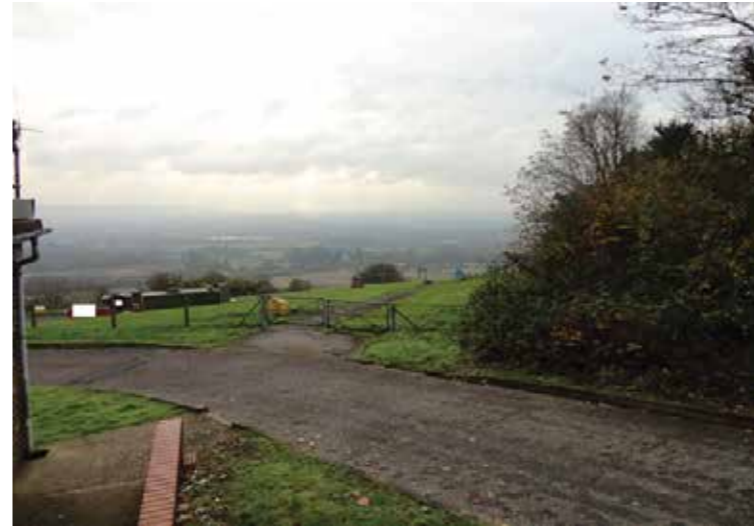
Plate 14 – Slope towards the practice firing range area (looking south west).

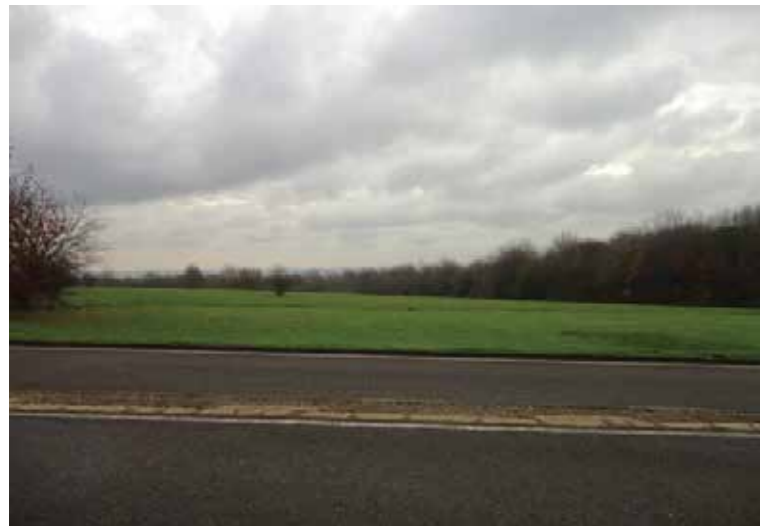
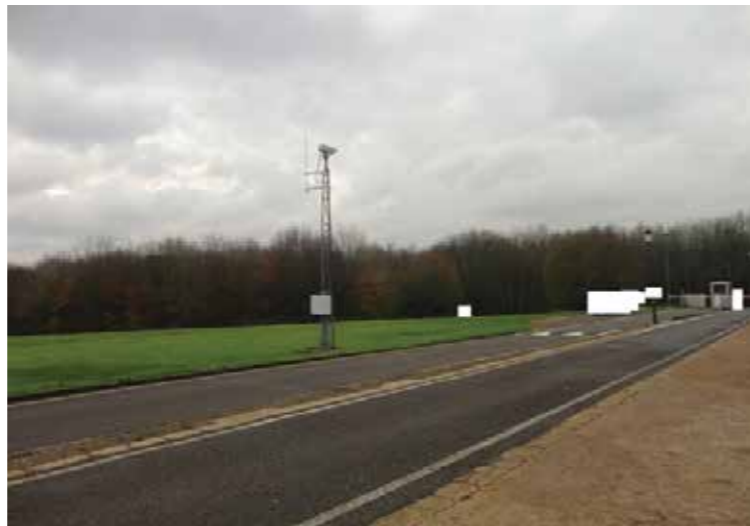
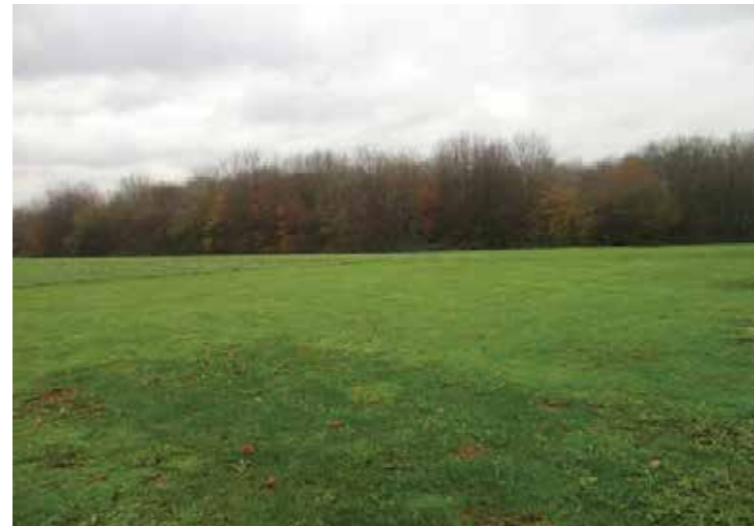
Plate 15a – Slope to the south east of Crow Drive (looking east).

Plate 15b – Slope to the south east of Crow Drive (looking south west).

Plate 15c – Slope to the south east of Crow Drive (looking south west).

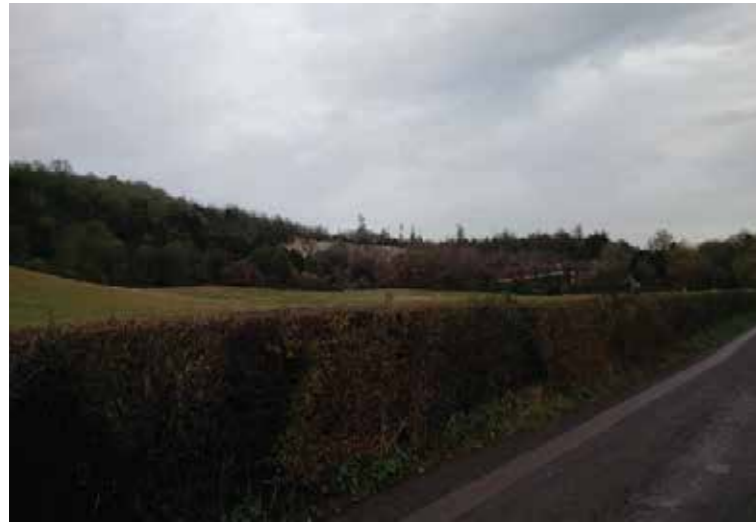
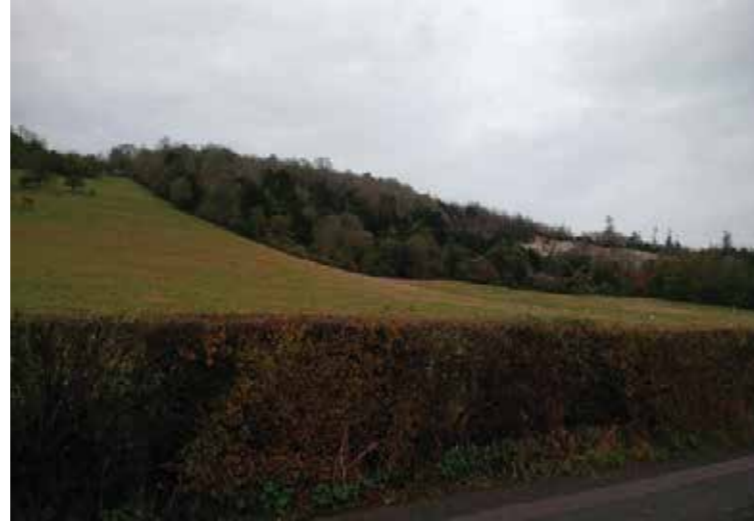
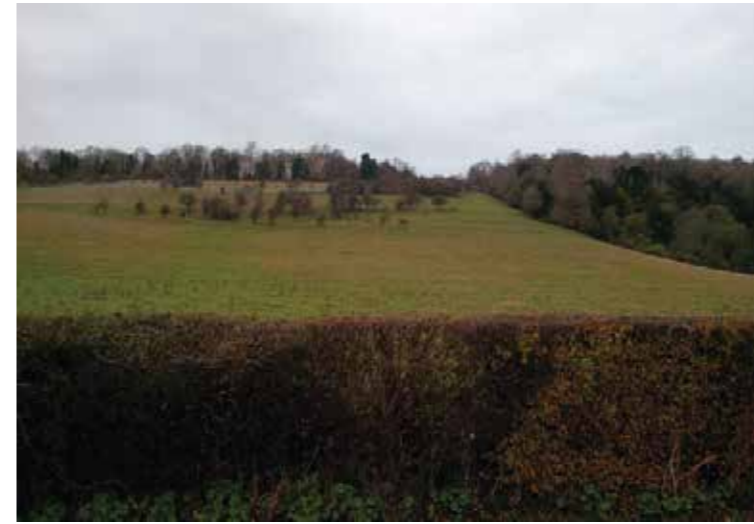
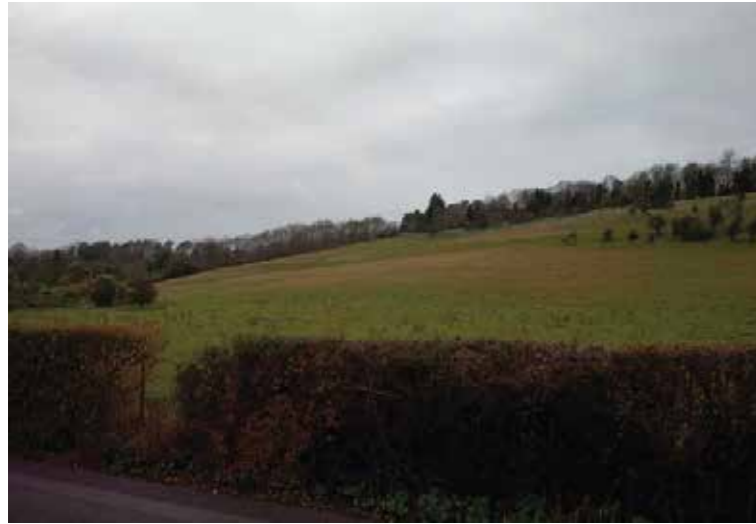
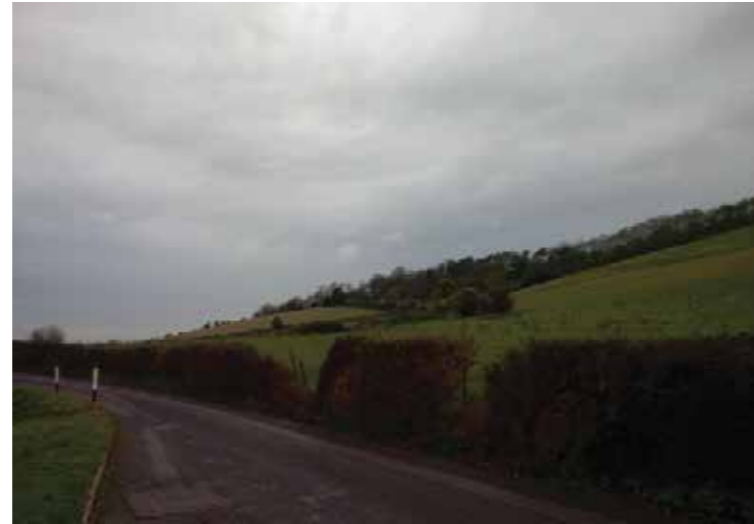
Plate 16a – Slope along Lime Pit Lane to the south east of the site boundary (looking north east).

Plate 16b – Slope along Lime Pit Lane to the south east of the site boundary (looking north east).

Plate 16c – Slope along Lime Pit Lane to the south east of the site boundary (looking north west).

Plate 16d – Slope along Lime Pit Lane to the south east of the site boundary (looking south west).

Plate 16e – Slope along Lime Pit Lane to the south east of the site boundary (looking south west).

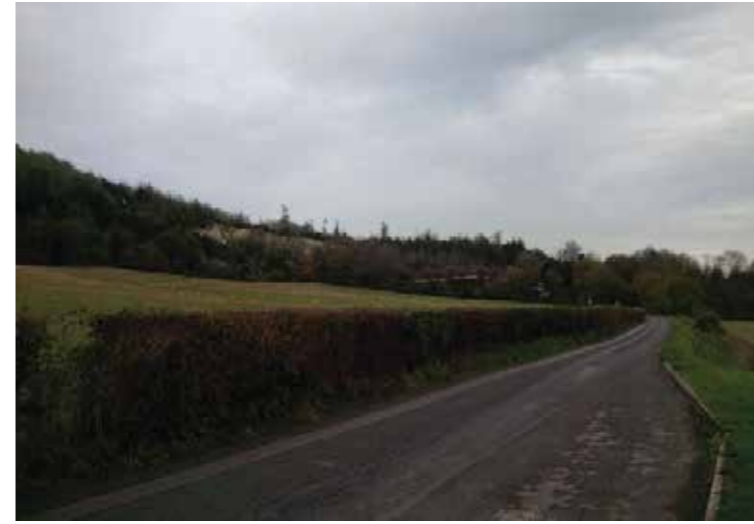
Plate 17 –Lime Pit Lane (looking north east).

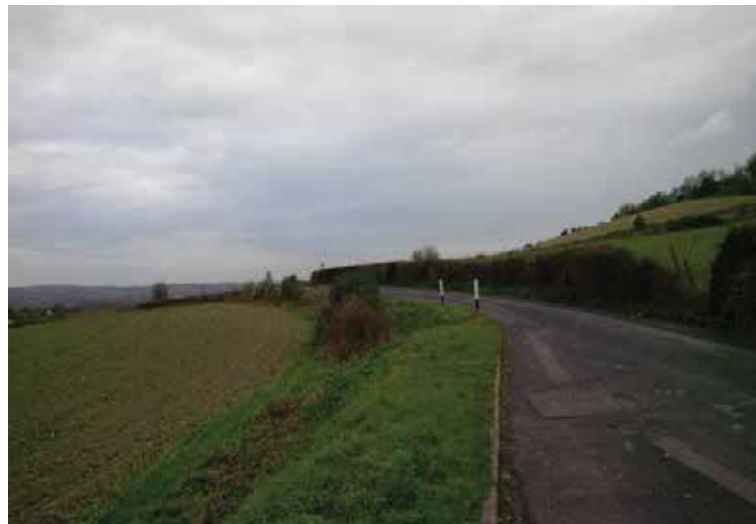
Plate 18 –Lime Pit Lane (looking south west).

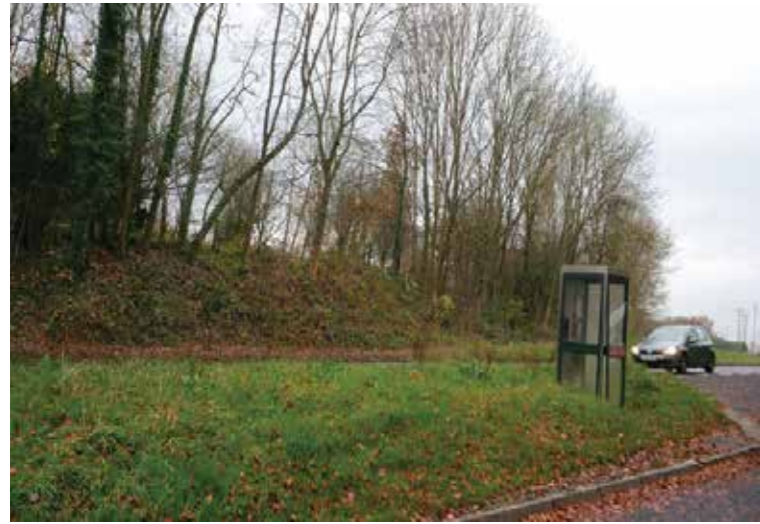
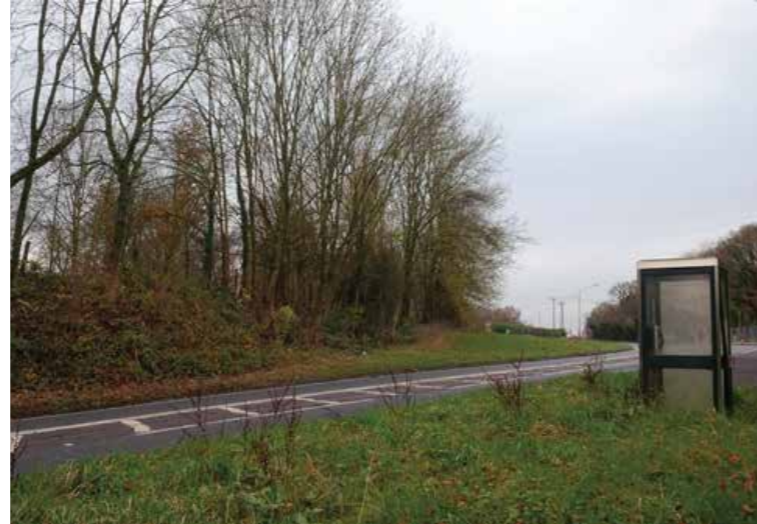
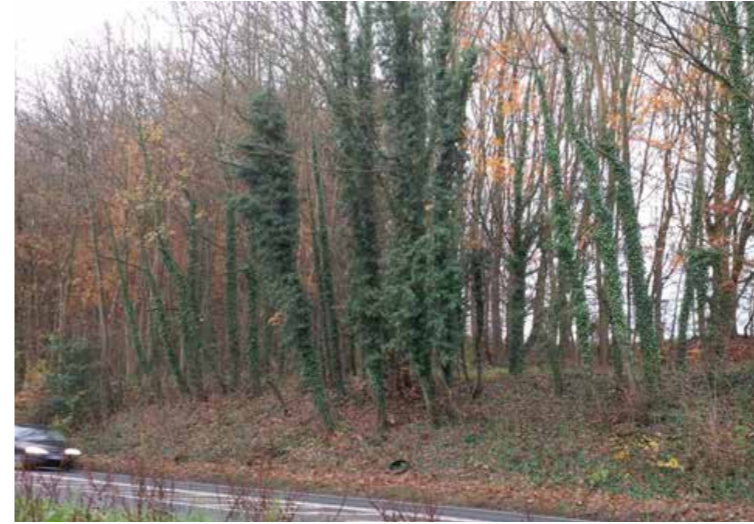
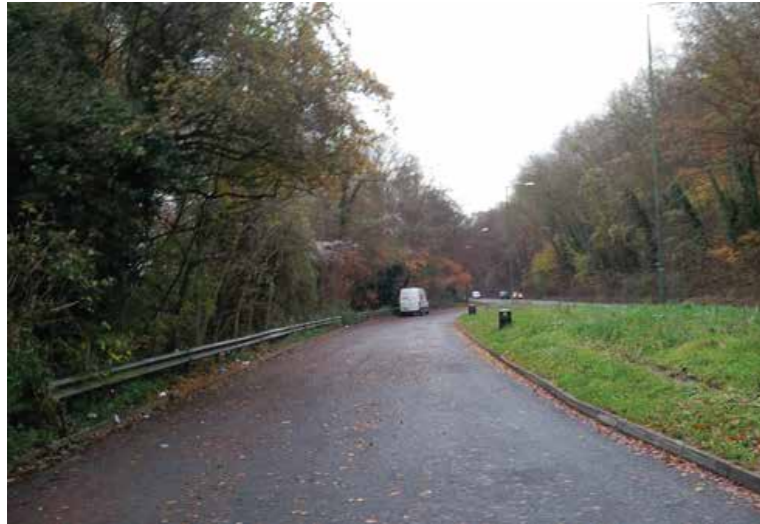
Plate 19a – Slope cutting along A224 to the east of the site (looking north west).

Plate 19b – Slope cutting along A224 to the east of the site (looking north west).

Plate 19c – Slope cutting along A224 to the east of the site (looking west).

Plate 19d – Slope cutting along A224 to the east of the site (looking southwest).

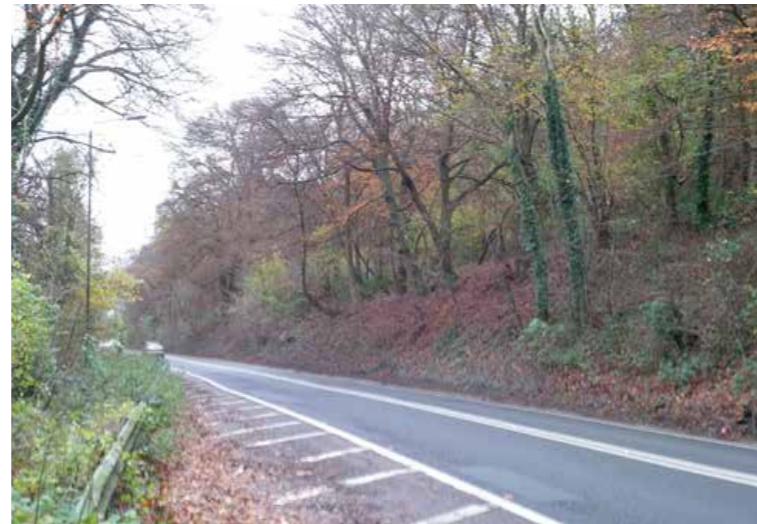
Plate 20 – The lay-by to the south of Polhill Arms public house (looking south).

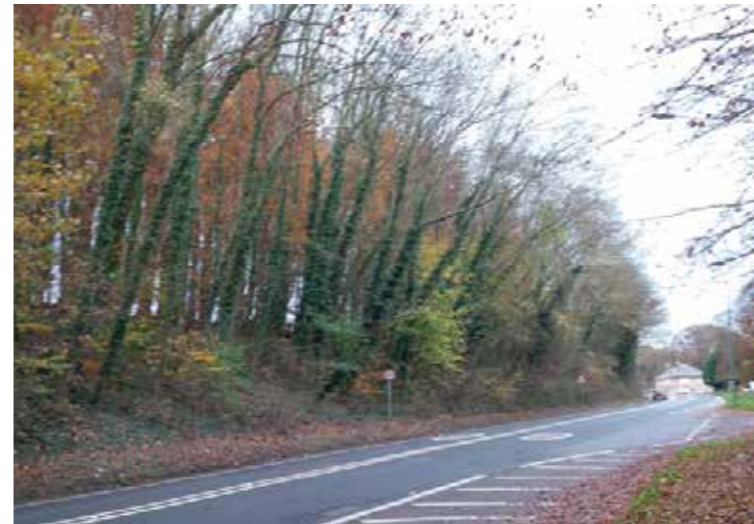
Plate 21 – A224 (looking south west)
