**27 Upper Gordon Road
Camberley
Surrey,
GU15 2HJ**

DOWLING AND SONS

The property situated at the address above is late Victorian. It is not listed but sits within a conservation area.

Painting work:

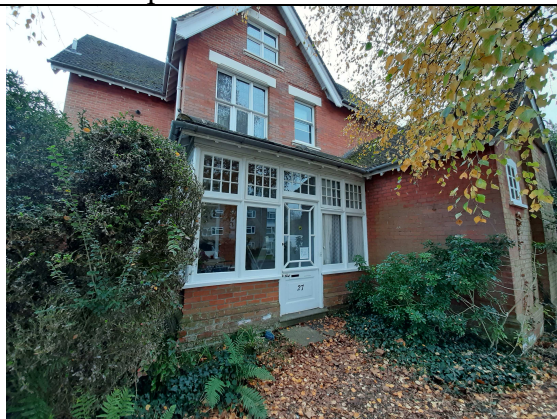
Front Elevation: Main door way and also all the window need painting. The eaves must be tested as the guttering has failed and dampness may have affected paint or the wood. Paint on the first-floor window on the right was found to be blistering off in September 2020 and the window and required prompt remedial action as the wood was exposed. The paint to the side of the entrance hallway has been affected due to the plants and the window on the ground floor toilet (not visible) is blocked with paint.

Window shown has been sealed with paint and needs to be cleaned and repainted so that it can open to allow for secure ventilation of the ground floor bedroom

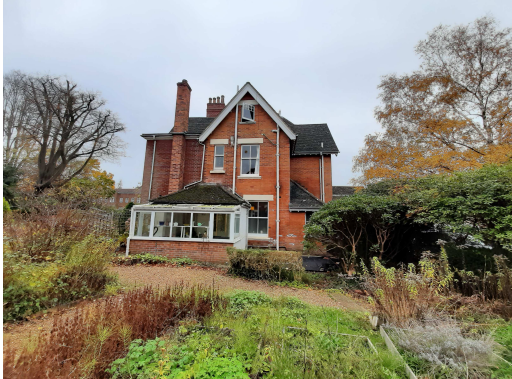
East side facing elevation.

Ground floor conservatory is made of plastic however all the other windows facing this way are wood painted with gloss. Both windows on the first floor do not open correctly and need to have paint removed from previous application of paint to allow for easy opening and then repainted as per methodology. Also the window on the right on the 1st floor the top part of the sash cord window has been painted with an inch opening and the paint needs to be removed to enable the window to close properly

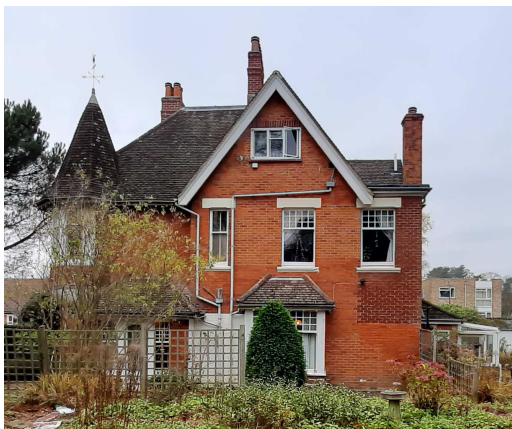
South side facing elevation

The top floor windows are made of metal and need to be checked for rust as when closing they have exhibited undue stiffness which maybe due to the painting work carried out in the past.

The middle floor windows, the turret and ground floor windows were seen to have paint blistering in September 2020 and required urgent remedial painting as the wood was fully exposed to the elements. The middle floor third window from the right of the picture is a bathroom window and needs to be easily opened however it is

extremely stiff due to painting work. The middle floor top sash windows have all been sealed with paint due to previous poor painting works and can't be opened and need to have all the paint removed and repainted so that they can open easily.

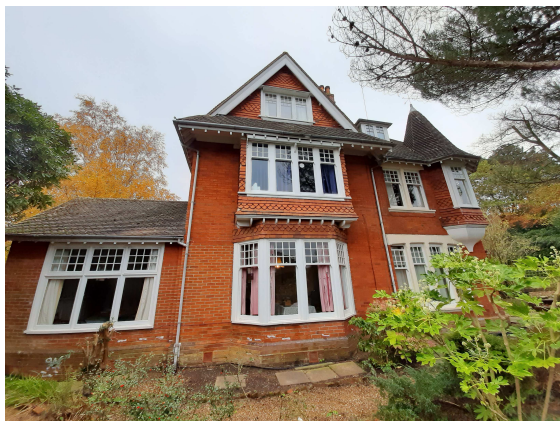
West side facing elevation.

The windows in the middle floor were found to be blistered in a number of places and required urgent remedial action where the wood was exposed. It is expected that the paint will continue to blister and fall off It is proposed that the paint is stripped off as per methodology.

The top floor window on the right is a plastic replacement windows which was changed a number of years ago.

All the fascia boards and eaves will need to be checked for soundness and repainted as per methodology

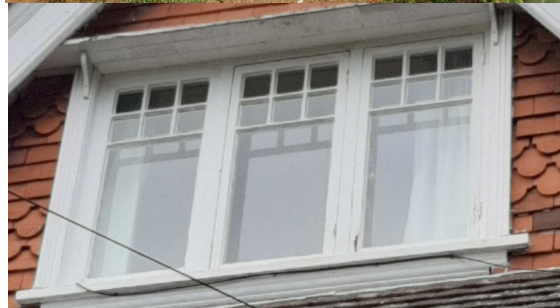
The window on the left is the top floor west facing left hand window on the previous picture and shows the weathering of the paint.
