RE: Trees at 9 Waterloo Road, Crowthorne, Berks, RG45 7PB

Instructions:

Thank you for your instruction to undertake an assessment of the pine tree at the above site. You asked me to undertake a visual assessment of the trees health and make recommendations for its future management. I duly visited the site on the 25th March 2021 and can now advise as follows.

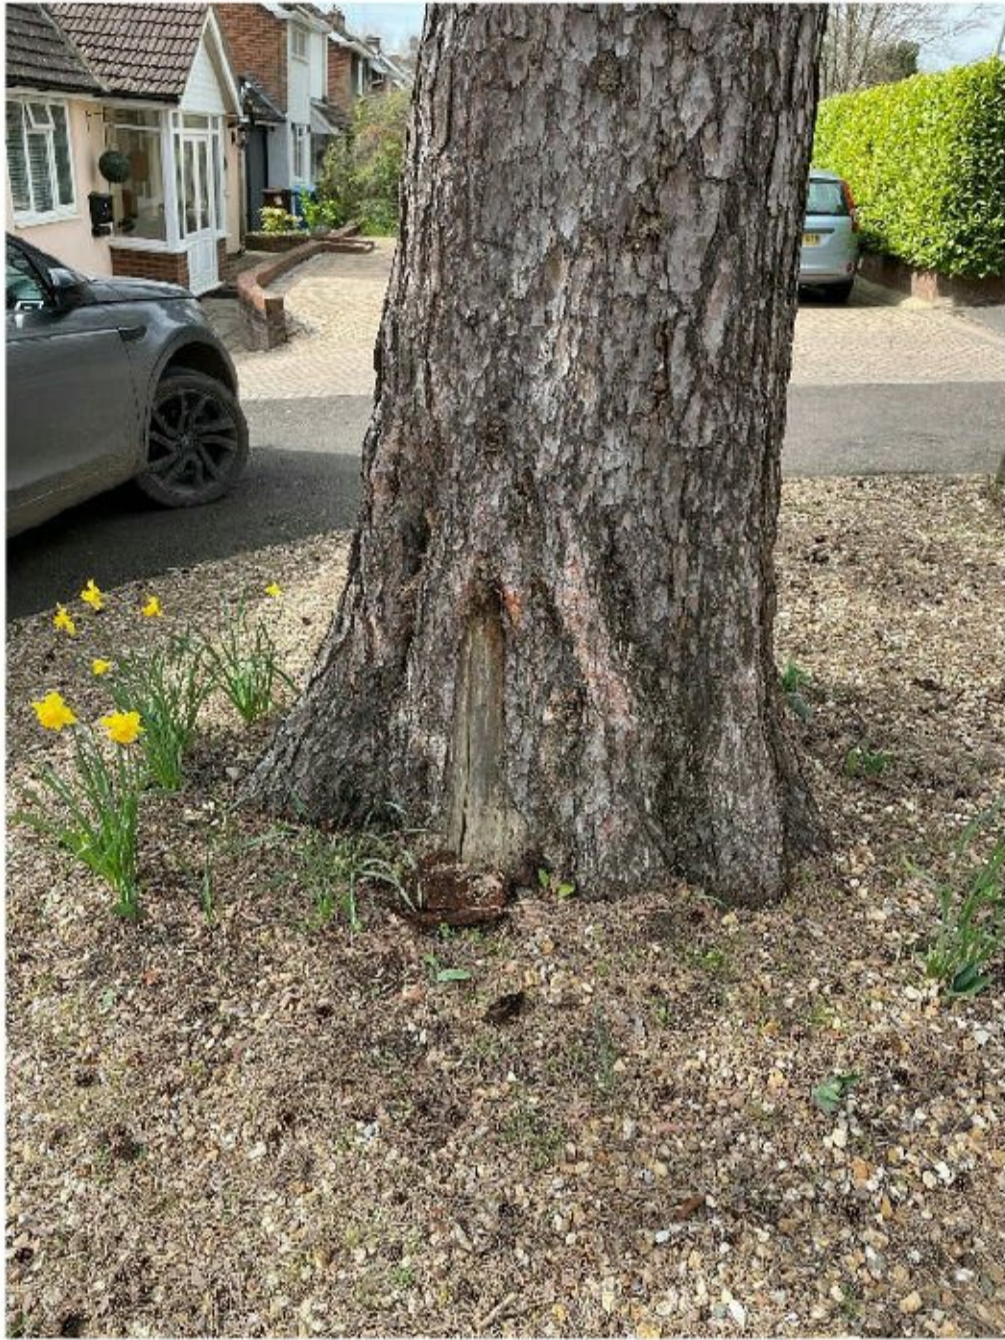
The tree has a large basal wound at ground level on the south side of its stem, extending to a height of 0.75m. The cause of this wound is not clear but it has clearly been present on the tree for many years.

At the base of the above wound there is the remnants of the fruiting bodies of *Phaeolus schweinitzii* (see left hand photo below). A smaller bracket was also noted on the other side of the stem (as seen in the right hand photo below). This fungus has likely colonised the tree following the creation of the aforementioned wound. The decay begins in the root system and often follows honey fungus (*Armillaria ssp*). The fungus will degrade the wood and, over a period of time, will cause a brown rot which reduces the tensile strength of the trees wood tissue. This decay can eventually lead to a brittle fracture. A resonance test (with a sounding mallet) of the affected area revealed significant decay in the area of the fungus.

The tree is in the onset of decline and I expect the crown to slowly deteriorate further as the basal decay progresses. The tree is located next to a busy road and near to several nearby houses. Therefore, action must be taken to avoid the risk posed by the tree.

Pine trees do not crown reduce well and I therefore conclude that removal and replacement would be the most appropriate action.

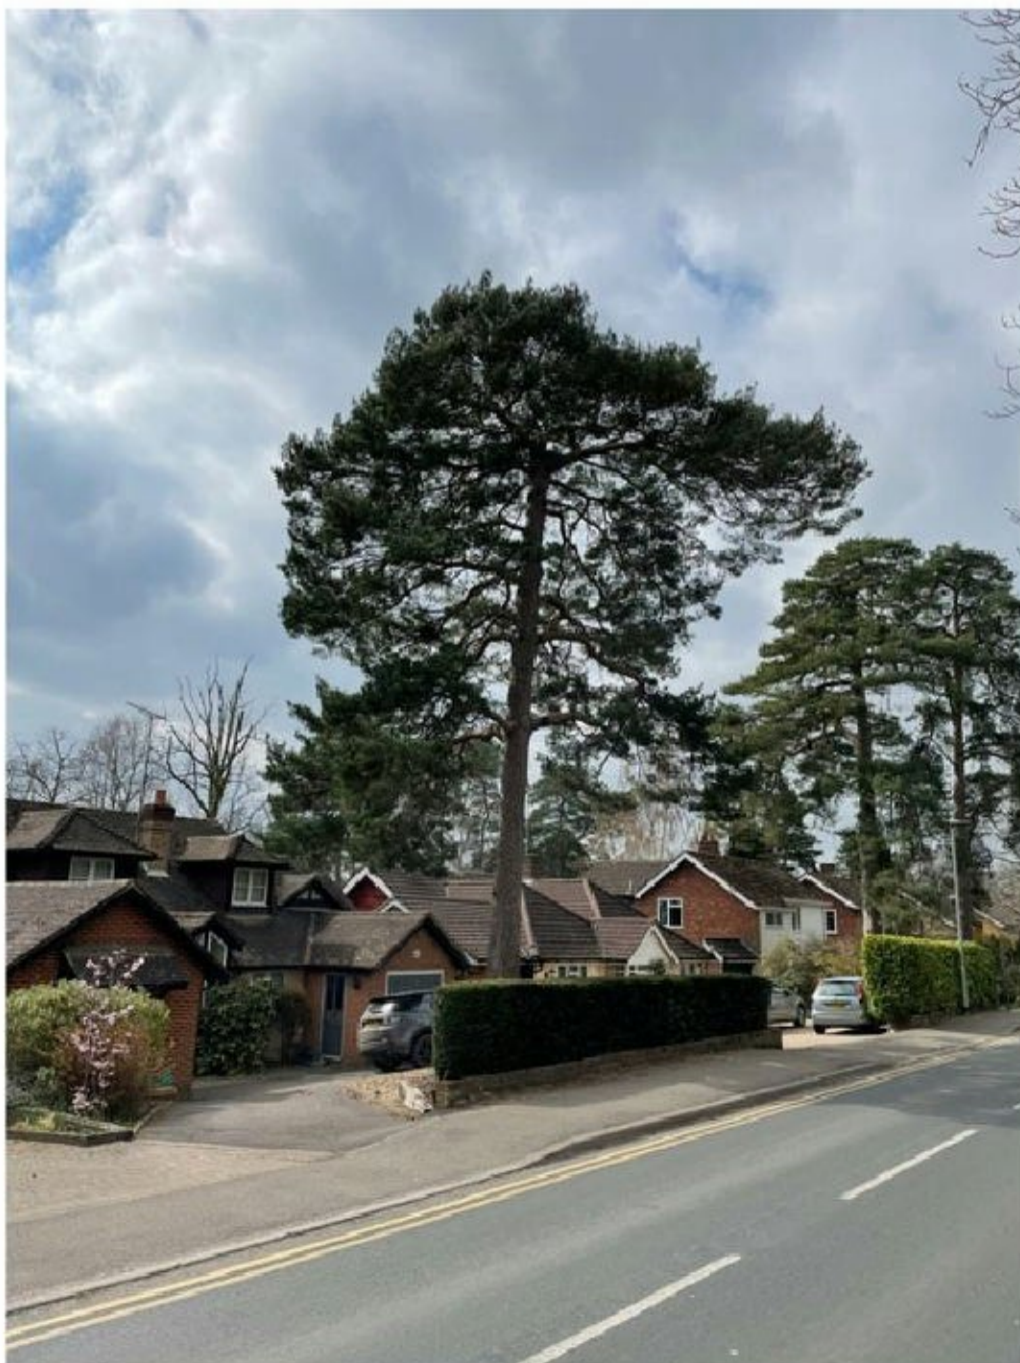
The tree crown is also more sparsely foliated than neighbouring trees of the same species to the west, as shown in the photo below. I estimate the subject tree to have 20% less crown density / vitality than these trees.
