# 4 MERIDIAN STREET, MONTROSE

Job No. 203966

**EXISTING BUILDING CONDITION REPORT**  
Interpretive report and recommendations from site observations.

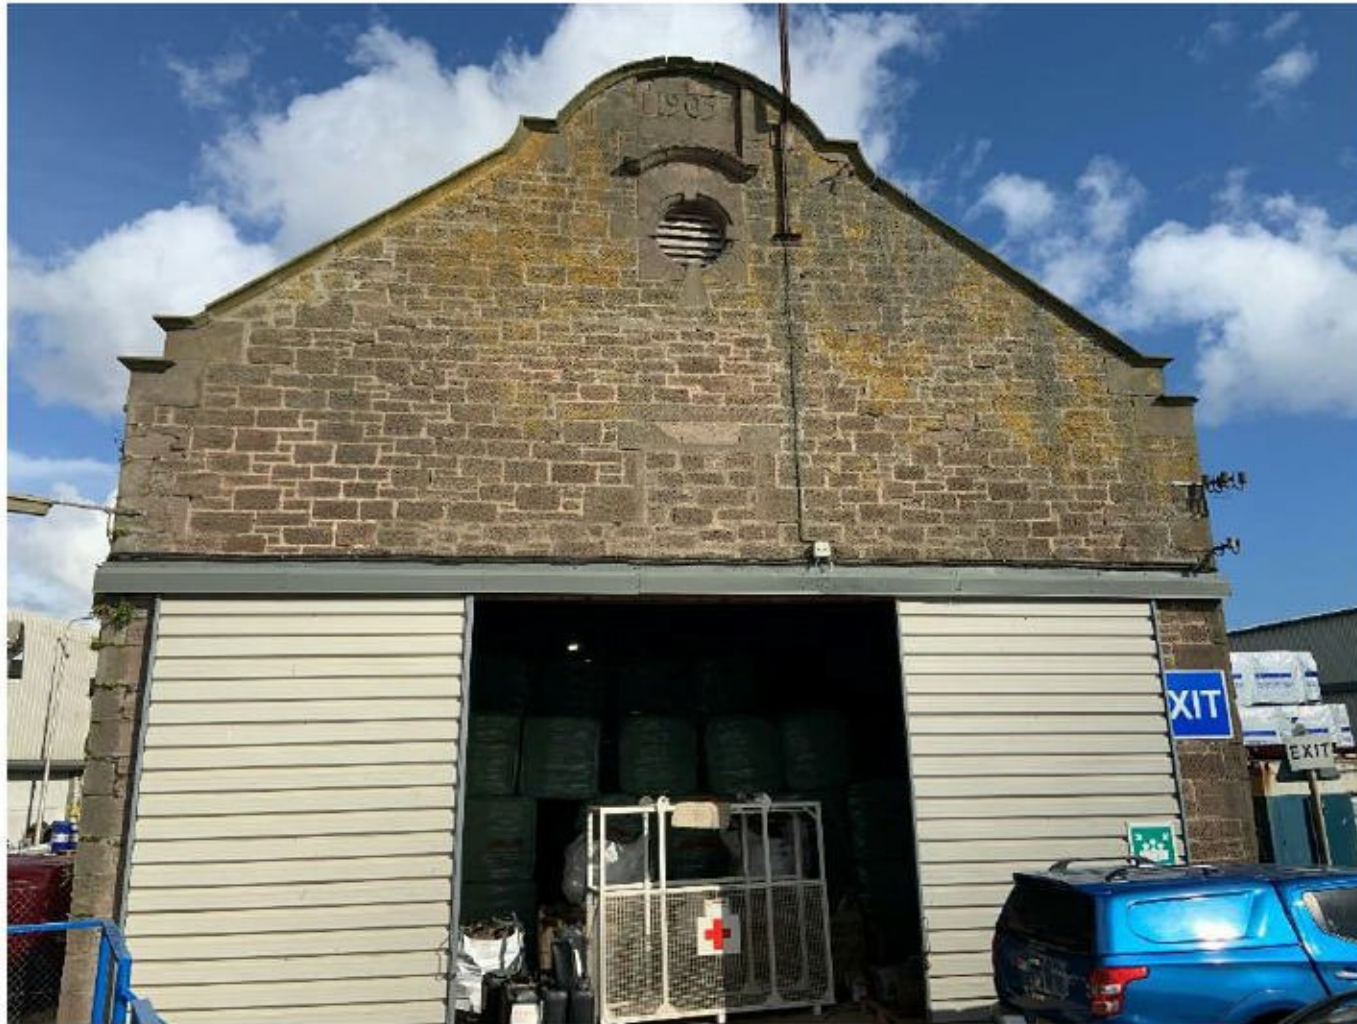
This elevation is a full gabled the coping stones are weathered. There is a new large full width opening forming a sliding door. There is evidence of the mortar being repointed and some cracking.

**Figure 1: South West Gable Elevation**

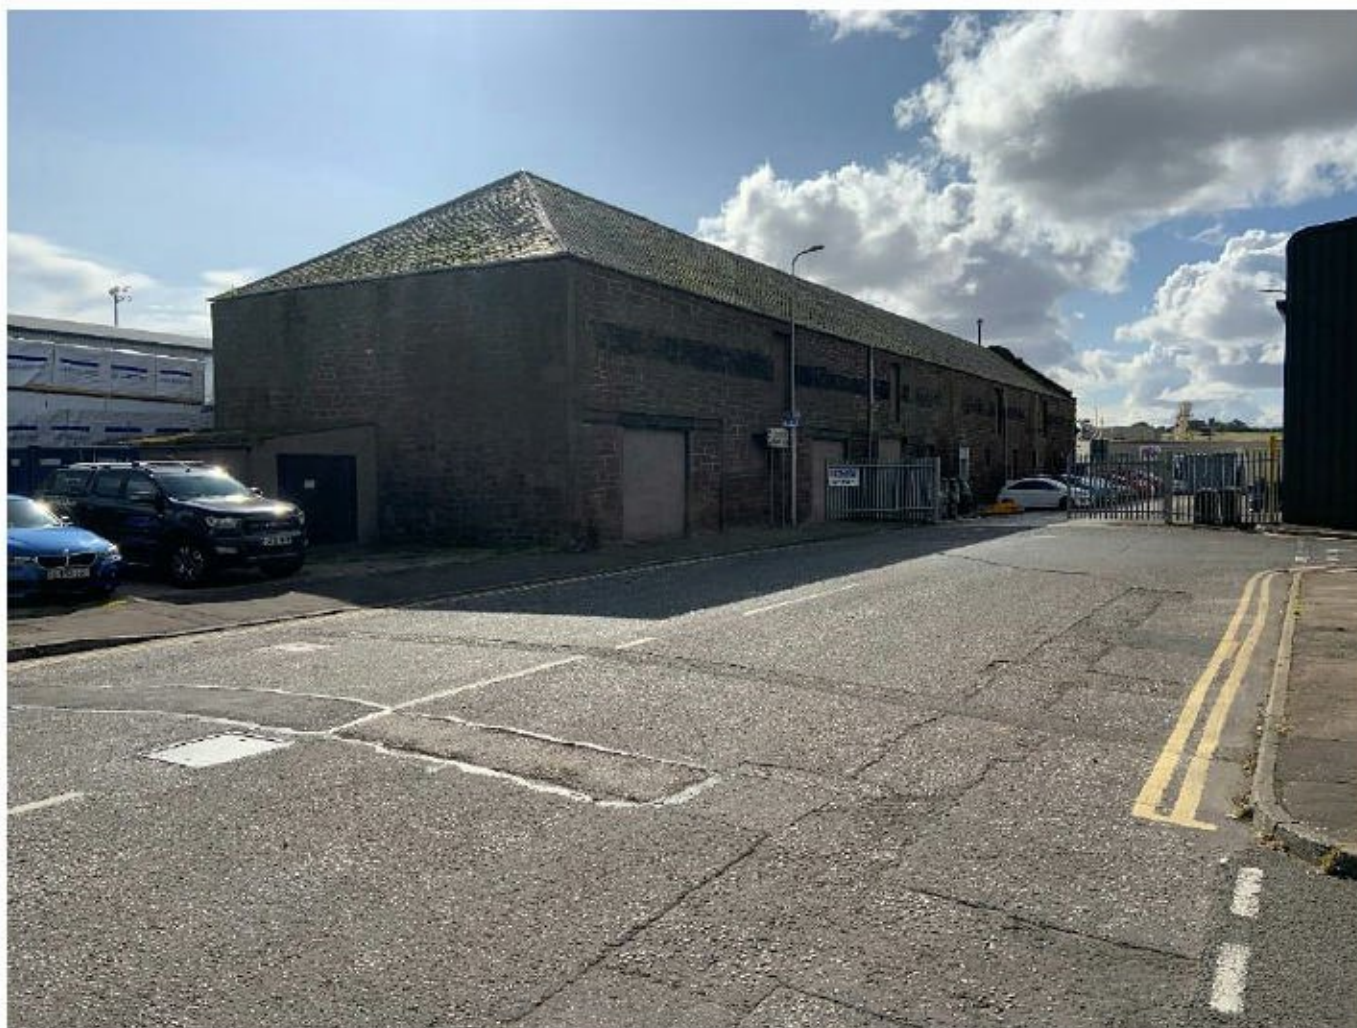
**Figure 2: North East Gable & North West Elevation (Meridian Street)**

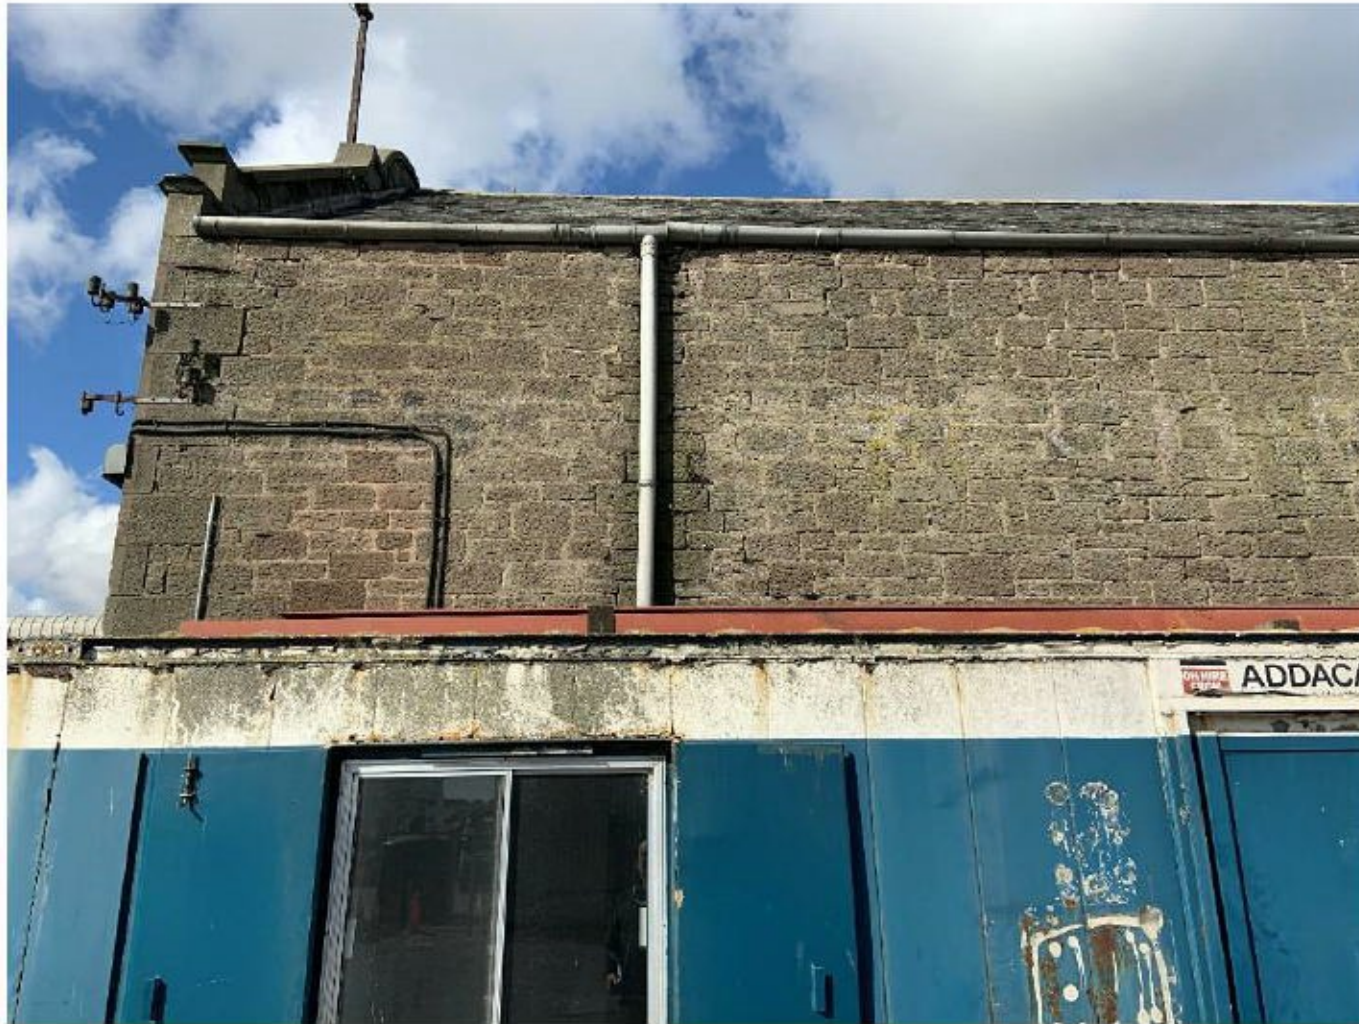
**Figure 3: Part South East Elevation**

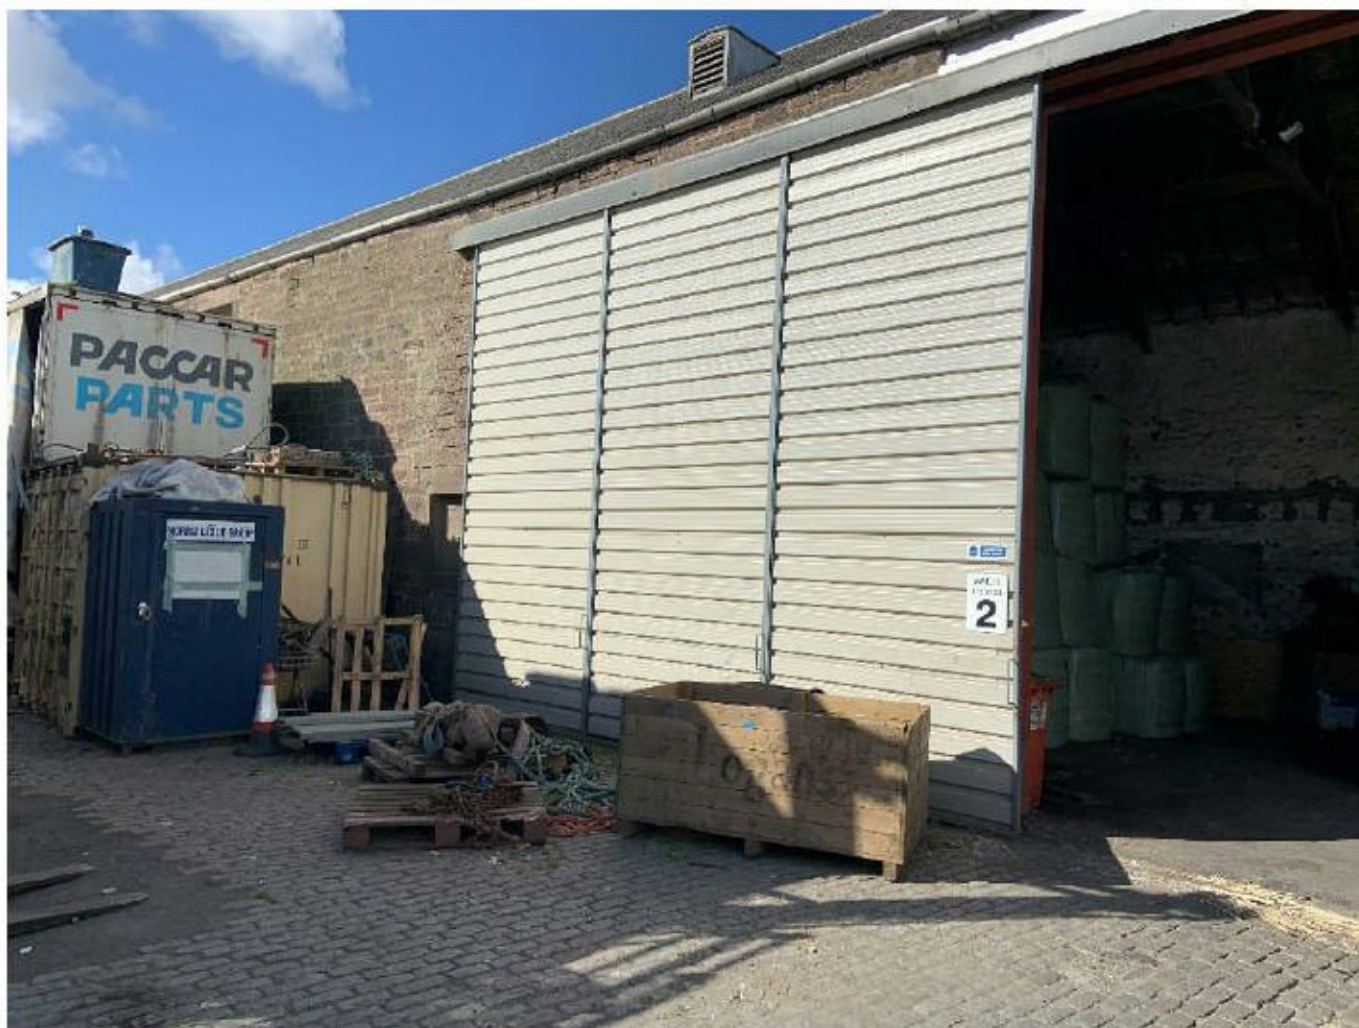
**Figure 4: Part South East Elevation**

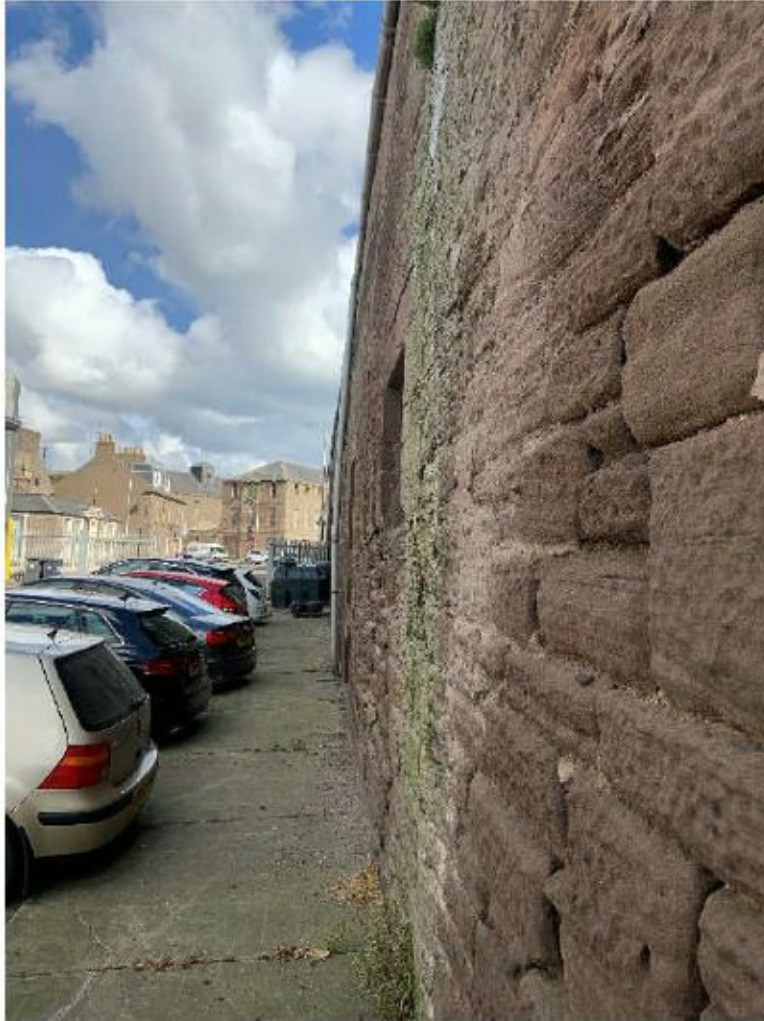
The building is generally in poor condition and in need of repair and maintenance. The north west elevation is particularly poor exhibiting a severe lean worsening towards the mid length of the building. The north east gable also has a severe lean observed by the wall relative to the gutter. Internally, the building is in very poor condition with very weak, friable mortar, loose and missing stones and numerous cracks.

**Figure 5: North West Elevation – Wall Lean**

To repair the building would be exceptionally difficult given the major defect is the wall lean to the side elevations and weak mortar throughout the building. The wall would need to be taken down and reconstructed to correct the lean or a repair mortar injected into the cavities.

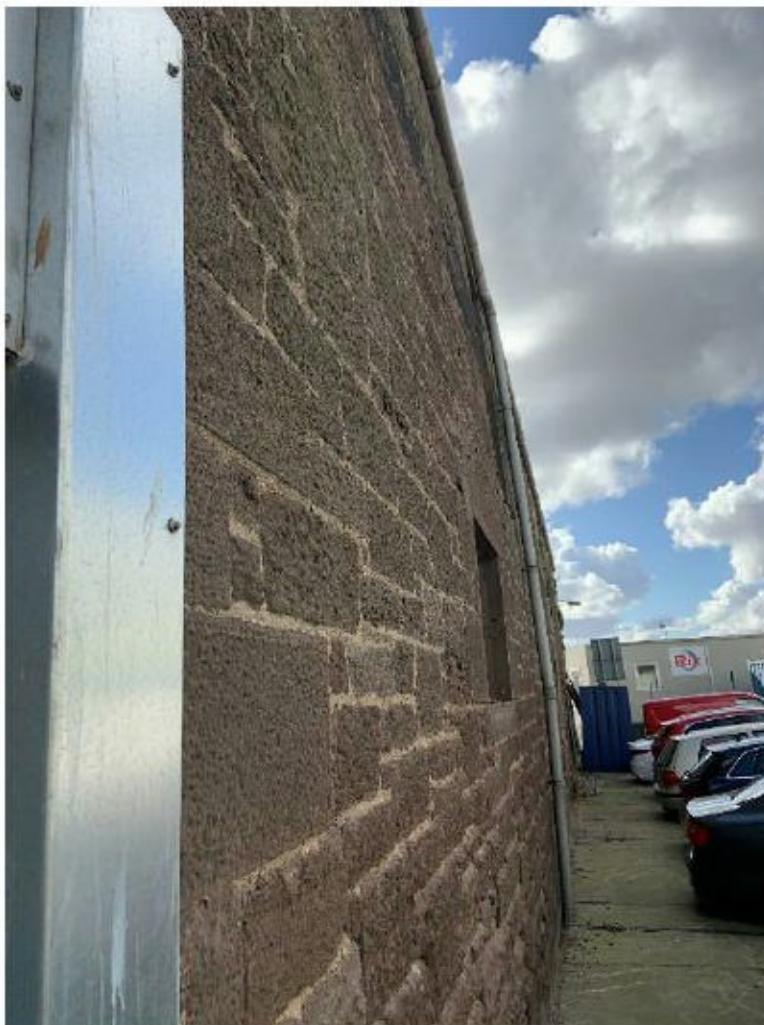
**Figure 6: North West Elevation – Wall Lean**

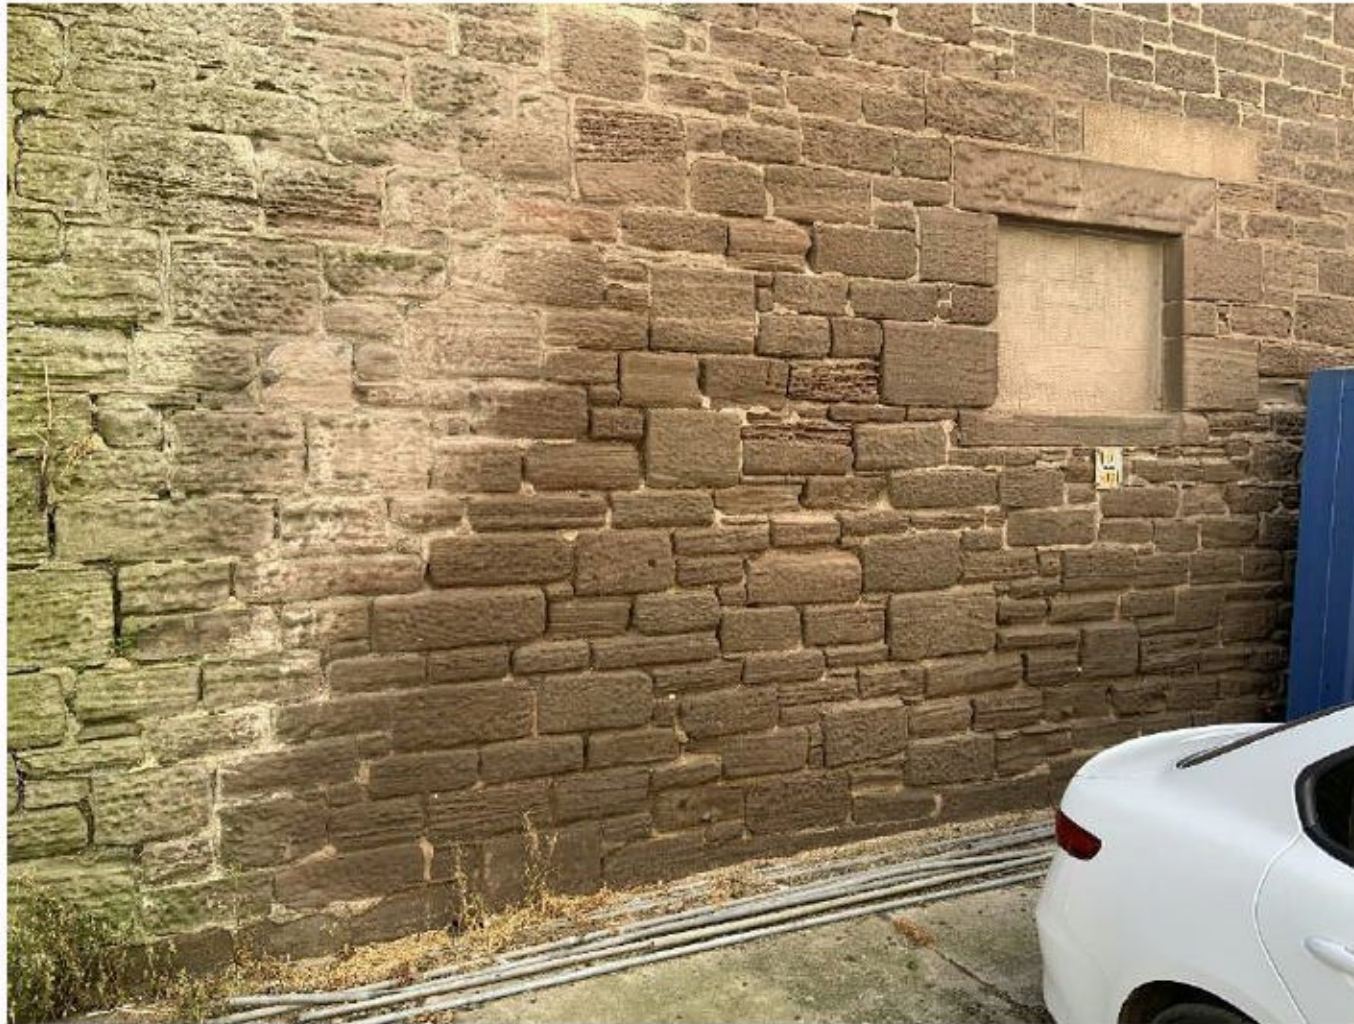
**Figure 7: North West Elevation – Damp Patch, Weathered Stone & Eroded Friable Mortar**

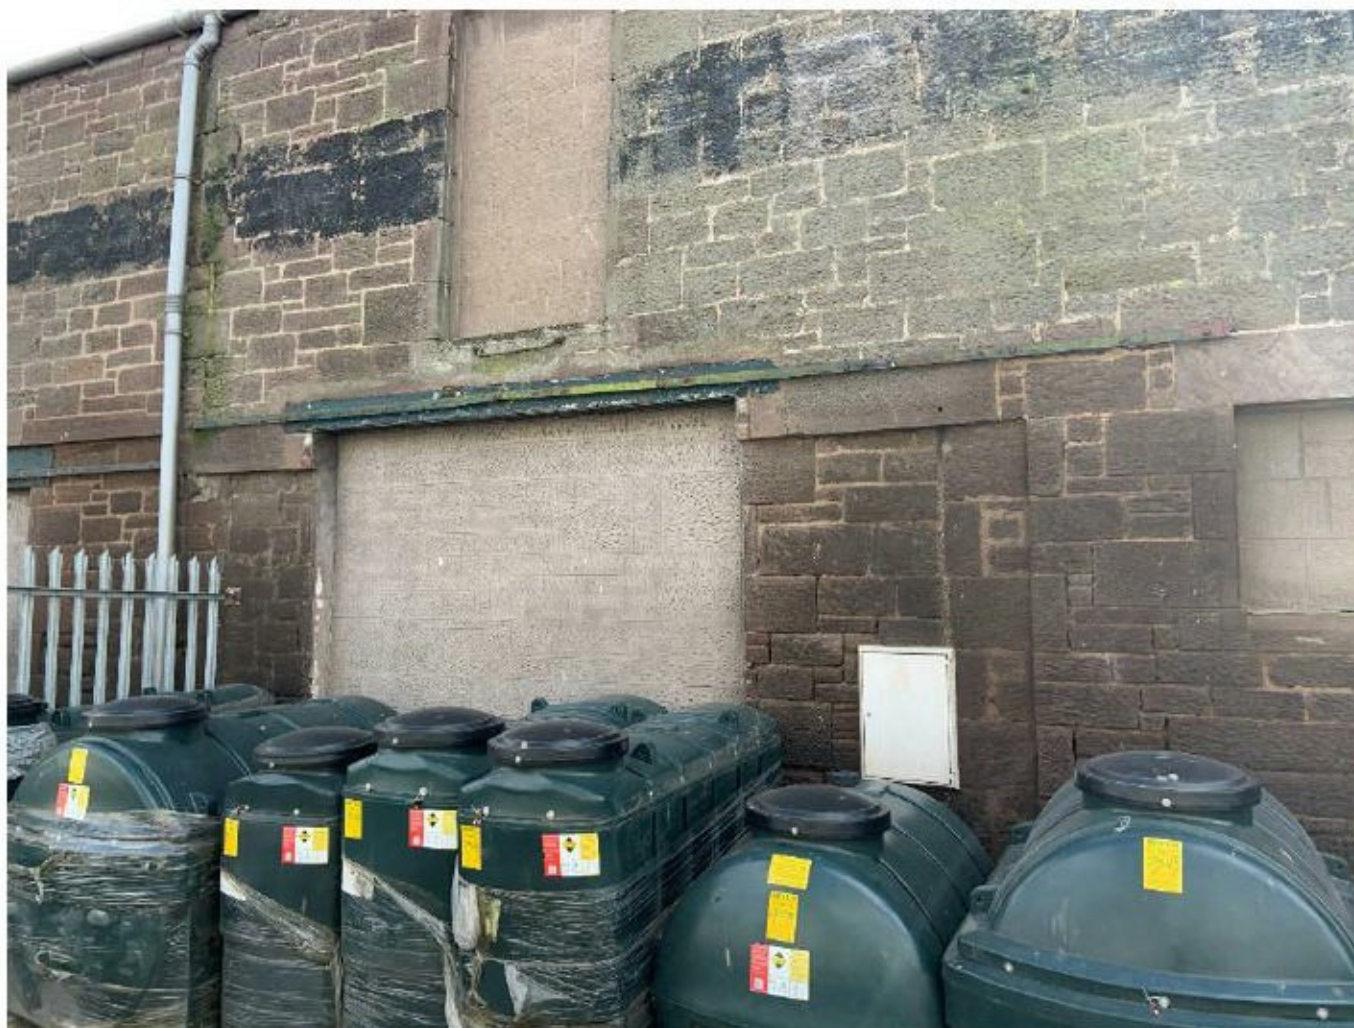
**Figure 8: North West Elevation – Altered Openings, Damp Pathces & Eroded Stone and Mortar**

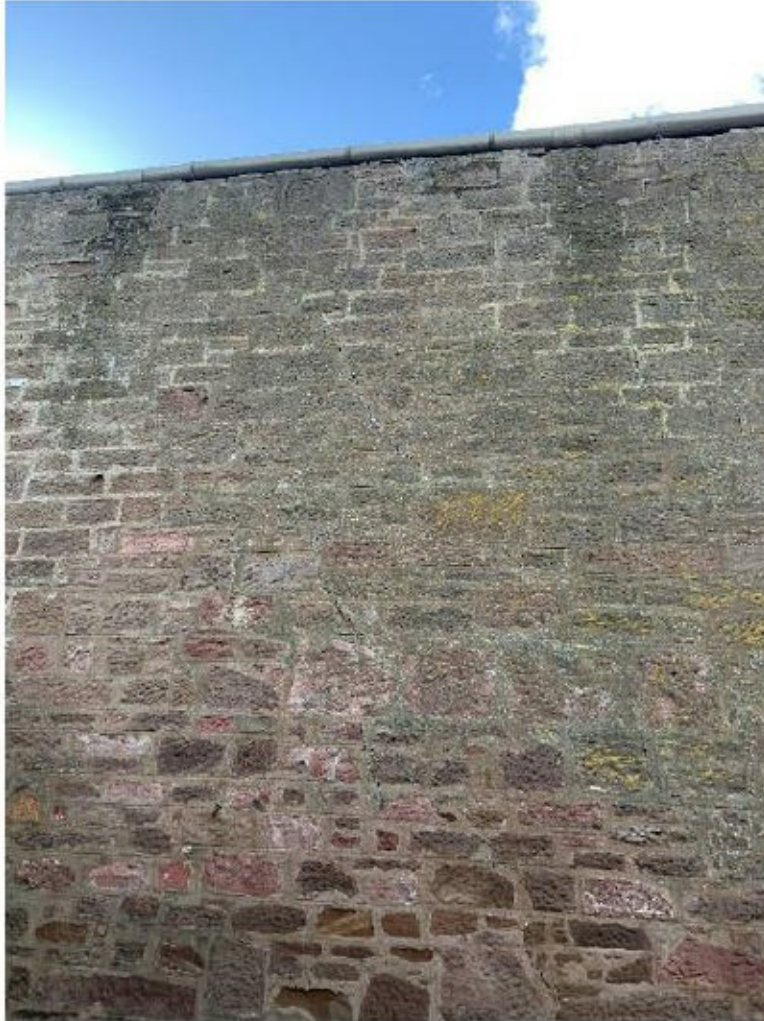
**Figure 9: North East Elevation – Damp Patch, Weathered Stone & Cracking**

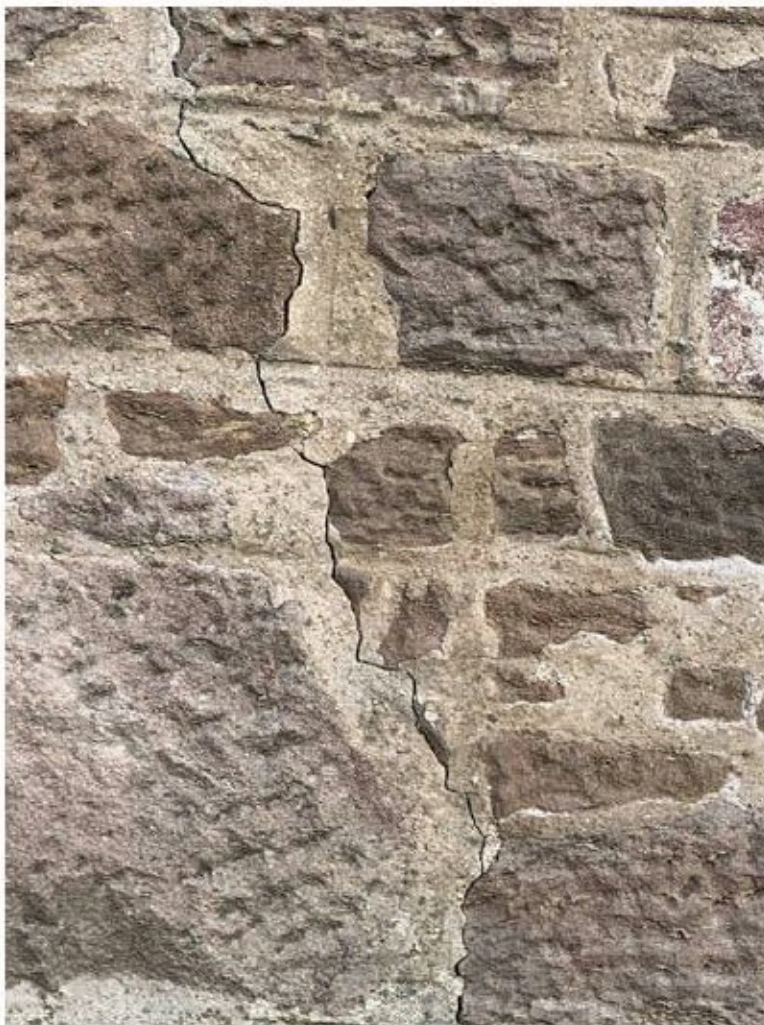
**Figure 10: North East Elevation – Typical Crack**

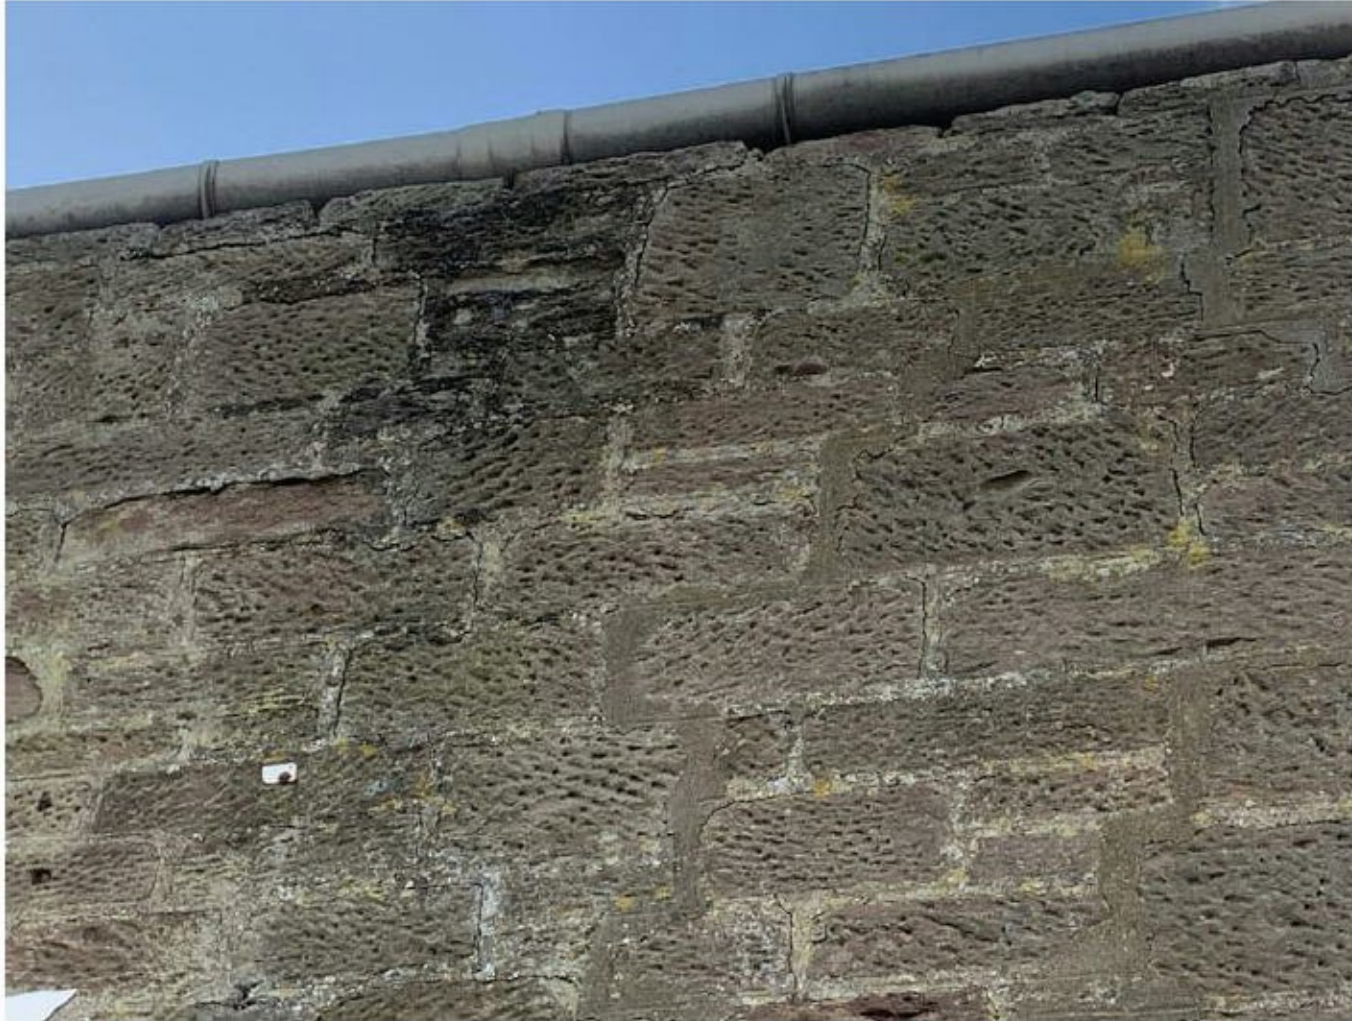
The masonry looks in reasonable condition. This is perhaps the most sheltered elevation and most difficult to access from plant and machinery. There are several vertical cracks from the eaves downwards. The wall has stepped out gutter inasmuch that the wall is approx. half the gutter width off plumb. The gable appears to be leaning at eaves level.

**Figure 11: North East Elevation – Damp Patch, Weathered Stone, Cracking & Gutter Position**

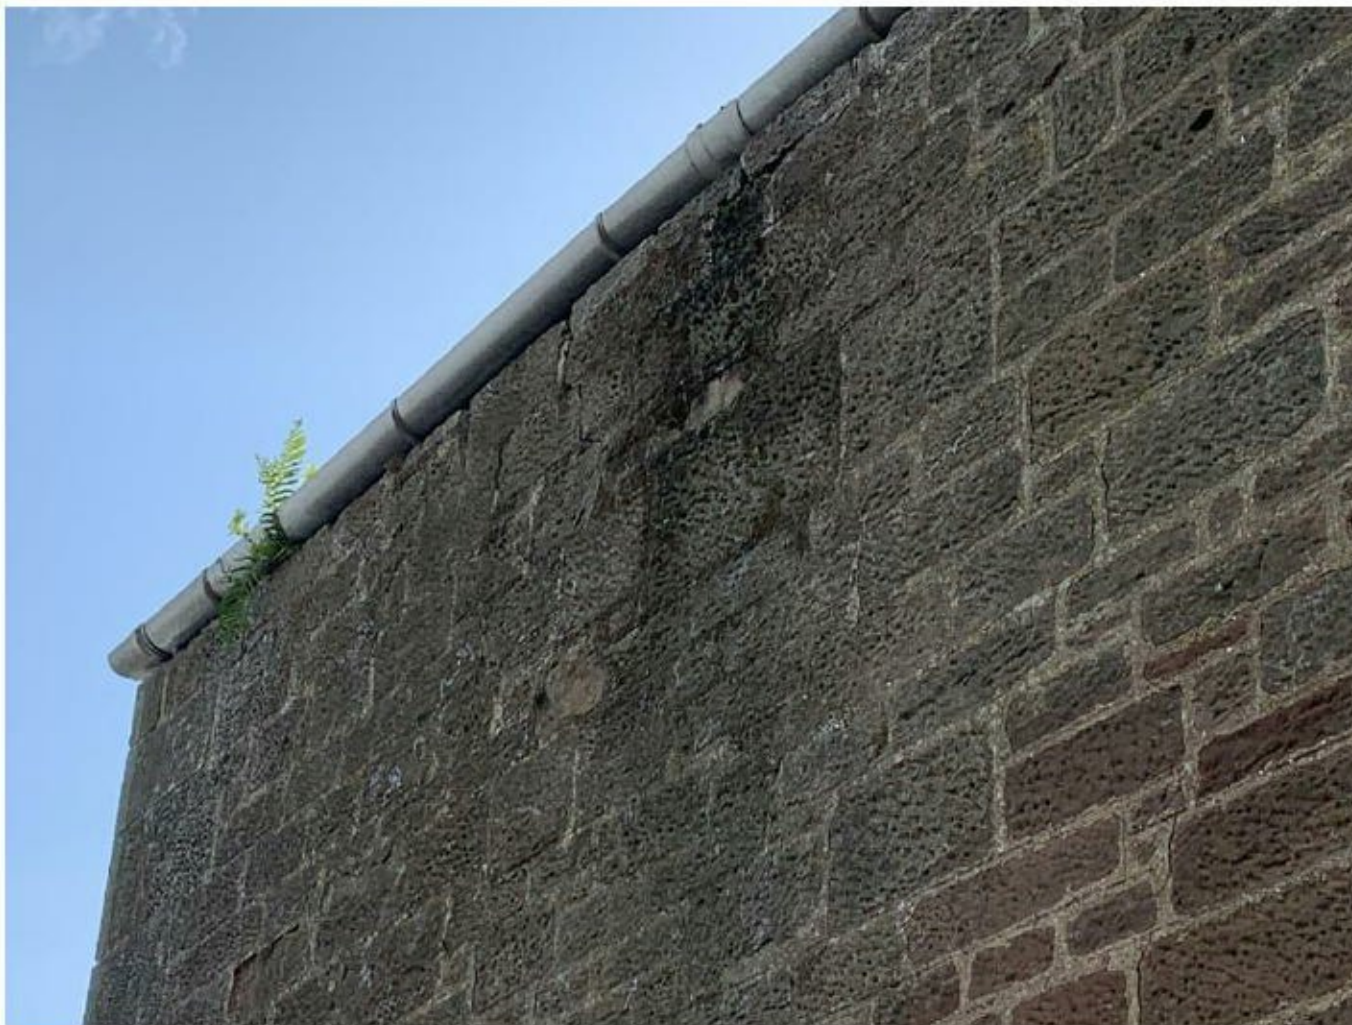
**Figure 12: North East Elevation – Damp Patch, Weathered Stone, Cracking & Gutter Position**

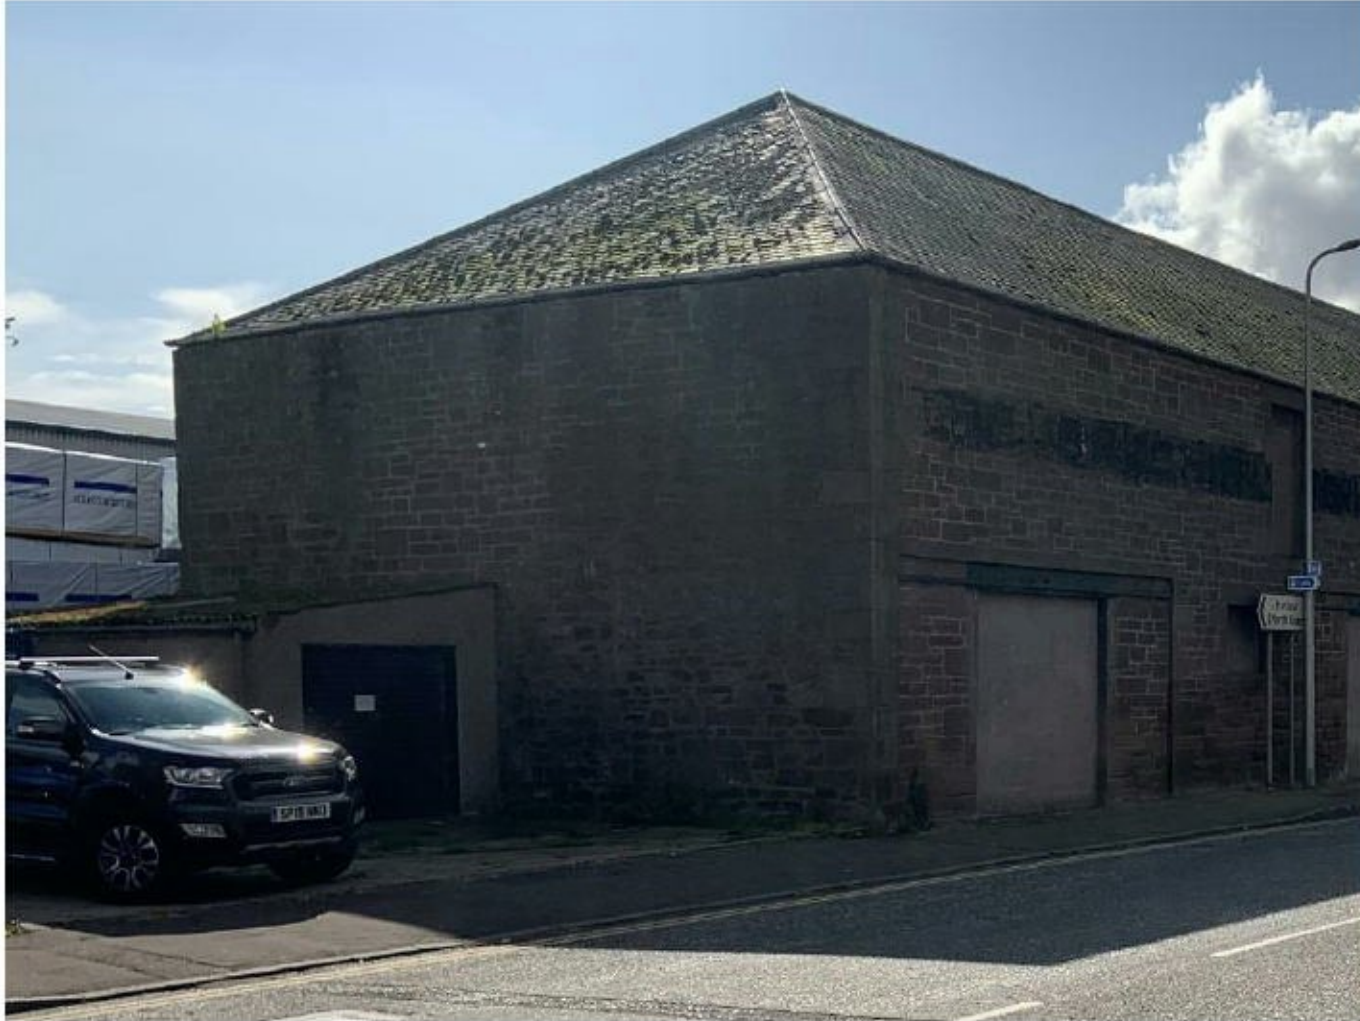
**Figure 13: North East Elevation – Wall off Plumb (Left Hand Corner)**

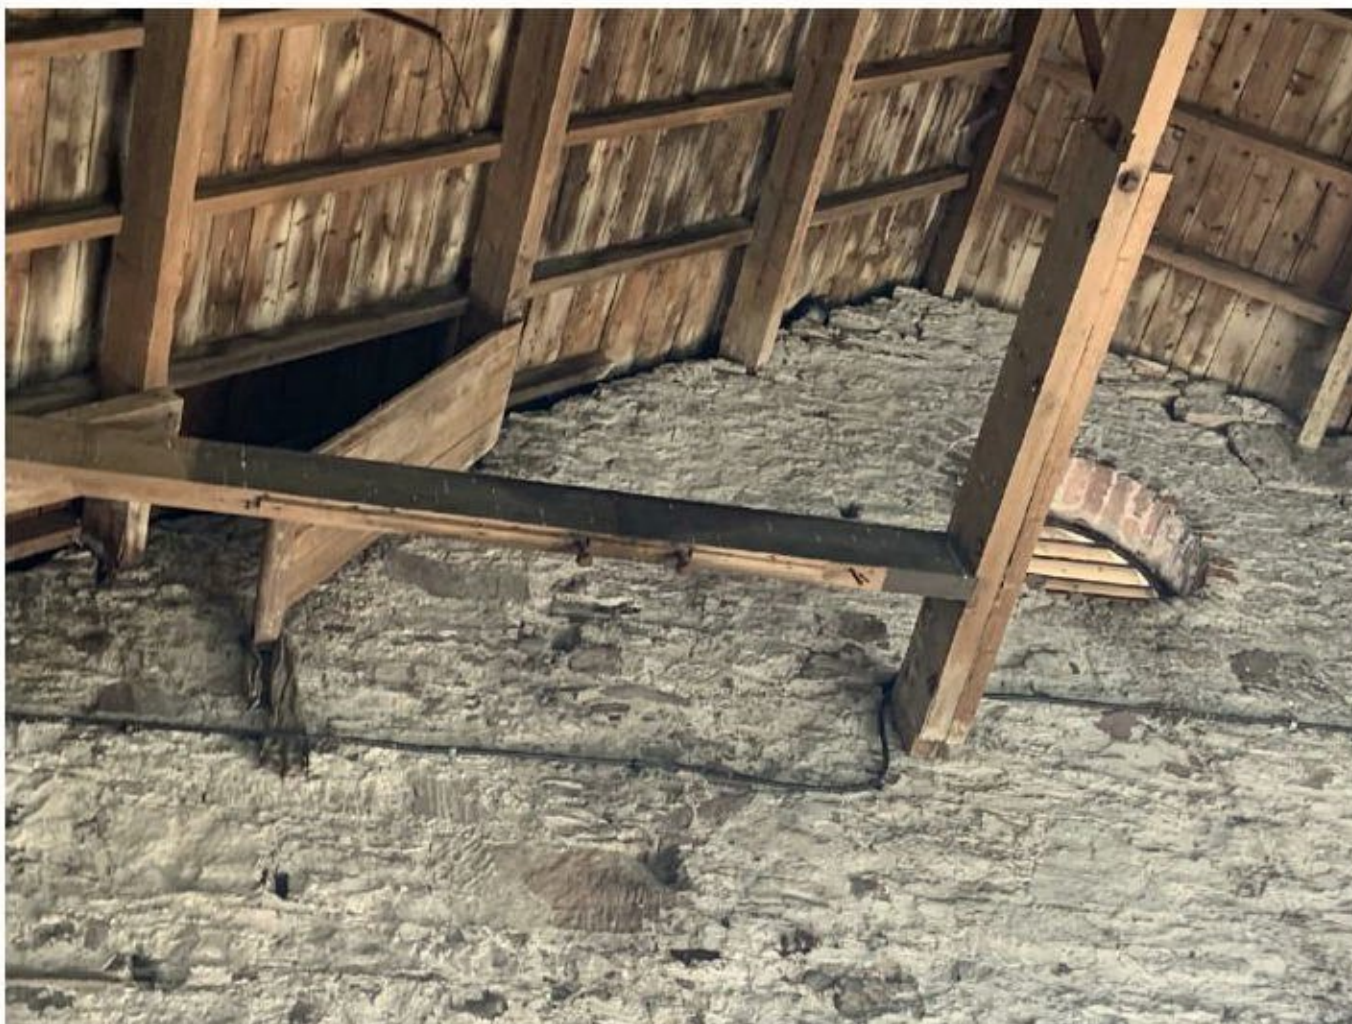
**Figure 14: Internal South West Elevation –Weathered Stone & Cracking, Truss Discolouring**

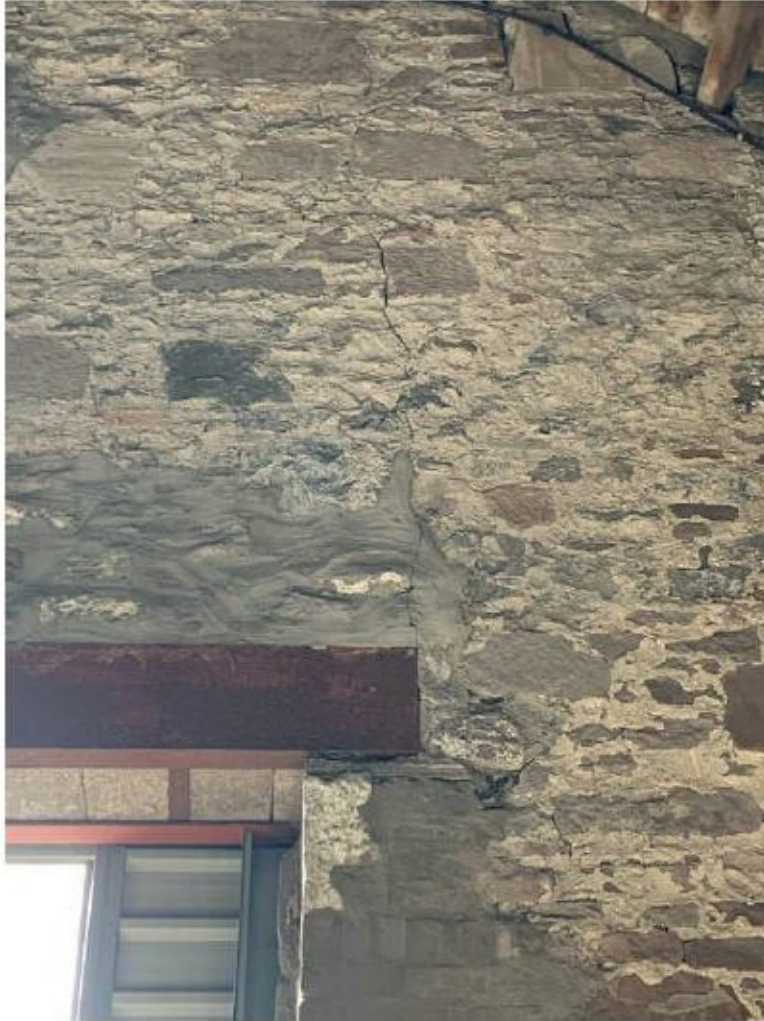
There is a large vertical crack at each side of the new opening emanating from the lintel support and projecting up towards the roof. Evidence of repair and repointing throughout this elevation.

**Figure 15: Internal South West Elevation –New Lintel with Vertical Crack**

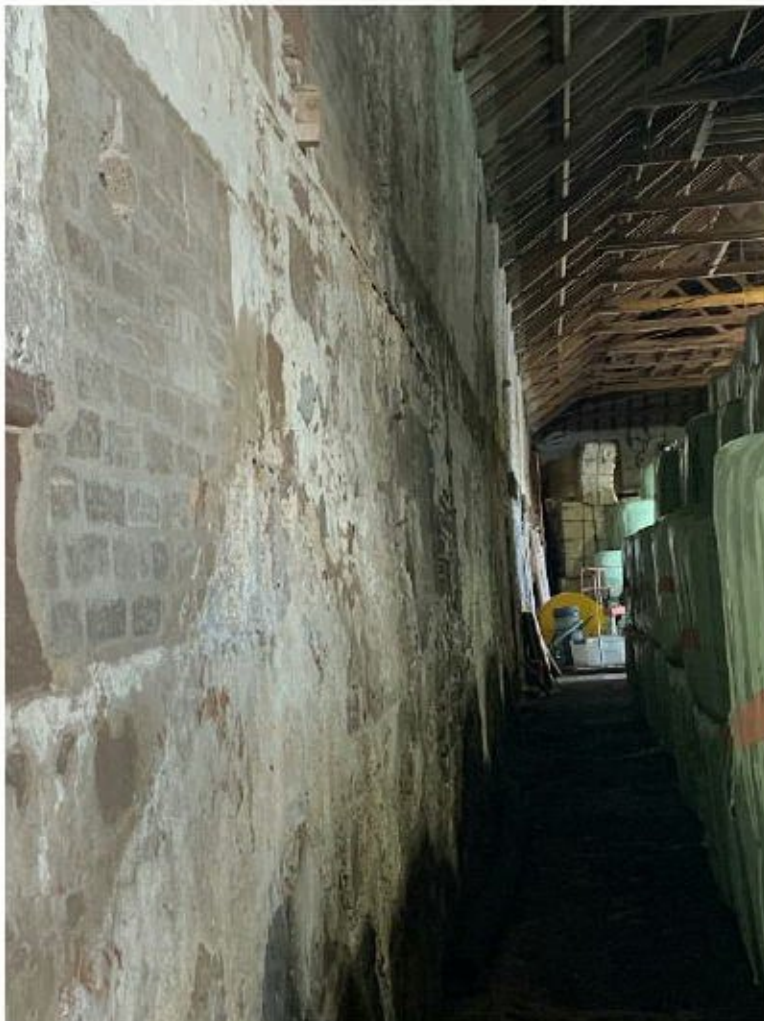
**Figure 16: Internal North East Elevation –Wall Lean, Weathered Stone, Patches & Cracking**

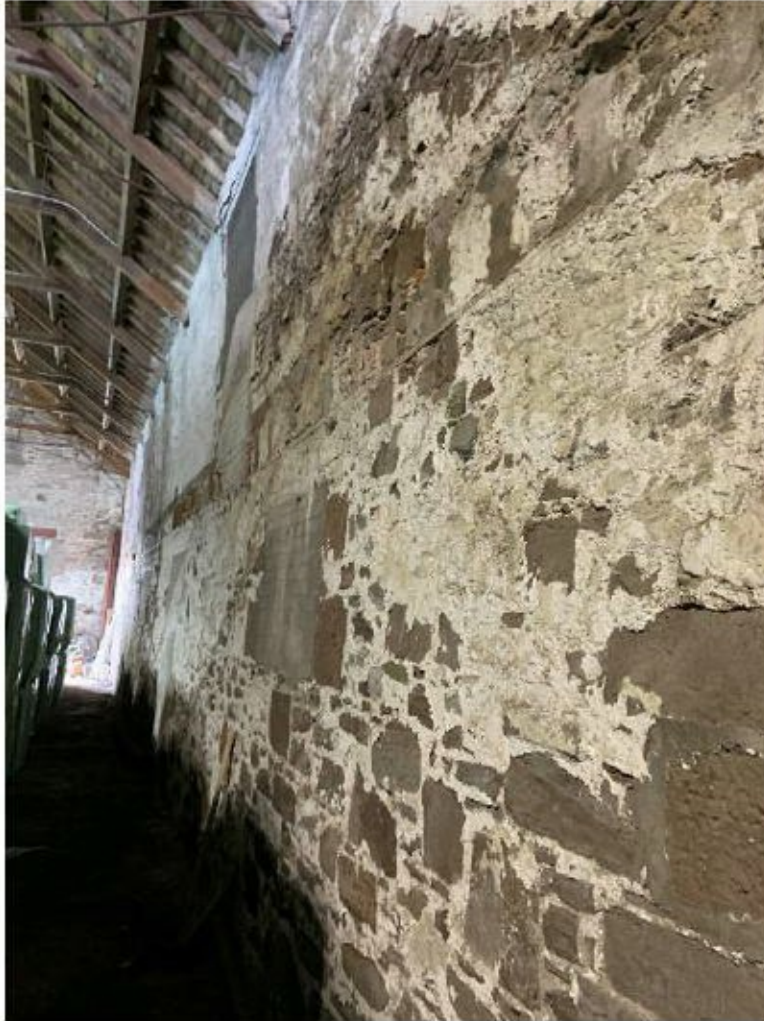
**Figure 17: Internal South West Elevation –Wall Leam, Weathered Stone, Patches & Cracking**

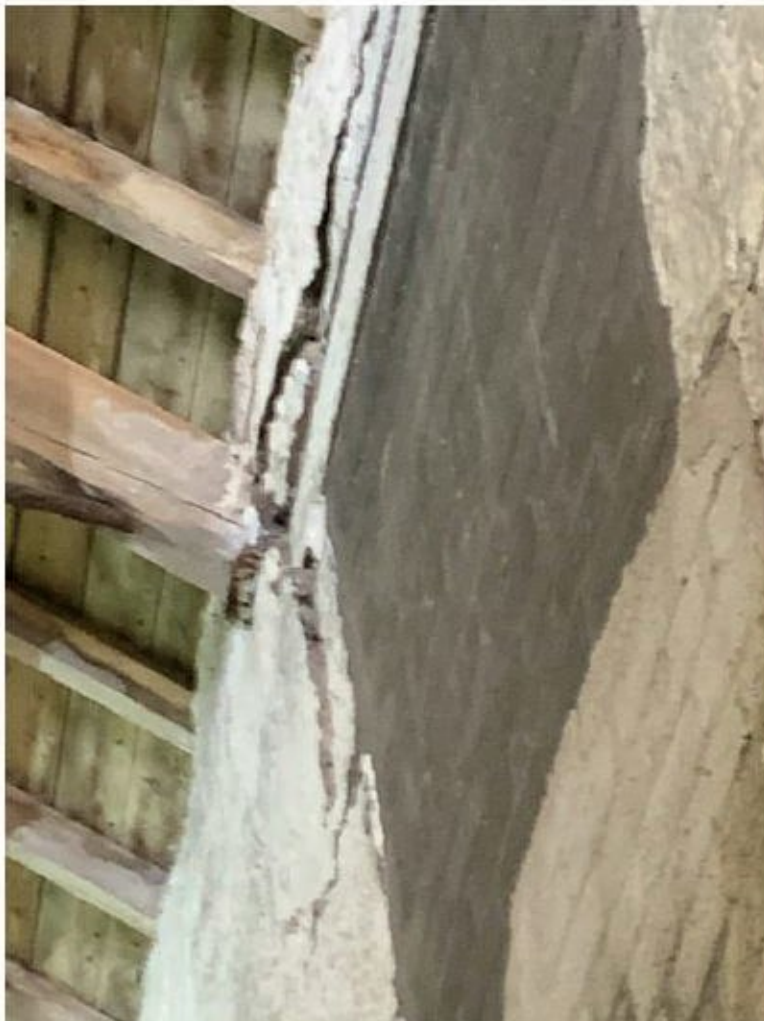
At the wallhead there is a horizontal shift in the masonry. The top course is fixed to the rafters and remains in its original position. The stone below has moved outwards by 150mm to 200mm. This is due to the fertilizer storage, either retention or the push into position.

**Figure 18: Internal North East Elevation –Wall Leam, Wall Displacement, Patches & Cracking**

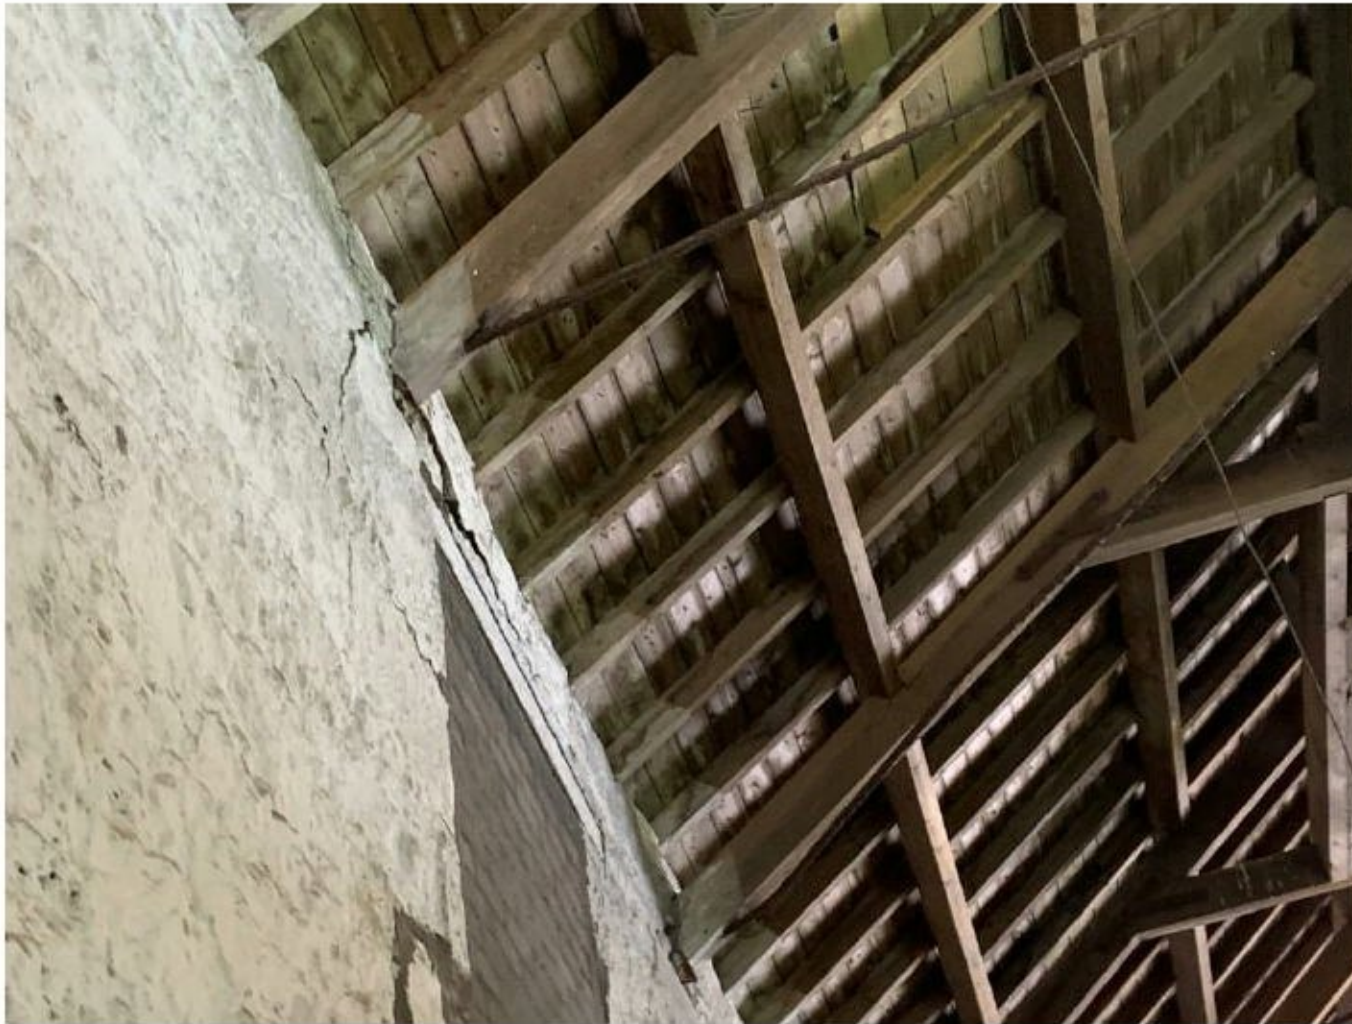
**Figure 19: Internal North East Elevation –Wall Leam, Wall Displacement, Patches & Cracking**

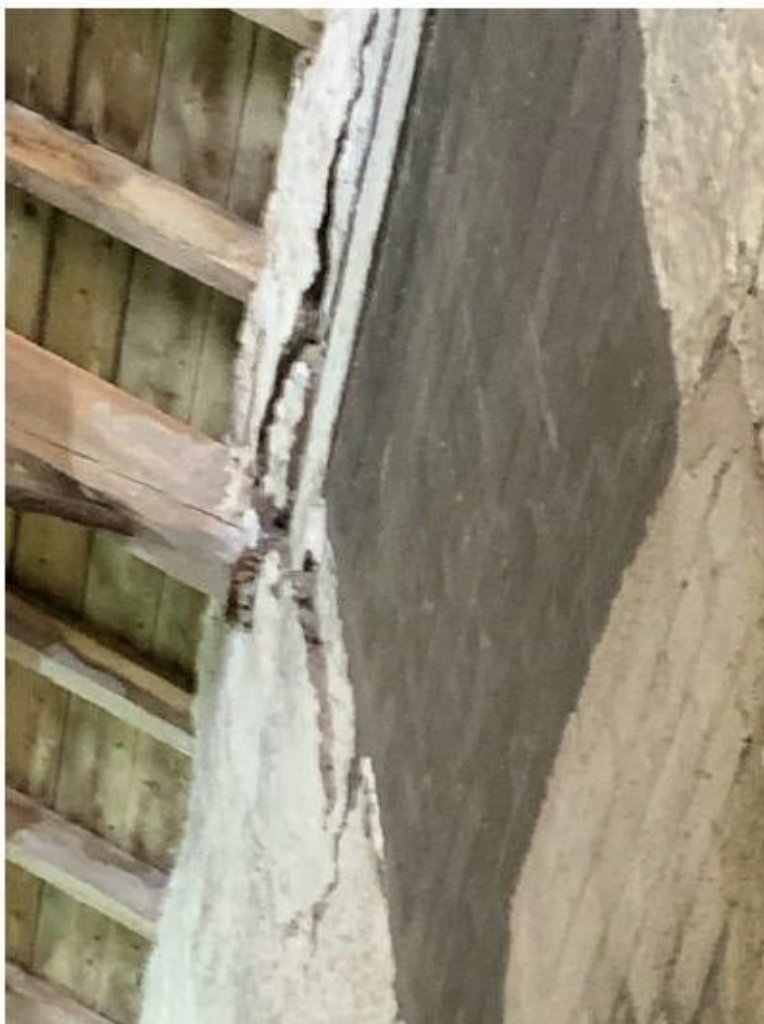
**Figure 20: Internal North East Elevation –Wall Leam, Wall Displacement, Patches & Cracking**
