# 4 MERIDIAN STREET, MONTROSE

Job No. 203966

**EXISTING BUILDING CONDITION REPORT**  
Interpretive report and recommendations from site observations.

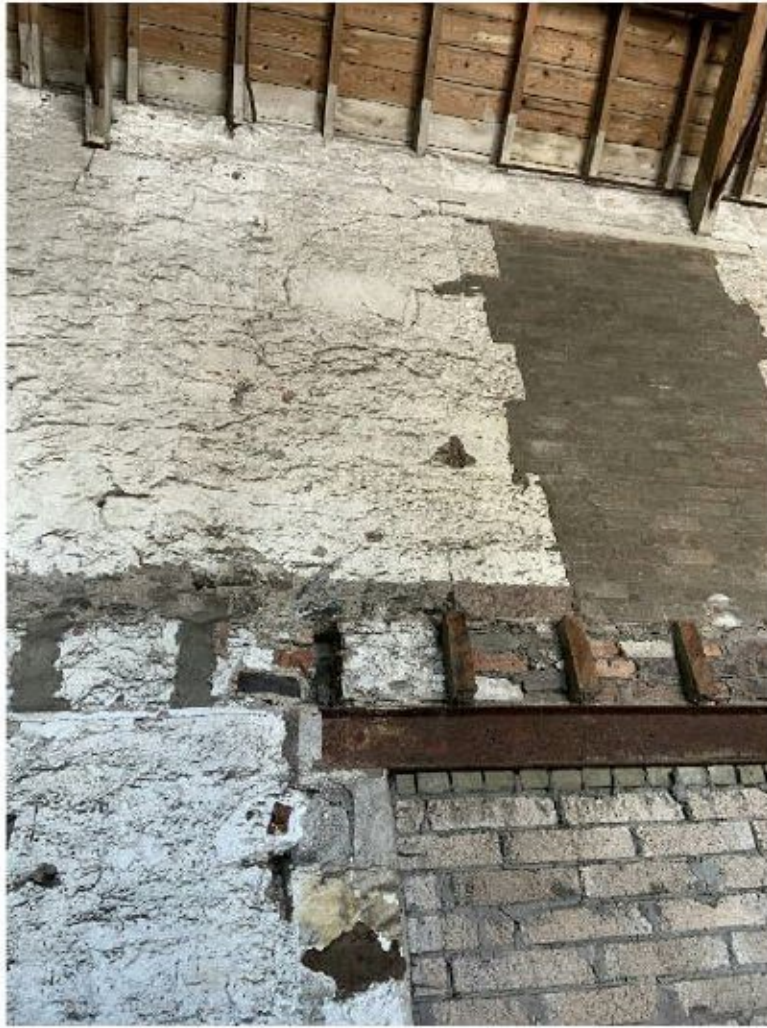
**Figure 21: Internal North East Elevation –Intermediate Floor, Patches & Cracking**

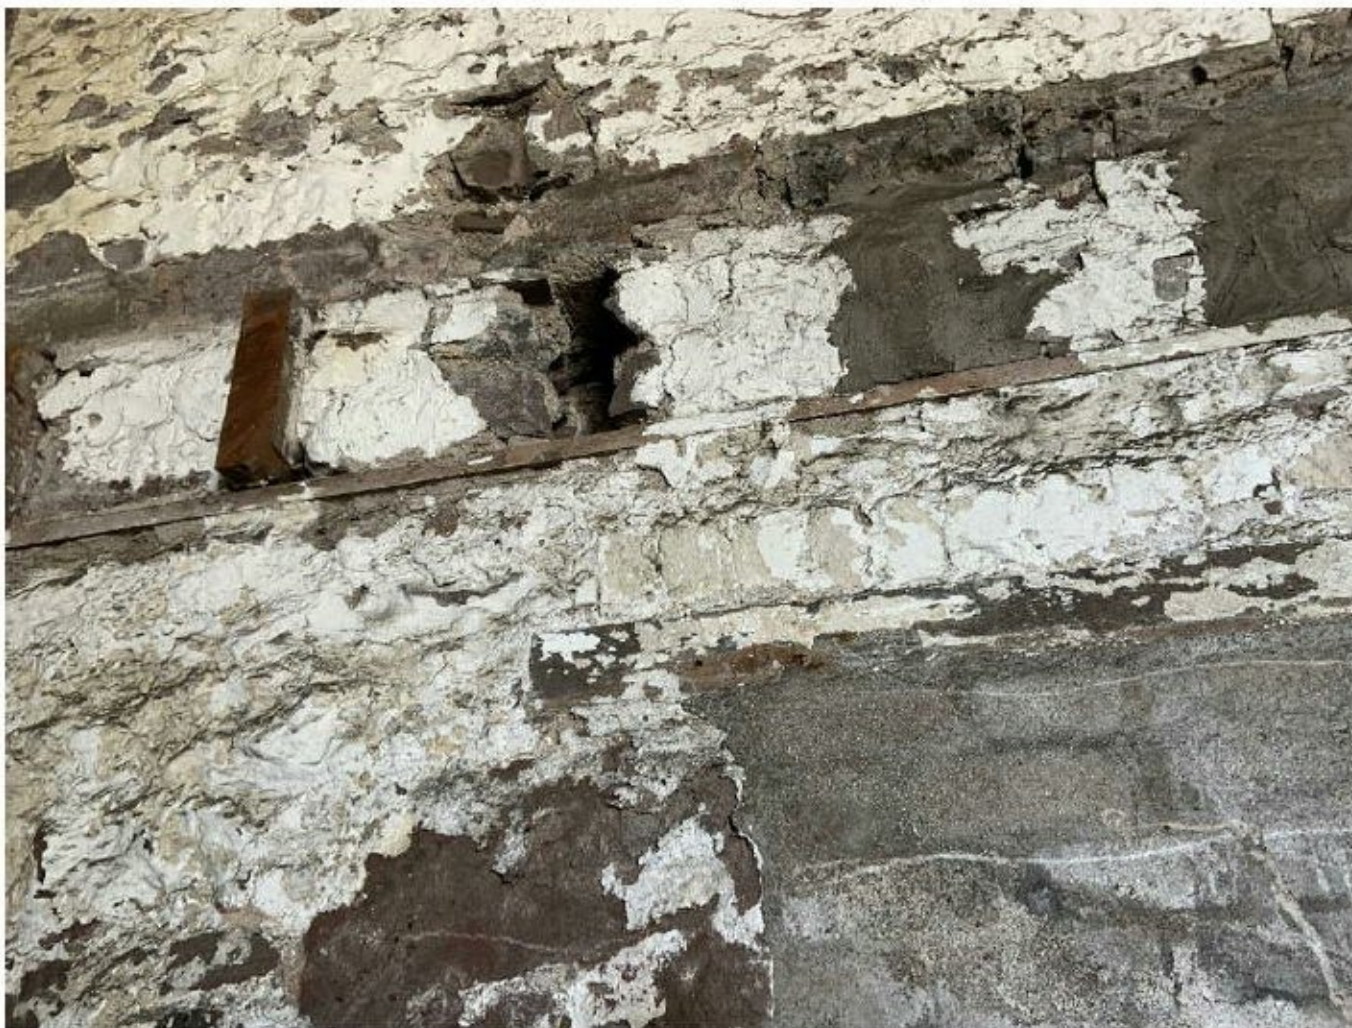
**Figure 22: Internal North East Elevation –Intermediate Floor, Patches & Cracking**

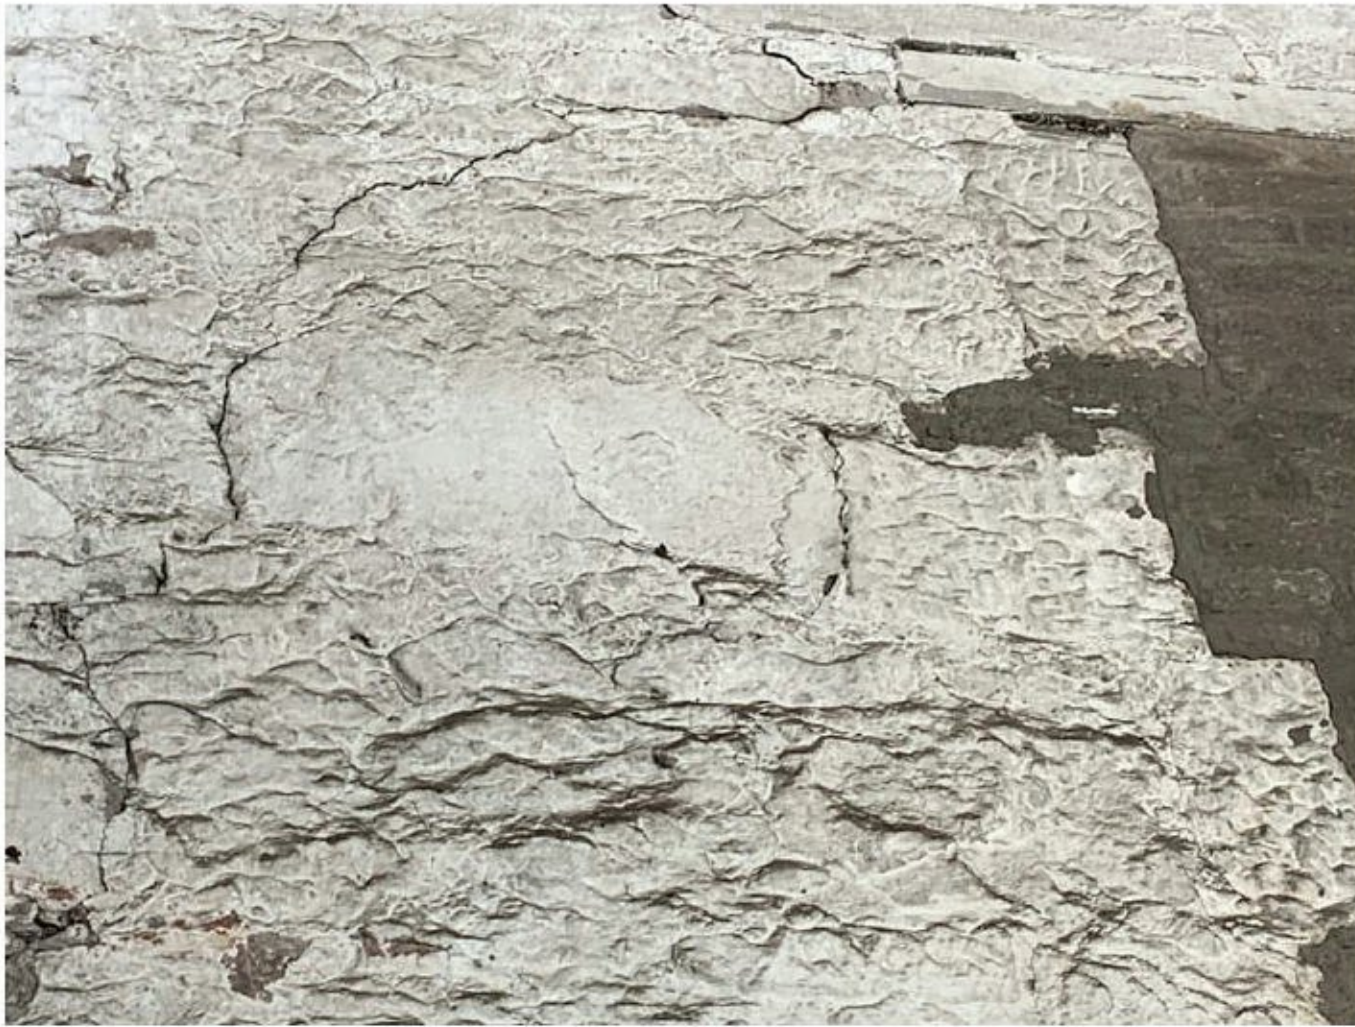
**Figure 23: Internal North East Elevation –Diagonal Crack**

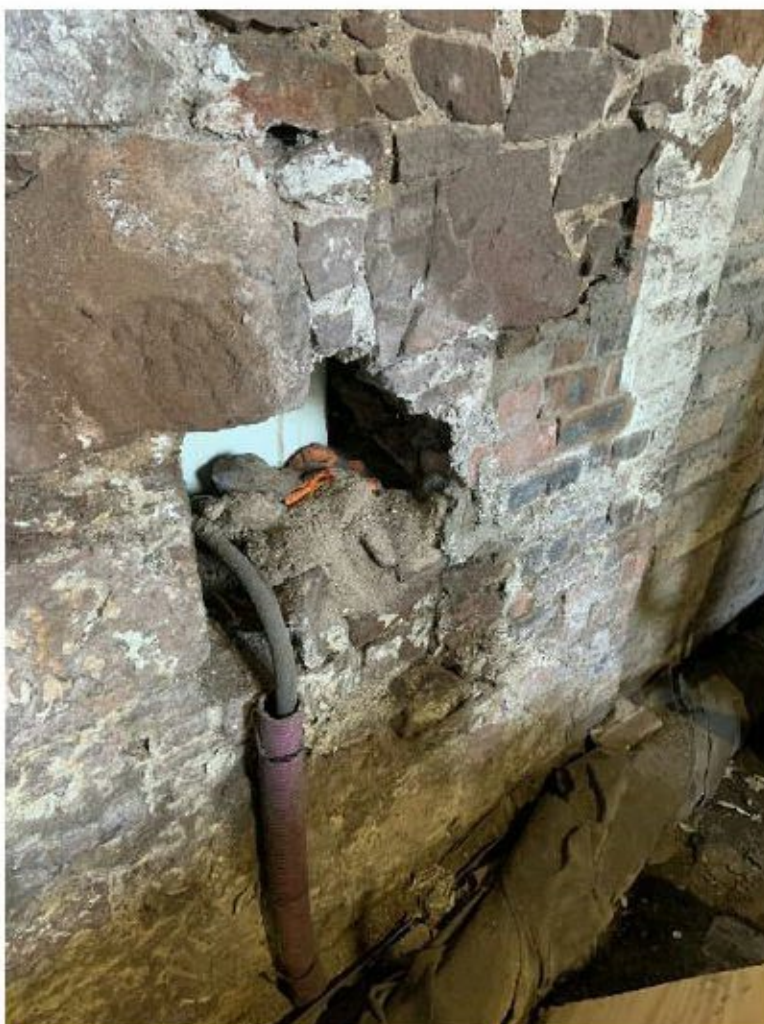
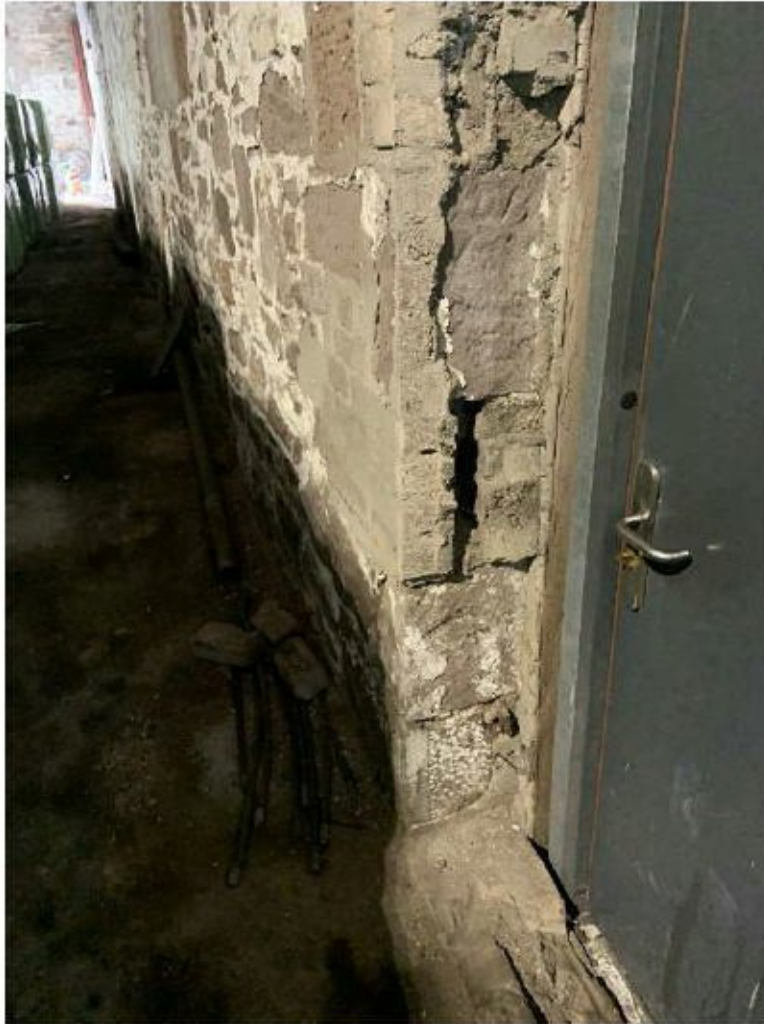
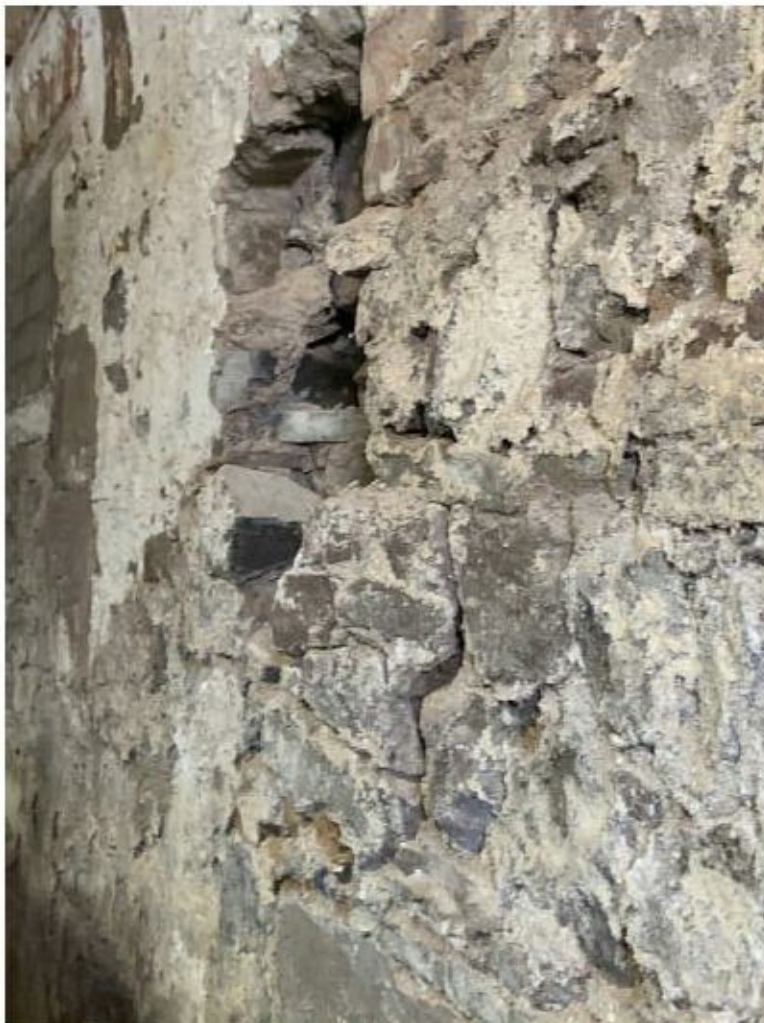
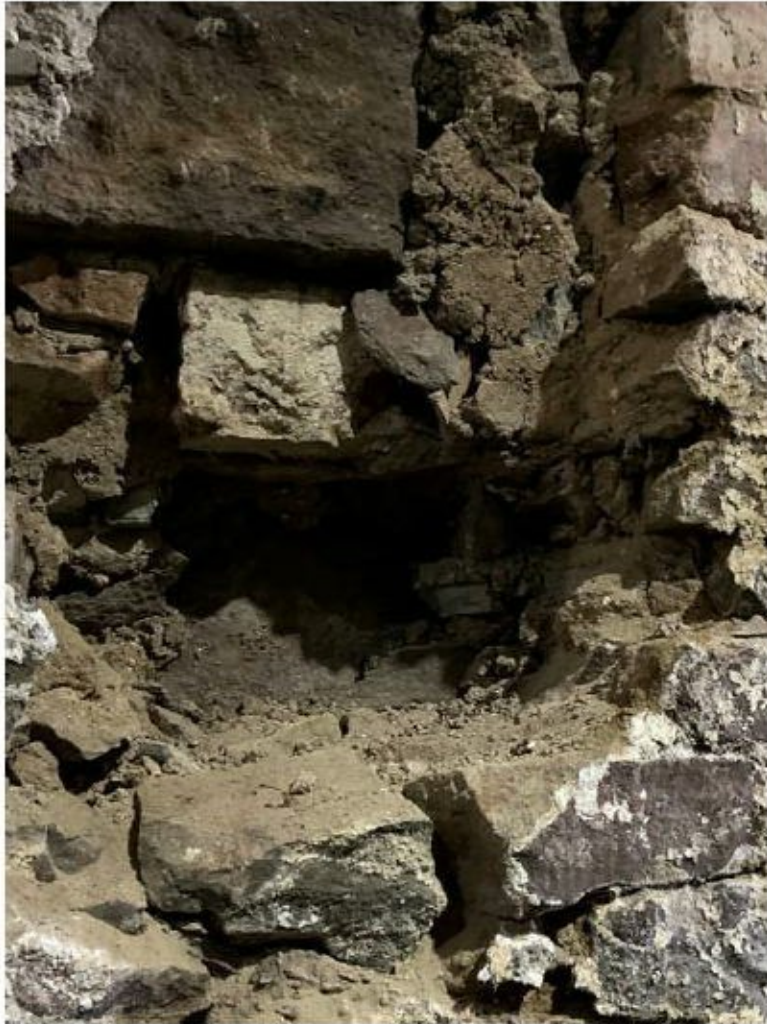
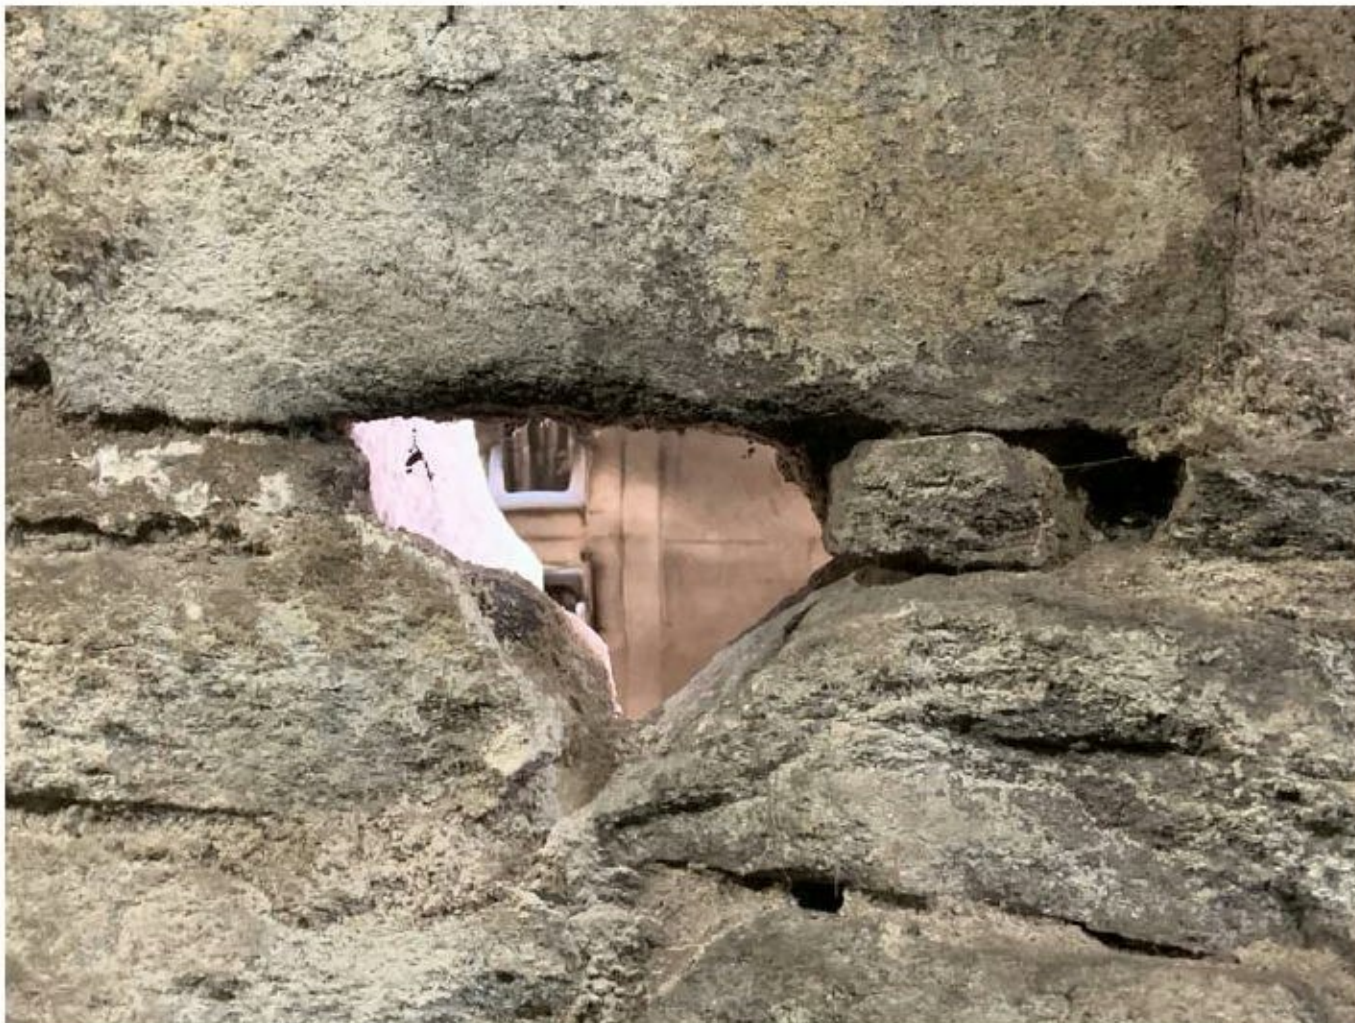
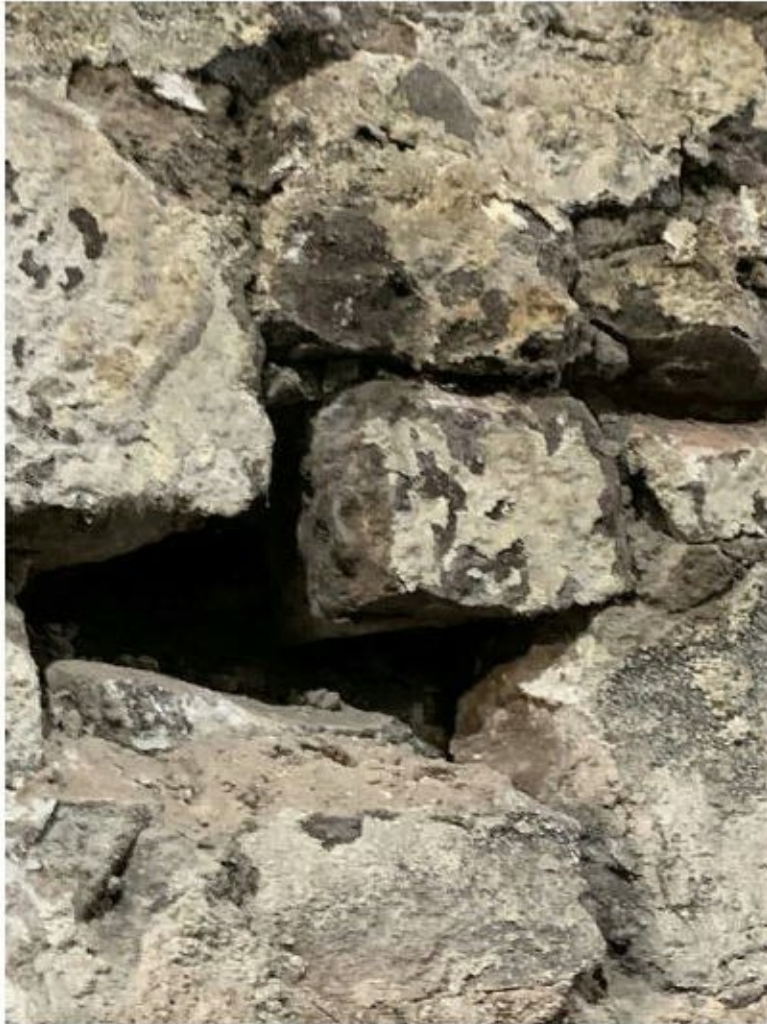
The wall is in very poor condition. The mortar is very friable, this is a combination of poor materials, poor maintenance and contact with the fertilizer. As a result there are numerous pockets where stones have been dislodged or missing.

**Figure 24: Damaged Stonework**
