Condition report/conservation proposal

Location: Bubwith Almshouses, Wells- Medieval glass to the Chapel

North east window- small rectangular light 310 x 1230mm

Date of survey: 7th March 2019

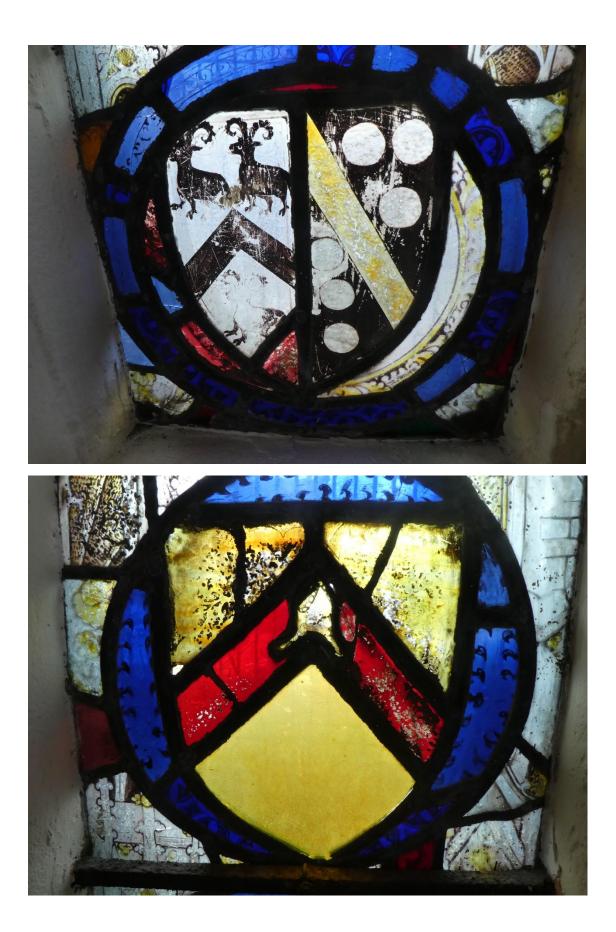
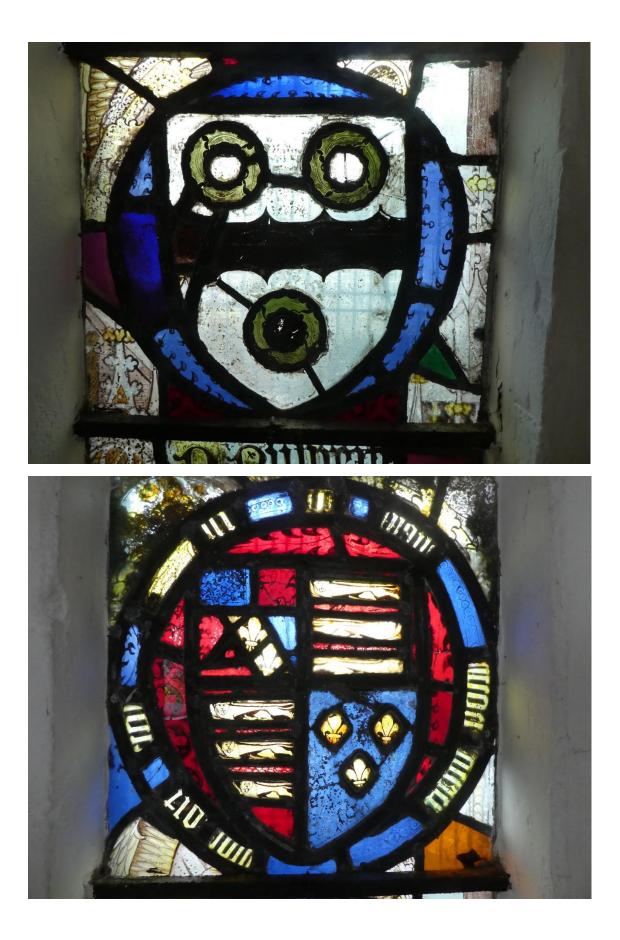
There are some insertions of unpainted purple, blue and green glass which date from the 19th century. The arms of Stafford has a large insertion of yellow stained glass, probably 19th century.

The shields themselves have some use of silver stain, but this is limited to- for example the bend on the dexter side of the lower arms (Stourton). The glass otherwise is largely pot metal glass with rich ruby and blue.

There is an external galvanised steel wire guard, which is necessary on the street side, but is very dirty, with a considerable build-up of debris at the base, which will hold moisture against the ancient glass, which is undesirable. (See appendix 3- Degradation of Glass).

The glass has corrosion pits on both faces, and some loss of painted detail, as well as surface abrasion. There is soma algal growth to the upper and lower edges on the internal face corresponding with debris trapped in the wire guard on the external face.

The glass is dirty on the internal face. There are a number of single cracks to the window, but the pieces of glass remain stable. The arms of Bubwith has a ground of holly leaves, there are several ugly historic repair leads, and fragments of glass are parted. This area needs some work to remove the repair leads and stabilise the fragments for aesthetic and structural improvement. However glass is not in danger of becoming dislodged at present.

There are also several other unsightly repair leads in the arms of Stafford

There is significant corrosion with pitting to the internal and external faces of the glass .This is fairly common in 15th century glass.

The condition of the painted detail is varied, but there is general slight paint loss. This general loss is almost certainly to do with cycles of condensation over the centuries. There are also areas which have been roughly handled with obvious abrasion- notable are the rams in the lower shield, and the Fleur de Lys in the Royal Arms.

The lead is a rather heavy 3/8 inch flat section, not sympathetic to the delicacy of the work, but of historic significance itself as part of a 19th century restoration. It remains in reasonable condition, there is no justification for re-leading at present.

There are a few glints of daylight where stained glass cement has fallen away, or glass is ill-fitting, but this is easily remedied with the application of small areas of linseed oil putty stained with Lamb Black pigment.

It would be sensible to clean, conserve and protect the glass to ensure its long term survival for the enjoyment of future generations. We suggest that the glass is cleaned, and minor repairs carried out insitu.

A new protective external screen of glazing to be introduced, leaded into four sections to correspond to the positions of the tie bars. This should be made of toughened glass, mounted into a slender bronze frame held in place with discrete screw fixings, and grouted with lime mortar at the perimeter. This layer could then be removed periodically (say every decade) for cleaning and maintenance.

Venting to be contrived by paring away mortar to the historic glass at the sill and apex of the light to allow airflow in the interspace.

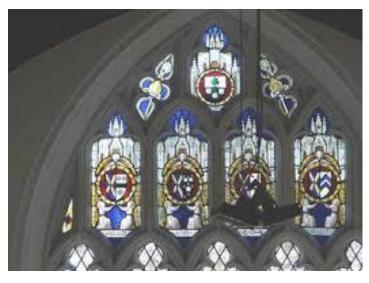
East window traceries

Woodforde states that the heraldic shields were previously placed in the tracery sections of the east window, which now has more modern heraldic glass circa 1850 by Bell of Bristol, (relatively recently restored), which references this original glass. It is reasonable to assume that the glass was moved to its present position at that point.
