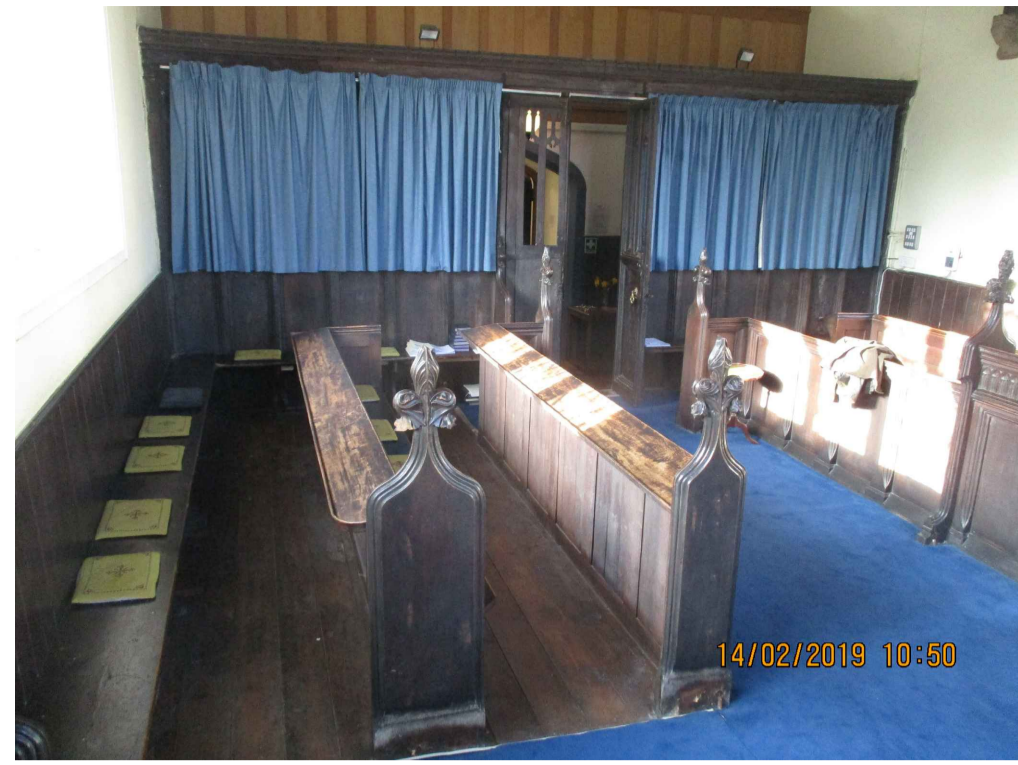
The interior of the Chapel looking west. The poppy head bench ends are an important part of the nineteenth century furniture. The perimeter benches are modern.

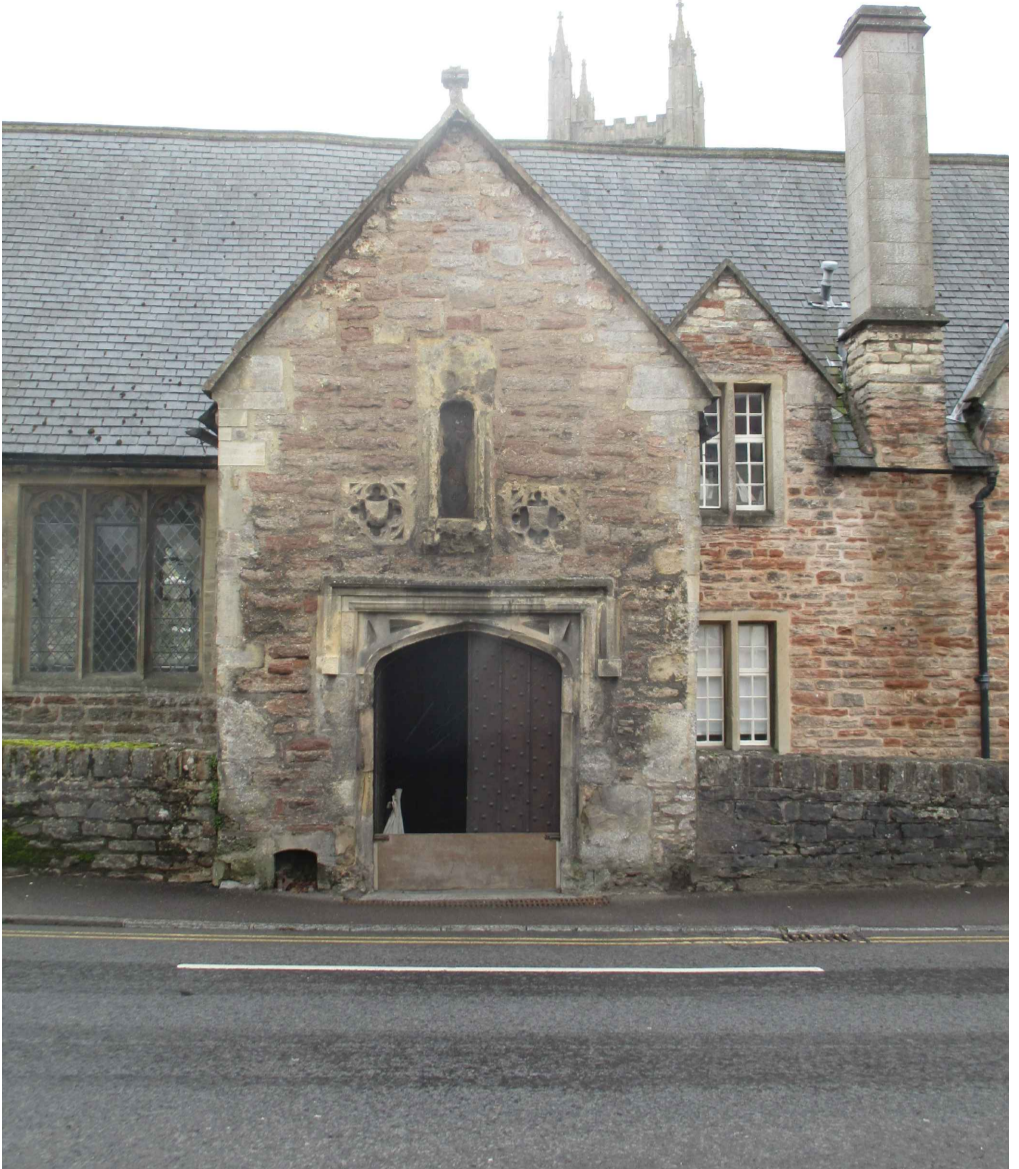
The North Porch almshouse entrance. The stonework condition is poor and the entrance poorly defined. Cement mortars are also present.

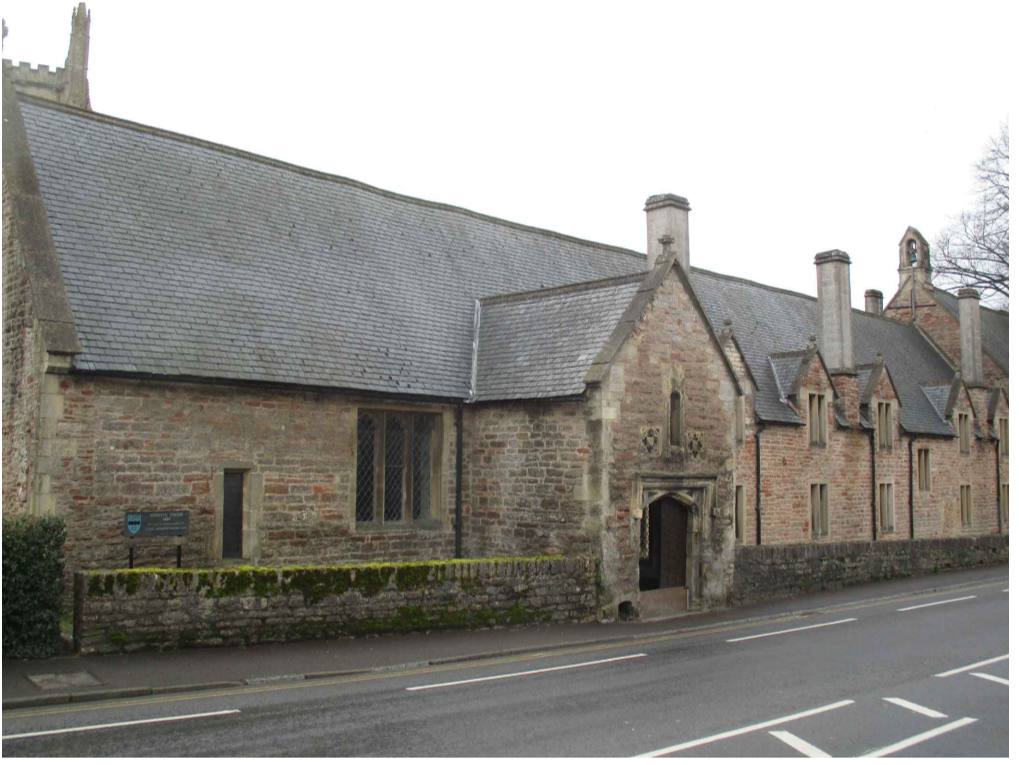
The North wall of the Chapel. The 'signposting' of the North Porch entrance is poor.

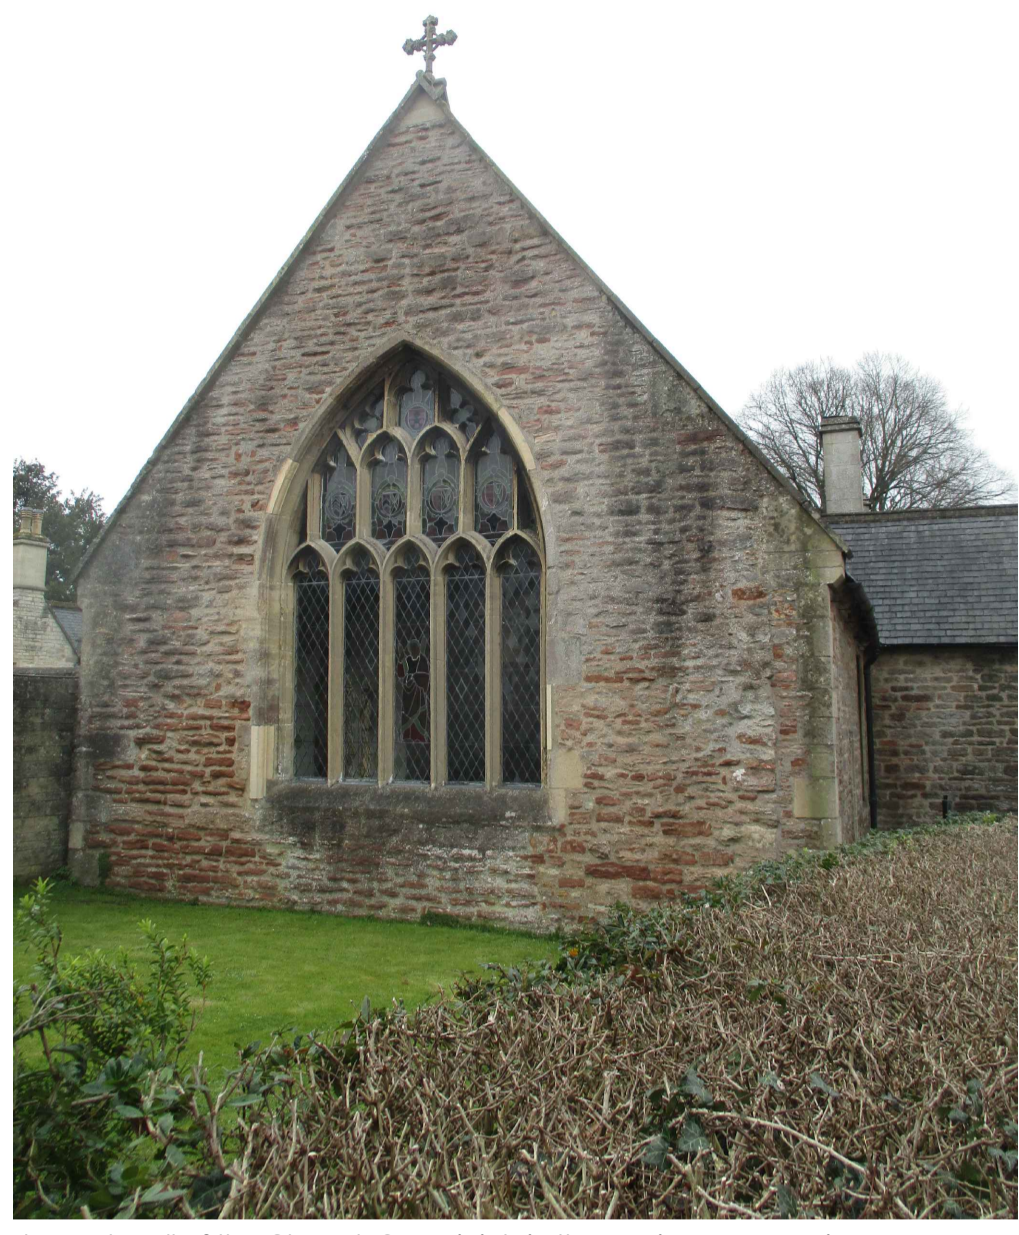
The East Wall of the Chapel. Open joints in the copings are causing water to flow into the wall. High ground levels are the cause of plaster problems internally.

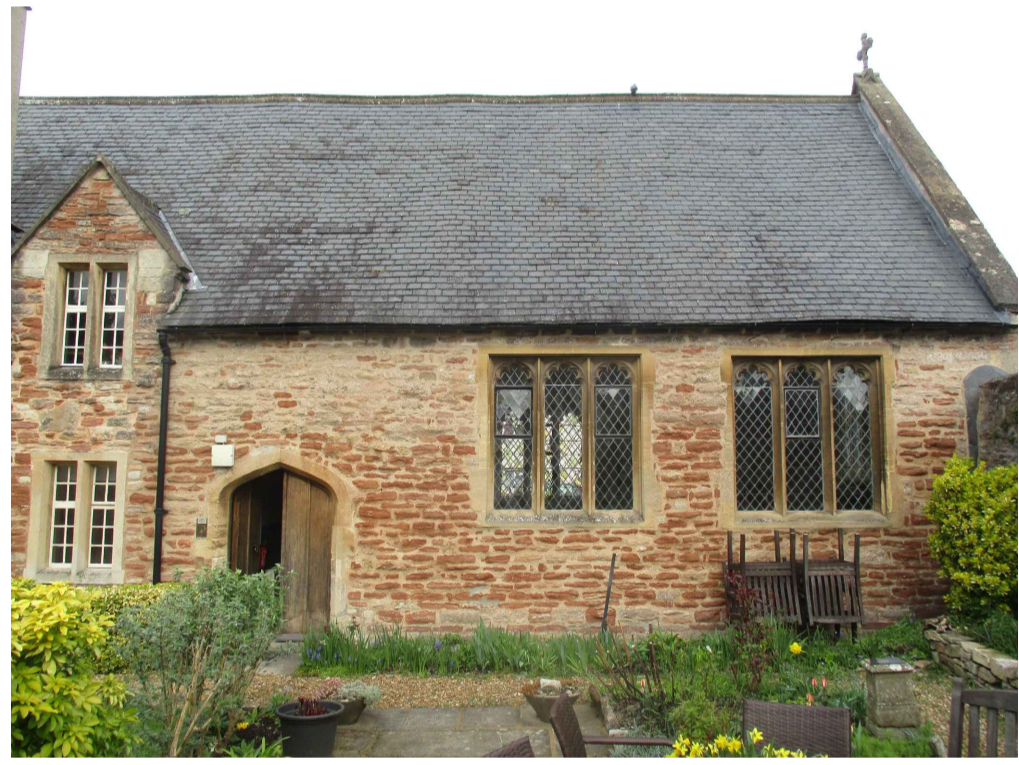
The South Wall of the Chapel. Cement pointing should be removed and ideally the wall should be repointed. The ground gutter in front requires repair.

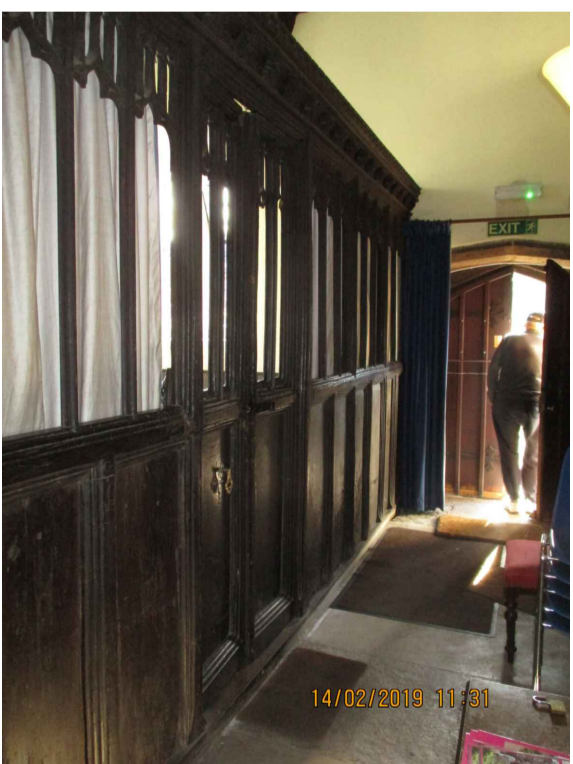
The passage with medieval screen. The floor is a combination of stone and concrete.

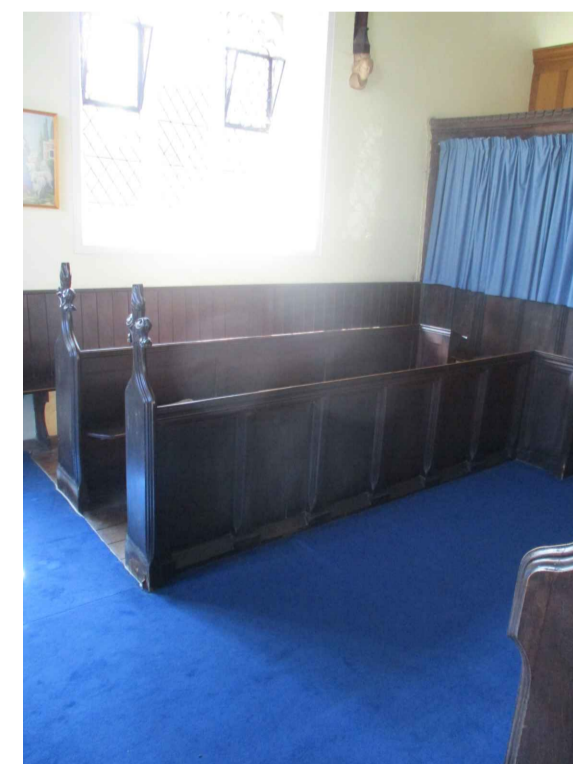
The existing benches and carpeted floor over a combination of a stone and suspended timber floor. There is no cross ventilation.

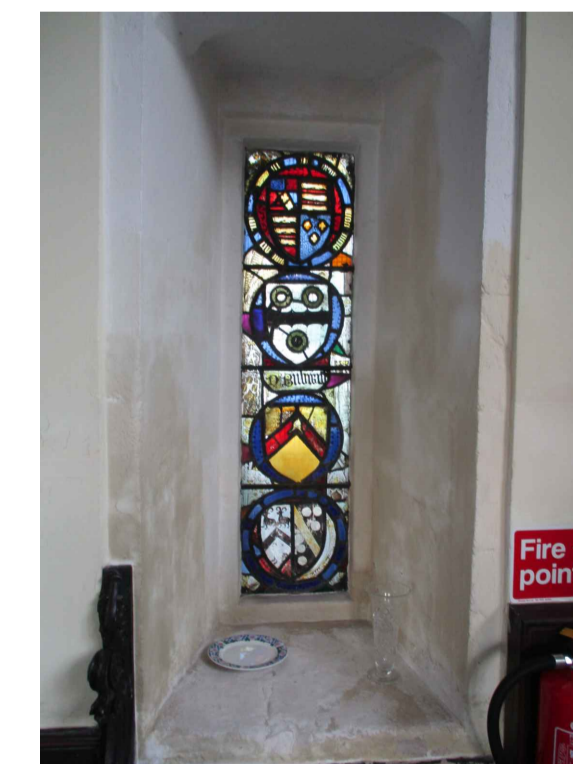
The medieval glass in window NIII. The window has been the subject to a specialist conservation report prepared by Holywell Glass.

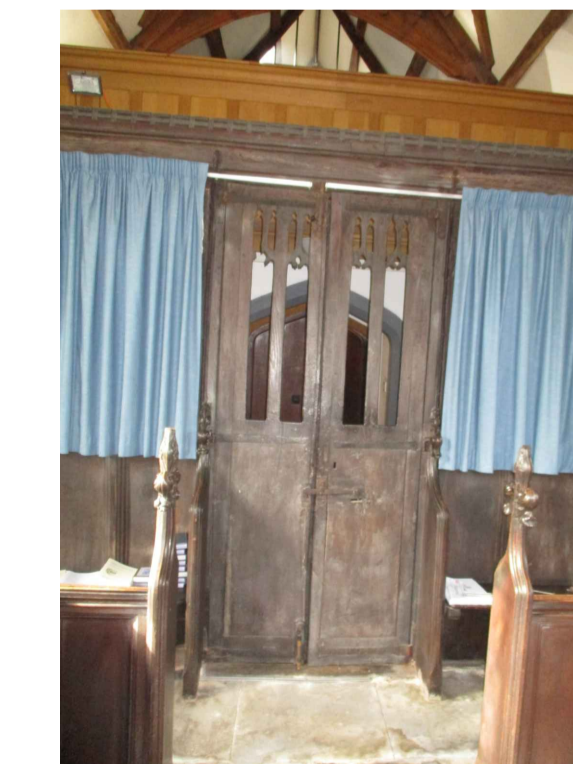
The doors in the screen. The benches have been secured to the screen.

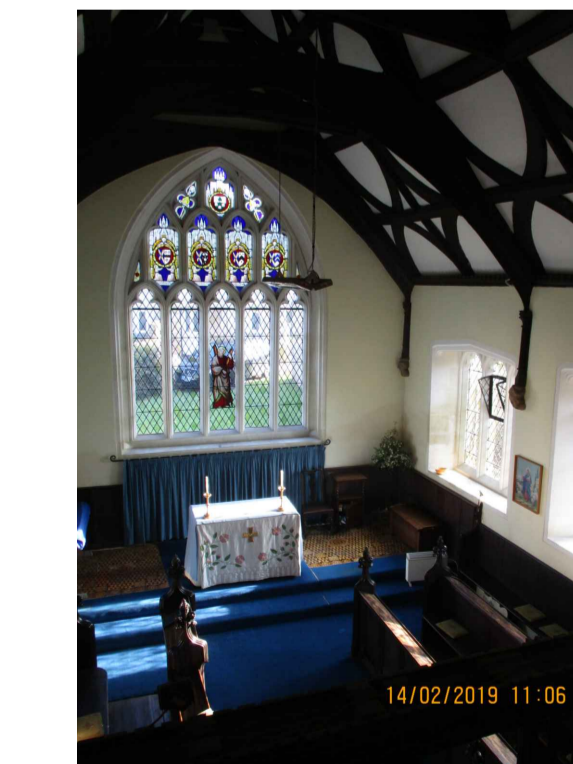
The Chapel looking out from the Gallery. An infrared heater hangs from the ceiling.

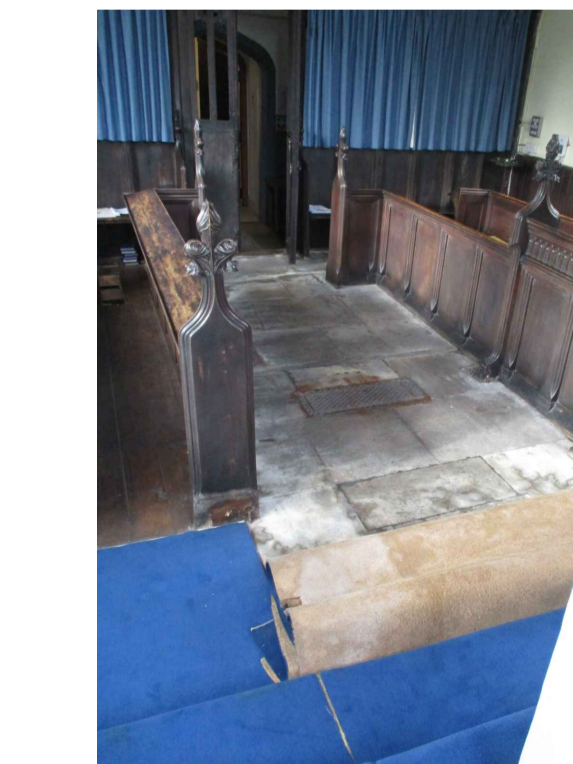
The carpet pulled back in the central aisle revealing a worn but not archaeologically significant limestone floor. The good quality priests stall is on the north side.

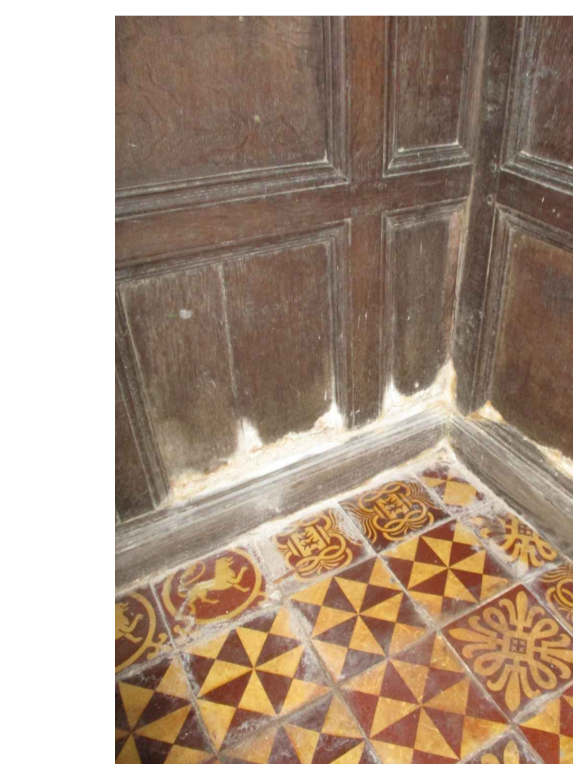
Decay to Sanctuary panelling in part caused by high ground levels outside.

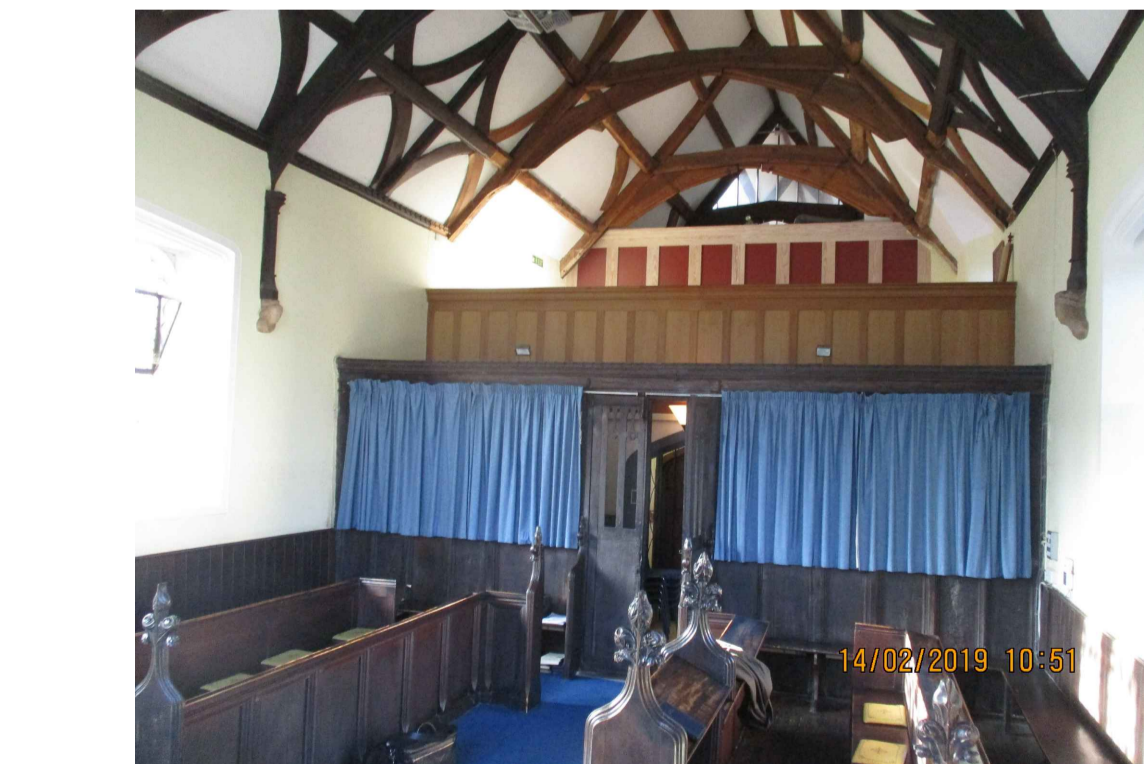
The Chapel interior looking west with the medieval curtain covered screen in front and the modern timber balustrade behind. A further modern screen at gallery level further sub-divides the original space.
