## Arboricultural Survey

Land adjacent to Laindon Link  
Basildon  
Essex

1<sup>st</sup> February 2021

PJC ref: 5607/20-01 Rev 02

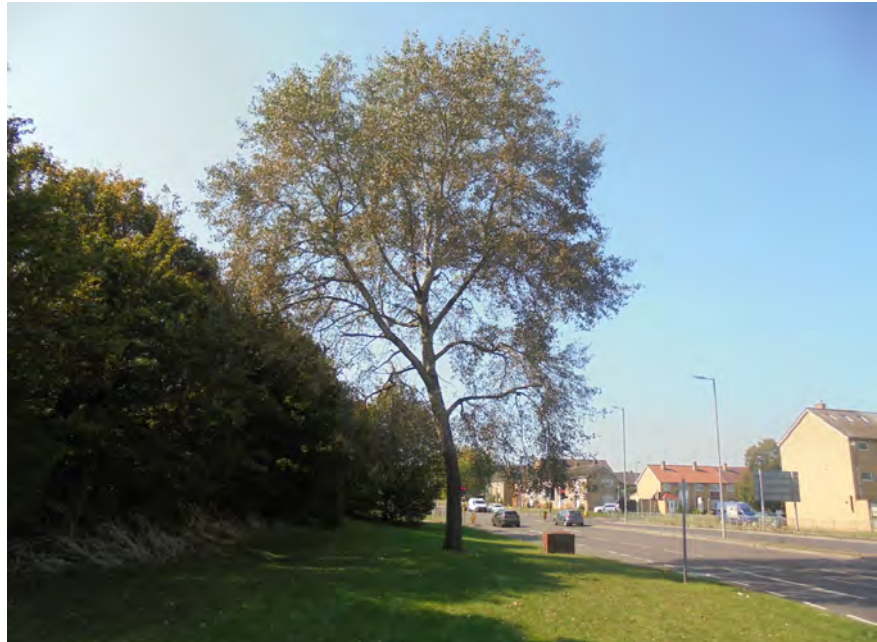
**Photograph 1**

Trees G1, T2 and  
T3 viewed from  
grass verge  
adjacent to  
Laindon Link.

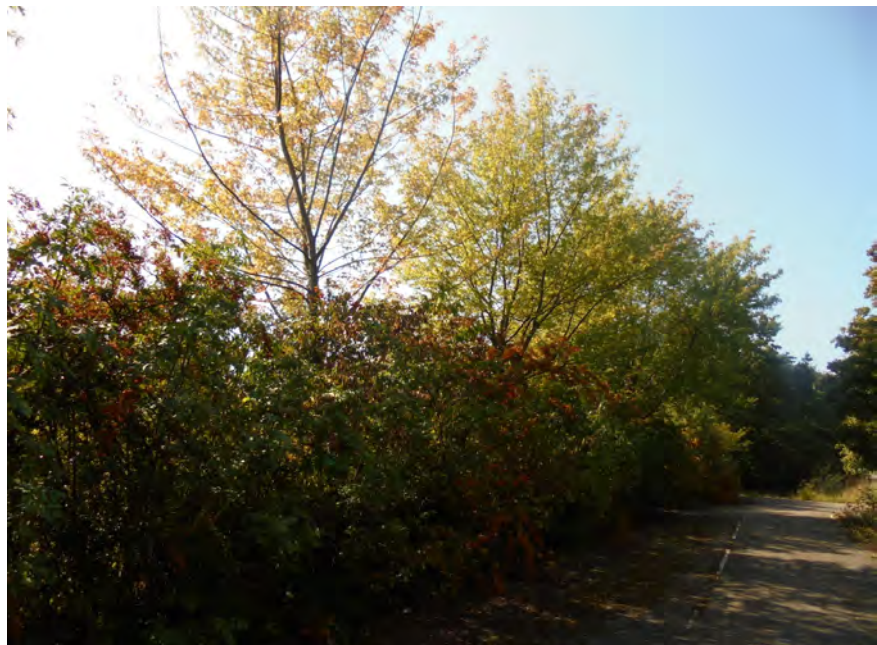
**Photograph 2**  
Groups G4 and  
G6.

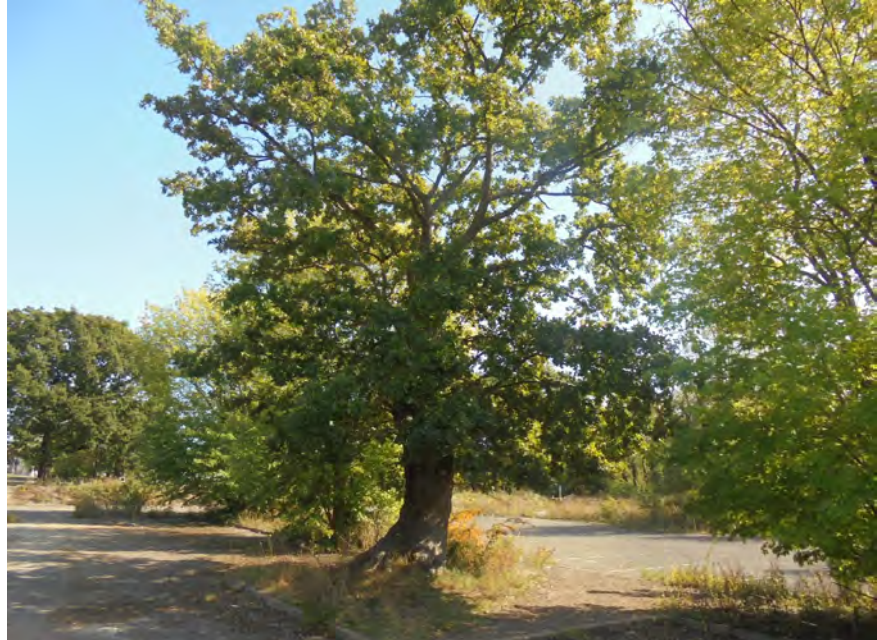
**Photograph 3**  
Tree T25.

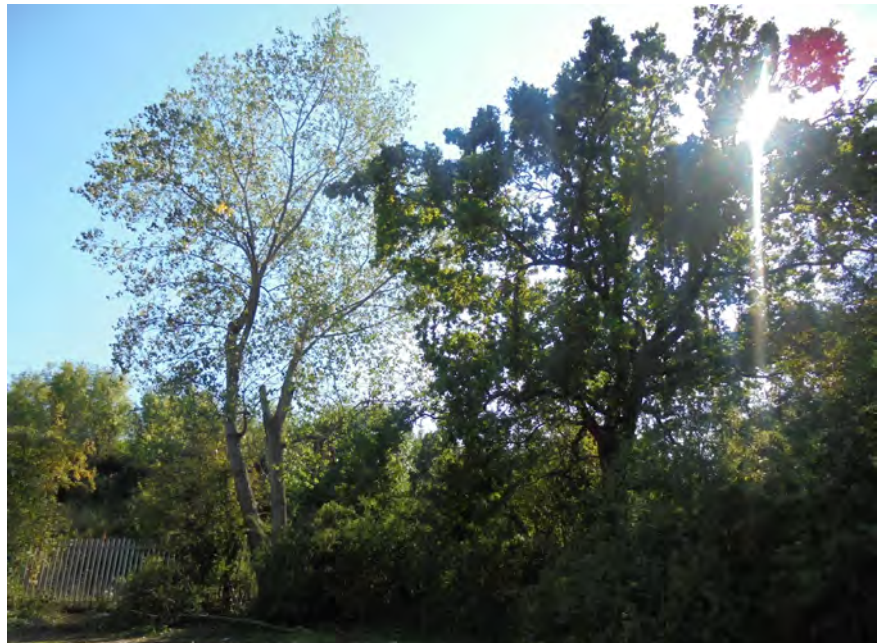
**Photograph 4**  
Trees T47 and  
T48.

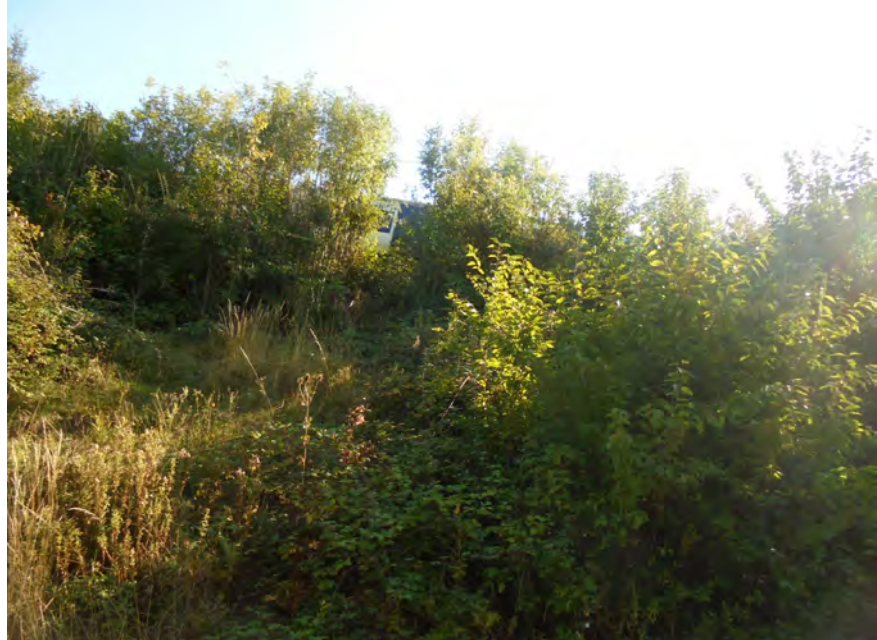
**Photograph 5**  
Railway  
embankment south  
of T47.

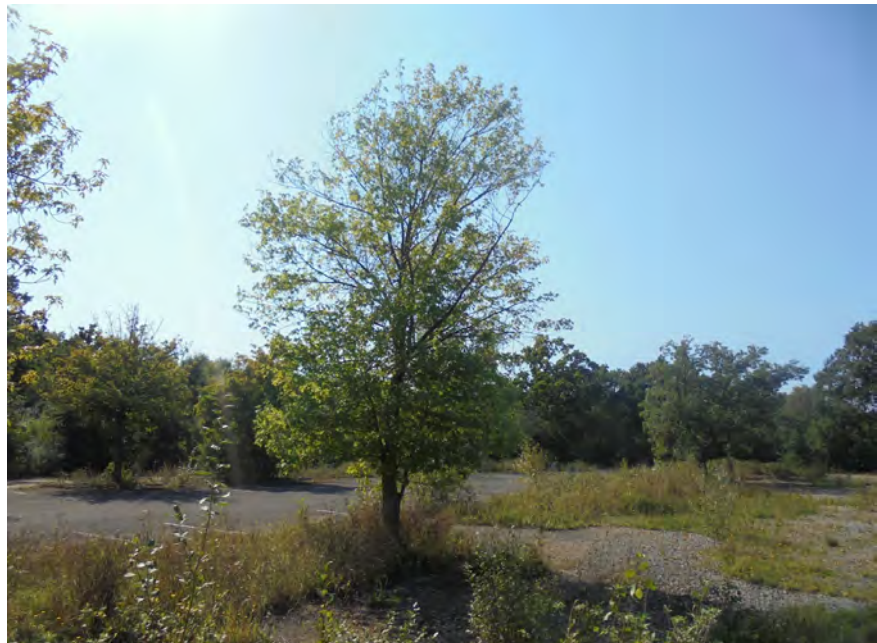
**Photograph 6**  
Tree T20.

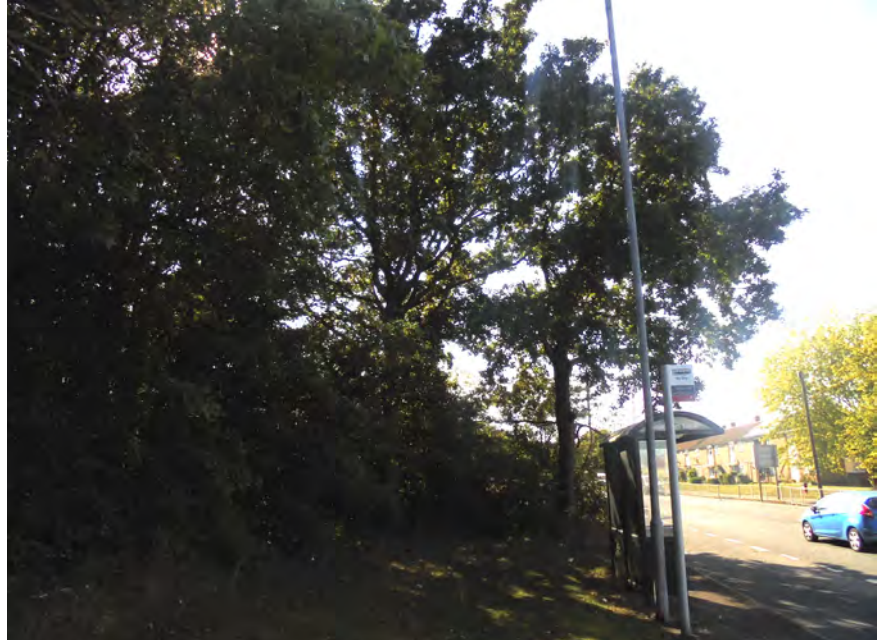
**Photograph 7**  
Trees T54 and  
T55.

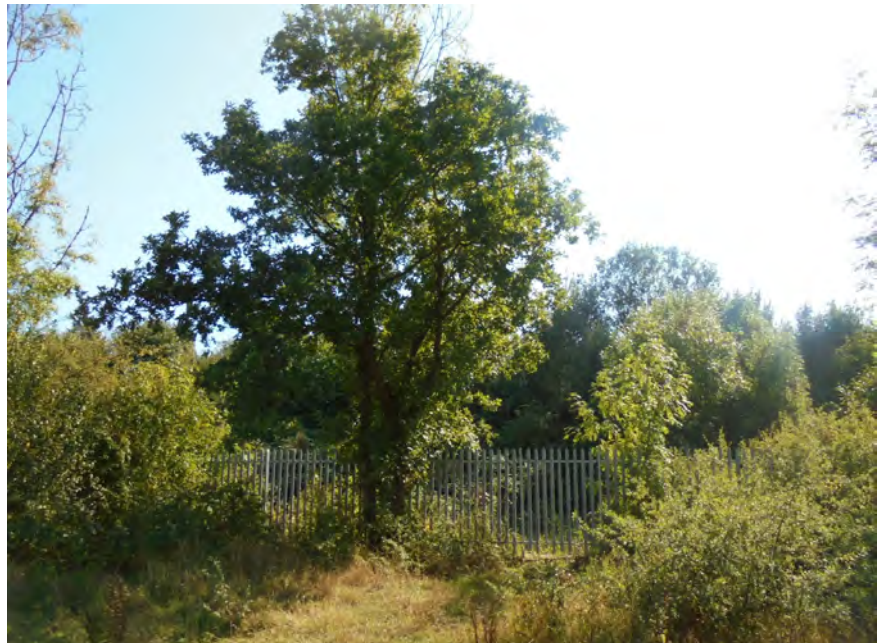
- 3.3.3 A mixed informal shrub belts (G44 and G45) containing tree groups G42 and G46 are located on the southern boundary of the car park. G42 comprises ash trees, all of which are exhibiting significant crown dieback which could be associated with Ash Dieback (*Hymenoscyphus fraxineus*). The trees in G42 are not considered to be immanently dangerous, however should not be considered a constraint to development. G46 comprises a mixture of oak and field maple that are not highly visible in the wider landscape, however are of reasonable condition so have been awarded category B. The railway embankment to the south of the site is covered with scrub and small trees, however the strip of land directly south of the site boundary has previously been completely cleared of trees and shrubs, potentially for maintenance access.

**Photograph 8**  
Trees G42 and  
T43.

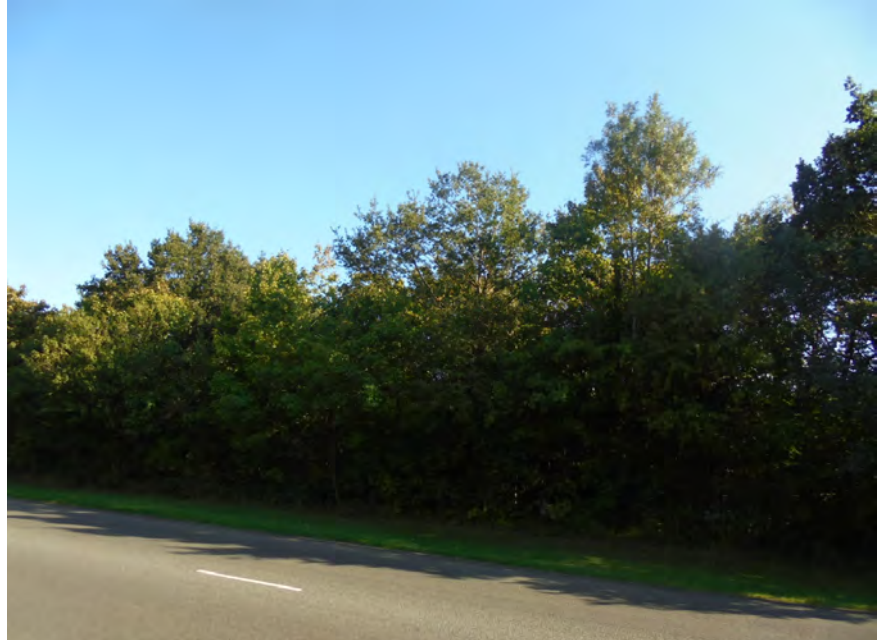
- 3.3.6 The majority of the western half of the site comprises a broad, informal woodland belt (G66) which contains mixed native species. Most of the individual trees in this group have suppressed growth habits due to group pressures and are of limited arboricultural value, however collectively are highly visible from the land to the north of the site. Contained within G66 are a number of larger and more mature oak and poplar specimens.

**Photograph 9**  
Group G66.

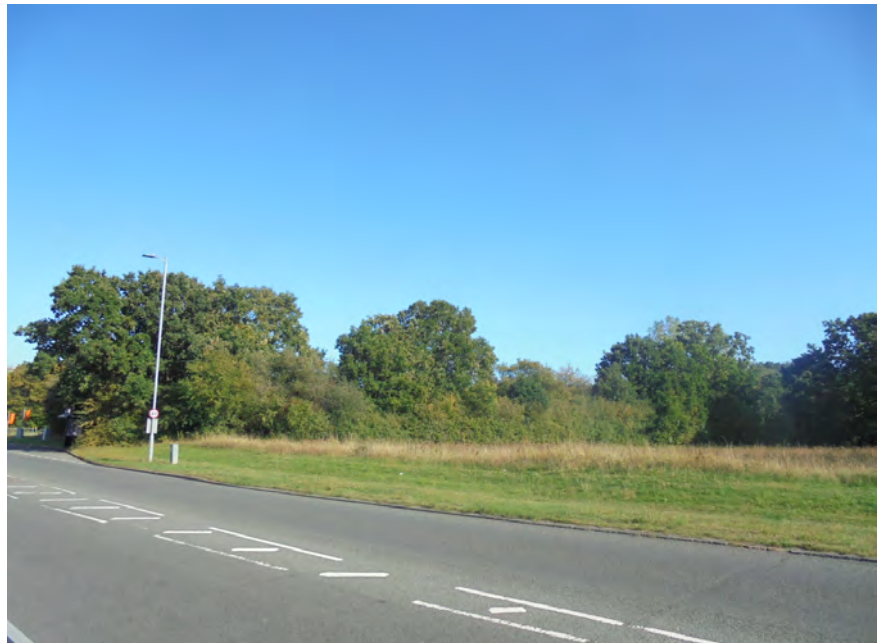
**Photograph 10**  
Group G49  
containing trees  
T48, T50–T55 and  
T57 viewed from  
Laindon Link to  
north west.
