Tree Condition Survey

Land adjacent to
7B Wissage Road,
Lichfield,
Staffordshire,
WS13 6SP

Undertaken by: Bramley Tree Consultancy

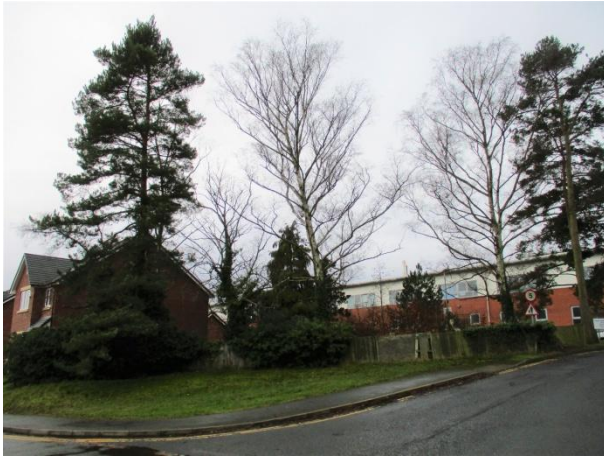
Picture One – View from Wissage Road

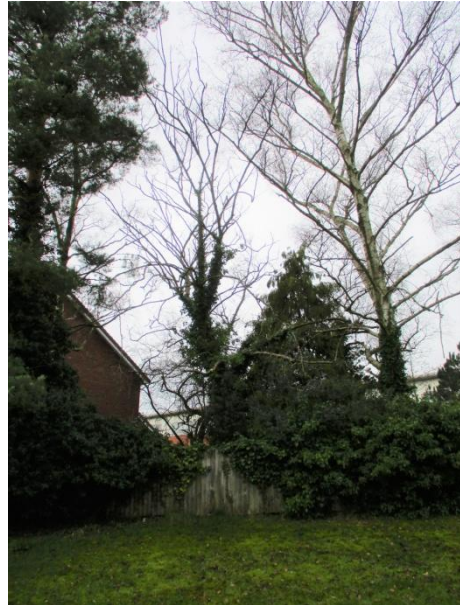
- 3.7** The majority of the crown of T03, Birch is dead with significant dieback on the remainder of the live crown. Due to the amount of crown that has died and the decline of the tree it is recommended for removal and replacement.

Picture Two – Showing the condition of T03
(centre)

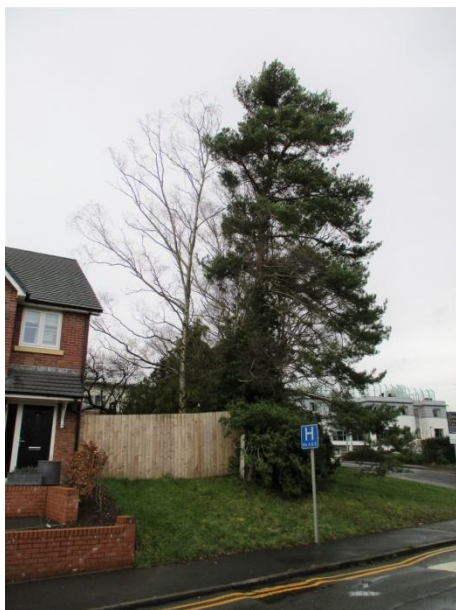
- 3.8** The crown of T04, Birch has thinned significantly resulting in less than 50% of the normal crown coverage expected of its species. It is likely that this is a result of root damage during the construction of the adjacent property. The structural condition is not compromised; due to this there is an option of removing the dead wood, along with minor pruning to clear the property to prevent direct damage. The tree may start to recover as it regains root mass, although due to the extent of the crown loss the tree may decline further. There is an option of removing to ground level and replanting with a new specimen to create age diversity.

Picture Three – Showing the thinning crown of T04
and also T05

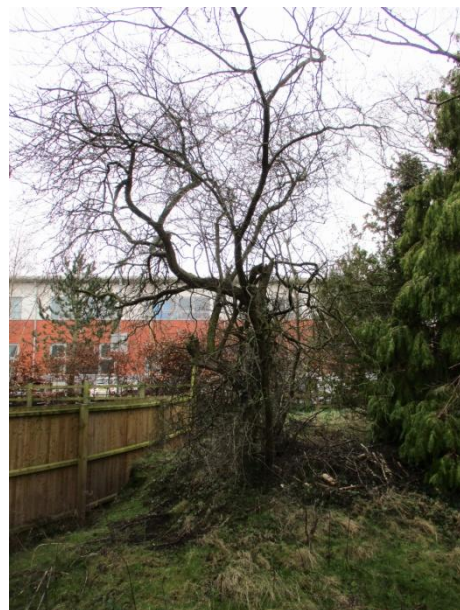
- 3.9** The roots of T07, Prunus have been severed on the southern side due to the construction of the adjacent property; it has also lost two larger limbs from within the crown one of which is still hung up. The crown of the tree is not well shaped and is in close proximity to the adjacent property, pruning to prevent direct damage will further affect the shape of the crown. Due to this and the root damage it is recommended for removal.

Picture Four – Showing T07 and root damage
