**Cart Shed
Manor Farm
Great North Road
Torworth**

Cannon Developments Ltd

Structural Inspection Report

PC/4970
June 2017

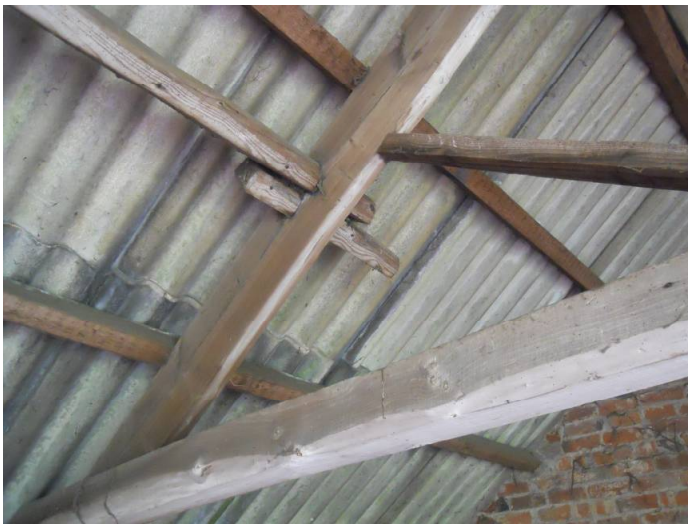
Photograph 1

The roof structure originally consisted of timber common rafters supported by timber purlins spanning between gable walls and timber king post trusses. The original pantile roof covering has been replaced with asbestos cement sheeting. The common rafters and some of the purlins have been removed and new purlins have been installed [Photograph 1].

It is assumed that the asbestos cement sheeting will be replaced with a new pantile covering and therefore new common rafters will be required throughout. The newer purlins are undersized and will sag under the weight of the heavier pantile covering and should be removed. The original purlins appear to be of suitable size for the proposed loading but the missing ones will require replacement and it is recommended that a full ridge purlin is installed in order to remove the risk of roof spread.

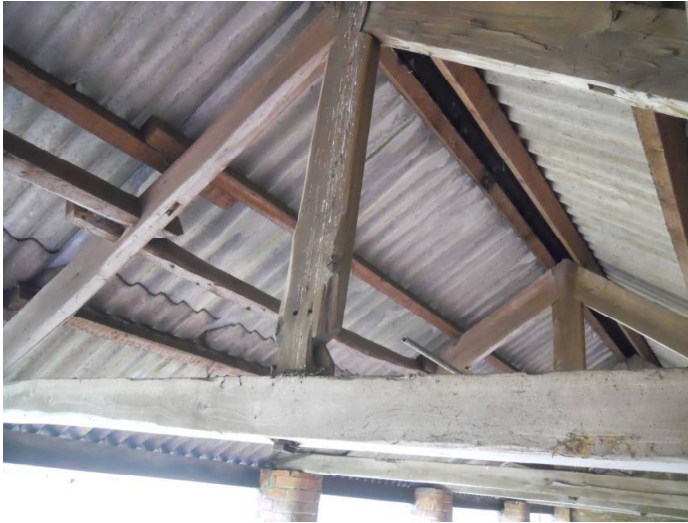
Photograph 2

The king post trusses appear to be of reasonable size and in reasonable condition and can be retained although diagonal internal timbers are missing from three of the trusses and will require replacement [Photograph 2]. The ends of the trusses are notched over the

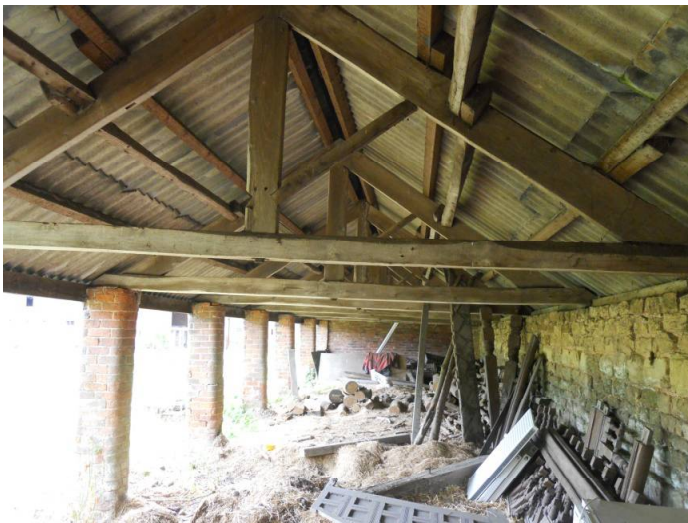
Photograph 3

wallplate on the stone highway elevation. The remaining timber is very small and on some of the trusses has split or distorted. The trusses have a noticeable dip from the open fronted elevation down to the highway elevation [Photograph 3]. Therefore it is assumed that for

aesthetic purposes the trusses will be jacked up to level and the ends of the trusses re-supported off the highway elevation without relying on the notched section. The end of one of the trusses has been strengthened by fixing additional timbers to the side and building a brick pier [Photograph 4]. Although the repair appears to be adequate it is not possible to confirm the condition of the truss rafter and therefore this area will have to be inspected once the roof covering is removed. If the brick pier is to be removed in the refurbishment then further remedial work to the truss will be required.

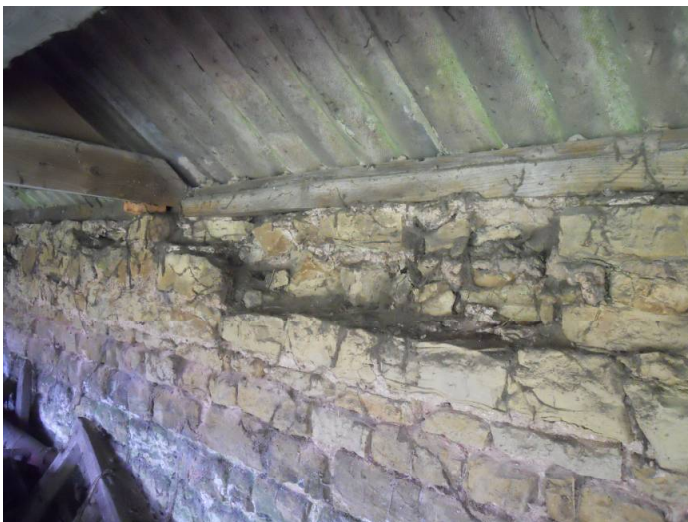
Photograph 5

The wall adjacent to the highway consists of cavity stone. The wall leans inwards by up to 60mm in a 900mm height but this appears to be old movement and has not affected the overall stability. Remedial work is not required. There has been some erosion of pointing that will require making good with a suitable lime mortar. In addition there are some stones missing from the inside face of the wall that will require making good [Photograph 5].

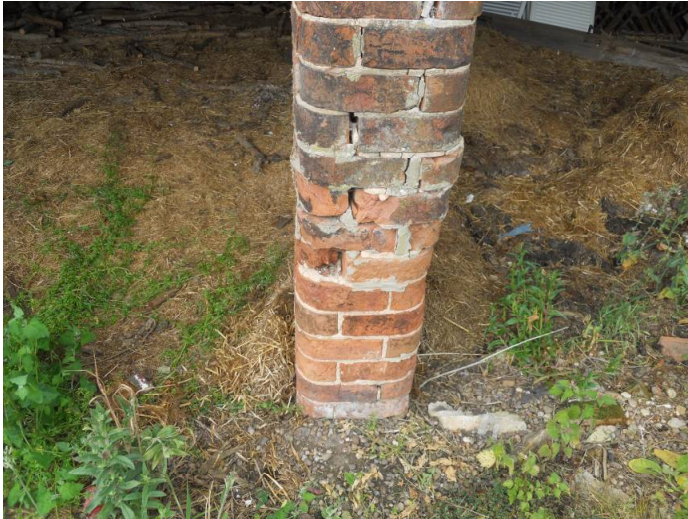
Photograph 5

Two of the brick piers to the open sided elevation have suffered from vehicle impact. One of the piers has been repaired but there is still loose brickwork on the other that will require making good [Photograph 6]. The majority of the piers are plumb but two lean outwards by

up to 40mm in a 900mm height. This may be due to old roof spread or due to settlement of inadequate foundations. The piers do not require rebuilding and the new roof will prevent spread. However it will be necessary to ensure that further settlement does not occur by excavating trial pits to confirm the details of the existing foundations and, if necessary, underpinning the piers. There is some frost damage to the brick piers but remedial work is not required unless for aesthetic purposes. Any repointing should be in a suitable lime mortar.
