Phase One Planning

Preliminary Environmental Risk Assessment

92, Yorktown Road, Sandhurst,
GU47 9BH

Report Reference
AEL-4491-PP1-990623

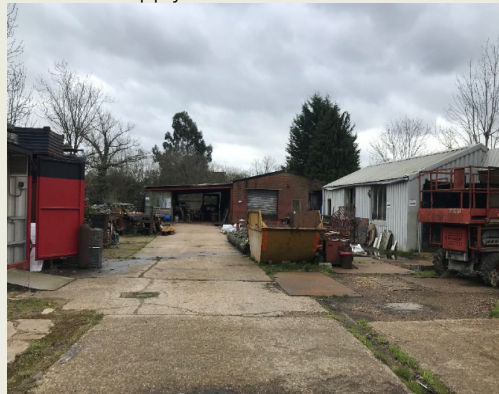
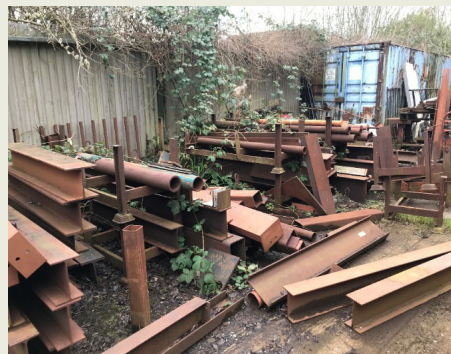
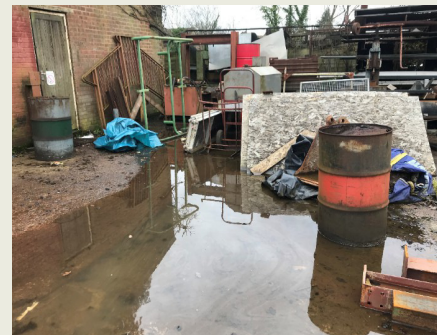
The Site visit revealed the storage of a number of disused chemicals/fuels and waste items. These include, but are not limited to: multiple 205l metal and plastic drums (some of which contained oil), a number of smaller 5-25l containers for items such as grease and hydraulic oil, steel beams, generators, gas cylinders including Acetylene. Furthermore, the site visit revealed evidence of oily spills/puddles, particularly in the west of the Site, which is potentially the result of disused metal drums being left to degrade since the blacksmiths became disused.

A drainage channel runs along the southern boundary of the Site, but this was not accessible during the Site visit due to the quantity of materials and overgrown nature of this part of the Site.

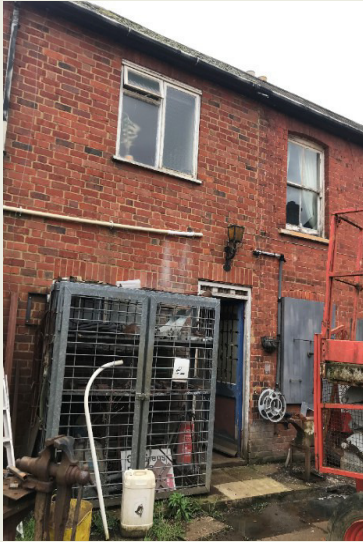
1. In the north west is a brick house, built in the late 1800s, with extensions in 1980s according to the Site representative.
2. In the south is a workshop - brick built and single storey, with a corrugated steel roof. According to mapping, it was built between the 1970s and early 1990s. This has a steel frame lean-to structure attached to it. Both were laid to good quality hard-standing. They contained machinery and tools such as rolling machines, cutting machines and various small quantities of chemicals/fuels such as greases and hydraulic oil. A digger was also noted. Steel beams and metal shavings were observed in the workshop.

The house in the north west.

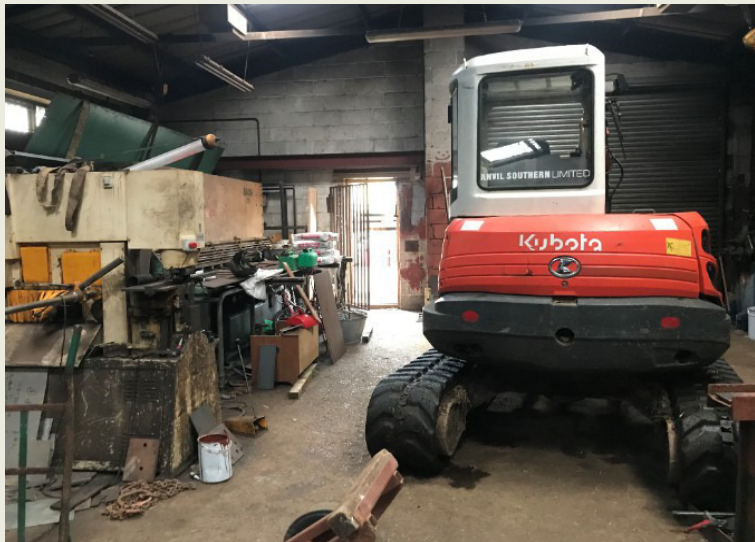
Workshop in the south.

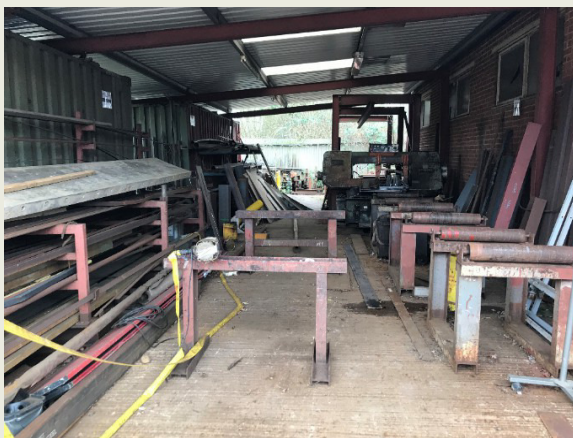
Rolling and cutting machines in workshop in the south.

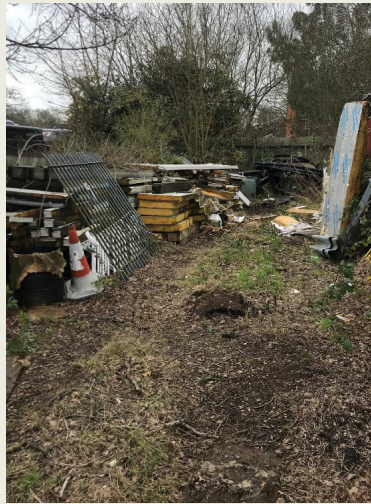
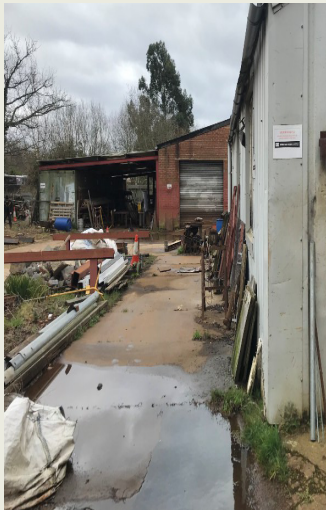
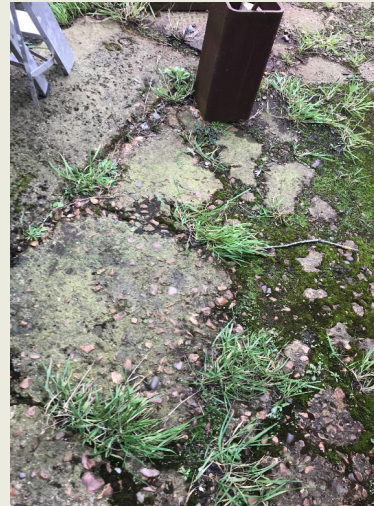
Site topography	The Site and surrounding area appeared to be relatively flat.
Surface conditions	Areas of soft landscaping/topsoil were noted in the north east, south, and some central areas. Rubble/stones/bricks and areas of exposed soil/grass were also noted along the eastern boundary. The remainder of the Site and building surfaces comprise of concrete hard-standing. The quality of the hard-standing was good inside the buildings, but poor in parts of the yard, with evidence of cracks and vegetation growth. Finally the site visit revealed evidence of oily spills/puddles, particularly in the west of the Site.

Vegetation	Areas of soft landscaping and vegetation growth are described in the surface conditions section above. In addition to this, areas of overgrown vegetation comprising of brambles and bushes were noted along the southern boundary, with two mature trees along the eastern boundary and one in the south eastern corner.
Drainage	Argyll have not been provided with service plans for the Site, however the client confirmed that the flats will be connected to the sewer network. No surface water drains were observed during the site visit, but due to the quantity of material being stored on-site, and the overgrown nature of some sections of the Site, drainage could not be confirmed.

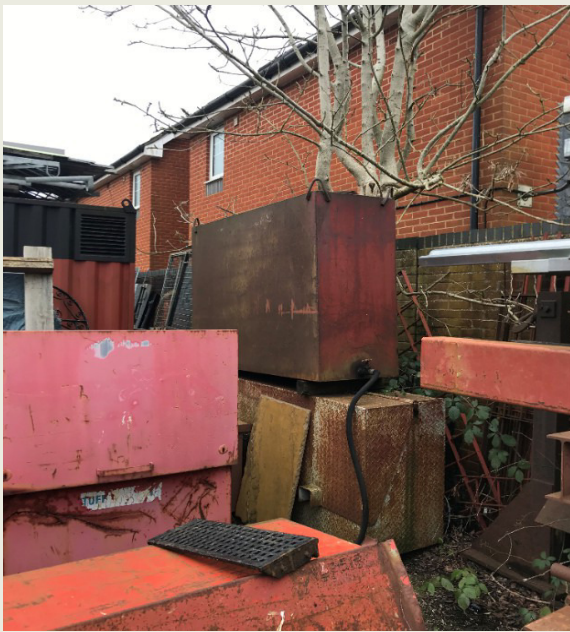
Source	Description
Above-ground Storage Tank 1	<p>Age: Unknown</p> <p>Condition: poor</p> <p>Volume: Assumed c.500 litres</p> <p>Contents: according to Site representative, the tank is empty, but previously contained fuel (assumed diesel) for vehicles on-site (such as forklift trucks)</p> <p>Type: assumed single skin</p> <p>Construction: steel</p> <p>The tank is located along the central eastern boundary of the Site, atop a metal container. There was evidence of damage to the tank and corrosion. A pump was attached.</p> <p>During the site visit, it was situated atop concrete hard-standing, but there was evidence of vegetation growth, suggesting cracks in some parts of the hard-standing. Some minor staining was also observed.</p>

The tank is located in the southern half of the Site along the western boundary; adjacent to the central workshop. The tank was sited atop bricks and there was evidence of corrosion.

During the site visit, it was situated atop concrete hard-standing, but there was evidence of vegetation growth suggesting cracks in some parts of the hard-standing.

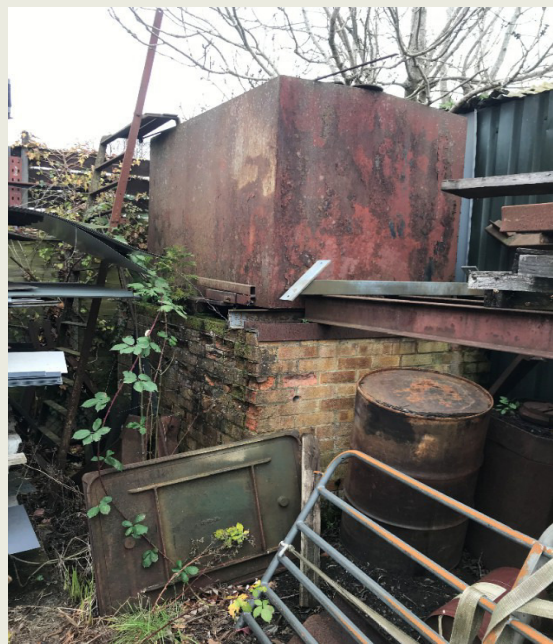
Tank 2

Condition: poor

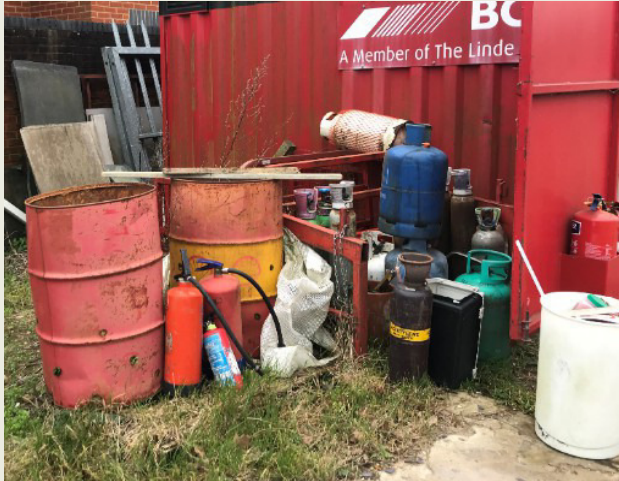
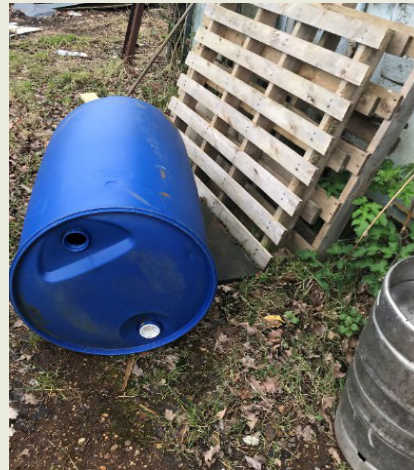
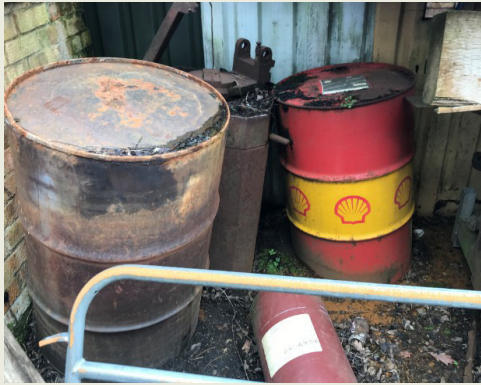
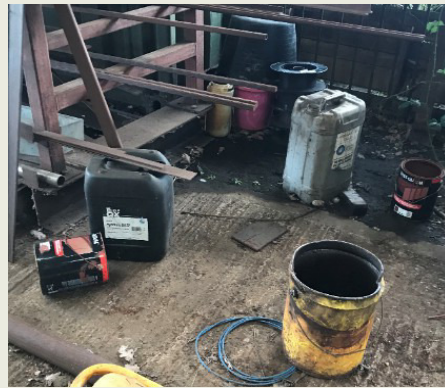
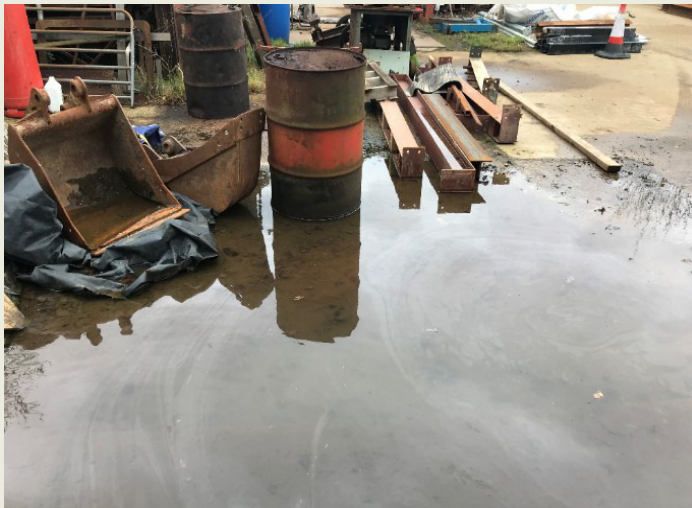
The Site visit revealed the storage of a number of disused chemicals/fuels and waste items. These include, but are not limited to: multiple 205l metal and plastic drums (some of which contained oil), a number of smaller 5-25l containers for items such as grease and hydraulic oil, steel beams, generators, gas cylinders including Acetylene. Furthermore, the site visit revealed evidence of oily spills/puddles, particularly in the west of the Site, which is potentially the result of disused metal drums being left to degrade since the blacksmiths became disused.

However, the Site visit revealed the storage of a number of disused chemicals/fuels and waste items. These include, but are not limited to: multiple 205l metal and plastic drums (some of which contained oil), two above-ground tanks, a number of smaller 5-25l containers for items such as grease and hydraulic oil, steel beams, generators, gas cylinders including Acetylene. The Site visit revealed evidence of oily spills/puddles, particularly in the west of the Site, which is potentially the result of some of these disused metal drums and fuel tanks being left to degrade since the blacksmiths became disused. As such, it is likely there is contamination in the made ground from these sources. We are unable to quantify the risk at this level of reporting.

2. A Phase II Investigation should be undertaken at the Site to identify whether any contaminants associated with the former use as a blacksmiths are within the soil/controlled waters at unacceptable levels. Following this investigation, if necessary, remediation should be carried out to remove any identified issues. The Phase II should provide general characterisation, as well as target specific areas, such as proposed gardens. The Local Authority should be consulted regarding the scope of this investigation.

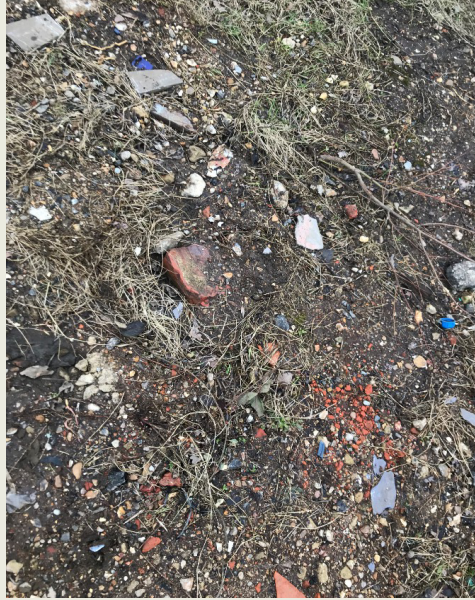
The majority of the Site is laid to concrete hard-standing, presumed to be underlain by made ground. The made ground may contain materials that include heavy metals and asbestos. Some buildings have been demolished over time, with evidence of a concrete slab in the north east, which remains from a demolished house. In addition, crushed hardcore comprised of brick/rubble/stone was observed in the east of the Site.
