◆ **DAVID SMITH ASSOCIATES** ◆ Consulting Structural & Civil Engineers ◆
◆ London ◆ Northampton ◆ Cirencester ◆ Birmingham ◆
www.dsagroup.co.uk

RE: KILBY ST MARY'S C OF E PRIMARY SCHOOL

Thank you for your request for us to carry out a Visual Structural Inspection of the chimney on the north elevation of the original Victorian School House. We can confirm visiting site on Tuesday, 9th February 2021.

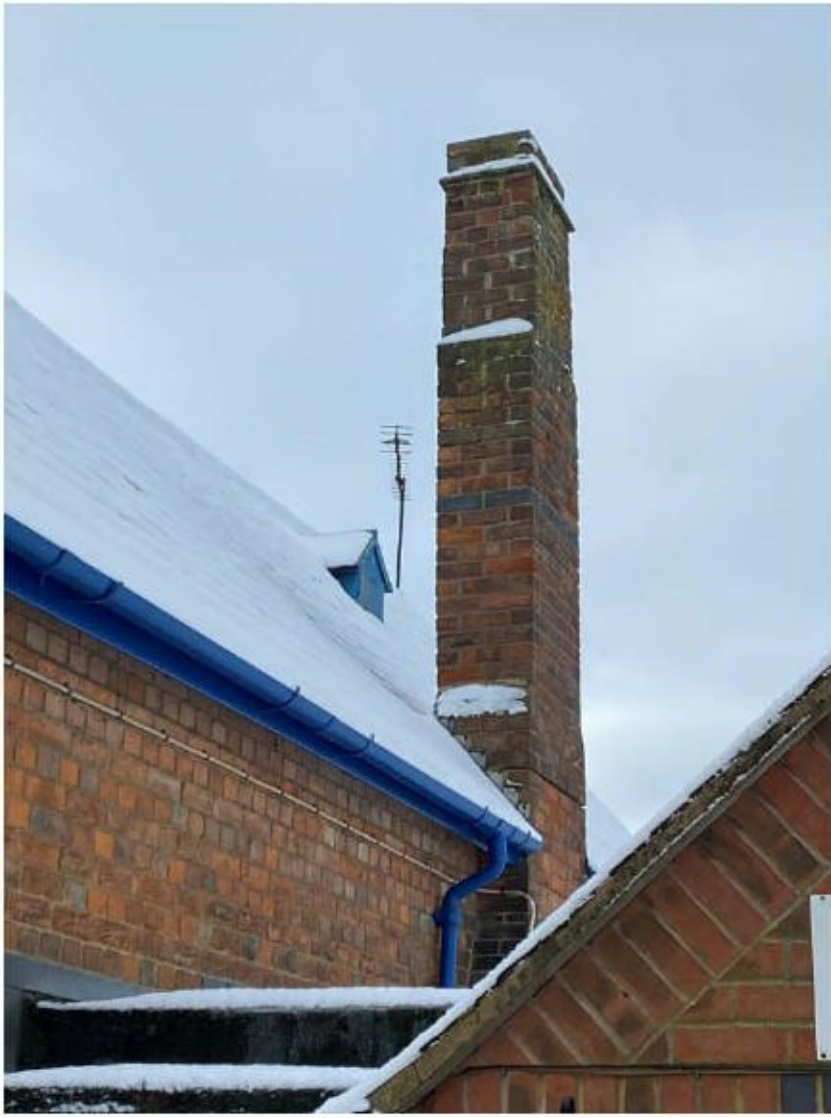
In principle, this is a large Circa 450 x 525mm chimney stack which extends from eaves level to above the ridge line of the main hall. (Please refer to Photograph 1 in Appendix A).

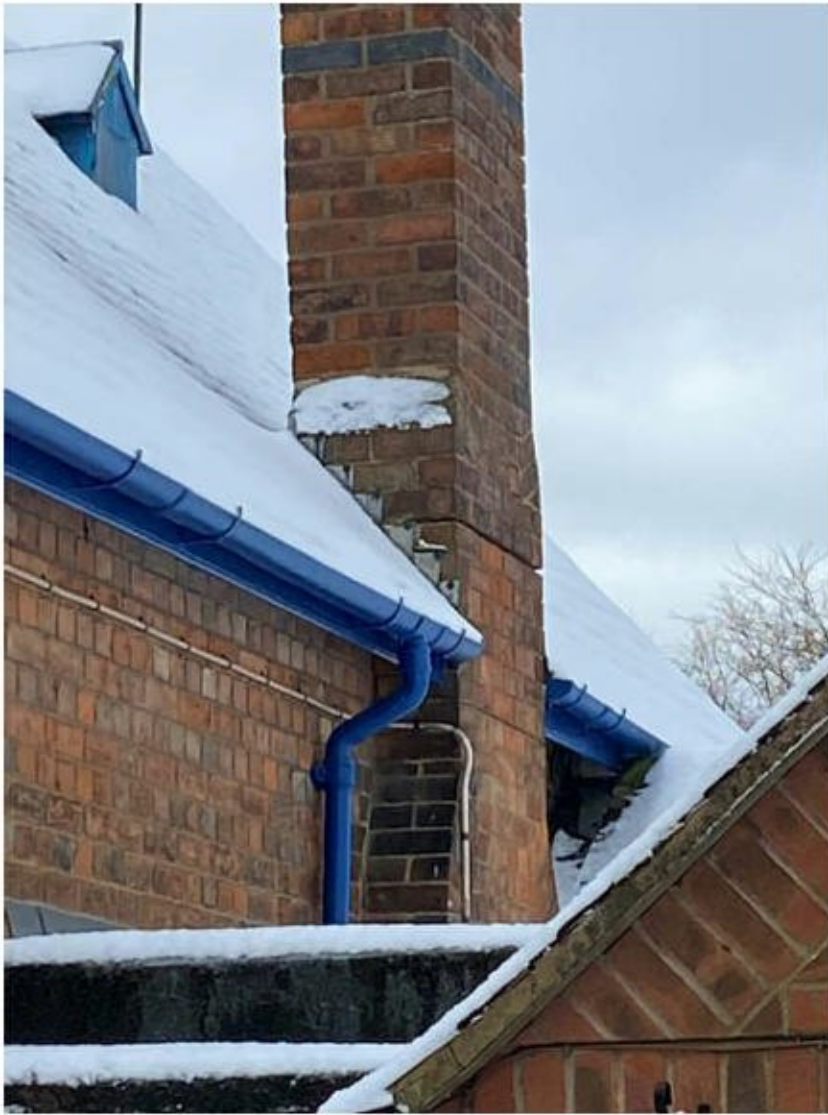
A horizontal crack has appeared approximately 5No. courses above the gutter line, which has created a theoretical hinge within the chimney stack. The hinge is a weak point whereby the stack of the chimney could potentially hinge about this position and collapse onto the roof structure of the School House. (Please refer to Photograph 2 in Appendix A).

Therefore, we recommend that the chimney is carefully demolished down to this position. The bricks should be cleaned and stored on site for re-use. The chimney should then be rebuilt using a sympathetic lime putty mortar mix to match existing with the previously stored original bricks. Please note some reclaimed bricks maybe required due to breakages.
