JRG/21/053
07 April 2021

Syleham House, Syleham. Engineers Report.

Further to our discussions and my inspection at the above (26/03/21), here follows my recommendations for the internal alterations proposed.

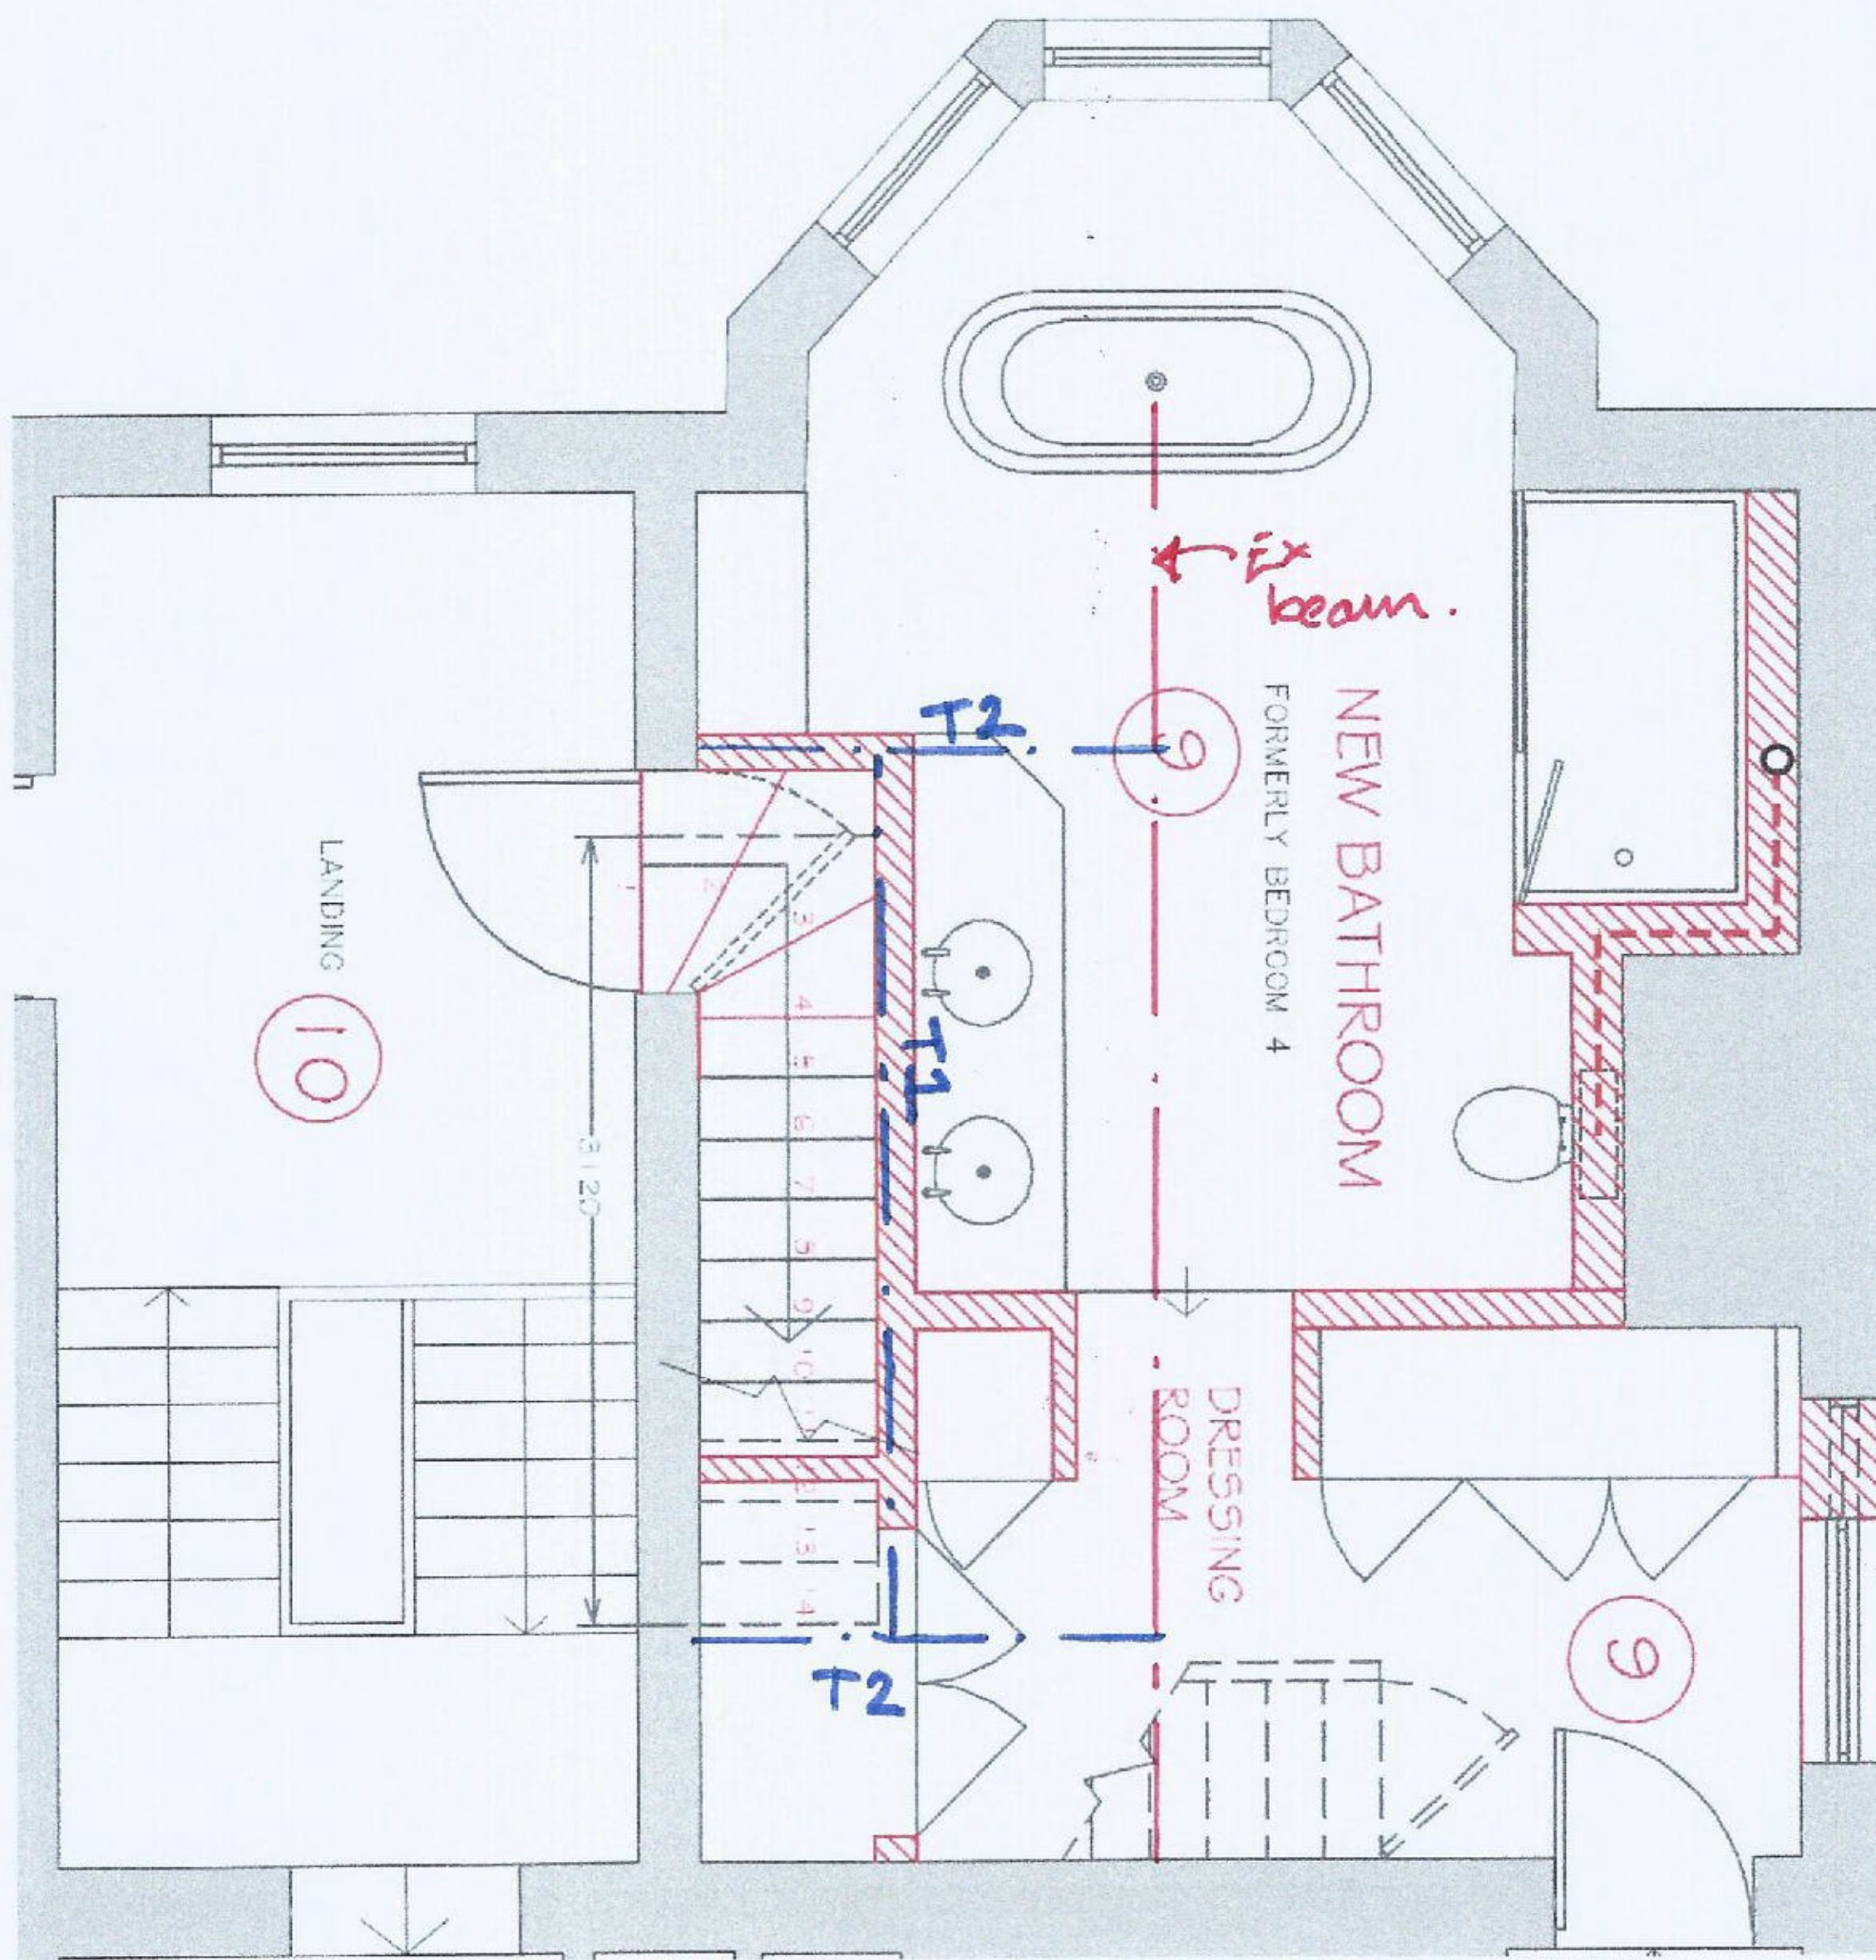
1st Floor

A - Trimming out of the second floor to accommodate the new staircase.

The new opening can be accommodated by the trimming of some existing softwood floor joists. New members will be required to form the opening, otherwise there is no further impact on the existing structure.

T1 - 3N° 145 x 47 C24

T2 - 2N° 145 x 47 C16

Details of trimming on page 2

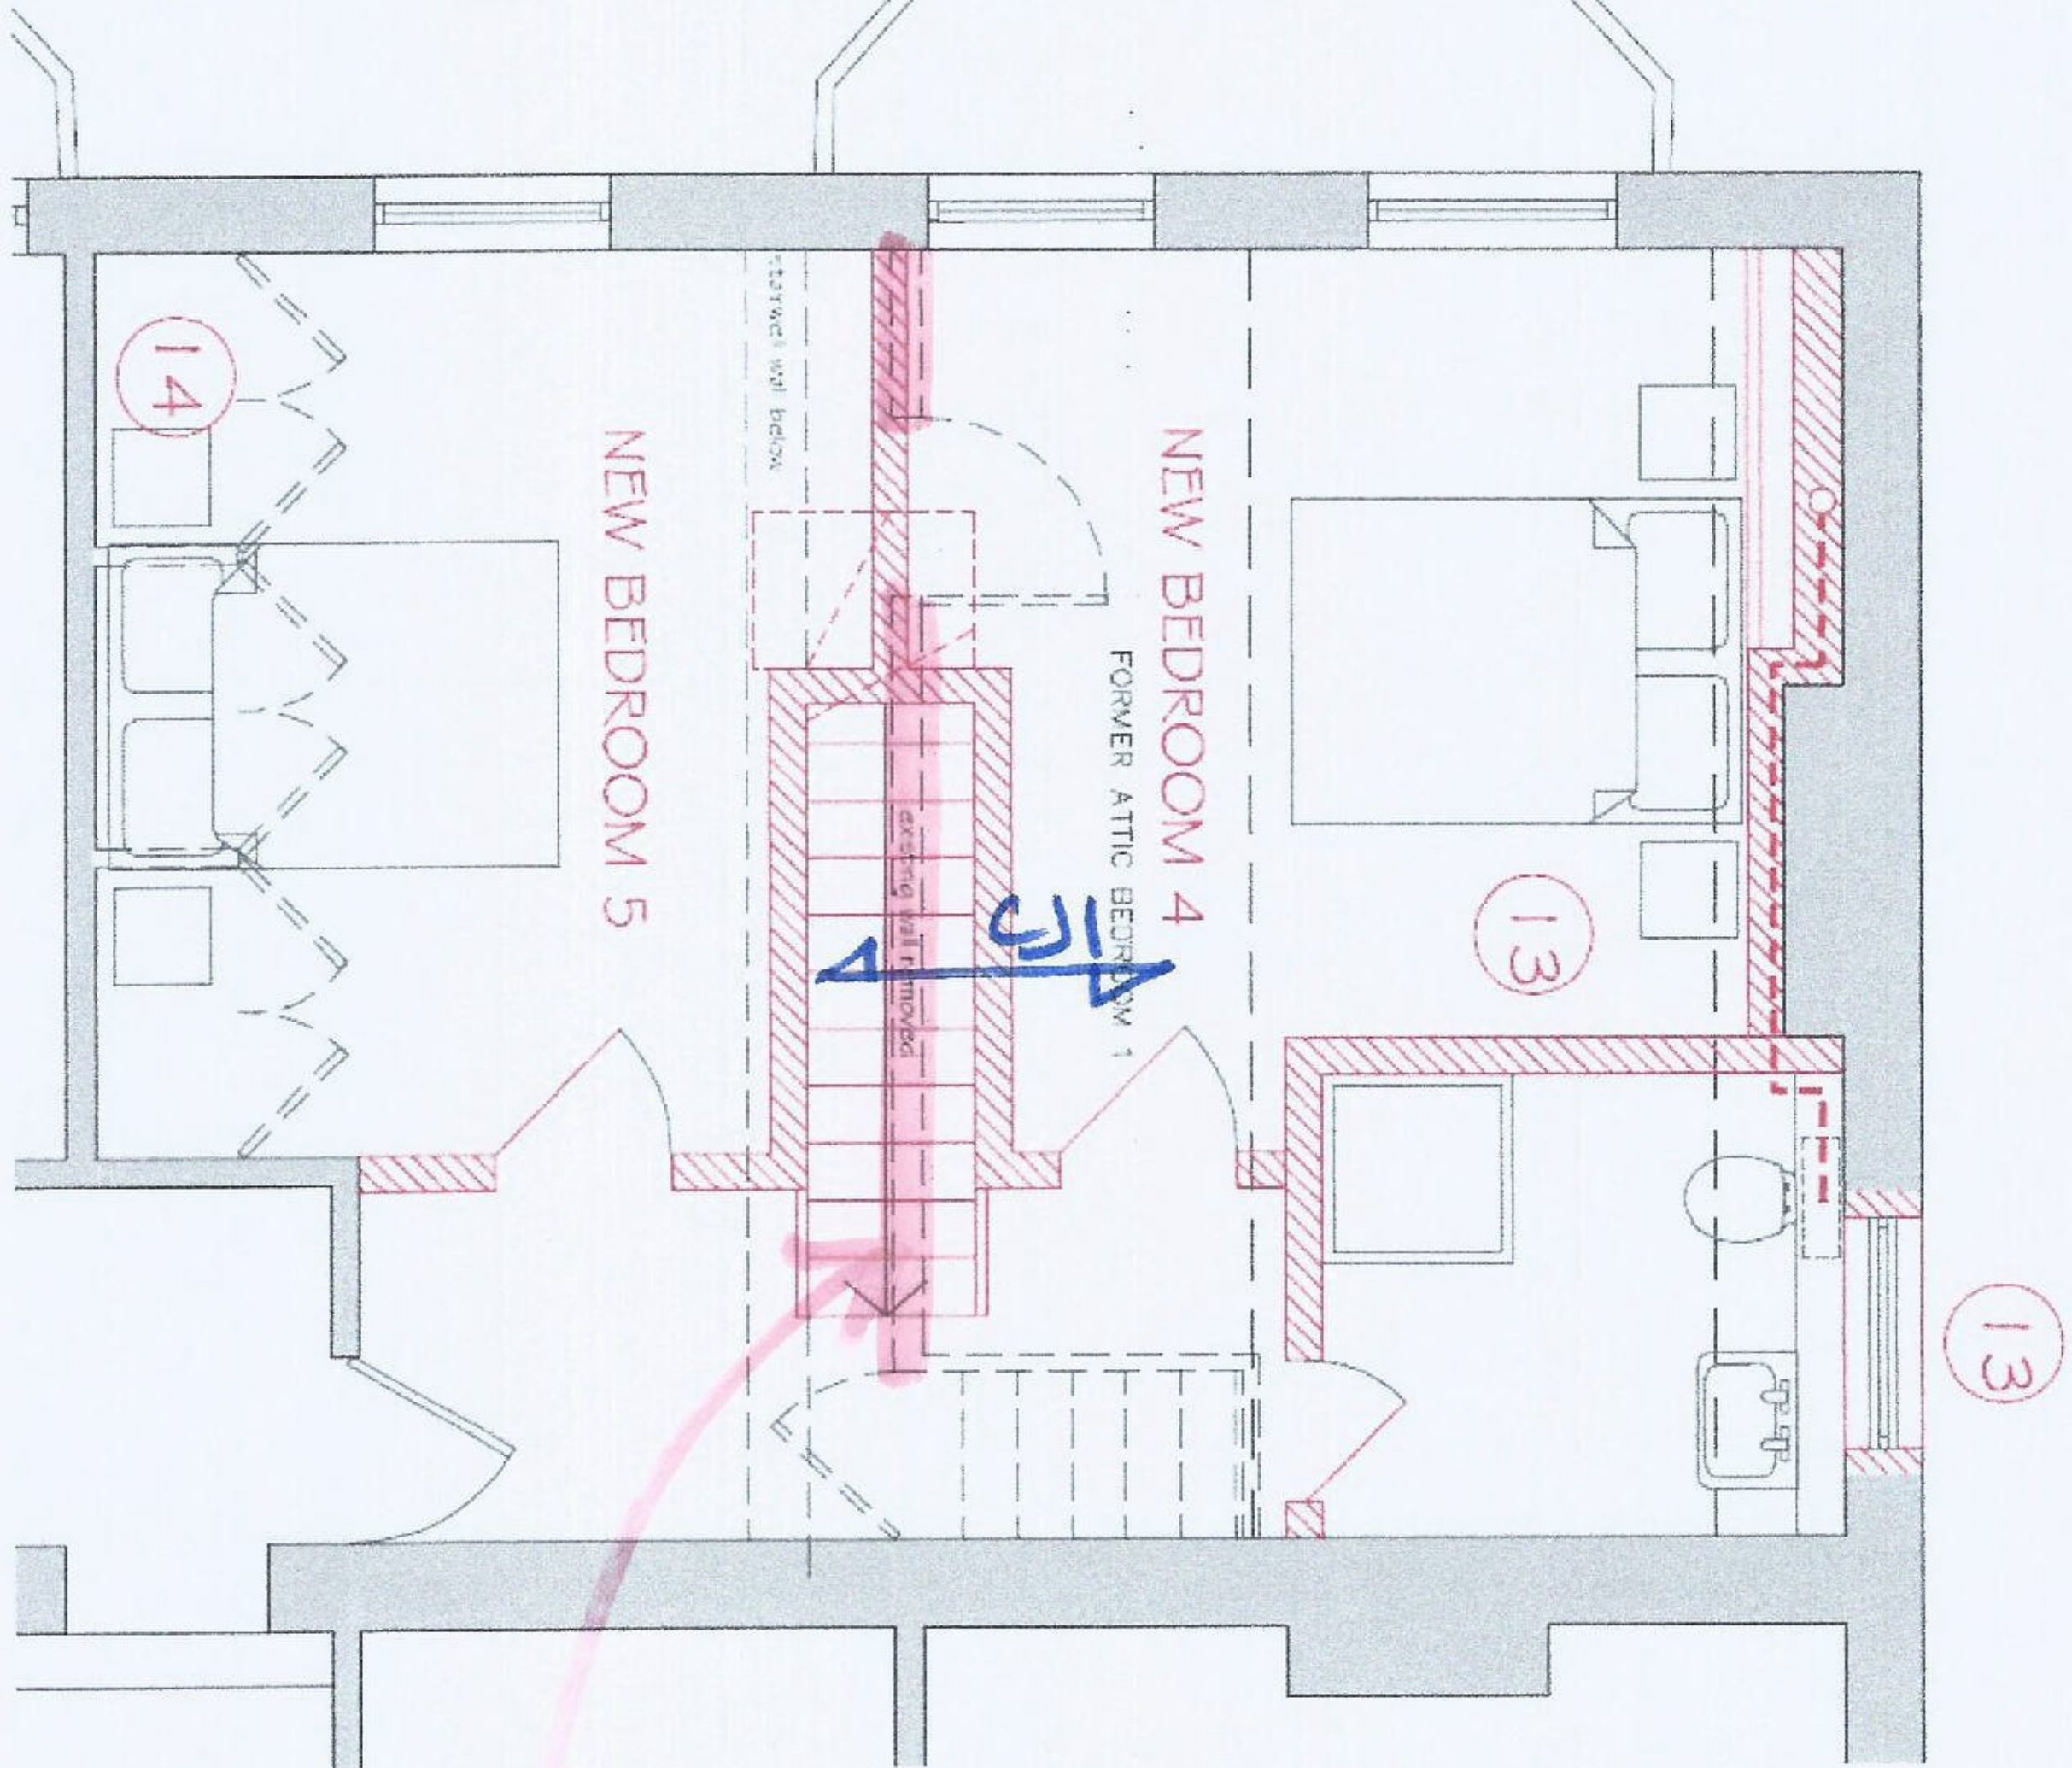
2nd Floor

B – Removal of a partition wall on the second floor.

The wall to be removed is of timber stud construction and is not supporting the roof structure. There are some waney edged and light ceiling joists passing over it which may be taking some support from the partition. I would recommend that some new partnering pieces of timber are fixed to the side of the existing ceiling joists to reduce any sag after the partition is removed. There is also a more recent section of raised ceiling on the Bed 4 side of the wall formed in softwood and plasterboard. This may be partially supported by the wall also. This should be investigated before commencing work, additional joists should be installed in this area if required.

Wall to be removed.

Details of the ceiling improvement on page 3.

CJ1- Improve existing ceiling joists with additional 95x47 C16 screwed to one side.
