Conservation Report: Gas Lamps at St Paul's Church, Covent Garden

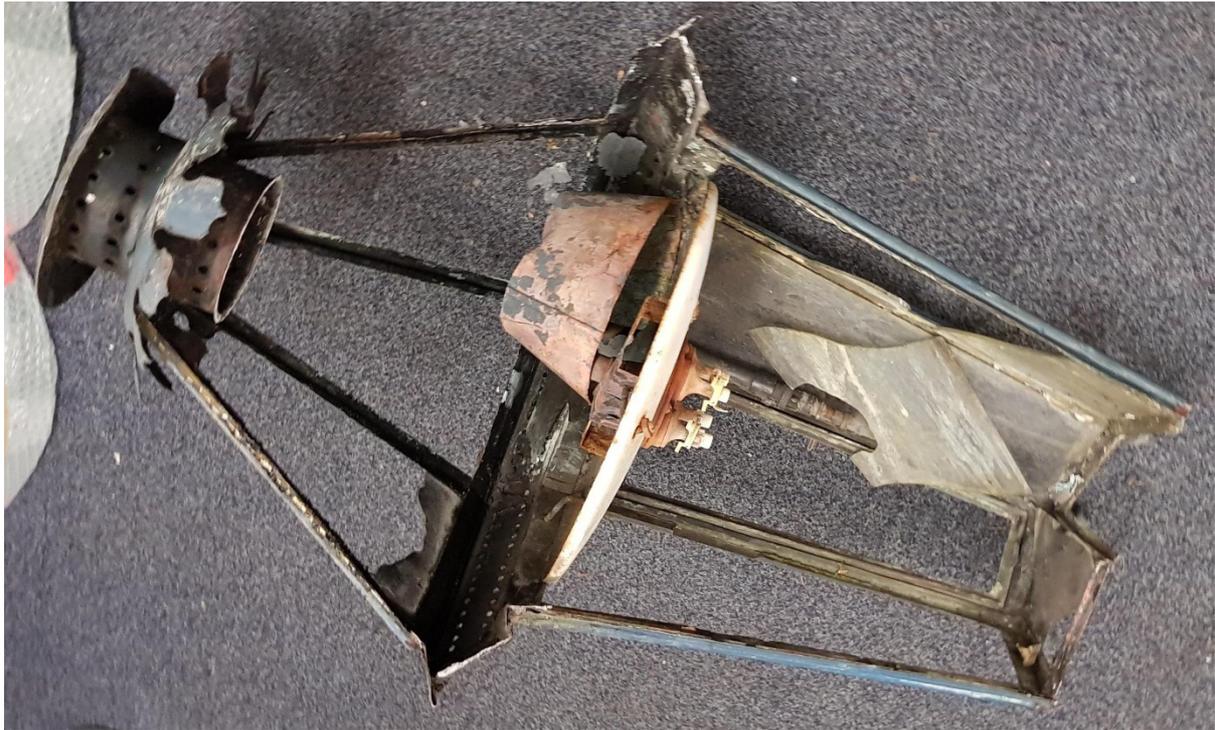
Notably one gas-lamp was damaged in an explosion in the winter of 2019/20. This was caused when a vehicle snagged on a cable around a standard facing the west front. Approximately half of the lantern still exists and all of the standard although it too is cracked and probably slightly deformed. Interestingly the ventilation trims look as if they are twentieth century replacements as they are rows of drilled holes rather than the slots of the other lanterns.

Damaged lantern – note slightly different, possibly cruder, interior details than to the other fittings

The damaged standard will be carefully restored. It is in reasonable alignment but fixed on features such as the wrought iron scrolls carrying the lantern and the lantern cage will be taken off and straightened or replaced. The internal gas pipe will be investigated for damage and repaired as required. A new lantern will be fabricated using existing lanterns as a model for each of the components.

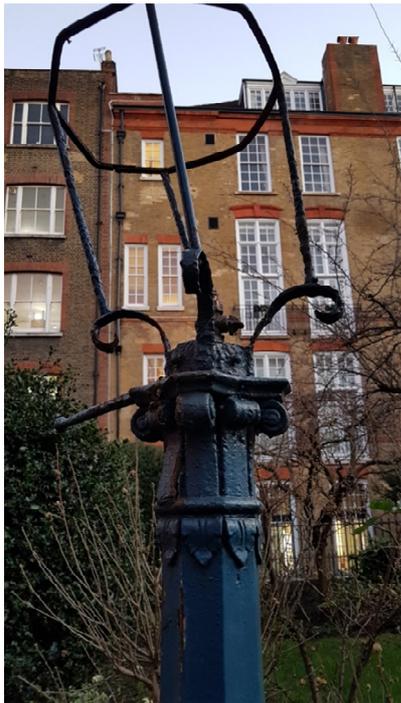
Damaged standard

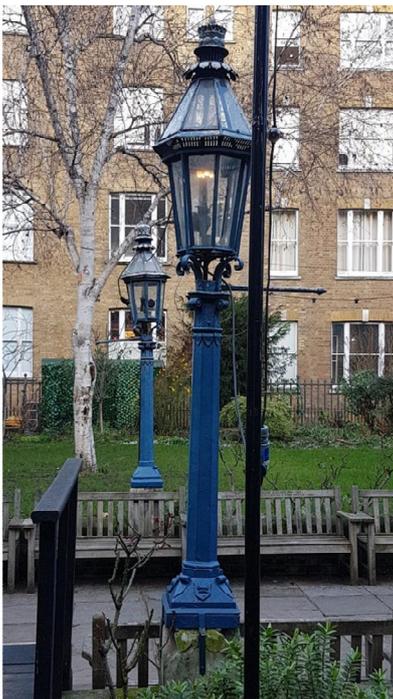
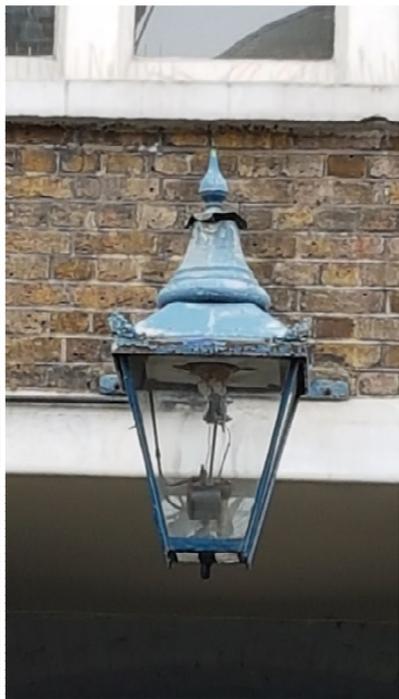
There are also two other gas lights which are hung on wrought-iron brackets over the church-yard entrances to the north and south. These are not listed and do not share the distinctive design of the lamps on standards in the gardens but the brackets are fine and the lanterns have unusual corner embellishments. These too require some straightening and re-glazing. For this latter reason one has been temporarily disconnected.

Gas lantern over passage (not listed)

The remaining seven lanterns and the two over-arch lamps will be stripped down and missing features replaced.
