**Report on  
Structural Condition**

**The Dipping Barn  
Bullsland Farm  
Bullsland Lane, Chorleywood  
Rickmansworth, WD3 5BG**

DATE: 31<sup>st</sup> March 2020

JOB REFERENCE NUMBER: RMW/13249/20

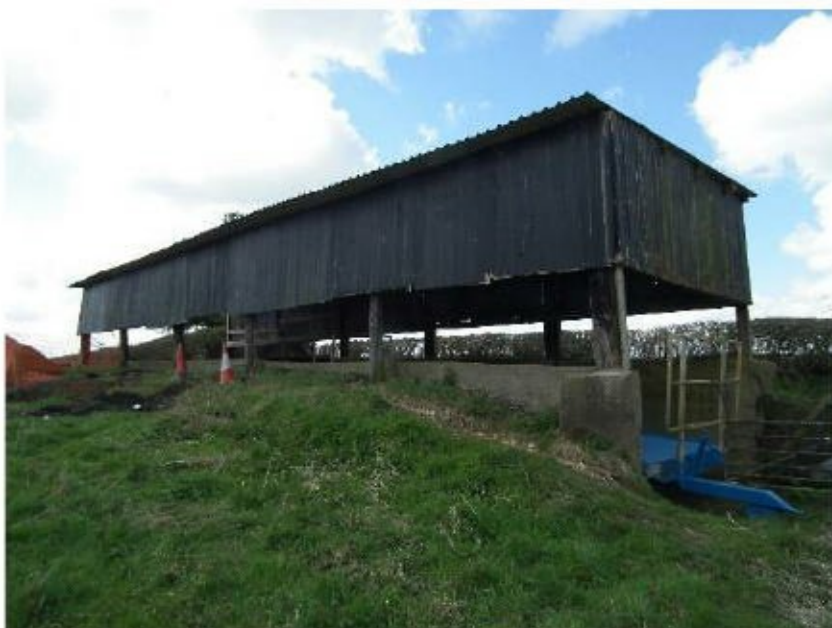
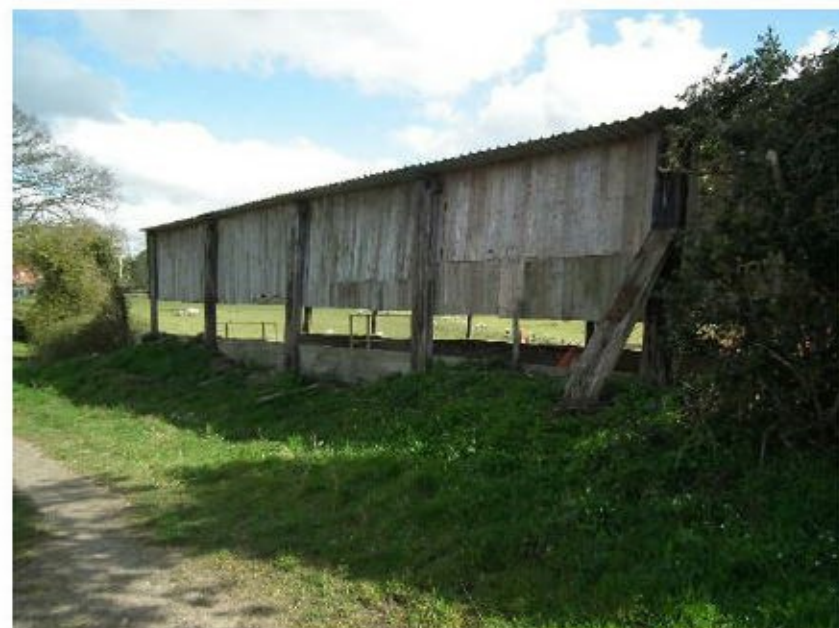
The Dipping Barn is a freestanding structure comprising of low-level cast in situ concrete walls measuring approximately 19 metres long by 5.5 metres wide, with intermediate timber support posts approximately every 4 metres that extend above the concrete walls which support the roof. Due to the tapering nature of the base of the concrete walls, the width of the structure at ground level is 4 metres.

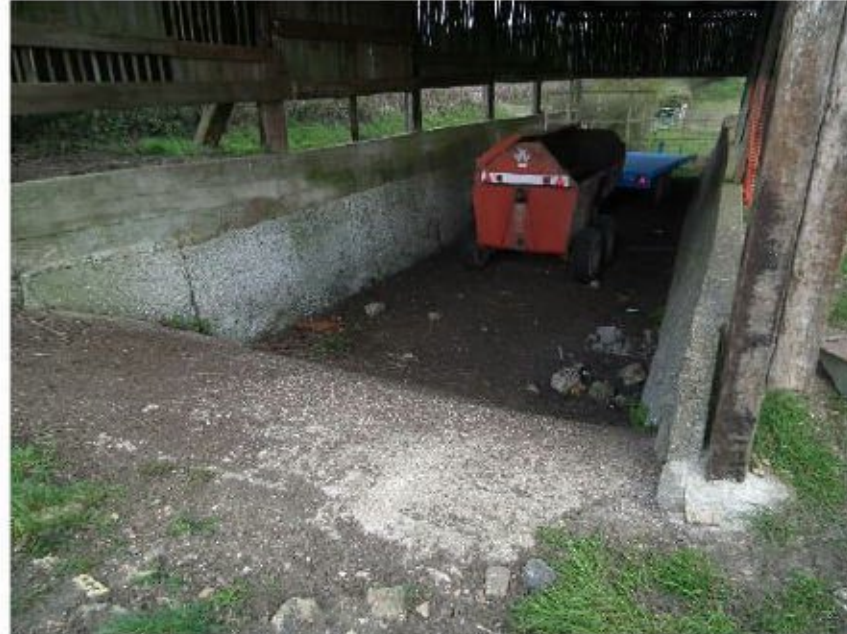
The timber roof posts bear onto cast in situ concrete longitudinal walls forming the original dipping pen. The earth has been banked up on either side of the longitudinal walls, but much of the dipping pen is subterranean. However, at the northern end the dipping pen is approximately at natural ground level and at the southern end approximately 1.5 metres subterranean.

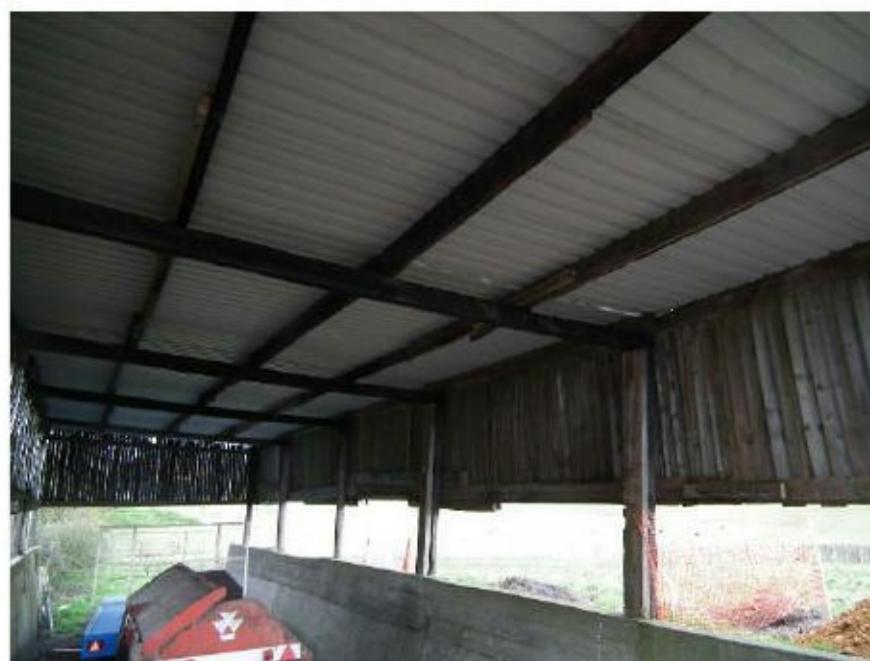
The longitudinal poles support the main roof timbers and purlins, which are clad in a metal profile sheets.

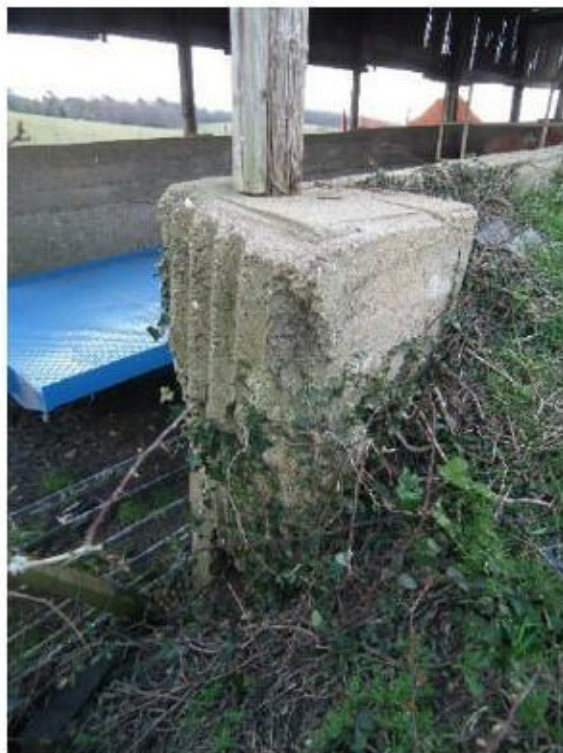
2.1

The original timbers have been set onto large blocks of concrete that go down to the full depth of the wall, but some of the circular posts have independent pad foundations cast onto the flinty clays that are naturally forming.

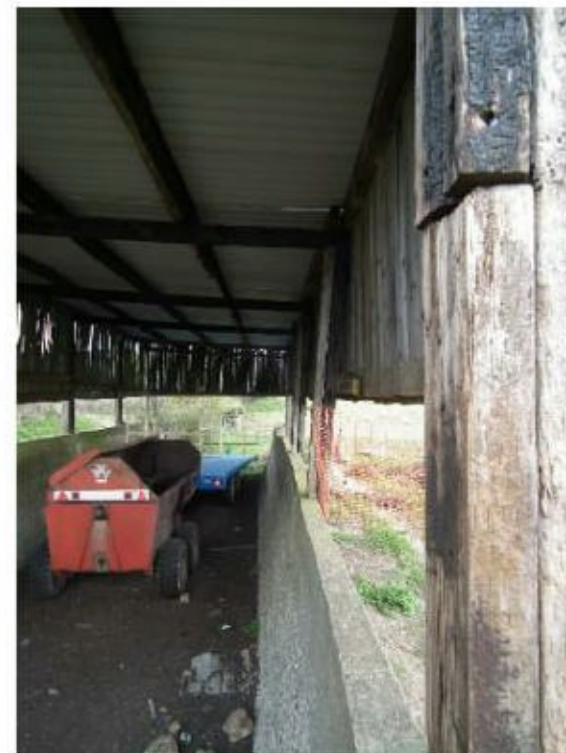
2.2

The posts to the eastern flank elevation have rotated out from the vertical, largely because there is no cross bracing to the structure and the roof timbers are hung from the longitudinal eaves timbers. Without adequate cross bracing, either by timbers or internal wall structures, the structure is always going to be prone to wind damage and racking. In addition, the racking may have been caused by a lack of restraint at a time when there has been a previous fire. There is clear evidence of fire charred timbers spanning across the structure as well as to the longitudinal purlins, which have been repaired and supplemented by other timbers to help provide support to the roof.

I propose the use of ply sheeting is adopted to create a diaphragmed wall, which will assist against racking in the future, otherwise the alternative would be to introduce diagonal members between the posts to create the same effect. Some of the posts can be moved back to the vertical very easily during this work.

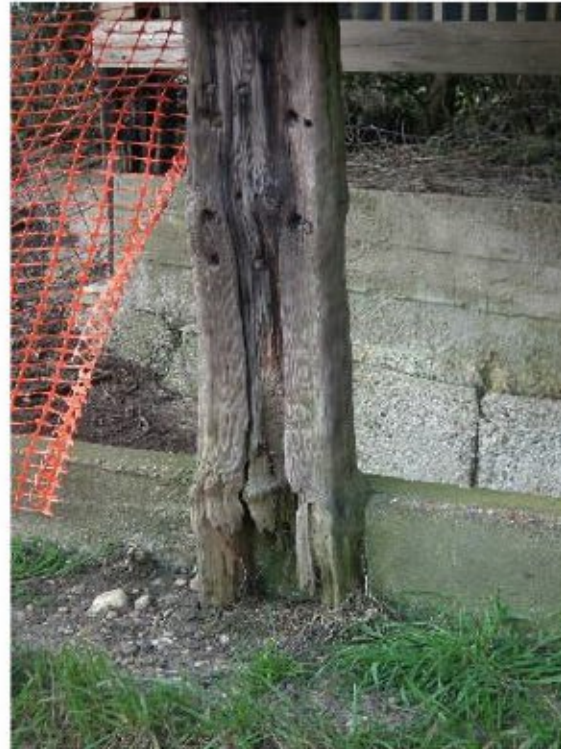
There is some hollowness in some of the original timbers, possibly as a result of some long term rot or deterioration of the timbers, and these have been supplemented by newer timbers on the reverse side and coach bolted through.

Where some of the timbers have experienced voids as a result of damp or fire, then some further supplementary work would be desirable to ensure that the bases of the timbers offer adequate long term durability.
