Structural Site Inspection Report - Rev A

The Old Eden,
Edenbridge

Project No.: 21108

Date: 15th March 2021

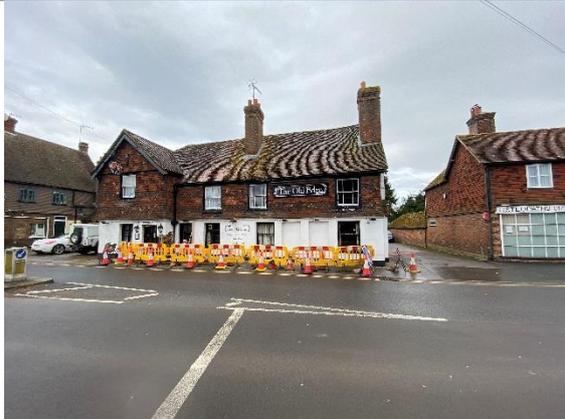
Photo 1: Front elevation

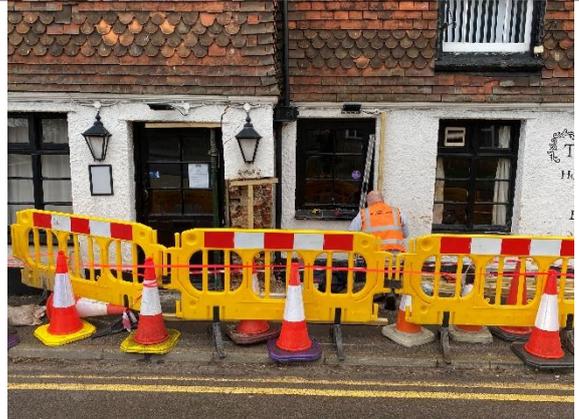
2. The vehicle appears to have collided with the pier on the right side of the front entrance door moving left to right as it travelled off the roundabout. The collision has rotated the brick pier anticlockwise, and the brickwork has been punched through to the right exposing the original timber frame within the pier.

Photo 2: The pier to the right of the front door has been hit by a car and has partially collapsed

Action: Carefully dismantle the right pier to the door over its full height, depth and thickness down to a sound undamaged base course of bricks.

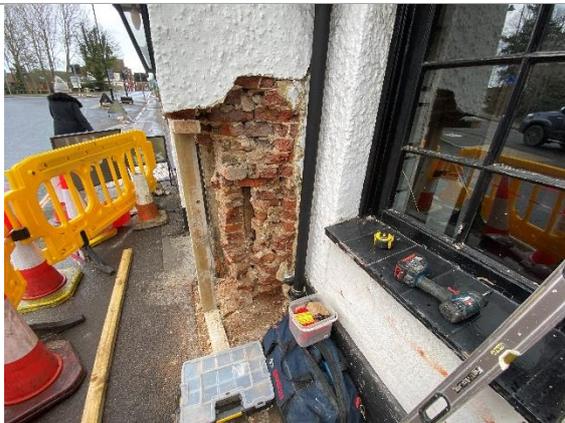
1. Due to rotation of the pier and the indication internally that the base of the brick pier has been punched through into the bar area, we believe that the entire right brick pier has been structurally compromised. The mortar joints will have sheared through and the brickwork will no longer be bonded together. We recommend the right-side brick pier be fully dismantled down to a sound base brick course, or down to foundation level and re-built-in reclaimed bricks.
2. The timber post inside the brick pier is brittle to touch and will also likely have been sheared through by the impact. The exposed timber post should be carefully exposed and inspected for any cracking.

Photo 3: The brick pier has been rotated anti clockwise and has been punched through to the right.

Action: The pier will need to be fully dismantled down to foundation level or to an undisturbed course of bricks.

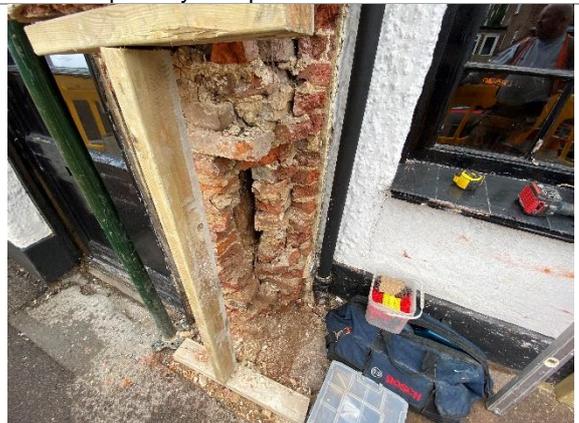
3. The exposed timber post is brittle to touch.
4. The door frame has also been shunted to the right and is now out of alignment.
5. The windowsill to the right of the front door has also cracked as a result of the shock of the collision.

Photo 4: As photo 3 – The original timber frame post inside the brick pier has been exposed. The timber is soft to touch and will also likely have been sheared through by the impact.

Action: Allow for the removal of any cracked or rotten sections of the exposed timber post with a new section of oak to be stitched in to replace any removed sections.

Action: Carefully expose the timber post so that the base of the post may be inspected for any shear cracks.

Action: Allow for the removal of any cracked or rotten sections of the exposed timber post with a new section of oak to be stitched in to replace any removed sections..

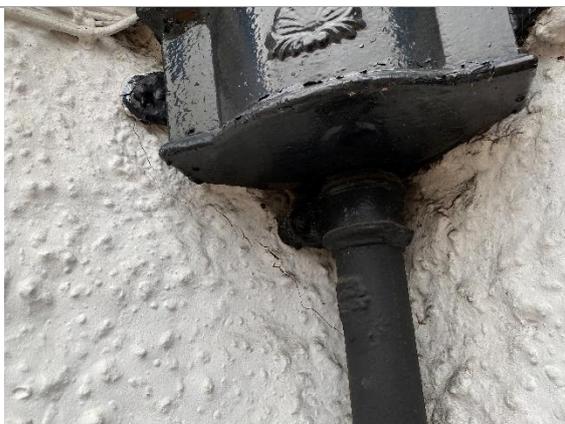
Photo 5: Minor cracks in the render around the rainwater hopper

Action: Rake out the cracks and re-point

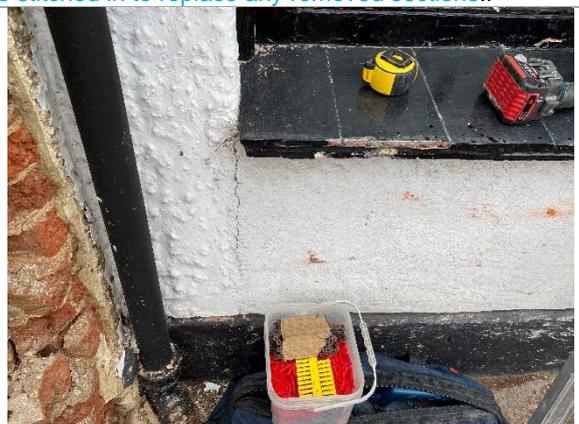
Photo 6: Cracks below the window to the right of the front door

Action: Rake out the crack and re-point

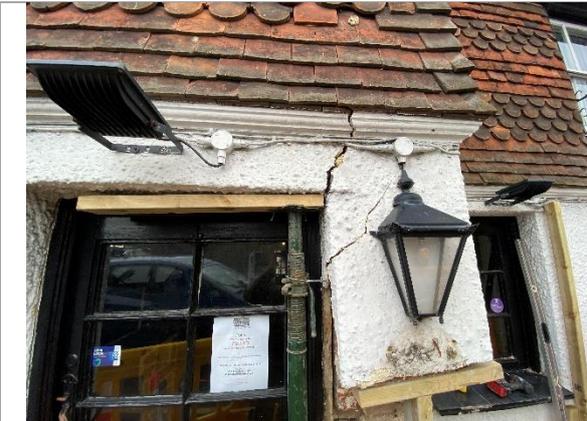
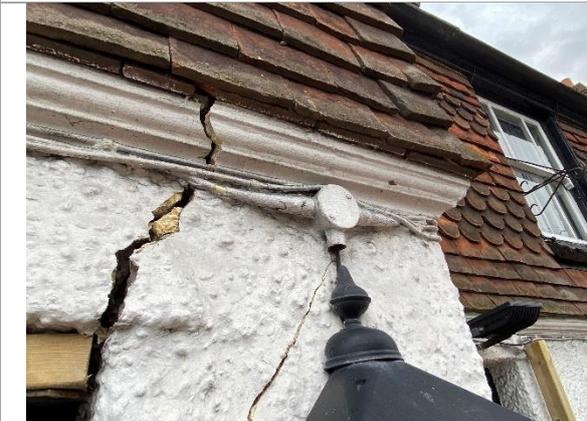
Photo 7: The section of brickwork at the top of the pier has been pulled away from the wall and appears to have been held in place by the electrical cabling. This has now been supported on timber acrow props.

Photo 9: As photo 7

Action: The loosened brickwork will need to be removed back to undisturbed brickwork

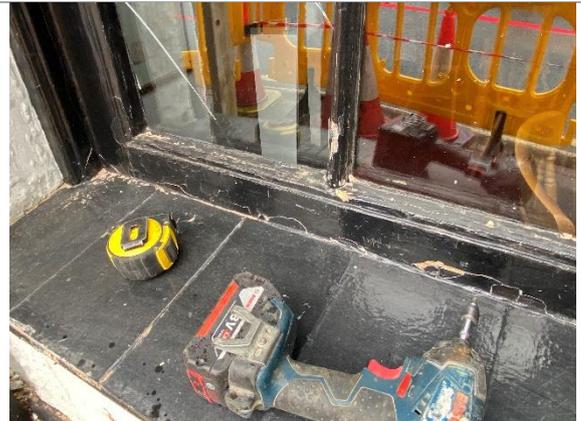
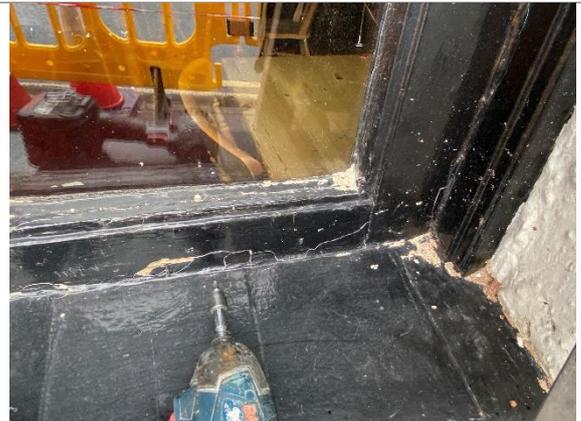
Photo 8: The window to the right of the door is cracked and the joint between the sill and frame has cracked

Photo 10: As photo 8

Action: Remove the old cracked paint and filler and re-seal

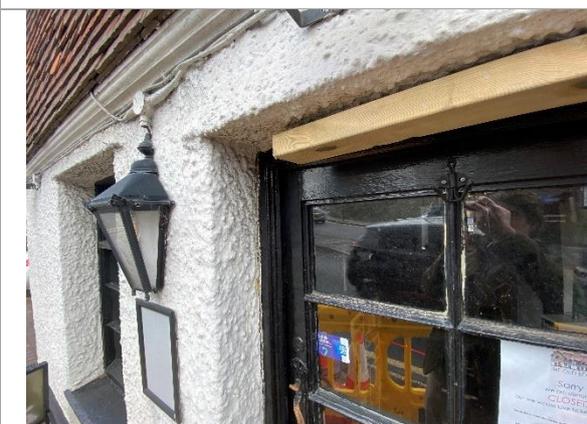
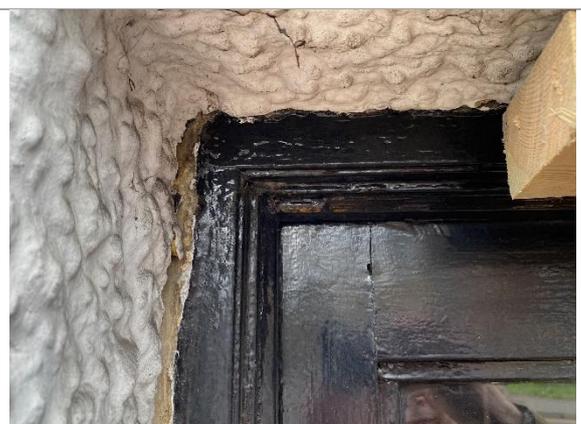
Photo 11: The front door frame has been shunted to the right by approximately 15mm

Photo 12: As photo 11

Action: Once the brick pier has been dismantled, try to re-align the door frame or replace it with a new door frame

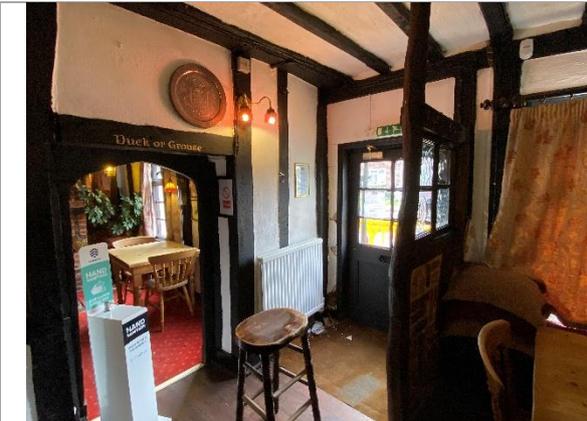
Photo 13: Internally the damage appears to be limited to some minor plaster cracks around the door frame

Action: Remove the cracked and loose plaster and repair with patch plasterwork

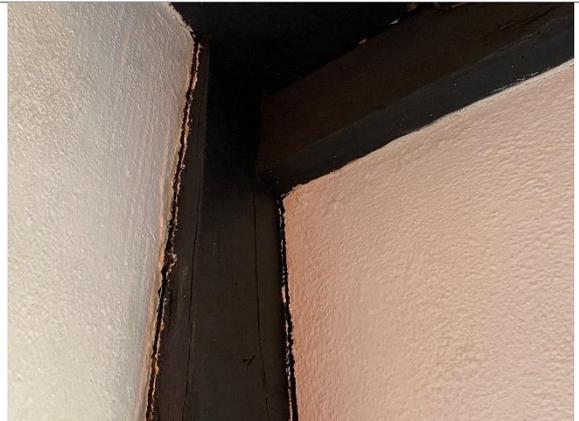
Photo 14: Minor cracks formed along the interface of the timber frame to the side of the door and the plaster finishes

Action: Rake out the joints and re seal

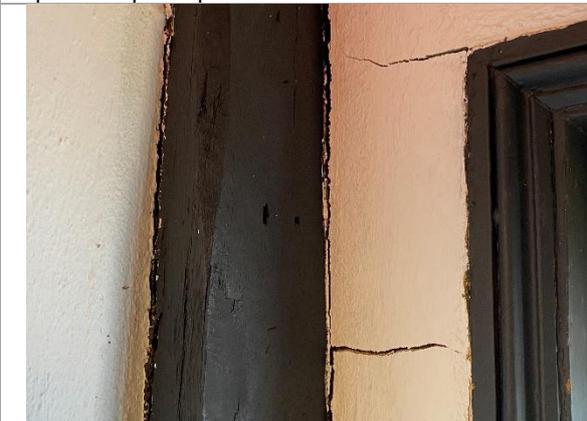
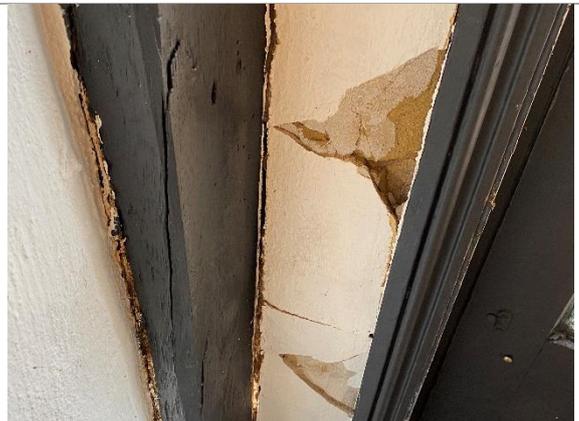
Photo 15: Cracking in the plaster to the side of the front door

Photo 16: As photo 15

Action: Remove the cracked and loose plaster and repair with patch plasterwork

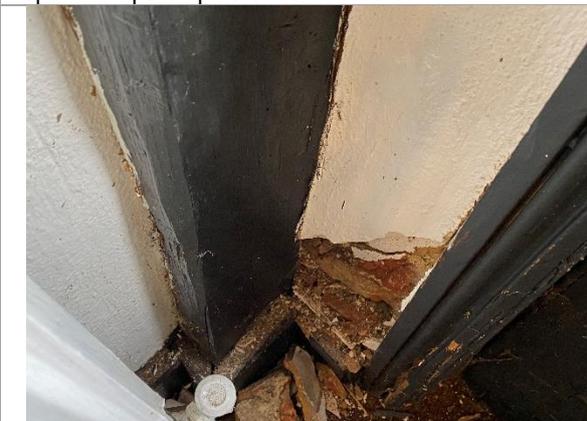
6. Internally the brick pier has been punched through into the bar area and there are several cracks in the plaster finishes.
7. At first floor there appears to only be minor plaster damage in the right-side bedroom above the front entrance.

Photo 17: The brickwork at the base of the door appears to have been punched through into the pub. This suggests that the strength of the pier has been compromised as the mortar joints will have been sheared through.

Action: The full pier to the right of the door will need to be dismantled and re-built.

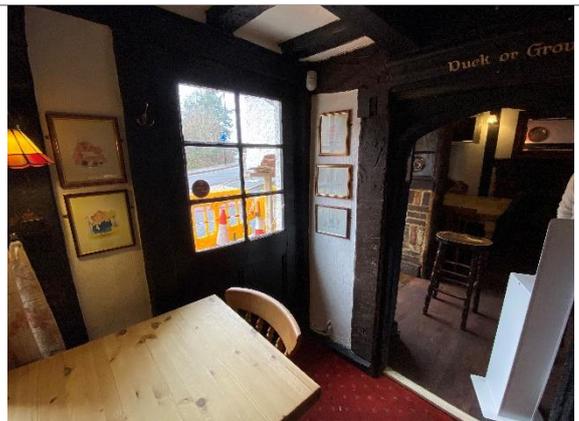
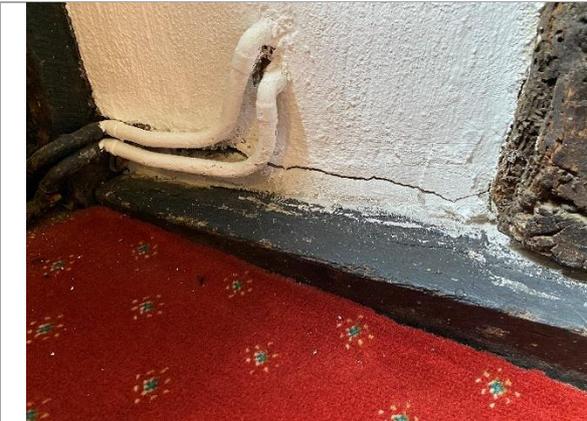
Photo 18: A minor crack on the wall behind the window to the right of the front door

Photo 19: As photo 18

Action: rake out the plaster crack and re-seal

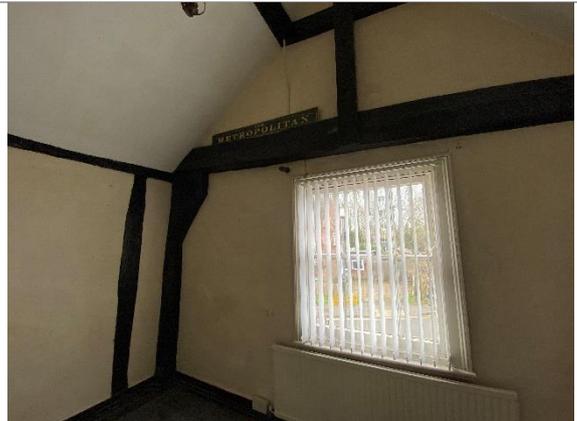
Photo 20: The first floor left bedroom above the front entrance appears to be unaffected

No action required

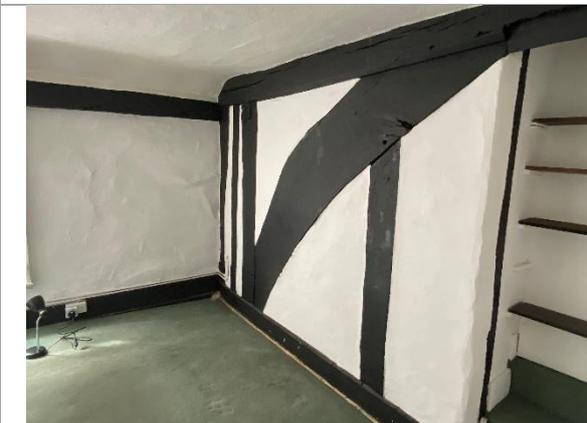
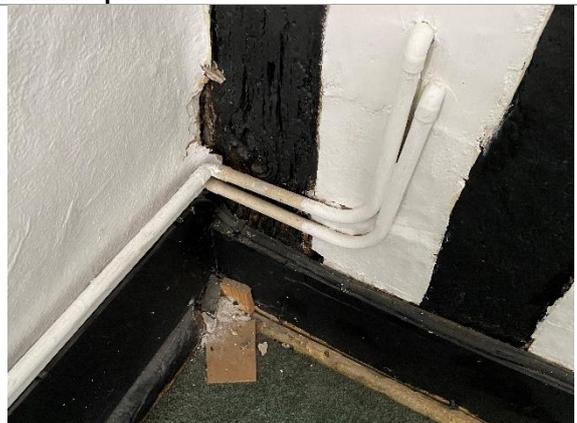
Photo 21: The first floor right bedroom above the front entrance has some minor plaster damage

Photo 22: As photo 21

Action: Patch repair the front corner plaster damage
