GROUND STABILITY APPRAISAL

8 PRINCES ESPLANADE
GURNARD
COWES
ISLE OF WIGHT
PO31 8LE

CLIENT : MCLEAN CONSTRUCTION

REF : 21C036

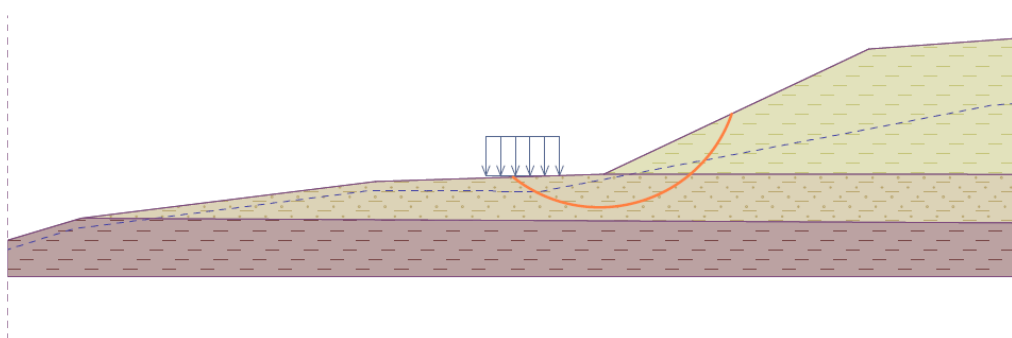
Figure 6 : Existing slope, from above

Figure 6 shows an example slip from above the site. The Utilisation Factor with applied partial factors was 133% and an unfactored analysis showed $F = 0.98$ (noting that $F > 1.0$ is required for balanced forces and hence theoretical 'stability').

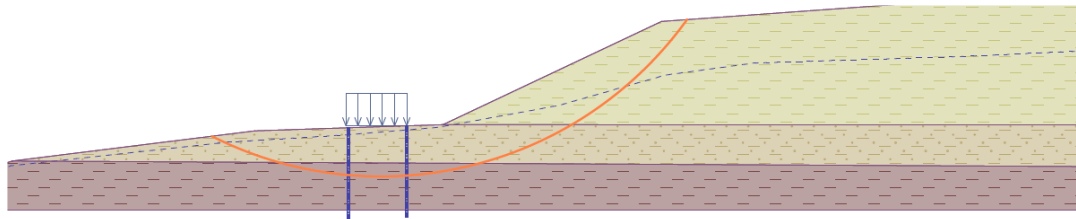
Figure 7 : Proposed site with piles, slip from above

Rerunning the model for the proposed new building and assuming piled foundation or piled wall showed that a suitable factor of safety could be obtained (Figure 7). The model showed that the piles would need to be to a minimum of about 15m depth and that ideally there would be 2 rows of piles one at the rear of the site and one at the front of the site. For this preliminary modelling the piles were assumed to resist any slips that they interrupt. Detailed design would require that the piles had a size, strength and lateral spacing determined.

Piled foundations are recommended. Subject to further assessment at detailed design stage, piles may need to be designed to support an element of lateral as well as vertical loadings.

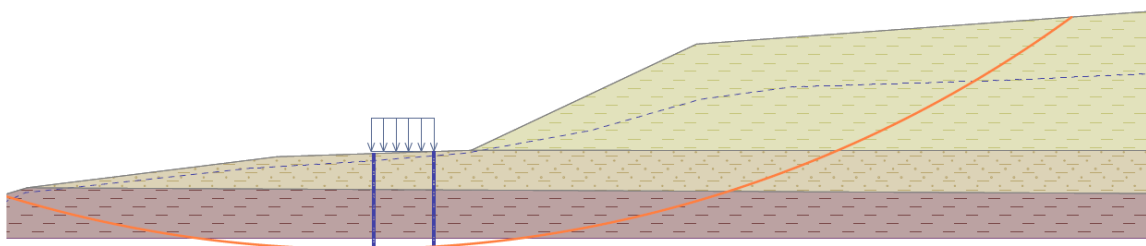
Figure 8 : Deep seated slips

Deeper slips seated on ancient bedding planes that may run below the piles showed a calculated reserve against failure that was much lower (Figure 8). Such slips move on residual strength ancient bedding planes and at a very slow rate. Such slip planes usually have a low calculated reserve against failure and for past schemes have been deemed acceptable as damage to a building is not likely during its lifetime.

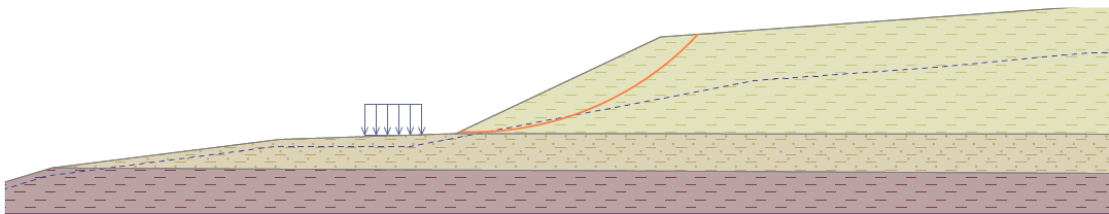
Figure 9 : Slips in slope to east

Even with a piled foundation to protect the proposed building, a small risk will be present for slips from above impacting the site. Assuming conservative soil strength parameters for the site, the existing slope at the east is shown as only just stable (Figure 9). The slope shall require further consideration as a part of detailed design.

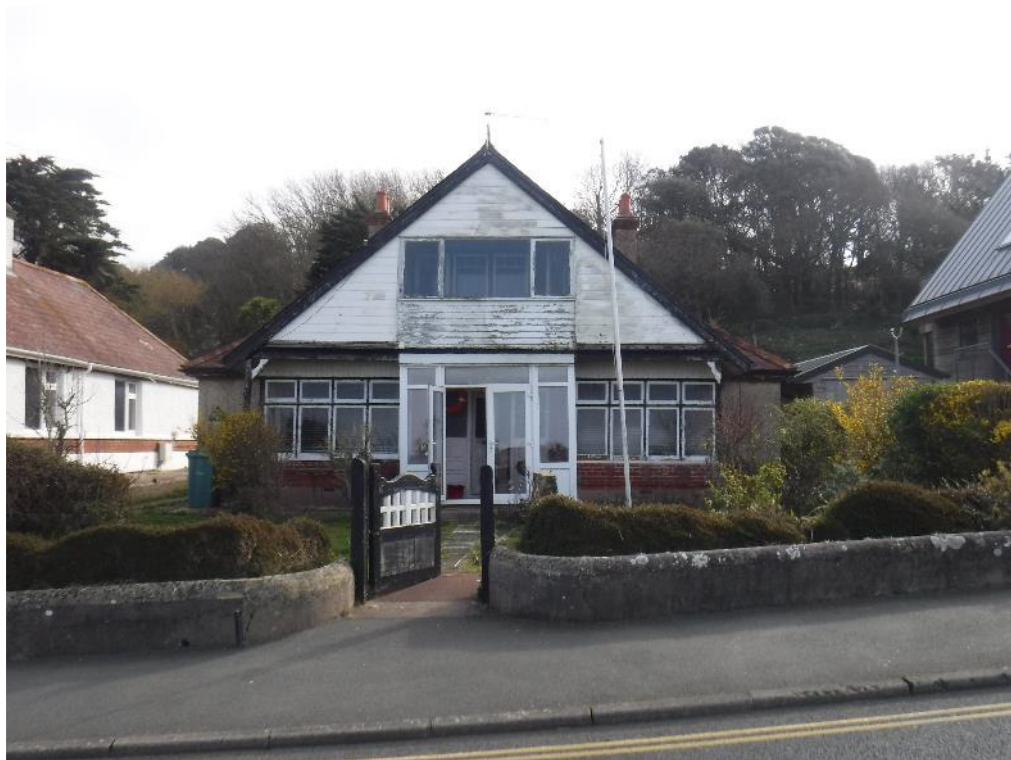
Views from Princes Esplanade

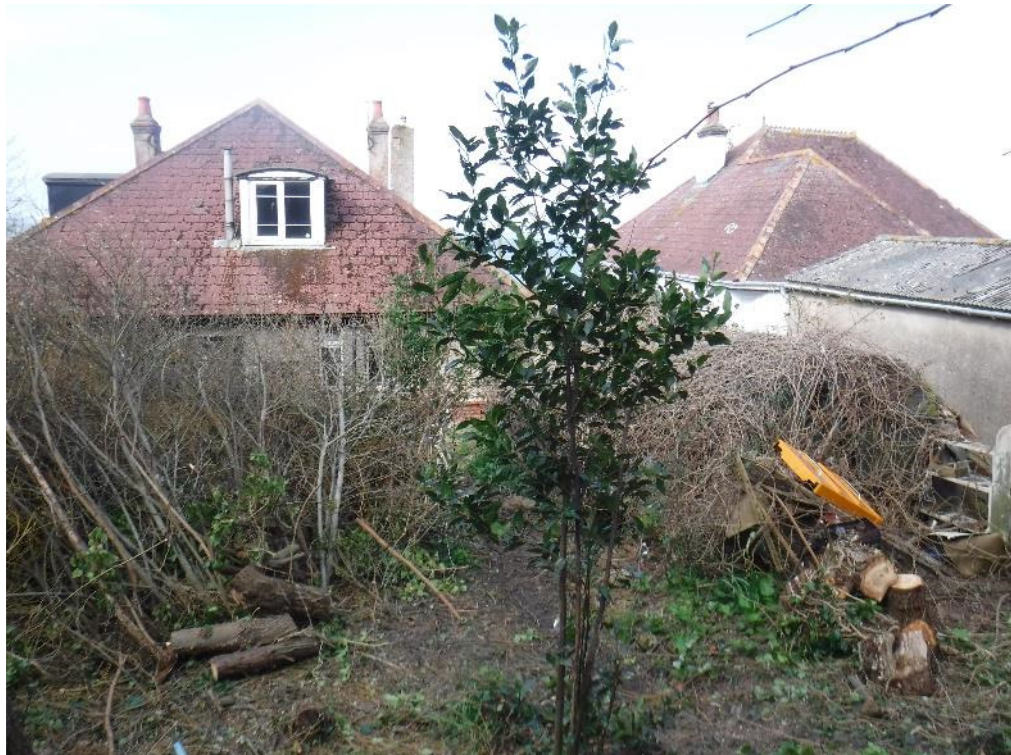
Rear garden towards existing bungalow

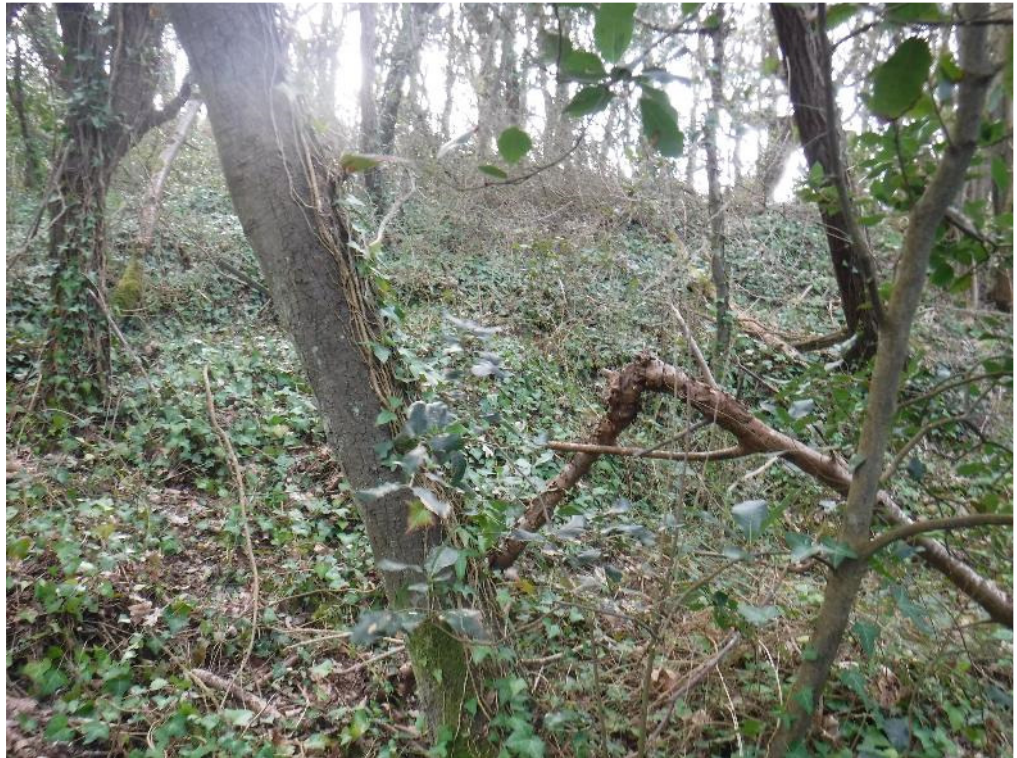
Vegetated slopes to east of site

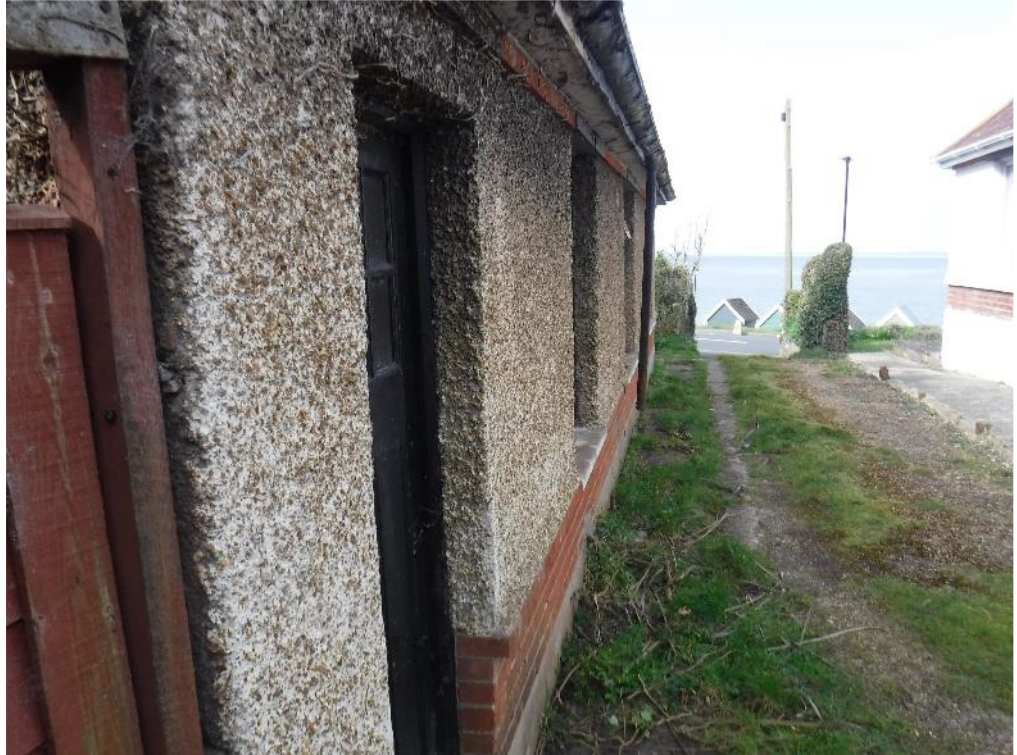
Access at north boundary

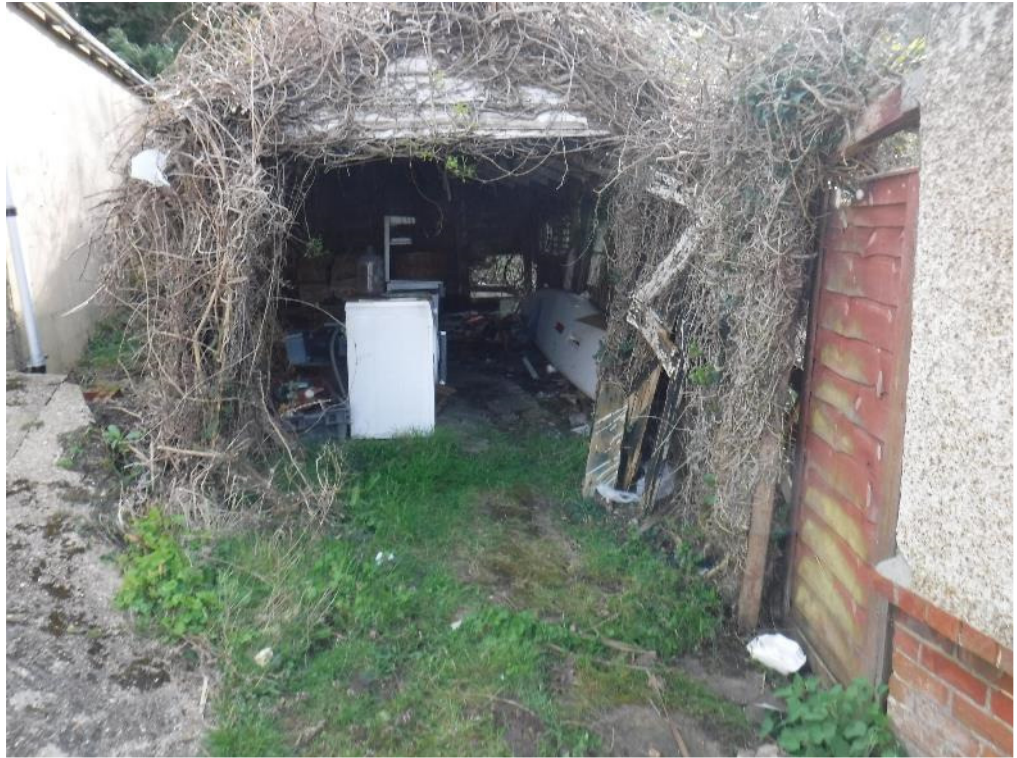
Dilapidated garage at northeast
