Arboricultural Appraisal Report

Subsidence Damage Investigation at:

Tasma, 16 Second Avenue
Frinton-on-Sea
CO13 9ER

CLIENT:	Crawford & Company
CLIENT REF:	SU2004458
MWA REF:	SUB201223-8114
MWA CONSULTANT:	Mark Johnson (FdSc; MArborA)
REPORT DATE:	27/01/2021

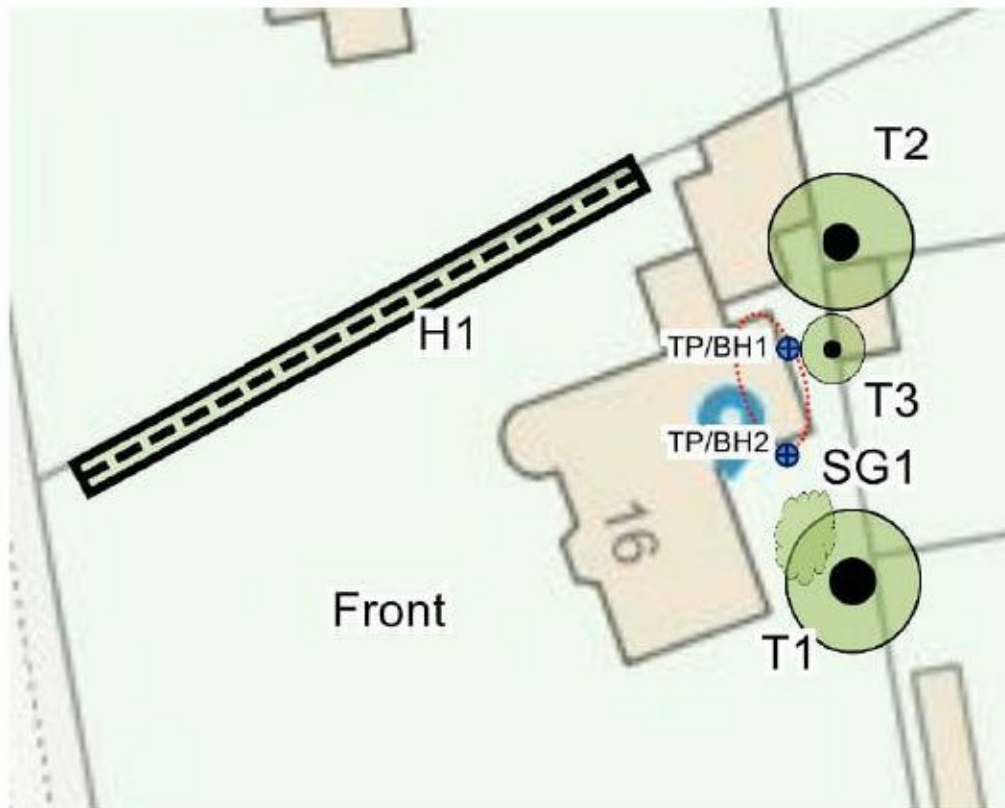
Site Plan

Approximate areas of damage

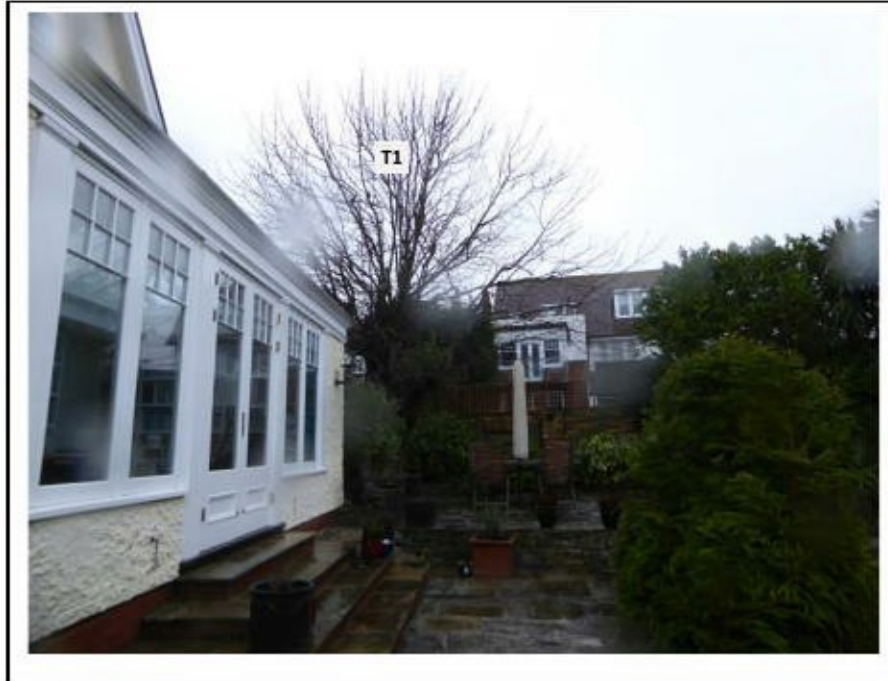
Roots were observed to a depth of 1600mm bgl in TP/BH1 and 1400mm bgl in TP/BH2 and recovered samples have been positively identified (using anatomical analysis) as Cupressaceae spp., and Aesculus spp., the origin of which will be T2 (cypress) and T1 (horse chestnut) confirming they are within influencing distance of the building with a current potential to influence soil volumes below foundation level.

View of T1

If an arboricultural solution is to be implemented to mitigate the influence of the implicated trees/vegetation we recommend that T1, T2 and T3 are removed. Other vegetation recorded presents a potential future risk to building stability and management is therefore recommended.

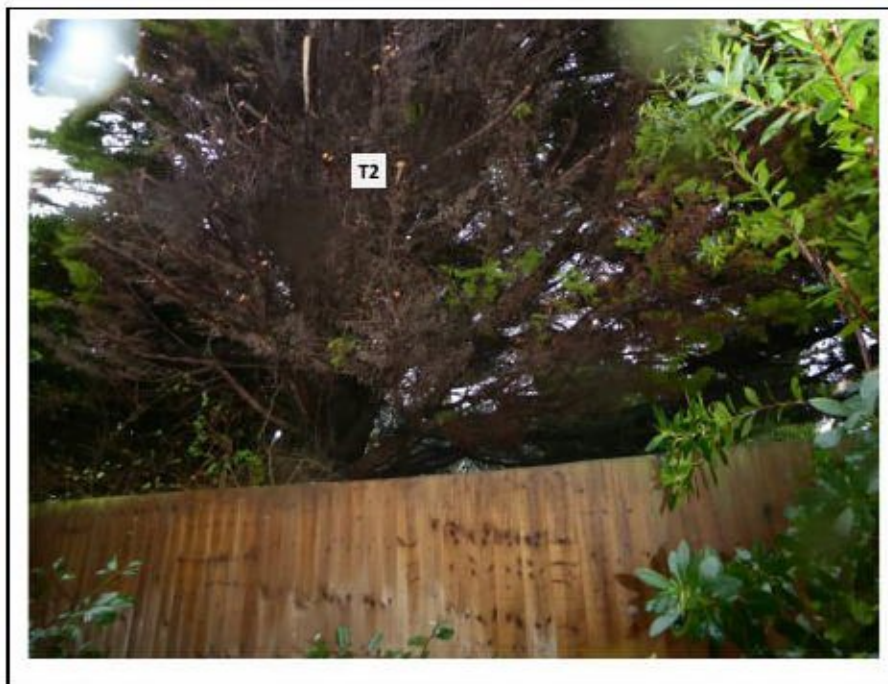
View of T2

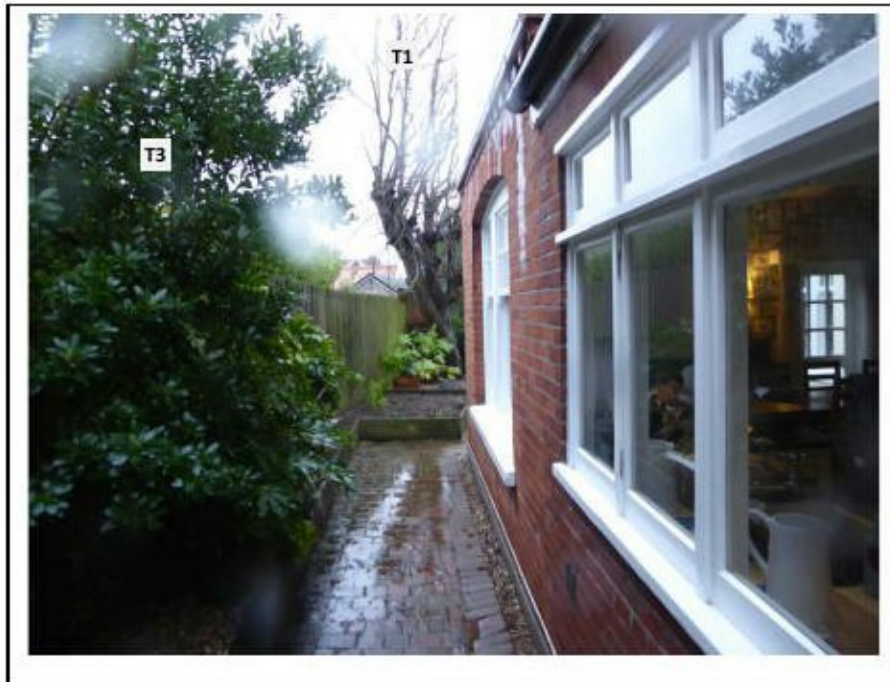
Irrespective of the identification of recovered root samples, the roots of T3 (bay) are also likely to be present below foundation level in proximity to the area of movement/damage and influencing soil moisture and volumes.

View of T3 and T1

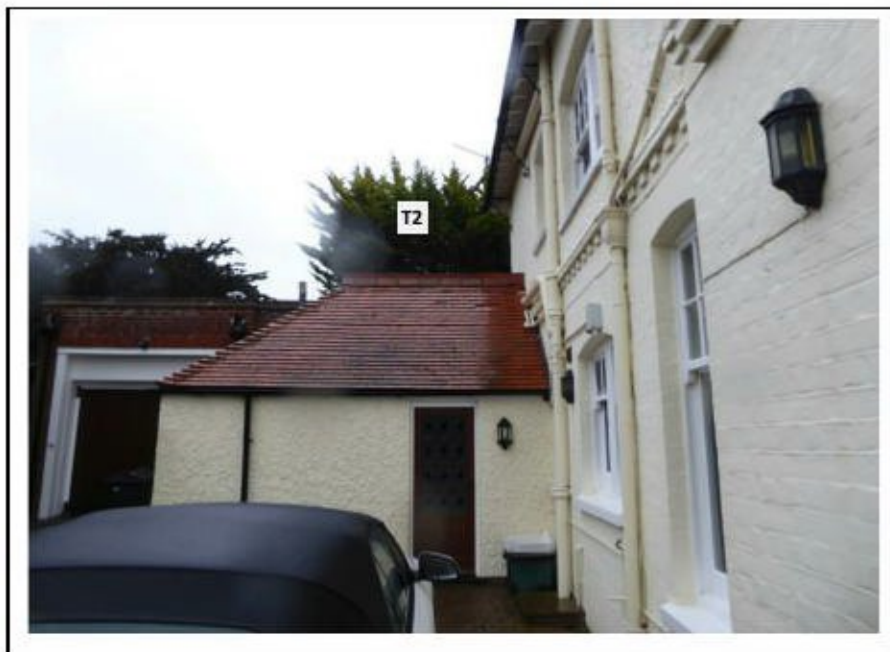
View of T2
