**TECHNICAL REPORT ON A SUBSIDENCE CLAIM**

**Crawford Reference: SU2004458**

**Mr & Mrs G Dodds  
Tasma  
16 Second Avenue  
Frinton-on-Sea  
CO13 9ER**

**SUBSIDENCE CLAIM**

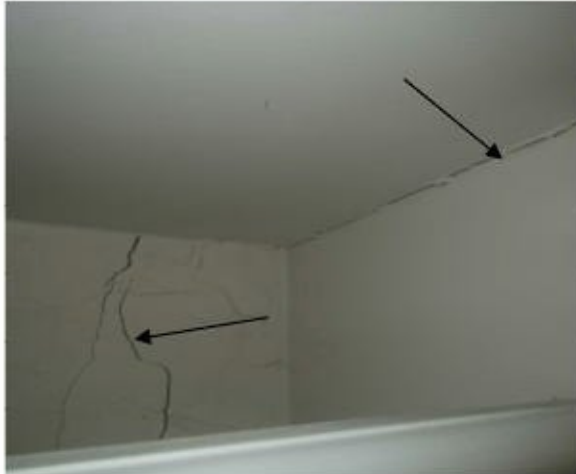
Crack damage in the kitchen above the wall units.

To the left of the same chimney breast is a 2mm wide horizontal crack between the chimney and ceiling. This then extends into a 3mm wide vertical and diagonal crack which continues down behind the wall units. Below the units the crack can be seen in the wall tile grouting.

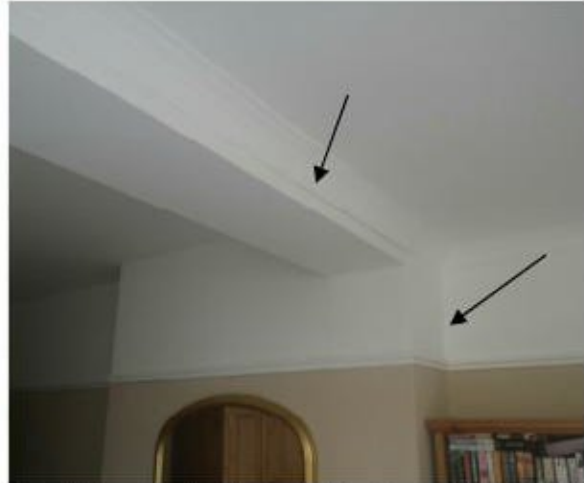
Crack damage in the rear first floor bedroom.

Extending along the down stand to the beam/lintel between the extension and the original house is a 3mm wide horizontal crack which extends down the walls to the left and right.

One of these cracks extends down along the side window reveal where damage has occurred to the window frame. This crack then extends down to floor level.

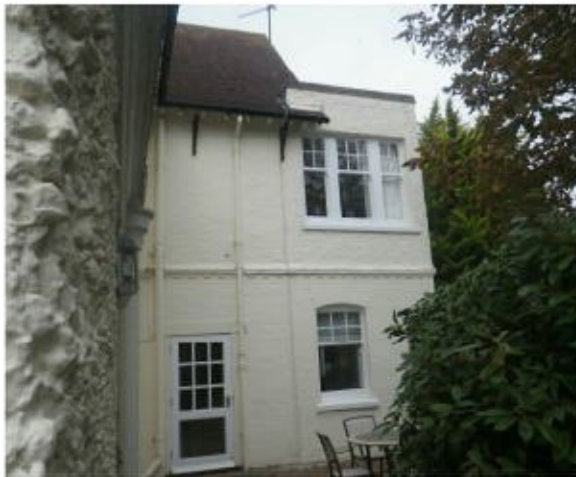
Rear 2 storey extension.

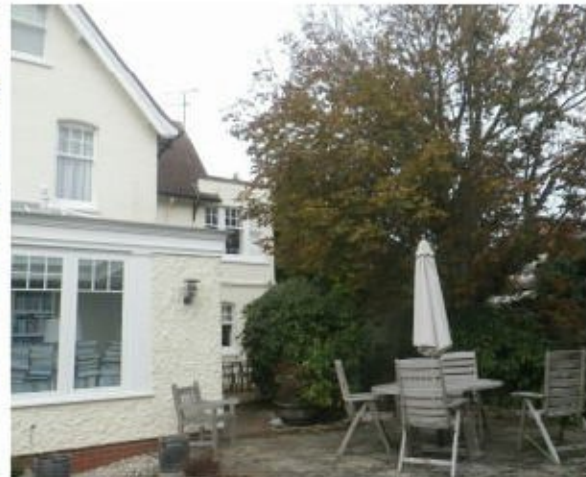
Location of Insured's tree.

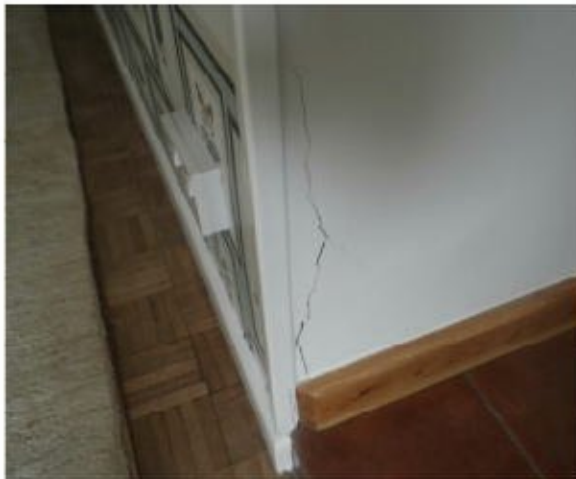
3mm wide vertical crack at low level on the opening to the kitchen. Above this there is cracking to the coving at ceiling level.

Crack damage in breakfast room with the kitchen.

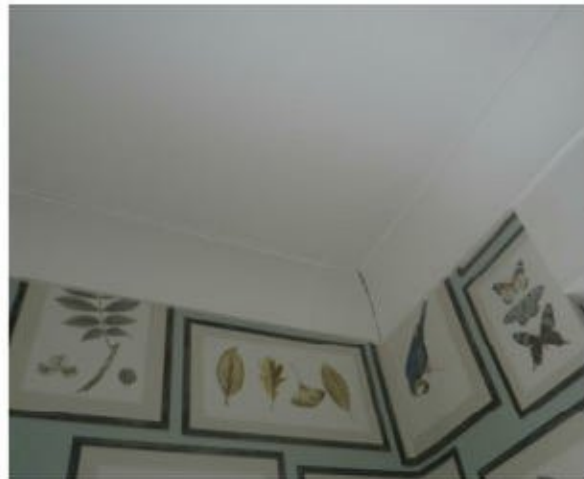
Crack damage at high level between the breakfast room and kitchen and also between the original house and 1930's extension.

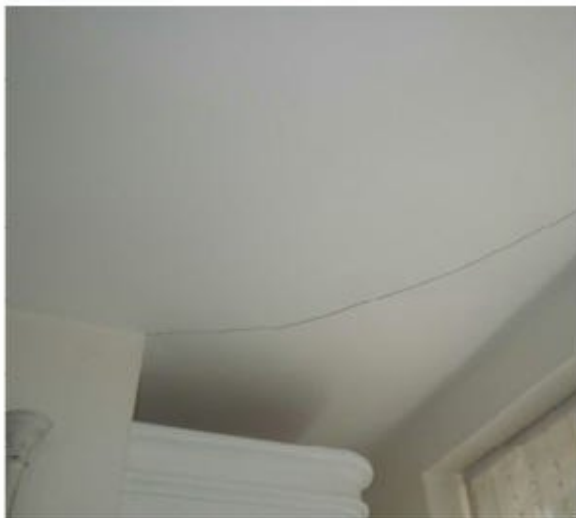
There is a 2mm wide crack to the ceiling between a former chimney breast and the rear external wall.

Crack damage to the kitchen ceiling close to the rear wall.

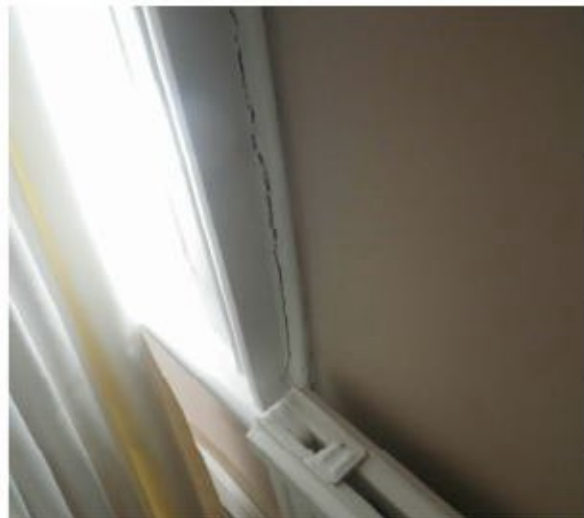
Crack damage to the bedroom between the original house and the 1930's rear extension.

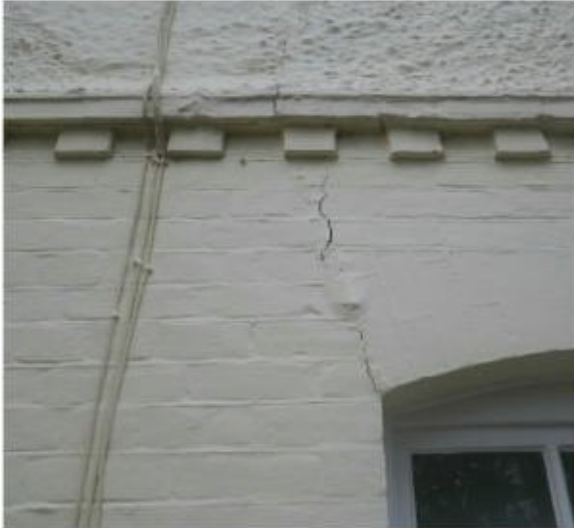
Over the window to the side there is cracking to the coving and which extends around to the rear elevation.

Crack damage above the breakfast room window.

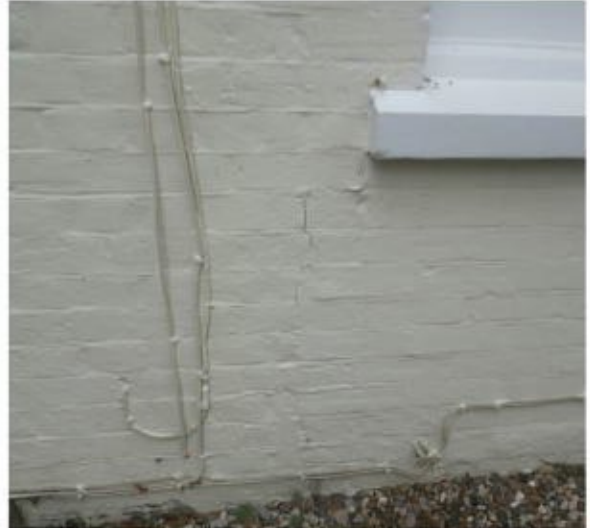
Crack damage below the breakfast room window.

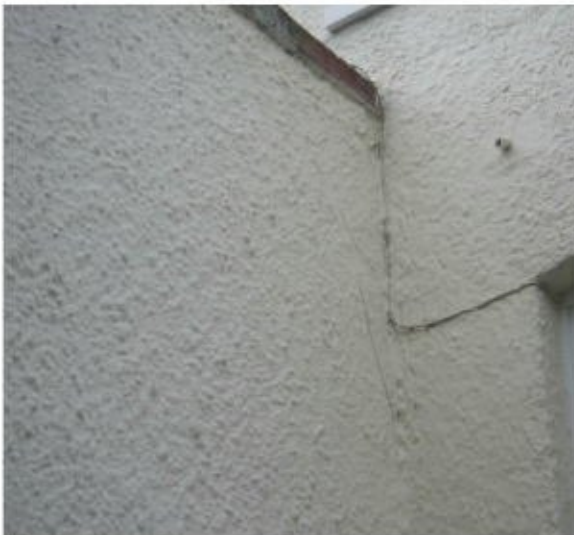
There is a maximum 4mm wide tapering crack at the junction between the original addition and the extension, commencing at ground level and continuing up to the roof.

High level crack damage between the rear extension and original house.

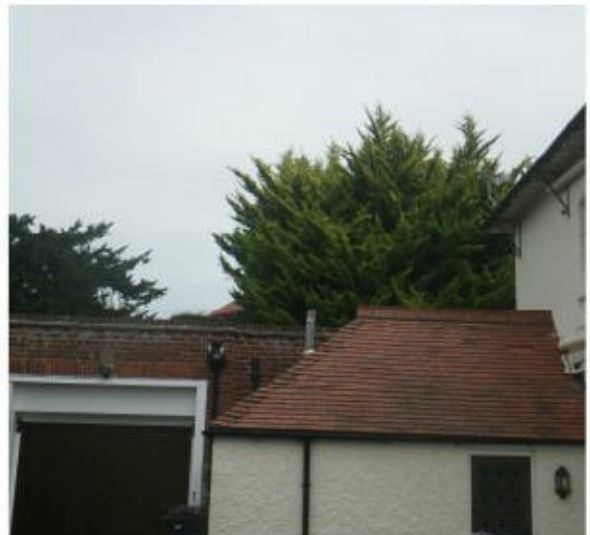
This would suggest that root induced clay shrinkage is the cause with the moisture being extracted by the adjacent trees which include a neighbour's conifer at the rear.

Rear neighbours conifer tree close to the rear boundary and area of damage.

Following completion of the site investigations, we may obtain an arboriculture report on the trees and whether any tree management work is required. If this implicates the tree in the neighbour's garden, then our Mitigation Unit will liaise with your neighbour in this respect to ensure the appropriate tree management work is carried out in order to prevent further damage to your property.

We have completed a soil risk analysis (VISCAT Assessment) and we are satisfied that your neighbour's and your trees can be removed.
