OVINGHAM FIRST SCHOOL

Structural Engineering Report

Ovingham First School, General Condition & Serviceability

Structural Inspection

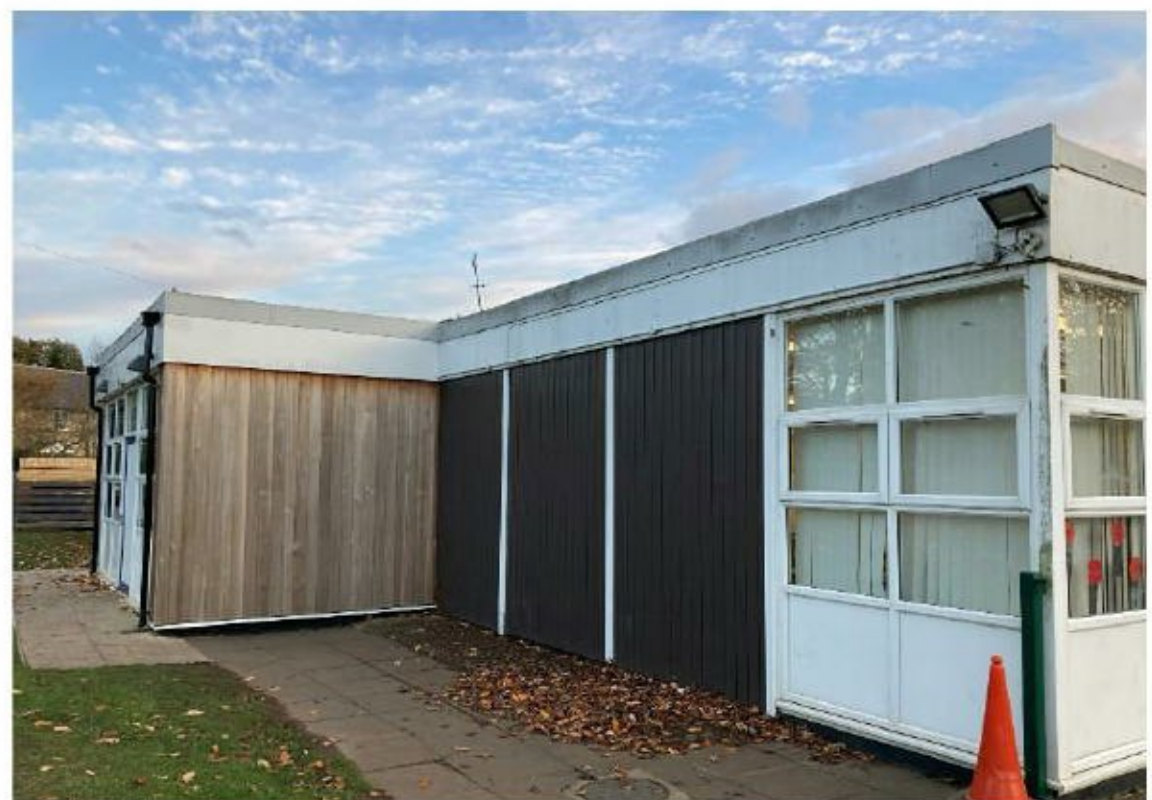
Figure 1 - Ovingham First School, showing the junction between an original and a relatively new element of the building.

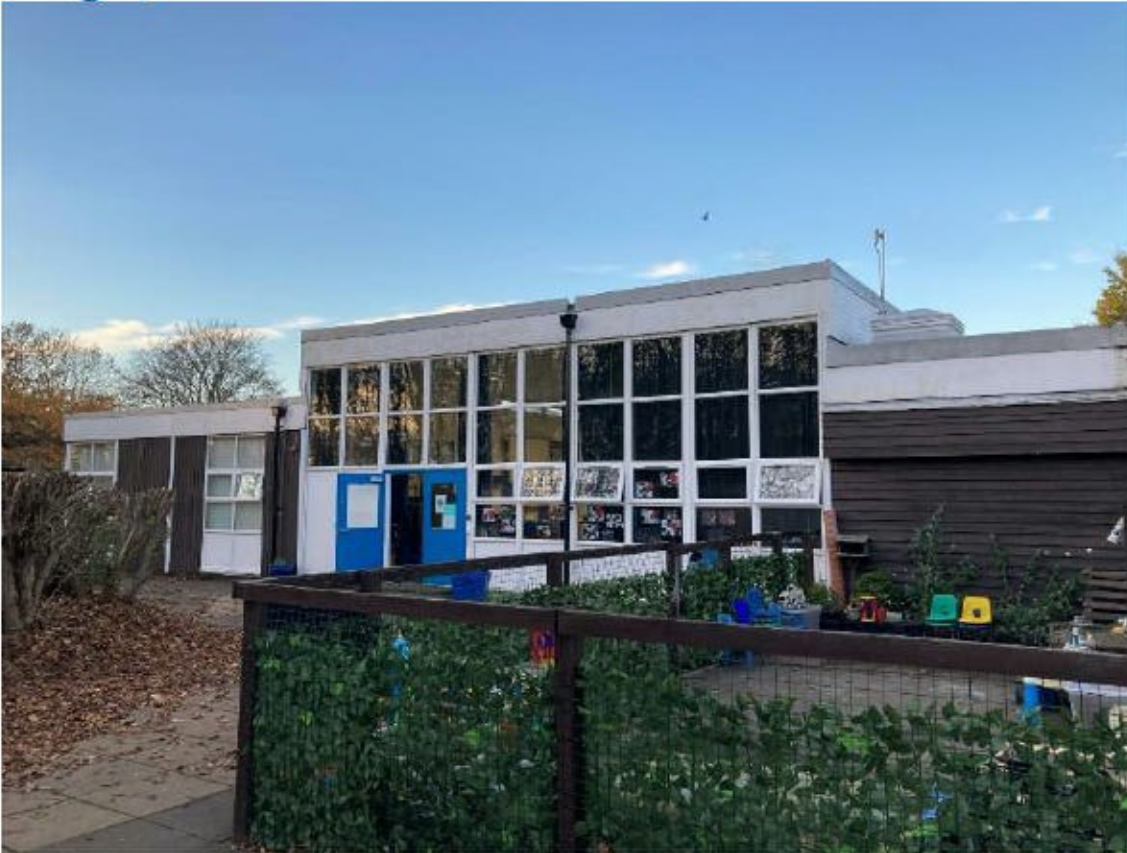
The timber columns on the glazed external elevation of the Main Hall are of a slightly larger cross-sectional size than those mentioned previously, however they restrain a significantly taller section of wall. The results of the analysis are similar to those of the regular timber posts, except that the degree of failure is more significant, and even the Grade C24 analysis shows the members to be susceptible to failure even in purely horizontal bending. The result of this analysis is that the existing timber posts on the glazed elevation of the Main Hall are under-designed and may be at risk of localised structural failures.

Figure 2 – Glazed elevation of the Main Hall, with timber posts significantly undersized to restrain the windows over such a span.

It is a strong recommendation of this report that the primary timber posts on the glazed elevation of the Main Hall are replaced by new members which are capable of resisting appropriate levels of vertical and horizontal load.

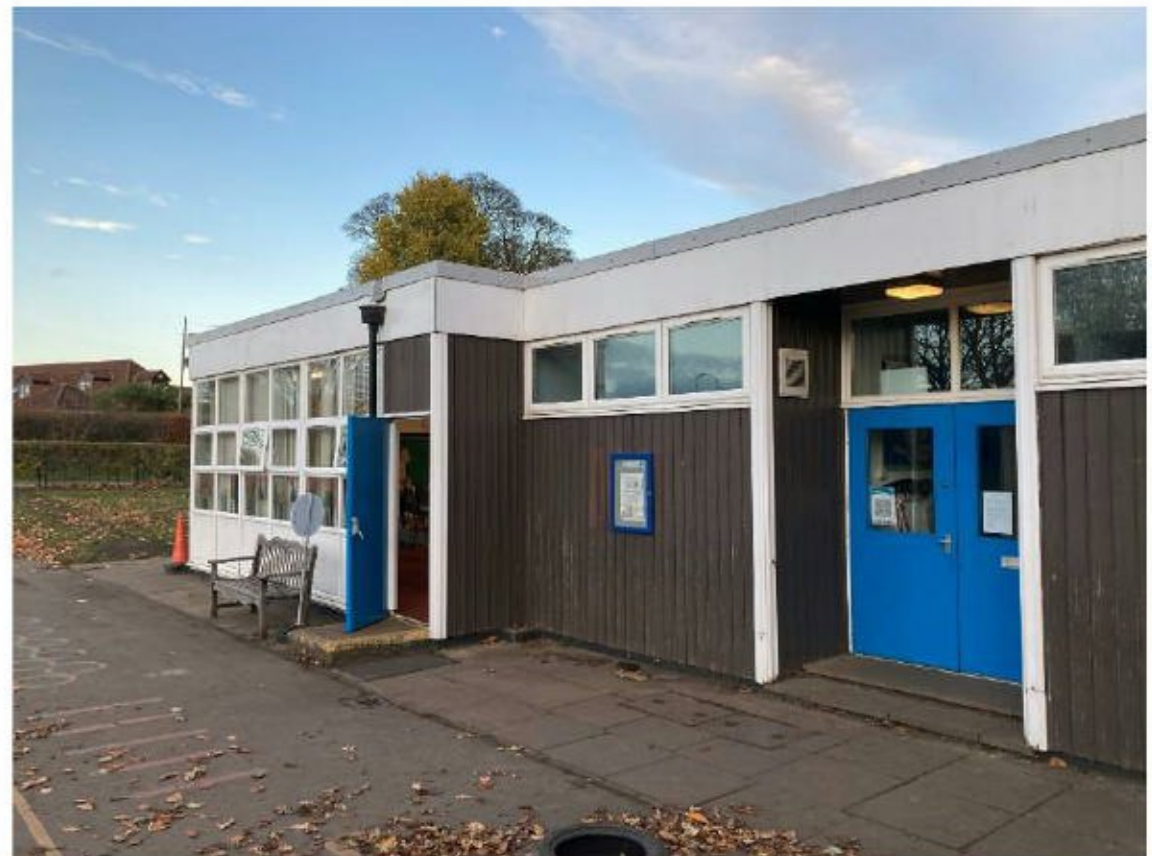
In some areas, wall panels are largely glazed. Upon inspection the regularly-spaced structural timber posts seem undersized for the vertical span and area of glazing restrained. Only slight pressure being applied to these posts resulted in noticeable deflection, and it was stated by Mr. Hogg that many of these windows had begun to exhibit difficulty in opening; this was tested and verified on site. On the external wall of the Main Hall this issue was also immediately evident, with seemingly-undersized posts and excessive deflection. These posts were available for measurement in several locations, meaning simple calculations could be carried out to determine their capacity. Without even applying any pressure, it was evident from the shape and form of the PVC frames, that excessive lateral deflection had occurred in this wall panel.

The regular timber posts, measured in multiple locations around the perimeter of the building, were analysed both as Grade C16 and as Grade C24 (the two most likely grades of timber used in the original construction). Detailed wind loading analysis was carried out in order to determine the possible wind gust loadings applied in the school's specific geographic location and altitude, with such loadings being applied to all external members analysed during this report. These particular members were shown to be susceptible to significant deflection, way in excess of normal design limits, and certainly beyond the limits which should be applied to members restraining glazing. This was true whether the members were Grade C16 or Grade C24, and the result is as expected, based on the observed size of the members and the noticeable deflection under manual pressure. Another important result of this analysis is that the columns are susceptible to failure through combined loading (axial compression through vertical loading and bending through wind loading) and also in overall member stability. Again, this is true of both Grade C16 and Grade C24, although Grade 16 analysis also shows the members to be susceptible to failure purely through horizontal loading. As mentioned previously, a failure to modern standards of analysis does not necessarily cause concern, however the degree to which these calculations indicate possible failure, particularly in the Grade C16 timber (which is perfectly plausible as being the actual constructed timber grade), indicate that these members are under-designed and may be at risk of localised structural failures.

Figure 3 - Typical elevation, with some largely-glazed elevations containing insufficient timber posts to suitably restrain the wall.

It is also recommended that the vertical posts on other glazed elevations around the building are either replaced or strengthened.

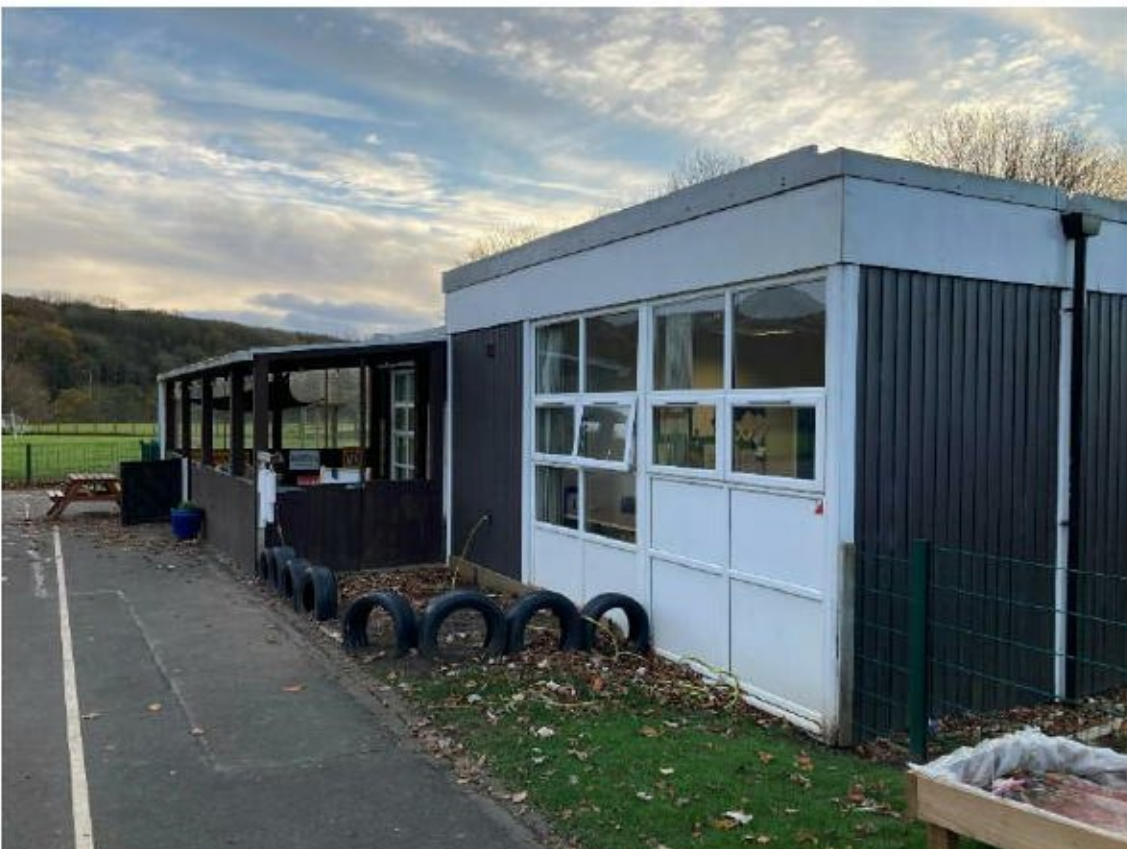
On the eastern elevation of the school, an external timber lean-to has been constructed, with primary timber posts immediately adjacent to the perimeter of the main building. The two frames appear to be structurally independent, meaning no additional load is applied to the above-ground structure of the building as a result of the construction. There are, however, localised signs of compression or settlement at the base of the timber columns framing out the external door of the main building. Mr. Hogg has previously carried out a localised trial hole (since back-filled), and photographs of this prior investigation seem to indicate very shallow foundations beneath the main structural frame, as well as an excavation for the new posts which extends down below the formation level of these original foundations. It is considered feasible that the excavations carried out for the installation of these posts undermined the existing concrete strip foundations and caused localised settlement.

Figure 4 - Timber lean-to, installed relatively recently, adjacent to the main original building frame.

Where the timber lean-to abuts the main building, localised trial holes should be carried out at column locations. These are anticipated to establish that the newer, external timber posts extend down further than the original foundations, and in such instances localised underpinning should be carried out in order to stabilise the foundations.

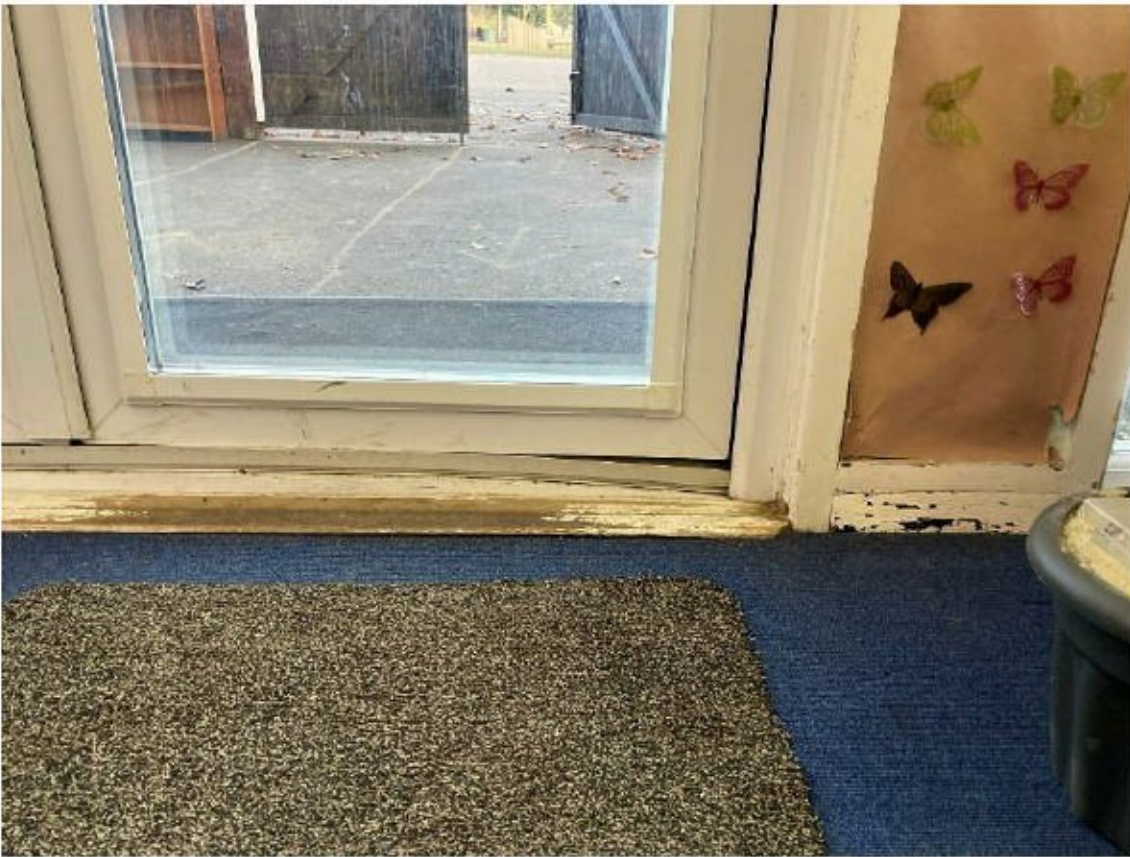
There are no significant indicators of likely structural failure either in the roof structure or the foundations, however it should be noted that very limited visual evidence was available to verify this. The exception to this is the eastern elevation, adjacent to the external lean-to, where there seems to have been localised settlement as a result of undermining from the installation of the external posts. The ceiling cracks mentioned earlier in this report are likely to be from deflection of individual members rather than imminent failure, and although this may raise the possibility of ponding and therefore overloading at roof level, this is only speculation at this point.

Figure 3 - Door frame immediately inside the timber lean-to, showing apparent signs of settlement.

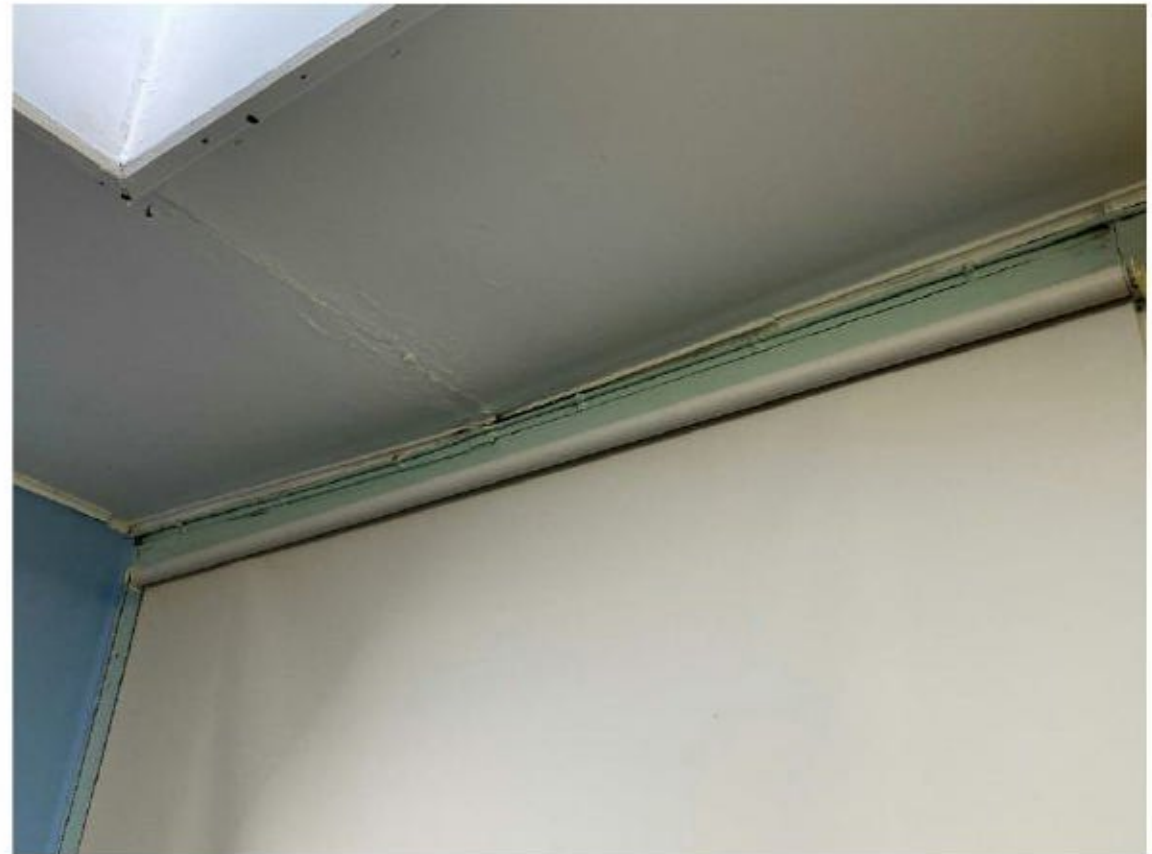
Some cracks were observed to the ceiling of the classroom to the far South-East of the building, including alongside the rooflight (which, in itself, is significantly larger than would be expected in a building of this construction type). Based on the timber frame observed across most of this building, it is considered likely that the members supporting the edge of this rooflight may be over-capacity and therefore deflecting more than standard limiting values, therefore causing the cracking to the ceiling. Due to the solid ceiling, the structural members of the roof were not available for physical inspection.

Figure 6 - Cracks to the ceiling of the South-Eastern classroom, adjacent to the long-spanning rooflight.

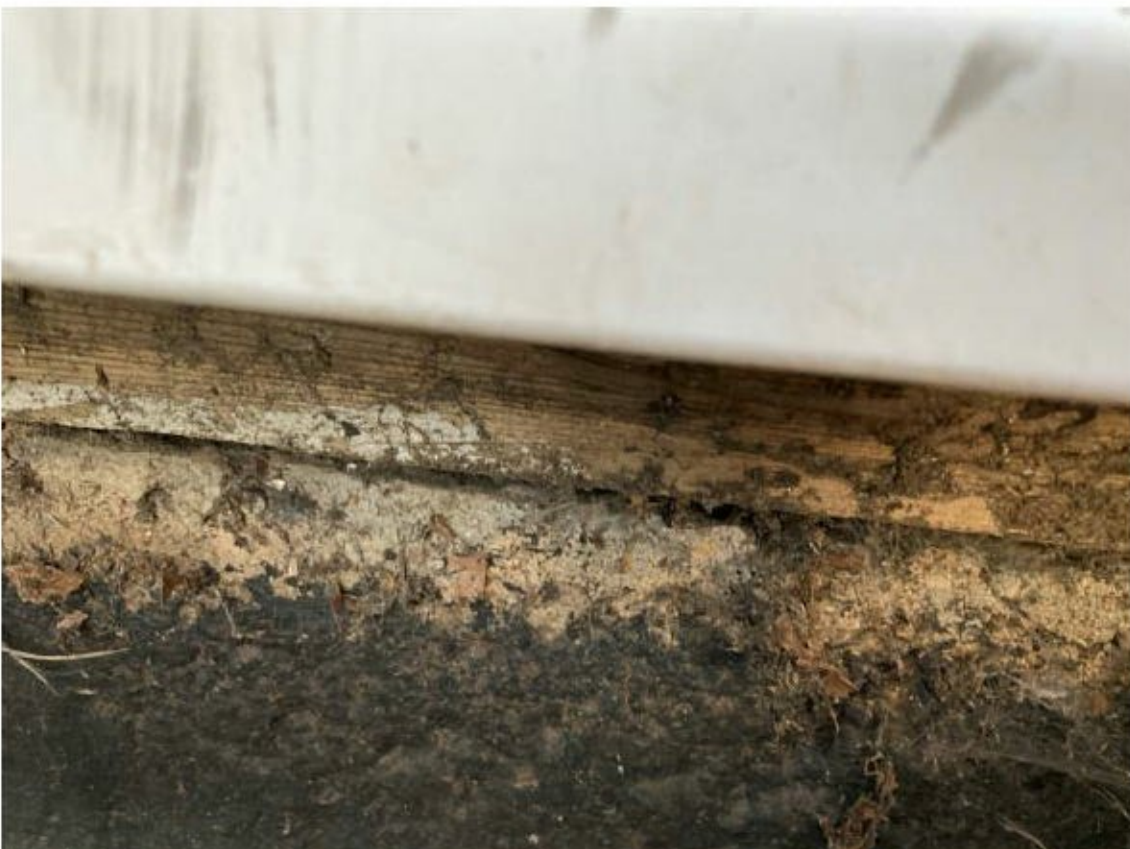
In some locations, PVC panelling was sufficiently loose to allow inspection of timber posts and sole plates. Some signs of damp and localised damage were evident, which would be detrimental to the capacity of the structural elements. These instances were not sufficiently serious to cause immediate structural concern, however they will deteriorate further over time and continue to degrade the integrity of the structural frame.

Figure 7 - Timber sole plate at the base of an external wall, showing some signs of deterioration.

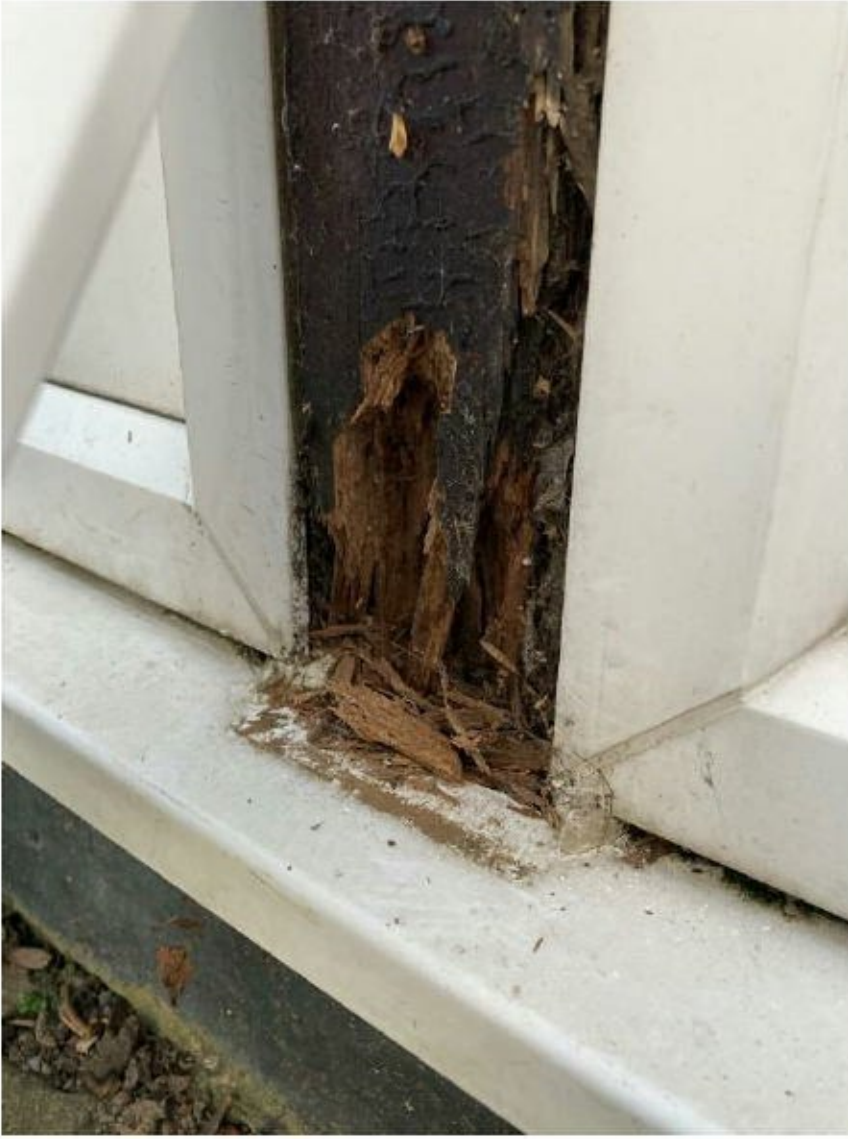
Figure 4 - Localised damage observed to the base of a structural timber column.
