**"HARRISON HOME, LIVERPOOL RD SOUTH, MAGHULL"**

### **BUILDINGS PROTECTED SPECIES SURVEY & BUILDINGS APPRAISAL REPORT**

**"Harrison Home, Liverpool Road South, Maghull, L31 8BS"**

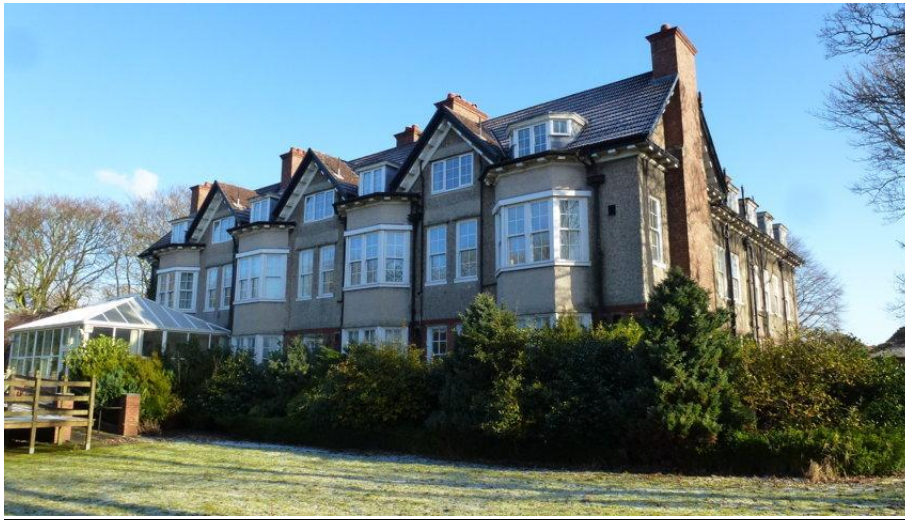
**Photograph B:** General view of west (rear) and south facing frontages to Building A.

*Note: Third floor windows protruding from roofing.*

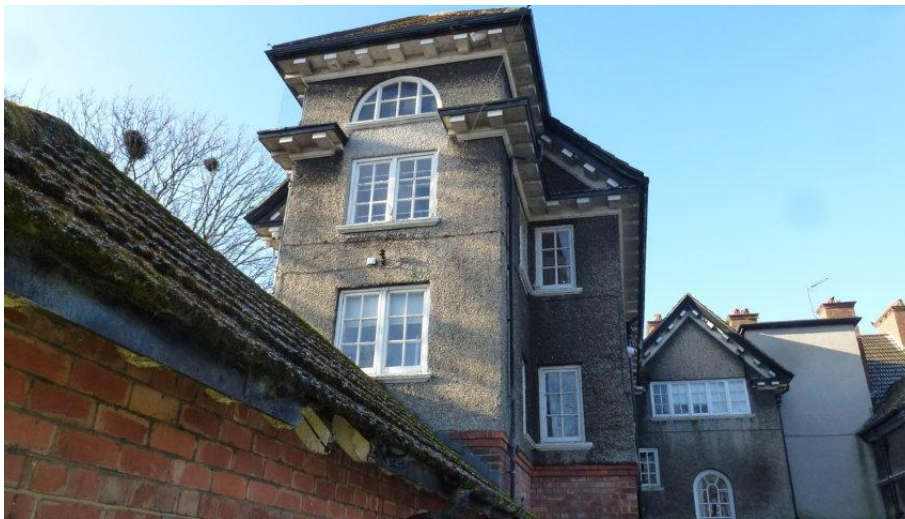
**Photograph C:** View of annexe structure to south east corner of Building A.

*Note: Note the variety of roofing and overhangs.*

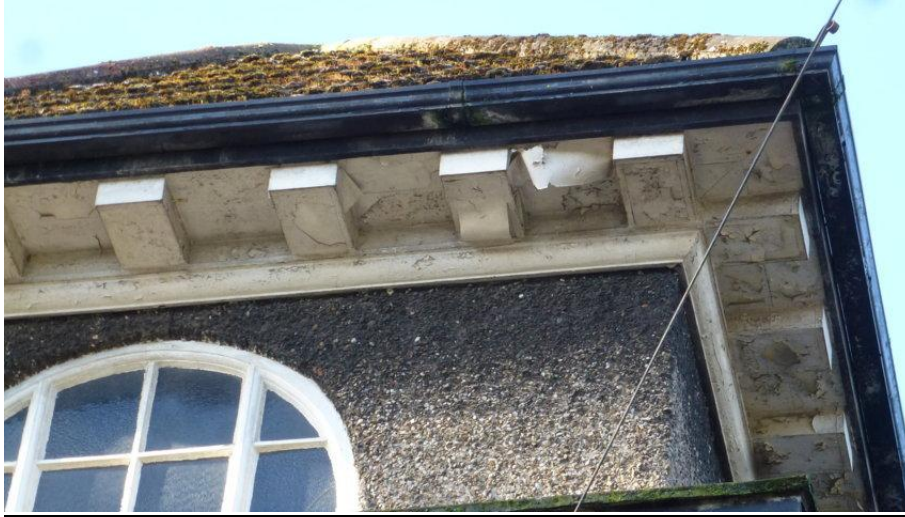
**Photograph D: Close up sample view of roof overhangs to Building A.**

*Note: Heavy timber overhang and absence of fascia. Although the timberwork has extensive peeling paintwork it is in good repair and well sealed at wall interface.*

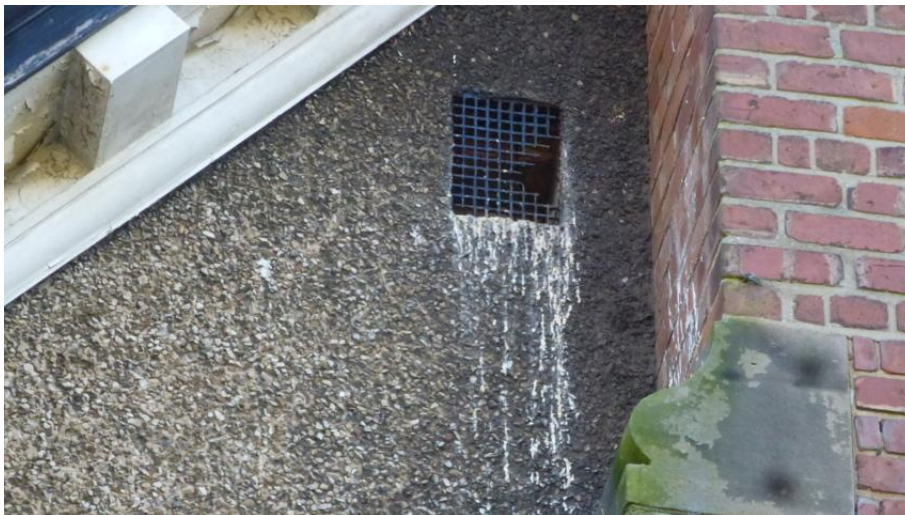
**Photograph E: Damaged vent grill to north facing frontage to Building A.**

Vents and openings within the brickwork are generally in good repair and well sealed, however one damaged vent grill was recorded to the northern gable end (Photograph E) with associated evidence of bird entry.

*Note: The heavy faecal staining. Kestrels have been recorded nesting behind the grill for several years.*

Evidence of former bird breeding activity was recorded for Building B. The surveyor was advised by the site grounds man that a pair of kestrels (*Falco tinnunculus*) has entering the building through a damaged vent (Photograph E) for a number of years. No other evidence of bird breeding activity or roosting was recorded for Building A.

One damaged vent (Photograph E) was recorded where bats could potentially gain access, however the opening has been exploited as a roost/breeding site by birds and is therefore unlikely to be occupied by bats.

Evidence of former bird breeding activity was recorded for the main building (**Building A**) only. A damaged vent to the north facing frontage (**Photograph E**) is currently allowing bird access. Although it could not be confirmed at time of survey, it is believed that pair of kestrel has been breeding in the building for a number of years. No further evidence of bird breeding activity was recorded for the structure.

**The level of risk to breeding birds associated with Building A is currently undetermined to satisfactory confidence levels and follow up survey during the bird breeding season is therefore recommended.** Appropriate bird mitigation measures to then be prepared based on survey findings.

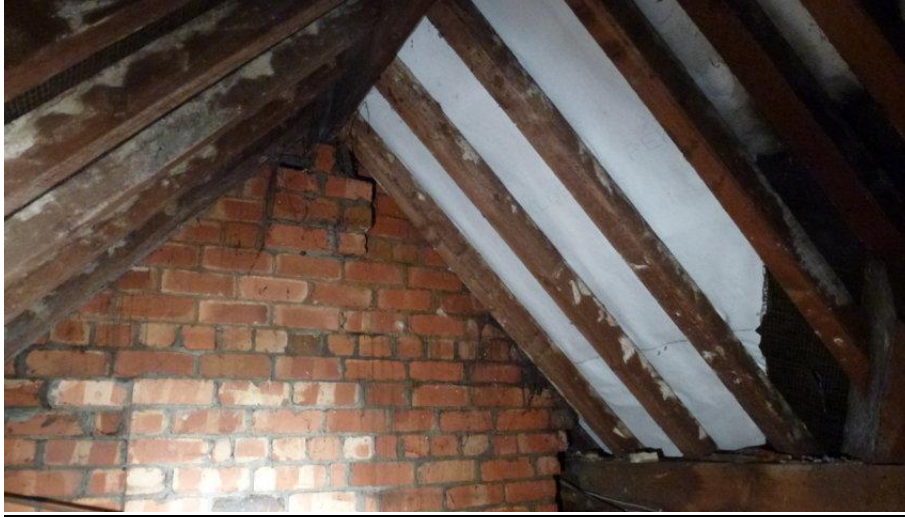
**Photograph F: Sample internal view of one of the multiple small roof chambers associated with Building A.**

**Note:** *Felt backing to roof tiles is in good repair. The chamber is well sealed throughout with no apparent access opportunities for bats or birds.*

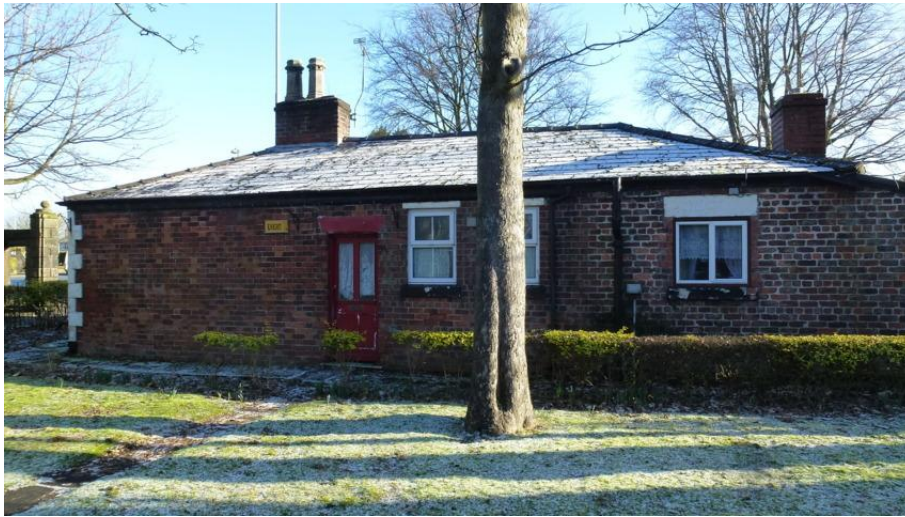
**Photograph G:** General view of west facing frontage to Building B.

*Note: Slate roofing and brickwork in good repair and well sealed.*

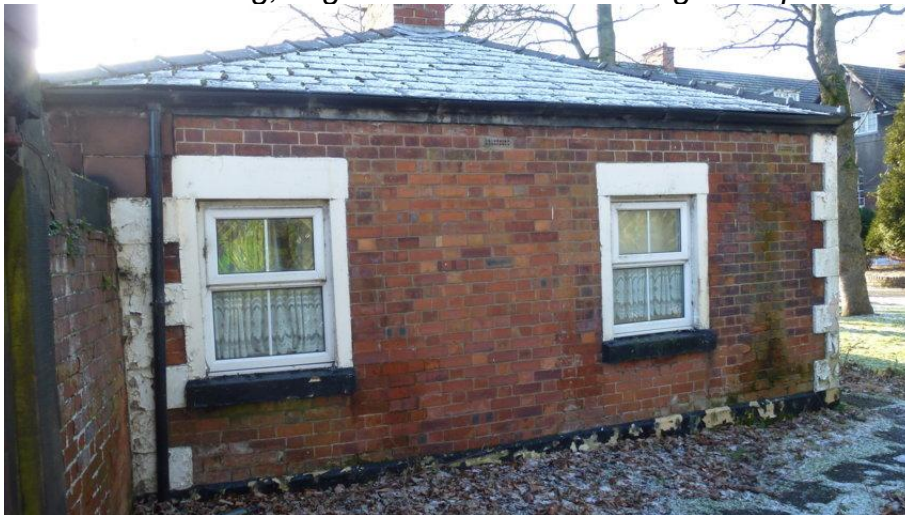
**Photograph H:** General view of north facing frontage to Building B.

*Note: Slate roofing, ridge tiles and brickwork in good repair and well sealed.*

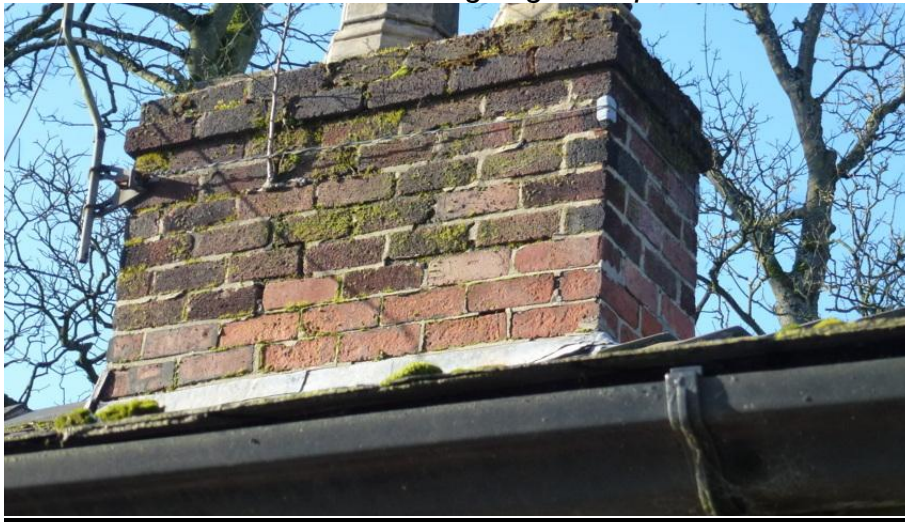
**Photograph I: Close up view of one of two chimney stacks on Building B.**

*Note: Note brickwork and flashing in good repair and well sealed.*

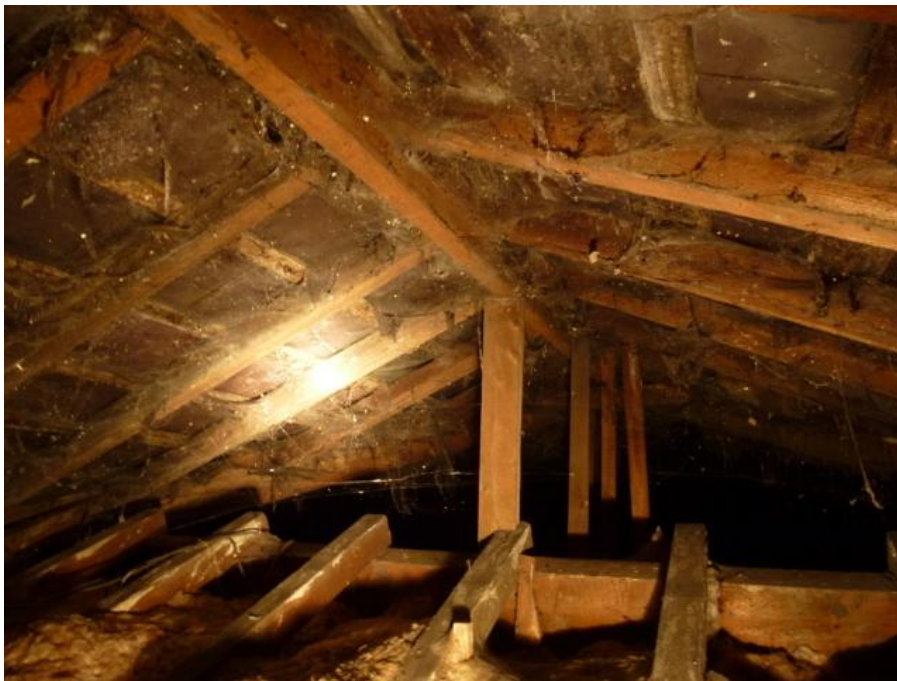
**Photograph J: View into roof chamber of Building B.**

A single roof chamber runs the length of the structure (Photograph J). There is no internal backing to the slate work however the roof chamber is well sealed with no day light penetration. Extensive spider's webs fill the chamber (Photograph J) which infers lack of bird or bat activity within.

*Note: No felt back to roofing slates, however the chamber is well sealed throughout. The extensive undisturbed spider's webs indicate absence of birds or bats.*

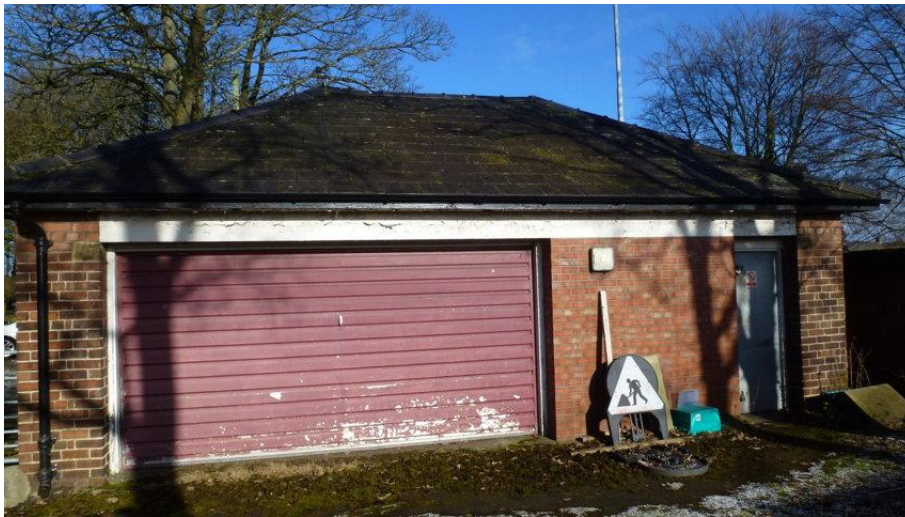
**Photograph K**: General view of south facing frontage to Building C.

*Note: Slate roofing and ridge tiles in good repair and well sealed.*

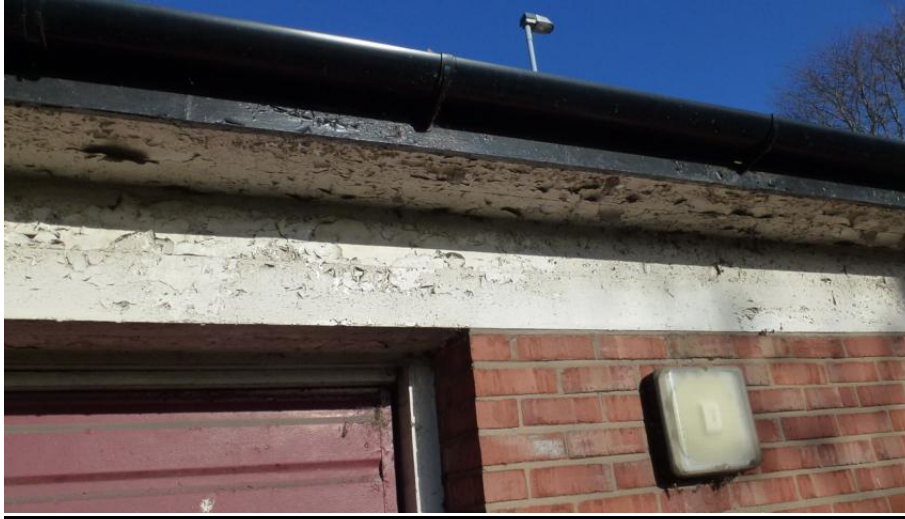
**Photograph L:** Close up sample view of roof overhand to Building C.

*Note: The roof overhang timberwork is subject to extensive paint peeling but is in good repair throughout with no openings or gapping at brickwork interfaces recorded.*

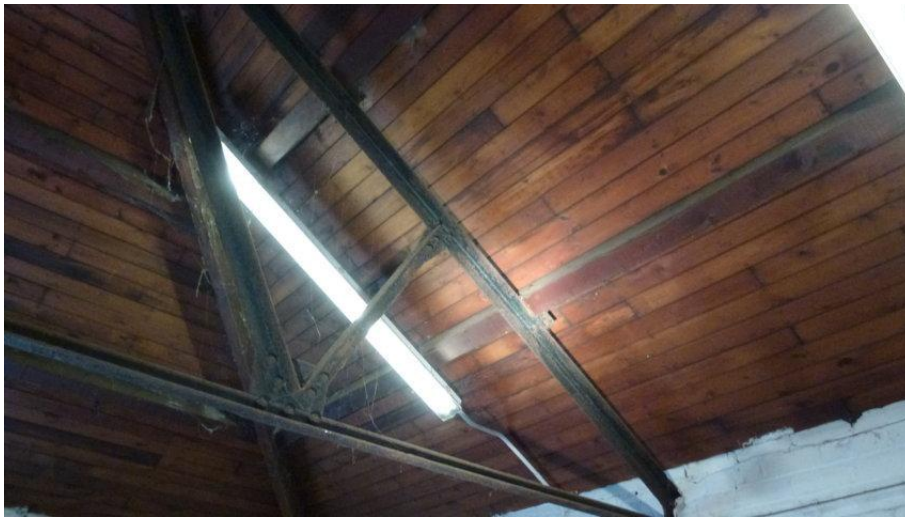
**Photograph M:** Internal view of timber panel backing to roofing to Building C.

*Note: Roofing supported on metal framework, and absence of enclosed roof chambers. The timber panel work is in good repair and well sealed.*

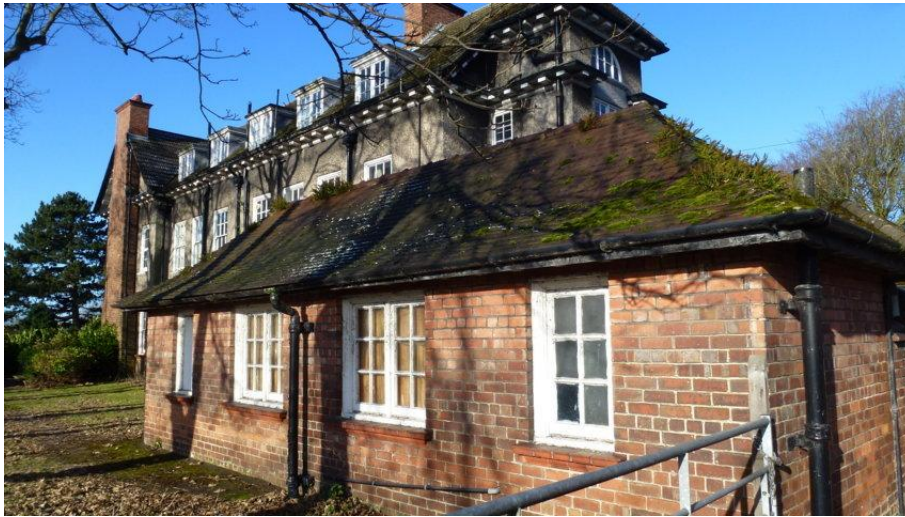
### **Photograph N: General view of south facing frontage to Building D.**

*Note: Pitched the slate covered roofing is in good repair and well sealed. Ridge tiles are well bedded down with no gapping. Timber roof overhang is in good repair and well sealed to brickwork.*

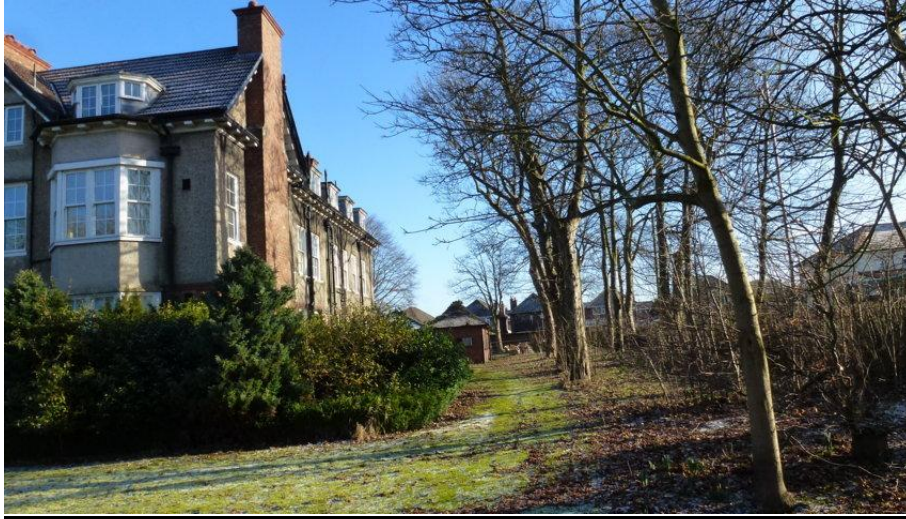
**Photograph O: View of line of trees to south facing frontage to Building A.**

*Note: Evidence of former bird breeding activity (species unidentified) in the tree canopy was recorded.*

Rows of semi mature and mature trees are found to the site boundaries and one row is located in close proximity to the southern frontage to Building A (Photograph O). The trees were subject to inspection and none located within a 10m radius of the buildings were identified as having potential to support roosting bats.
