Proposed Barn Conversion
Woolley Cross
Bude EX23 9PS

Structural Inspection Report

for Mr and Mrs Olde

1200-R01A
October 2020

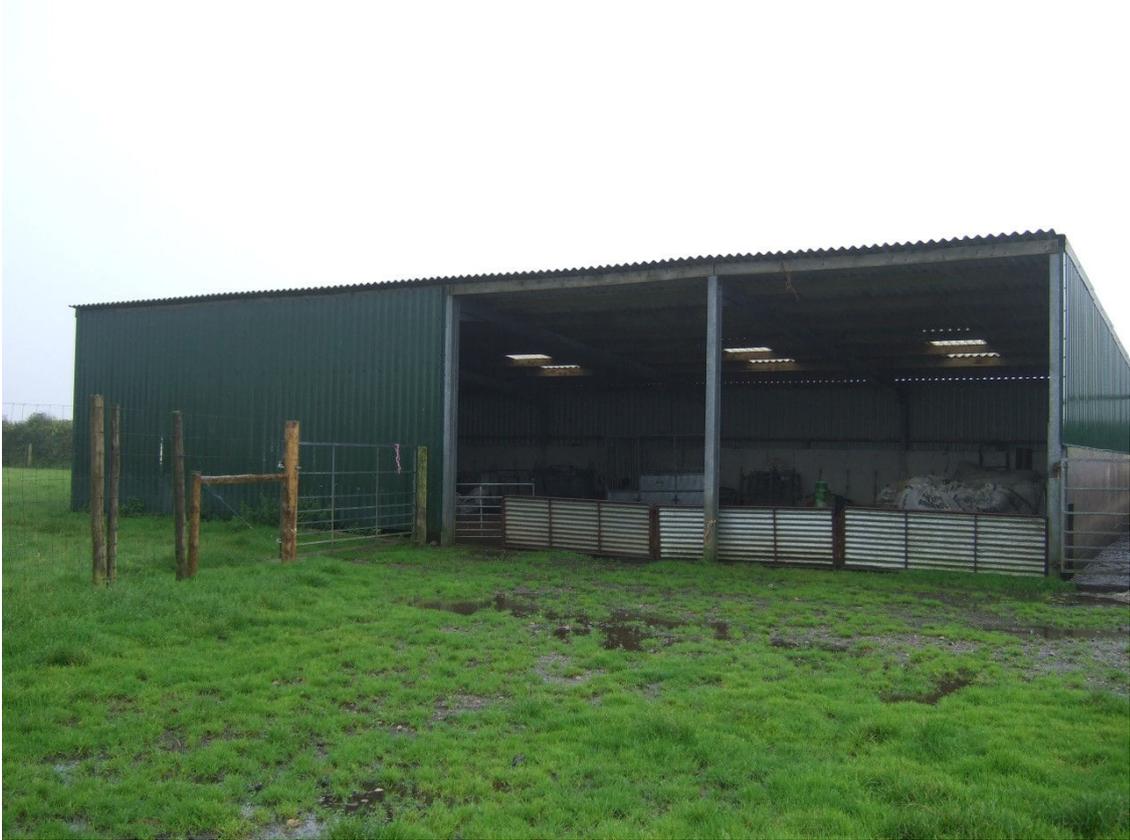
Front (north) elevation

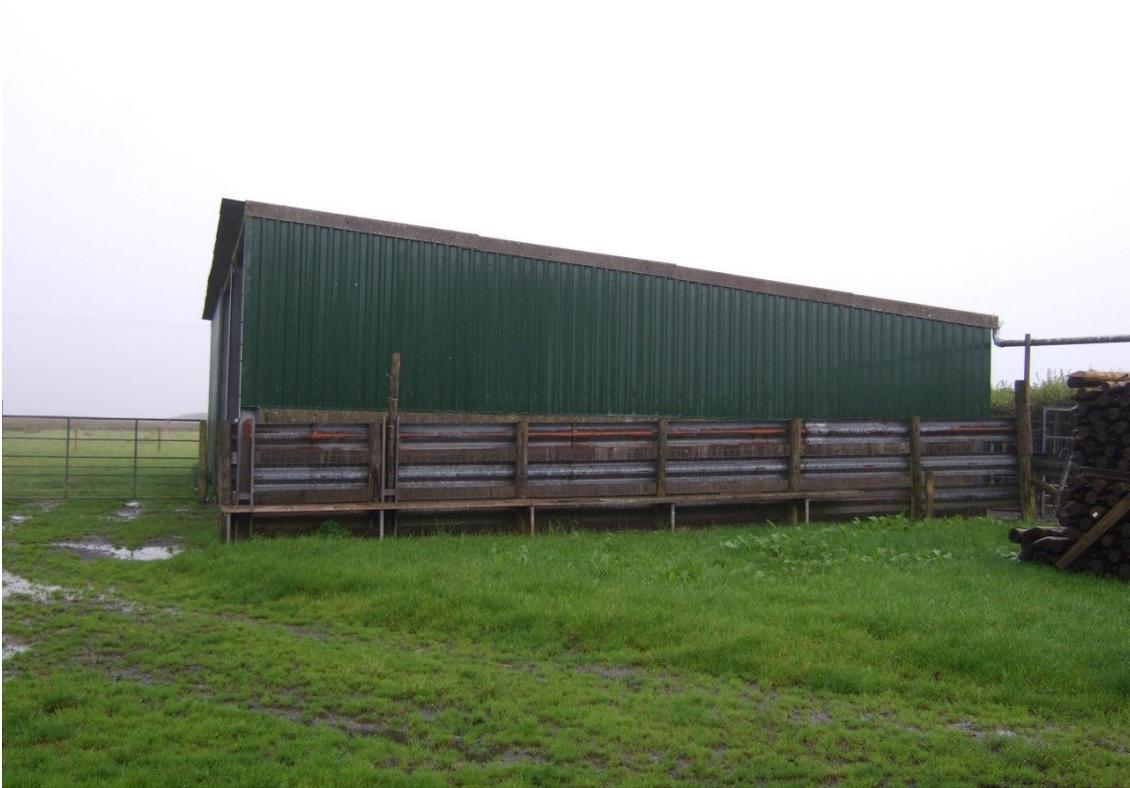
End (west) elevation

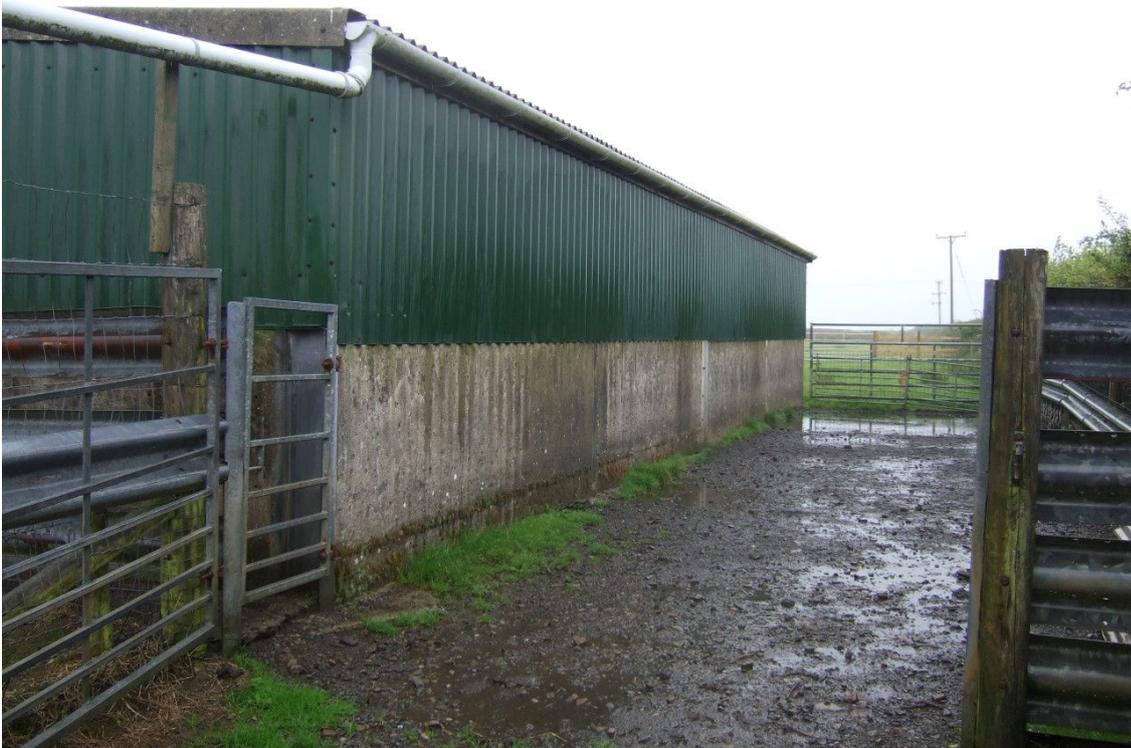
Rear (south) elevation

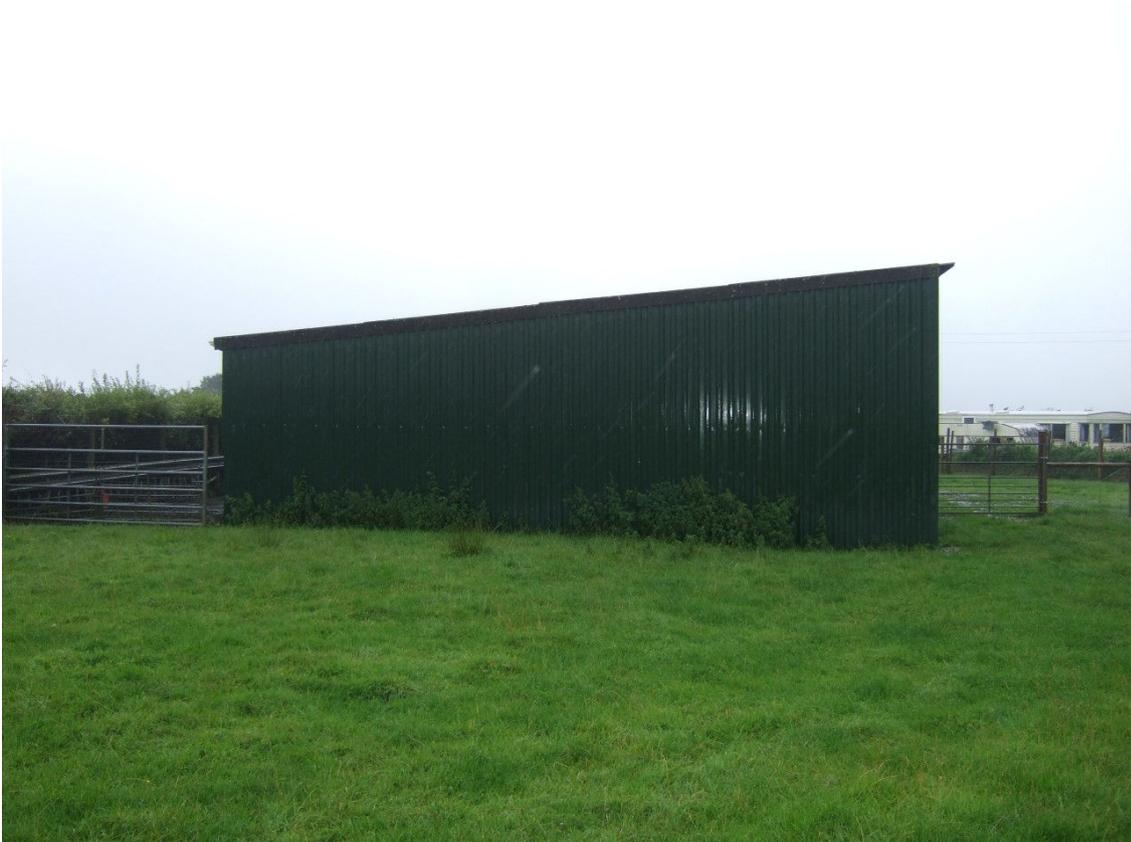
End (east) elevation

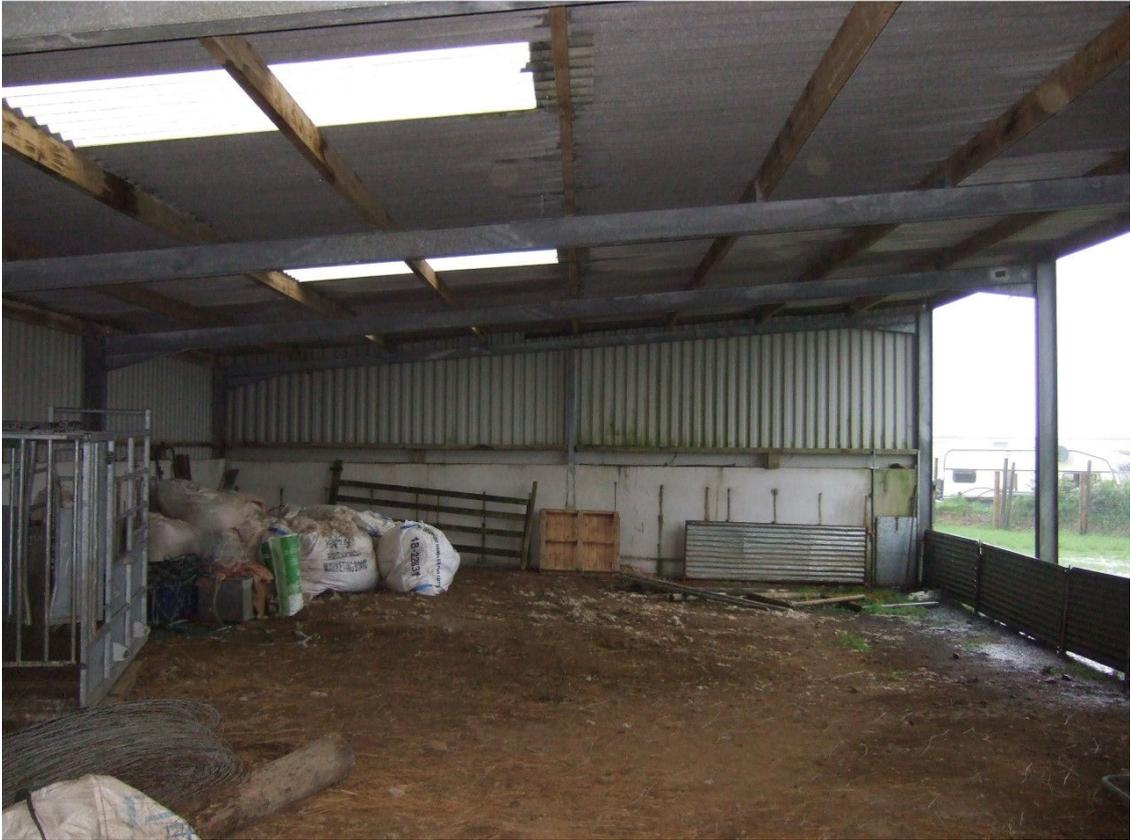
Internal view looking west

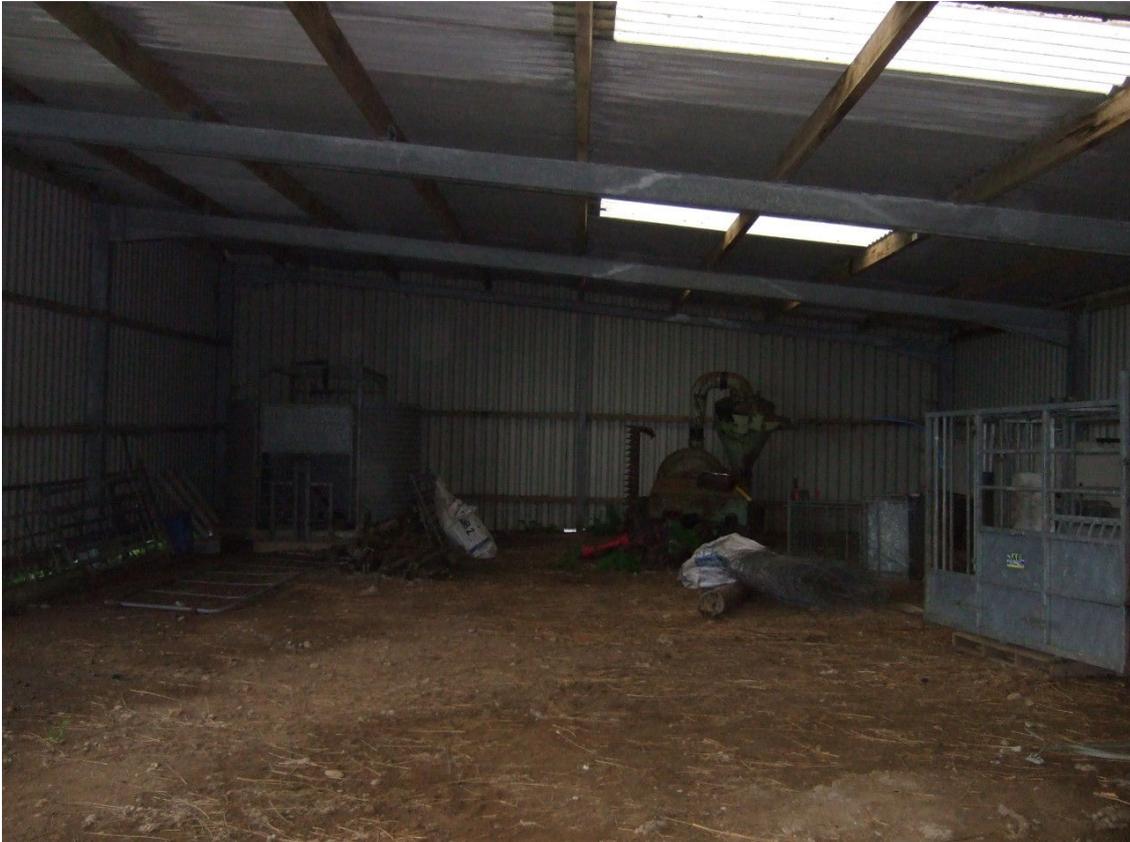
Internal view looking east

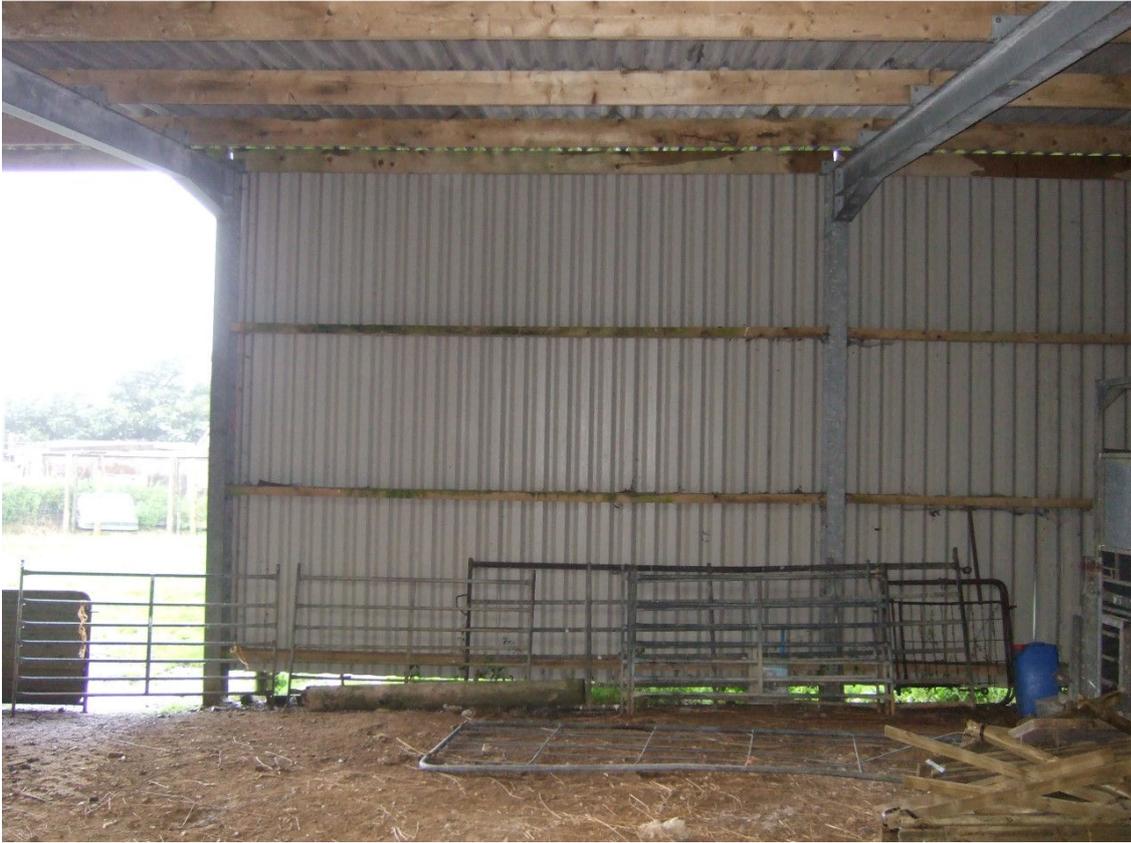
External wall (inside of north elevation)

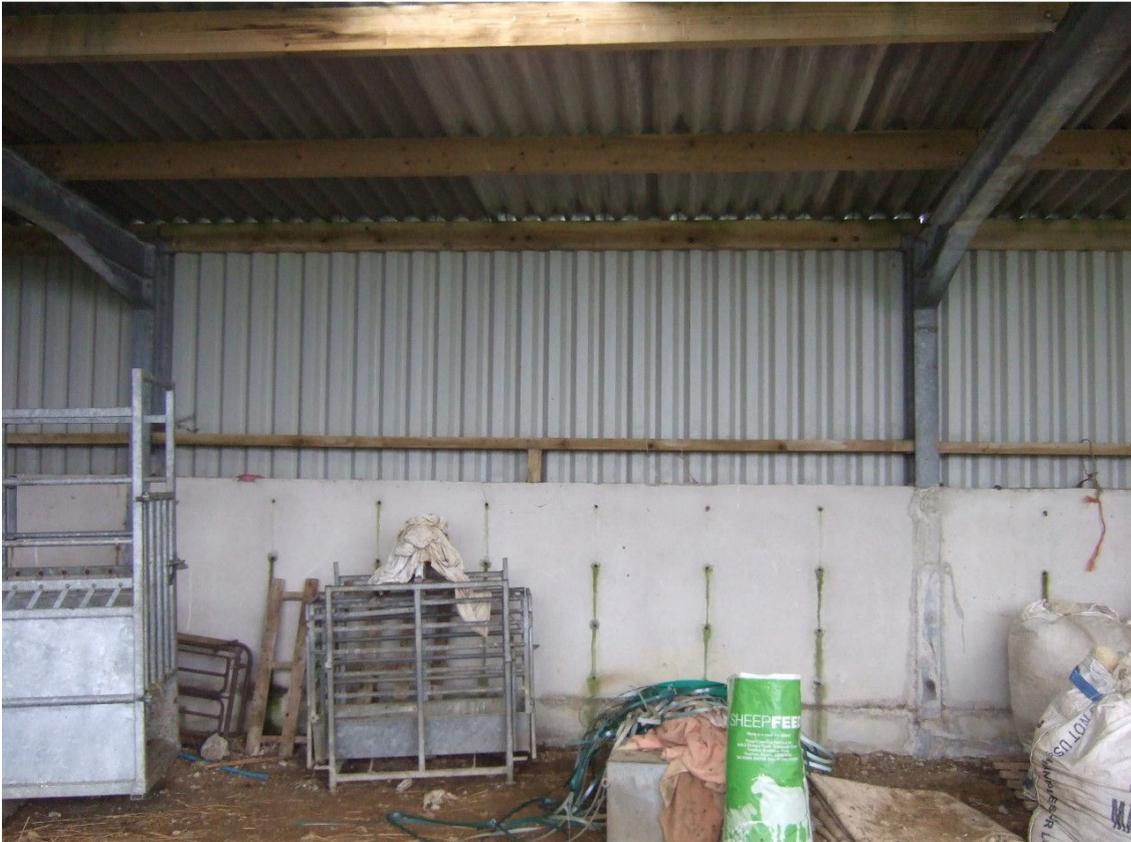
- 2.16 The majority of the purlins and cladding rails are visibly deflected.
- 2.17 There are part-height concrete walls along the full length of the west and south (rear) elevations. The concrete walls are about 200mm thick, cast insitu between the columns. The walls extend up to about 1.4m to 1.8m height depending on the sloping floor level. The cladding starts at the top of the wall on the applicable elevations.

- 2.18 The concrete walls are cast on the ground, which appears to be approximately at the same level internally and externally. All of the concrete walls appear tight to the steel columns with no significant deflection or movement noted.

External wall (inside of south elevation). Concrete wall at low level.

- 4.6 Where new window openings are cut into the existing concrete walls, the openings should be limited to the size of the windows only, not full height.

- 4.7 The proposed floor slab should be at a relatively high level to avoid undermining the existing concrete walls. The slab should be designed to support the liner walls and internal walls, carrying loads transferred from the steel frame.

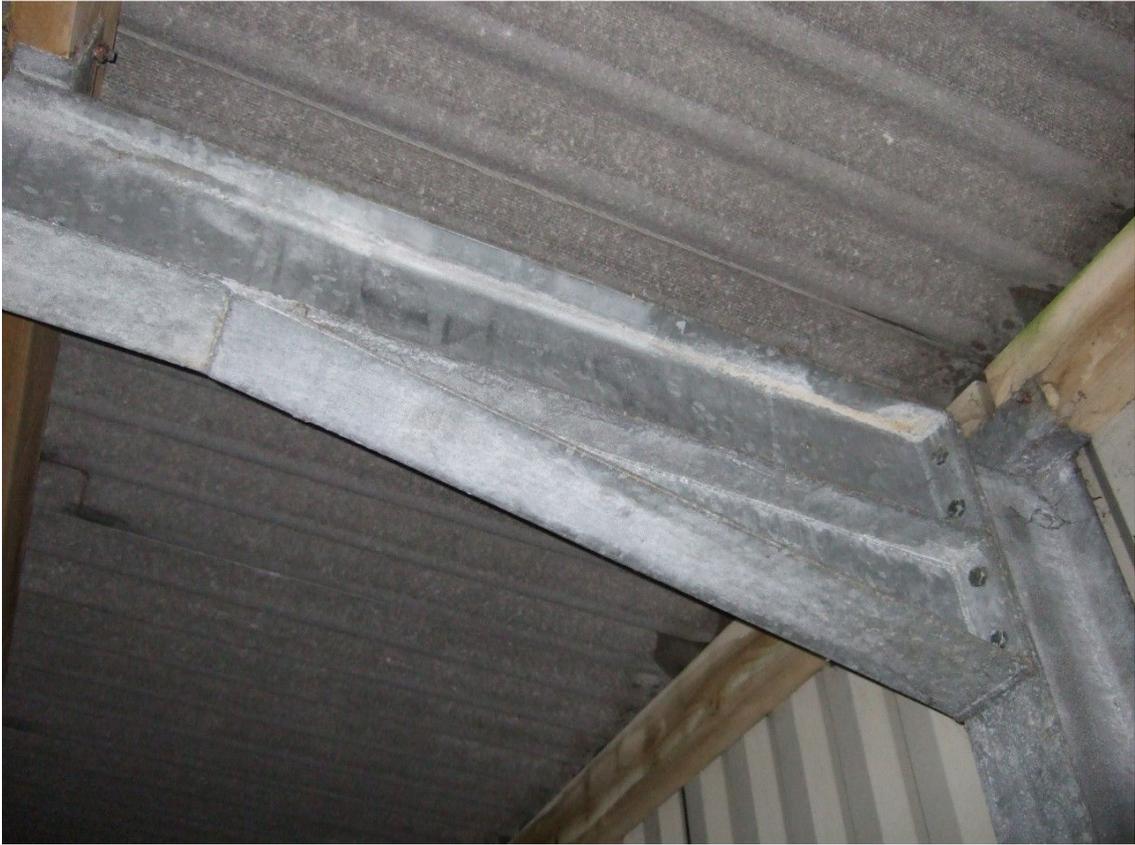
- 2.9 The three clear span portal frames are formed from 203x133 UB column and rafter sections, fixed together using haunched bolted connections.
- 2.10 The two gable portal frames are 203x133 UB end columns, with 152x89 UB rafters and intermediate gable posts.

Typical portal rafter to column connection.

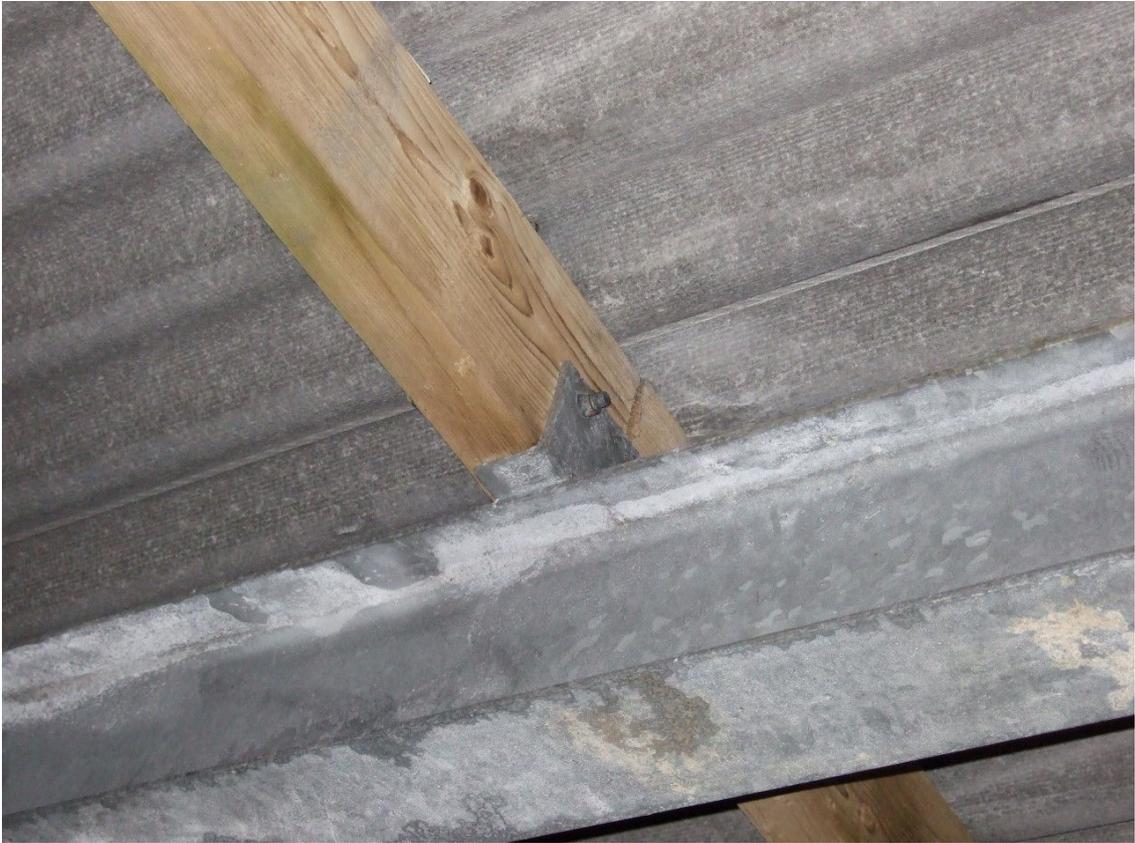
- 2.14 There are timber purlins spanning between the portal frames. The purlins are estimated as about 62mm wide x 170mm high, at around 1.3m to 1.4m centres. The purlins support asbestos cement or fibre cement sinusoidal profile roof sheeting above.

Typical purlin to rafter connection.

- 4.3 The purlins and cladding rails are over-stressed and need to be replaced or strengthened, taking into account any additional loads for the replacement roof build-up, ceiling and wall build-up where applicable.

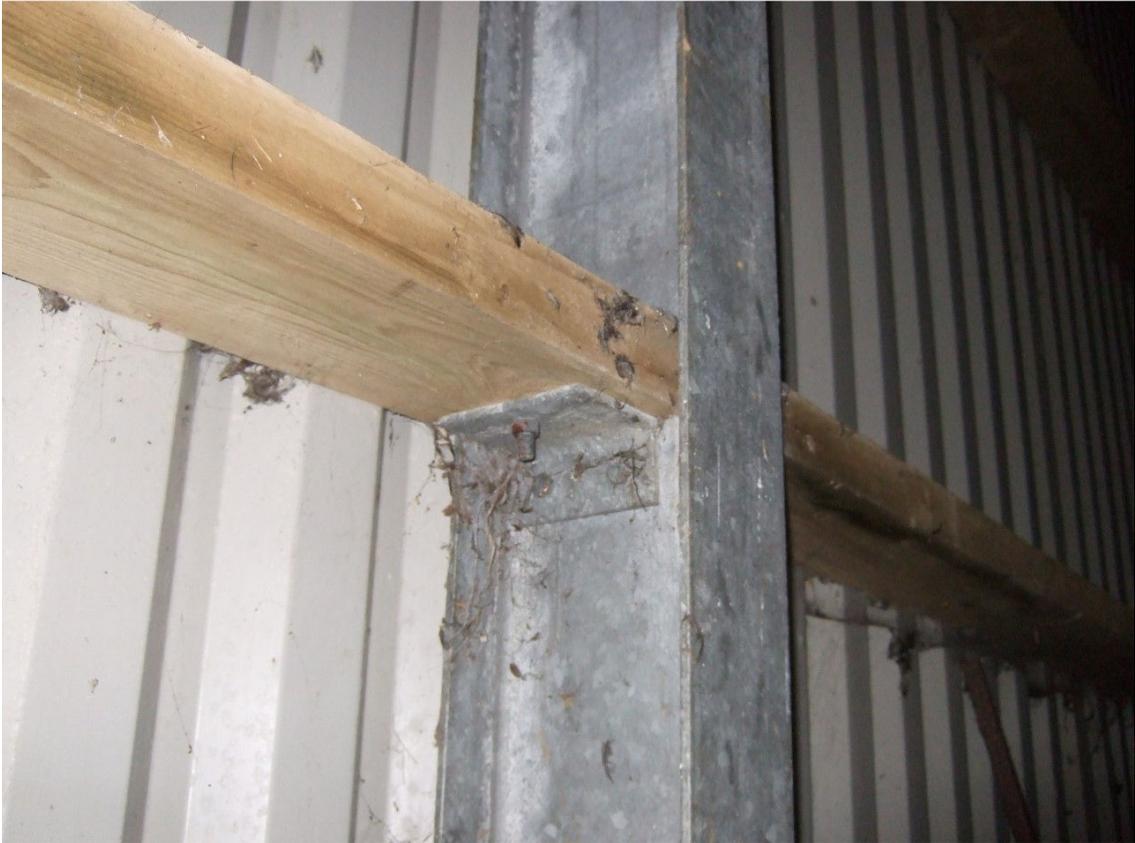
- 2.15 There are timber cladding rails spanning between most of the columns. The cladding rails are about 170mm wide x 62mm high, typically at around 1.3m centres. The cladding rails support steel trapezoidal profile external sheeting. The two west bays are open at the front of the building therefore there are no cladding rails at this part.

Typical cladding rail to column connection.

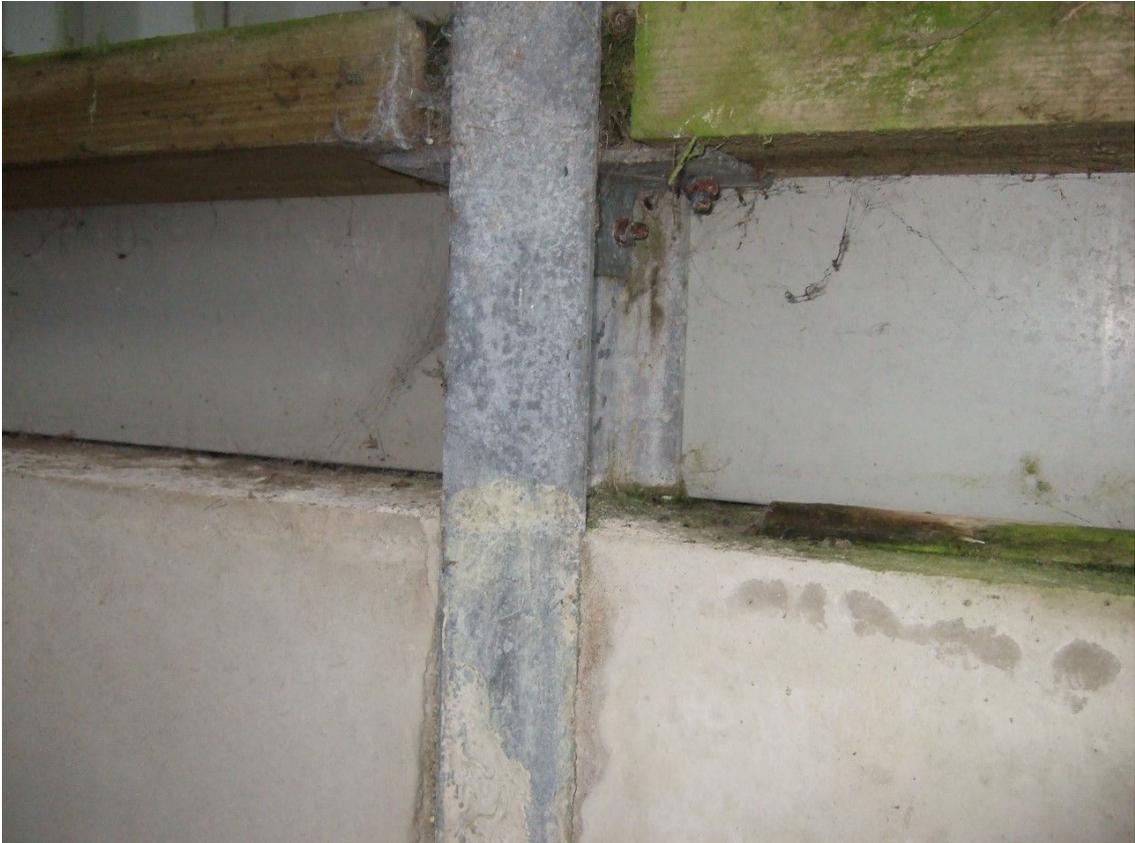
Typical interface between concrete wall and column. Concrete cast into column.

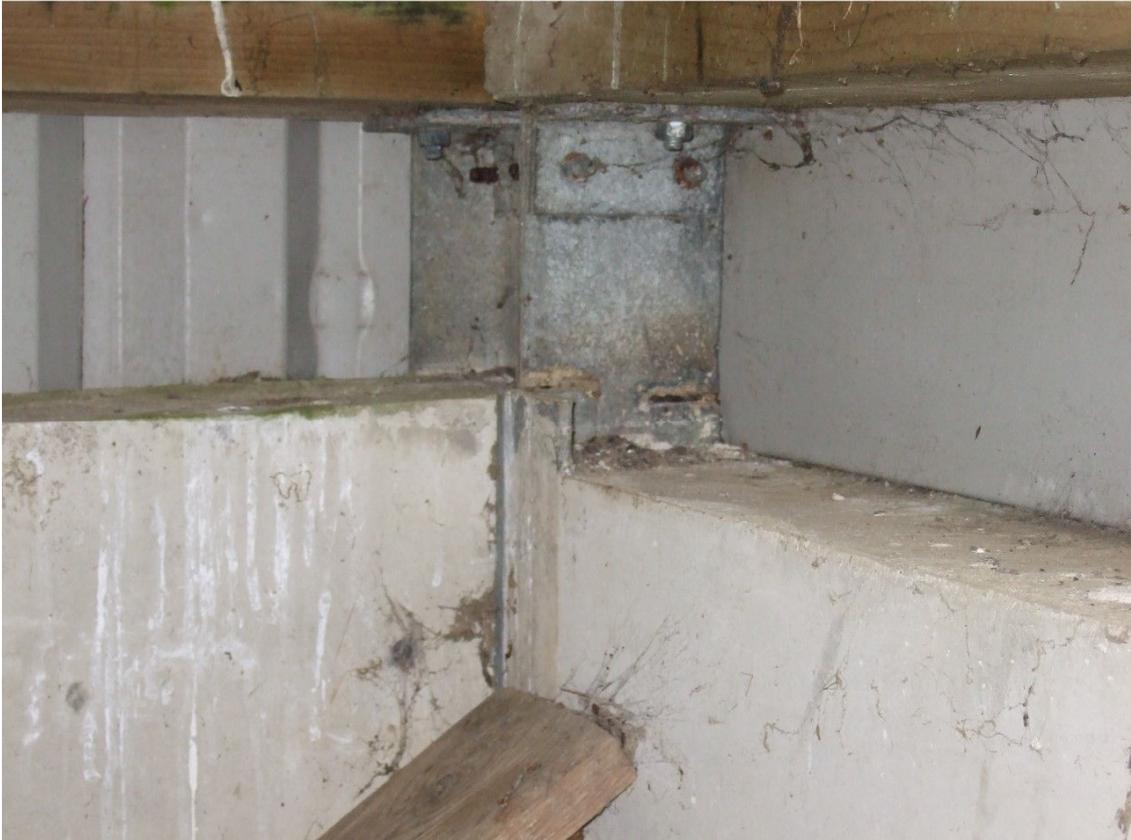
Interface between concrete wall and south west corner column.

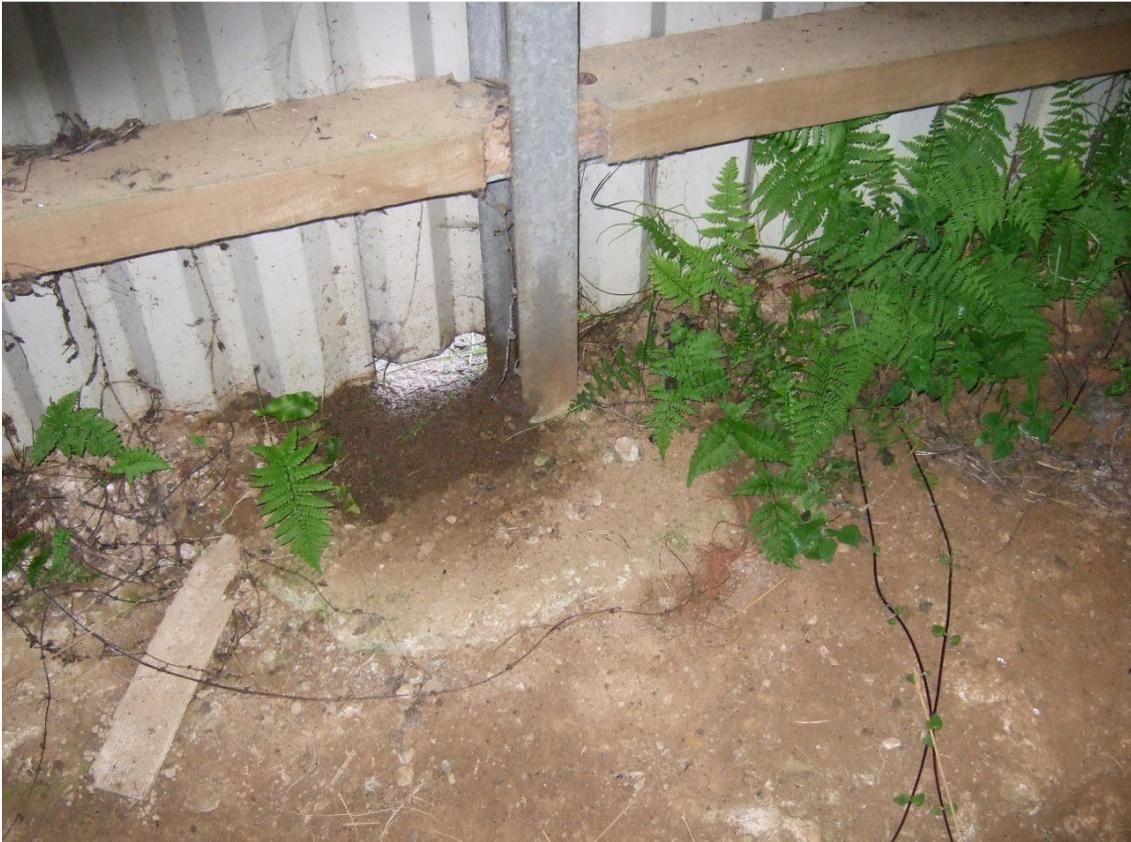
- 2.19 There is concrete around the columns at ground level. It is not known if this concrete is part of pad foundations supporting the columns, or concrete surround above foundation level.

- 4.8 The existing foundation details are not known. There are currently no signs of foundation movement therefore the foundations can be considered adequate for the conversion provided that the replacement roofing system does not significantly exceed the weight of the existing sheeting which is estimated as about 16kg/m².

Concrete around column at ground level.
