Dairy Cottage, 2 Kings Lane, Little Harrowden, NN9 5BL

External House Improvements Application

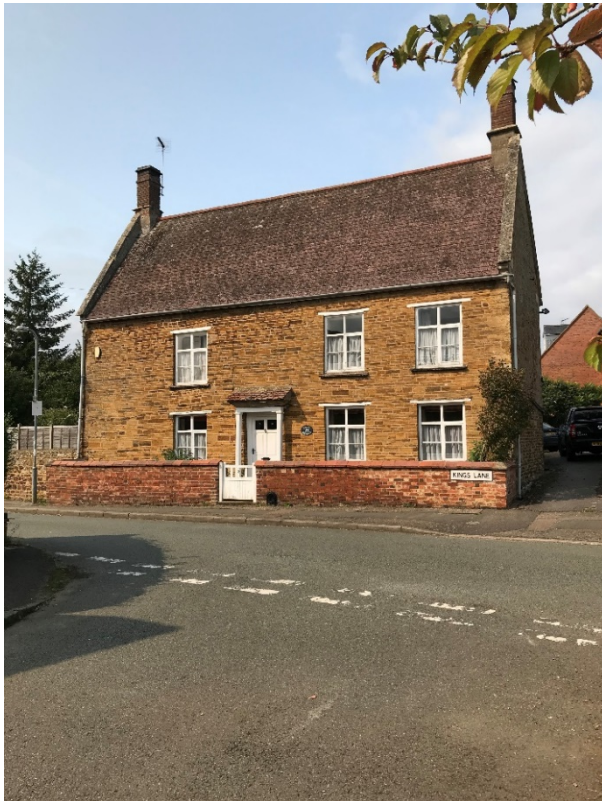
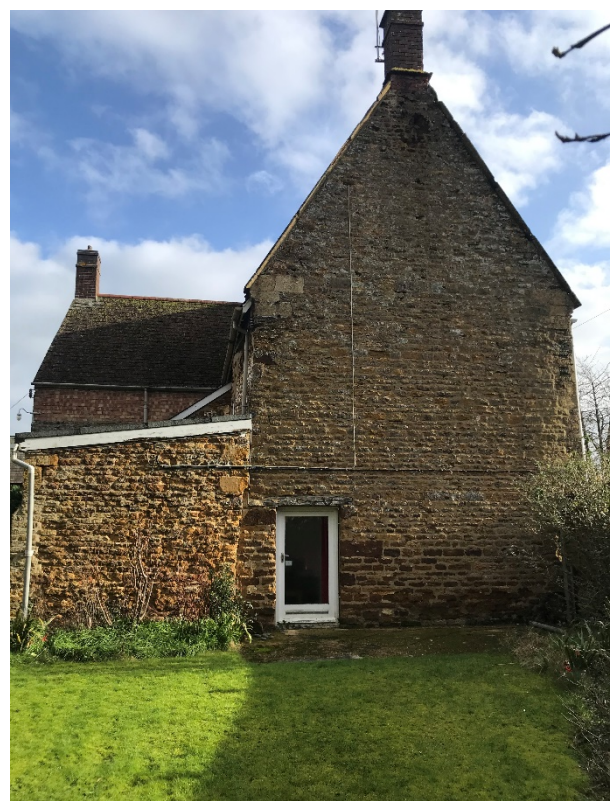
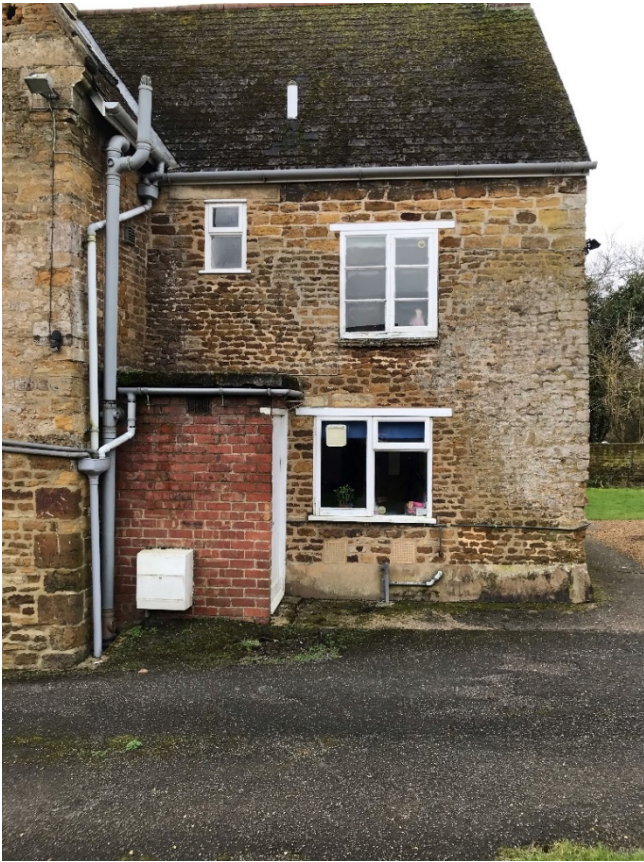
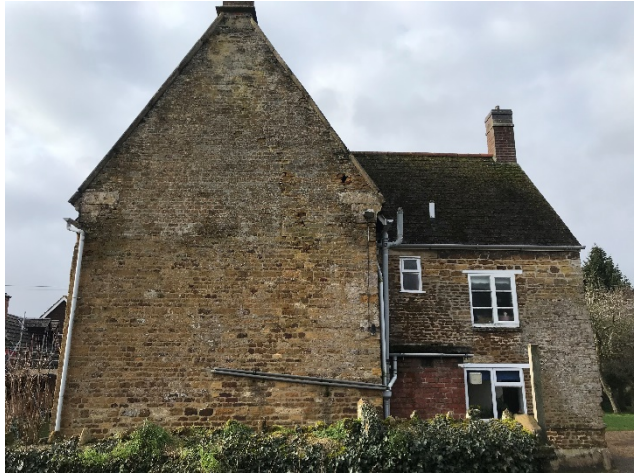
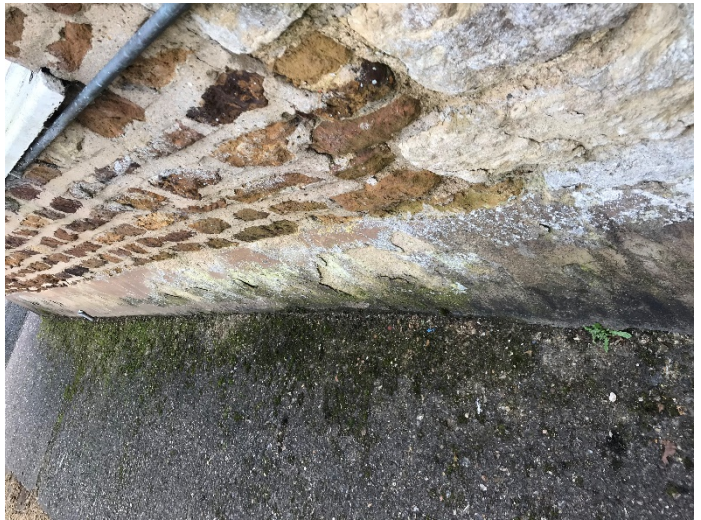
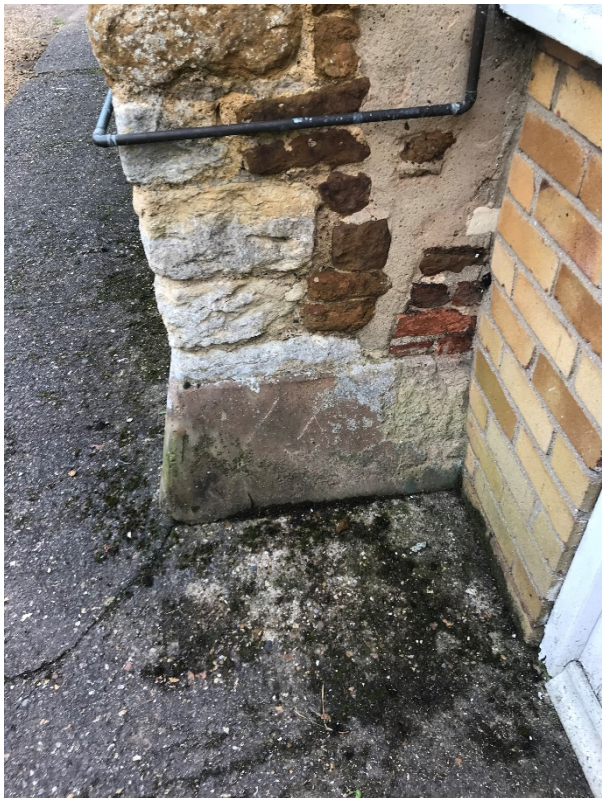
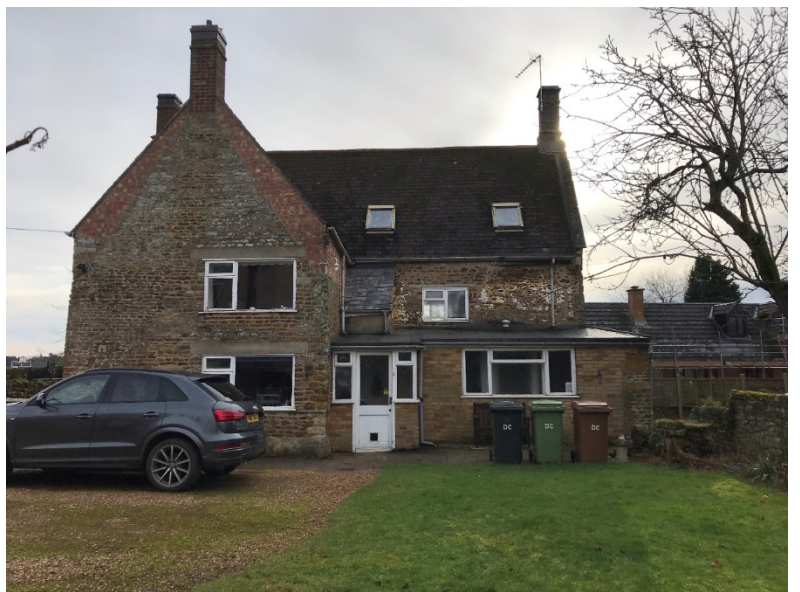
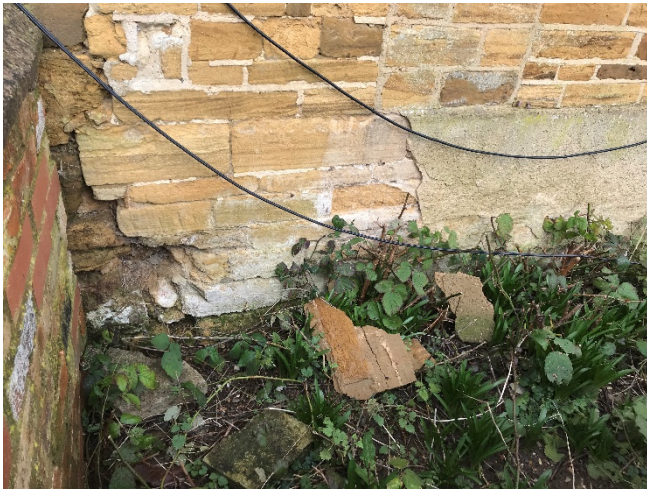
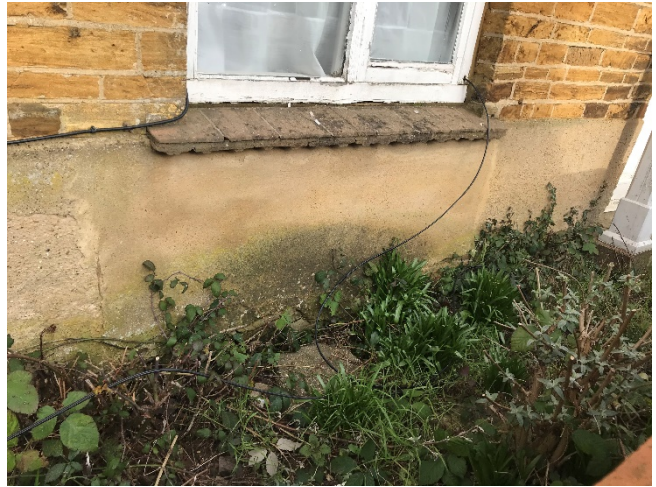
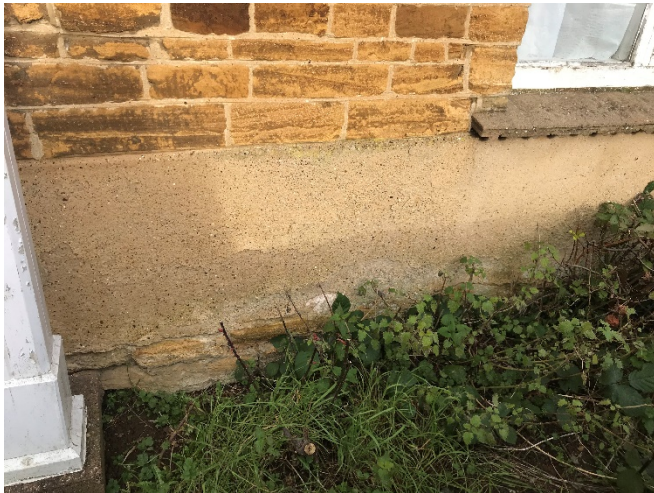
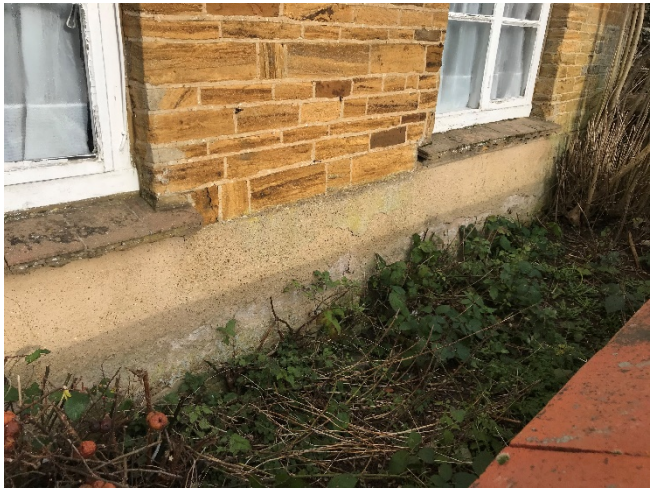
The façade of the building has had various repointing works done at various times over the past century and this is evident by the varying colours of mortar around the building façade. There is also a low-level concrete skirting around the perimeter of the building at varying heights. Unfortunately, some of this re-pointing and skirting was done using a sand and cement mortar and not a lime mortar as this building requires. This has resulted in varying impacts to the building namely:

- Damp is apparent internally to some external facades as a result of the building not being able to breath.
- Stone decay where the building hasn't been able to breath and the sandstone which is the next softest thing in the structure has crumbled in some locations. It is also acknowledged that this will also have taken place due to weathering as this occurs on each gable end.
- The concrete skirting has both fallen away from the building and the topcoat is de-bonding from the scratch coat in various locations.

I propose to rake out and repoint the whole building in the correct lime mortar mixture. This will require raking out and removal of the existing mortar to a depth of 25-40mm. The exposed joint will then be cleaned with water before being repointed. The sequence of these works will start at the top of the wall and work downwards.

To ensure an appropriate colour mortar is achieved, I propose to do a small sample panel with several different colour mixtures for agreement with yourself. This will ensure the colour is appropriate for the property. The desired effect is to match the existing mortar colour as close as possible. These works will take place from the Spring onwards when the correct temperatures are present, and all works will take place from scaffolding to be erected around the perimeter of the building. The scaffolding to the front of the property will be a 3+1 board scaffold which will not require the scaffold to protrude beyond our land boundary.

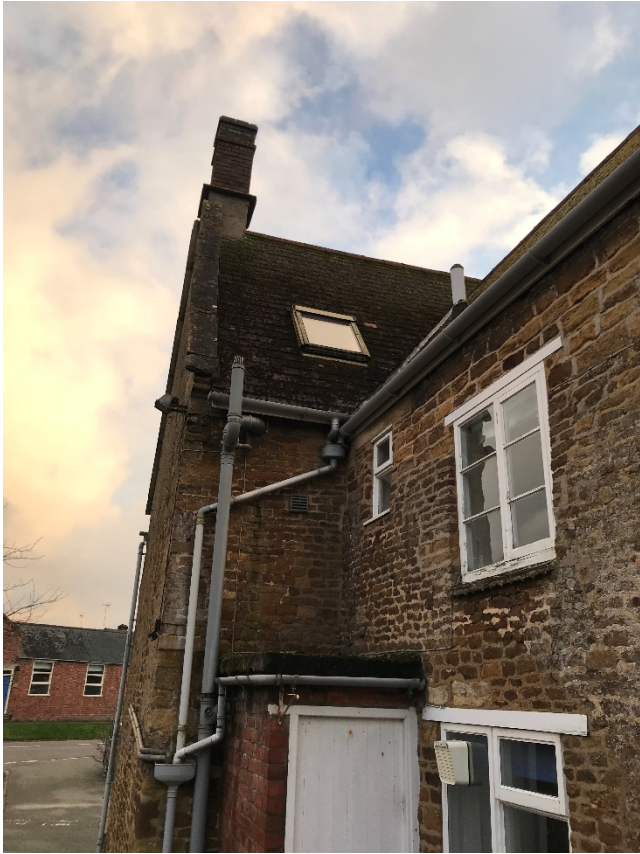
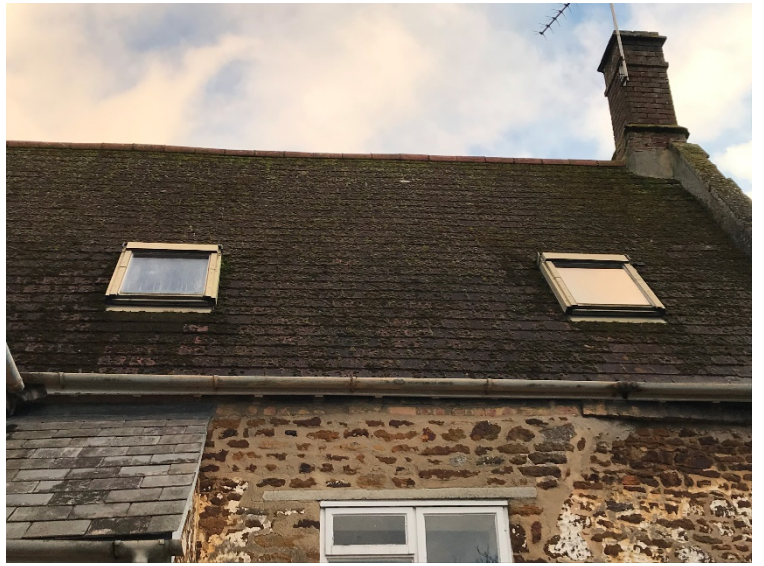
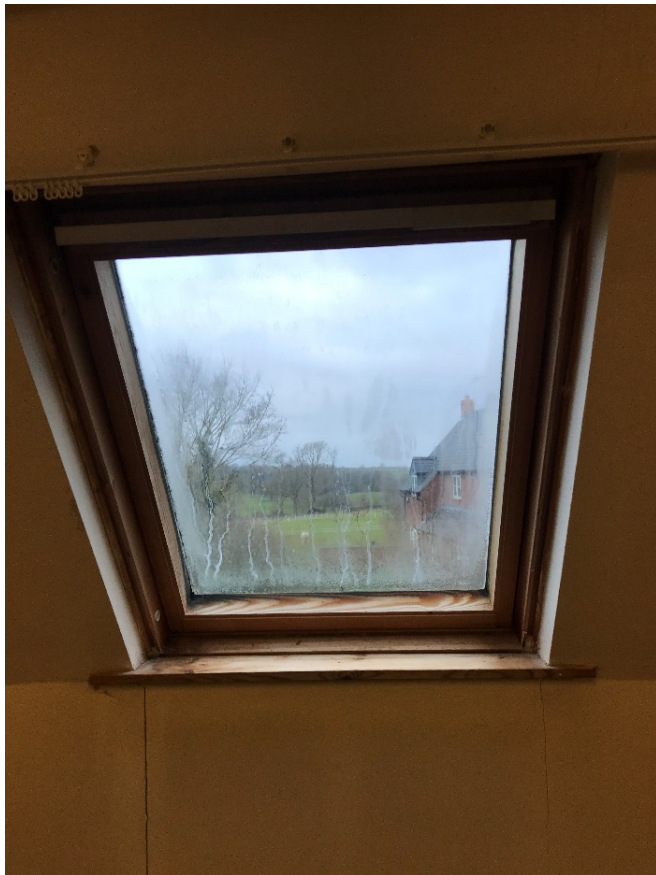
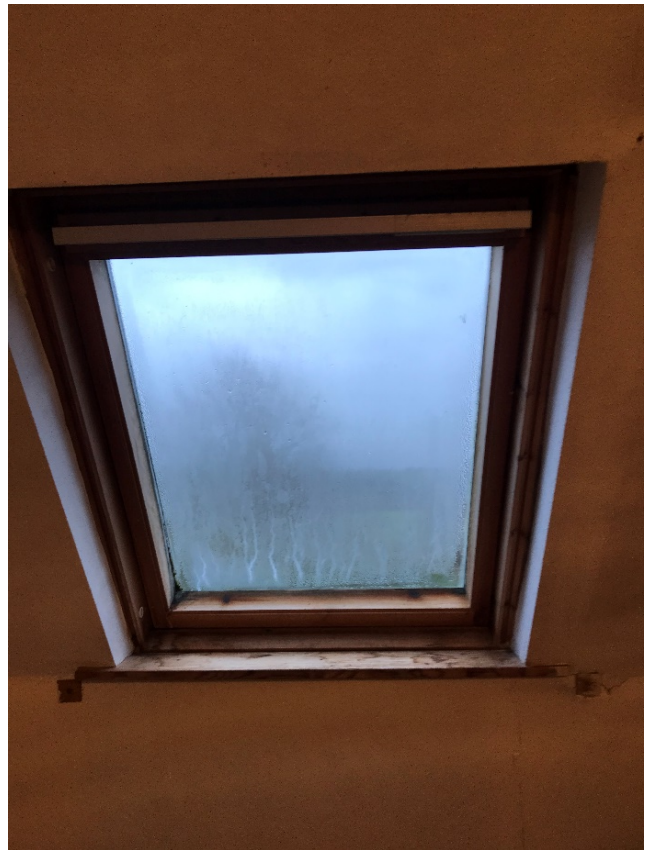
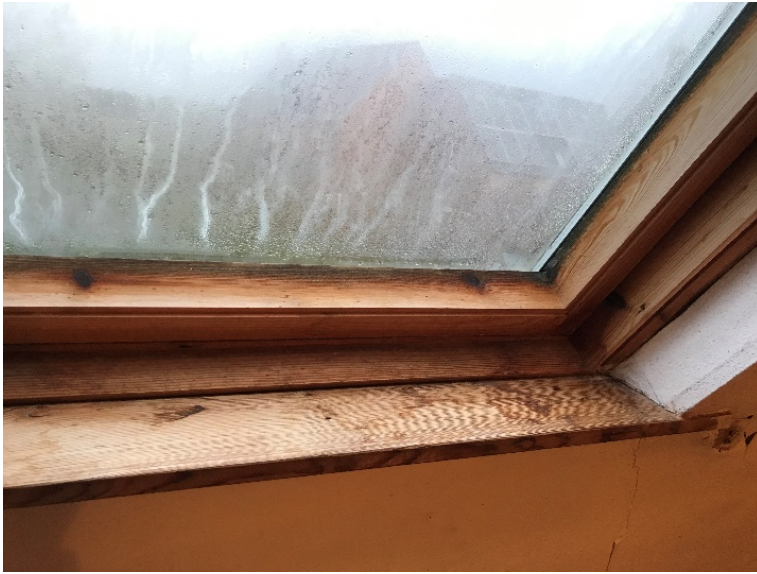
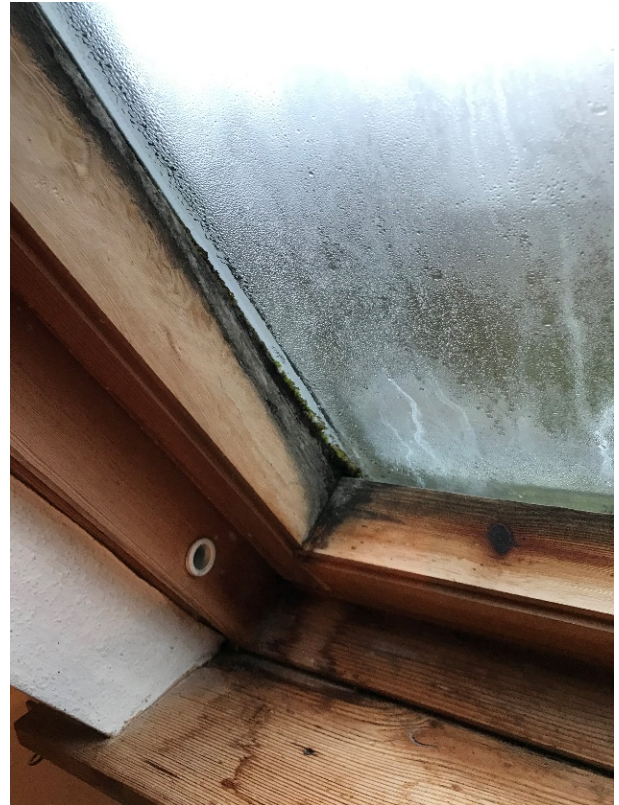
There are 3 rooflights to the loft area, 1 to the WC, and 1 each to the 2 loft rooms as can be seen from the below photos. Internally these are all pine wood and due to water ingress and failure of the system, the internal timber frames are badly damaged. Also, the glass has failed within the rooflights where the glazing has misted. A local roofer has reviewed and reported that these rooflights were installed in the 1980s and are beyond repair.

I propose to replace these rooflights with Velux GGL MK04 2070H Special GGL roof window V22 with external glazing bar rooflights as the below information. Each rooflight has structural opening dimensions of 780mm x 978mm.
