Project Name: 2020-09-14309 Campbell Reith Whitworth High School Hall Fold Whitworth

Project Date: 04/11/2020

Inspection Standard: MSCC4 Sewers & Drainage GB (SRM4 Scoring)

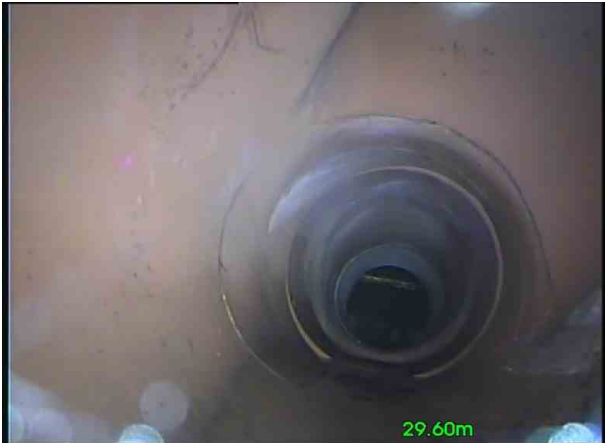
S30X_7a592401-48f7-4589-8a57-108e340d1ee2_20201105_130758_212.jpg, 00:01:49, 29.60 m

Crack, circumferential from 7 o'clock to 10 o'clock

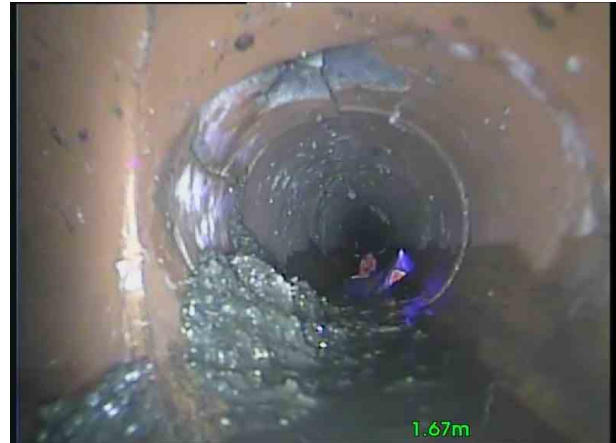
End O
 LineX_508b5ea3-3028-4401-aad6-392cc23e8313_20201105_162319_998.jpg, 00:00:14, 1.70 m
 Broken pipe at joint from 7 o'clock to 1 o'clock ,

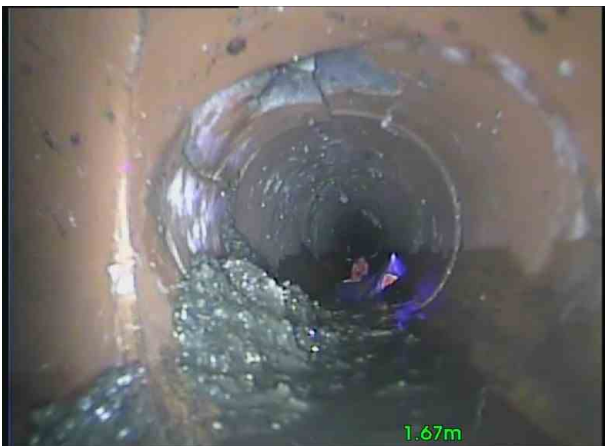
End O
 LineX_45453a69-058b-4e53-a29f-543728085864_20201105_162333_542.jpg, 00:00:14, 1.70 m
 Hole in drain or sewer at a joint from 11 o'clock to 12 o'clock

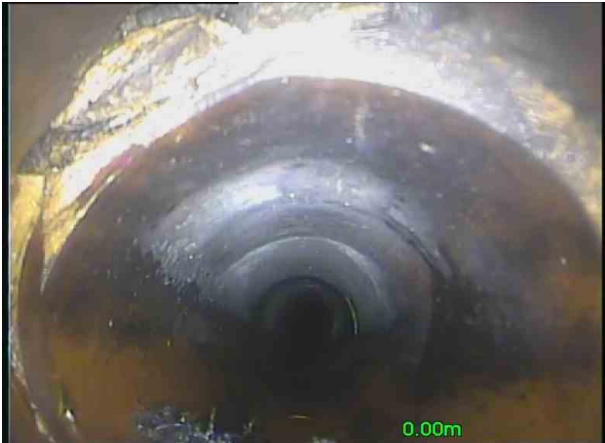
Branch
2X_73174870-0115-4315-bdd9-0c8b92c96928_20201106_12
2937_973.jpg, 00:00:07, 0.01 m
Broken pipe at joint from 9 o'clock to 2 o'clock ,

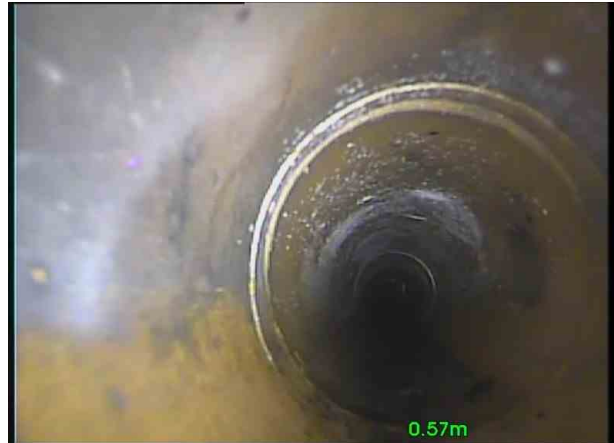
Branch
2X_f1a0522c-ab74-4fc0-ad5e-59ed6b5eab52_20201106_123
046_728.jpg, 00:00:12, 0.57 m
Crack, circumferential at joint from 8 o'clock to 2 o'clock

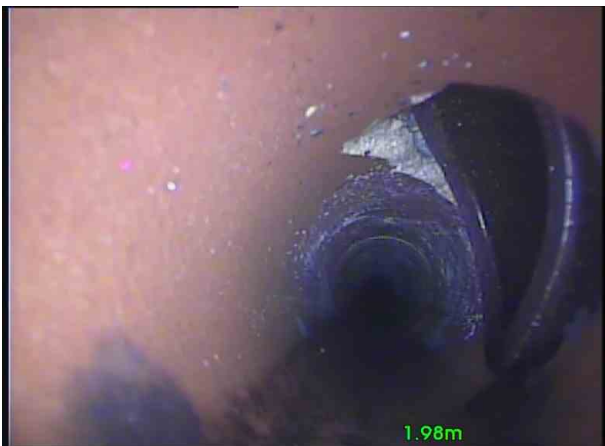
Branch
2X_dce7c60e-3e78-4d2a-ad8a-b66cf6cfe55f_20201106_1231
30_117.jpg, 00:00:21, 2.00 m
Connection defective, position incorrect at 2 o'clock, diameter:
100mm

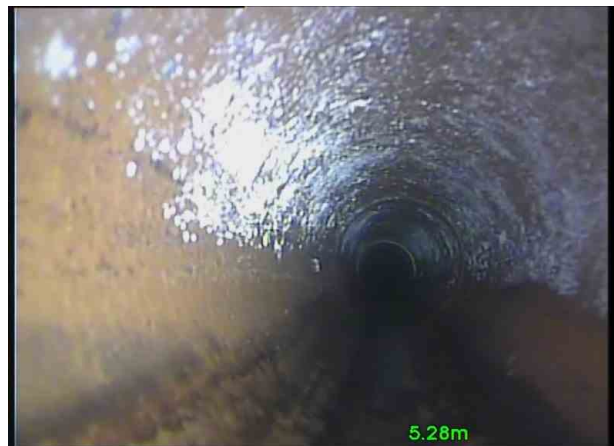
Branch
2X_2ac7df6a-352c-4816-a123-468eeb04a987_20201106_123
520_568.jpg, 00:00:49, 5.28 m
Attached deposits, grease from 9 o'clock to 3 o'clock, 5%
cross-sectional area loss

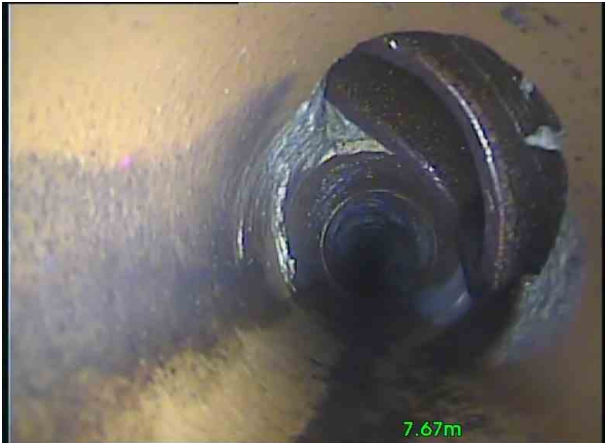
Branch
2X_a9ac3ae2-76b7-4033-8e6a-063dc7715efb_20201106_123
525_000.jpg, 00:01:00, 7.67 m
Connection defective, position incorrect at 2 o'clock, diameter:
100mm

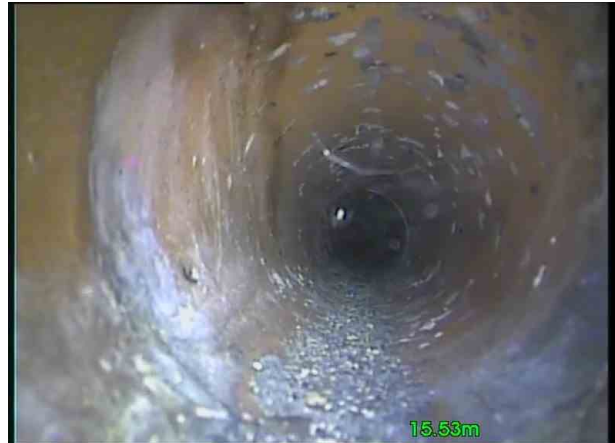
Branch
2X_365ecbab-3c0e-4c92-ba62-939207b87316_20201106_12
3955_239.jpg, 00:02:09, 15.53 m
Settled deposits, coarse, 5% cross-sectional area loss

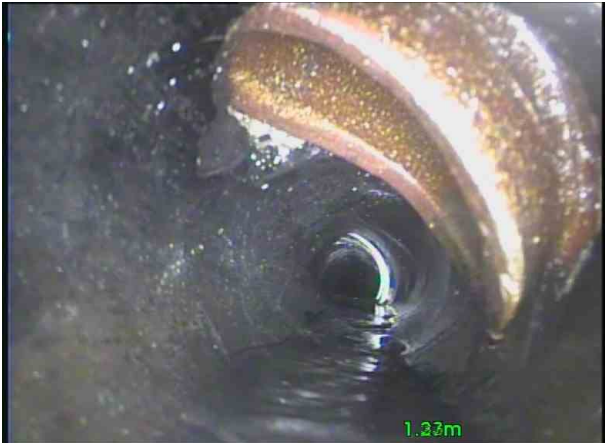
USX_c5e9e691-8fc6-474e-86e1-88aa62dba8e6_20201106_1
24640_341.jpg, 00:00:16, 1.33 m
Connection defective, position incorrect at 2 o'clock, diameter:
100mm

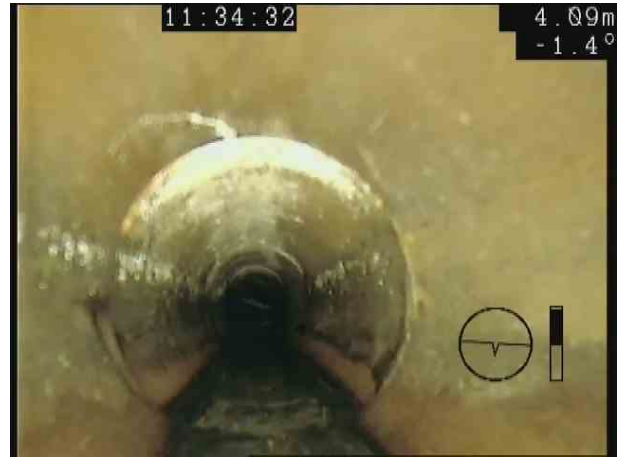
USX_1ae78ce8-9547-41b5-9e37-a0fb2de6d519_20201106_152845_412.jpg, 00:00:37, 4.10 m
 Crack, circumferential at joint from 11 o'clock to 12 o'clock

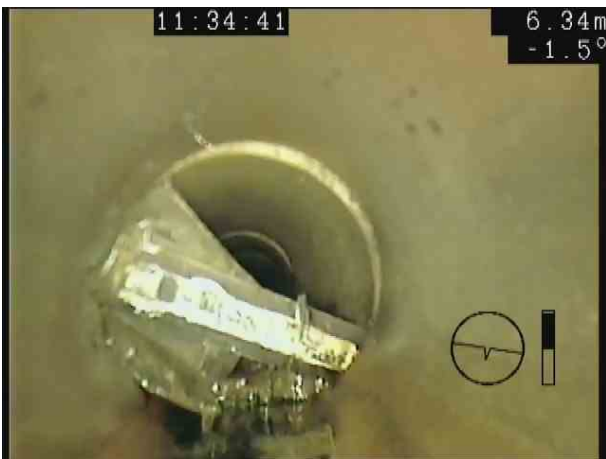
USX_0fa3ea63-c32a-4277-b14b-fbac7b0ac528_20201106_153046_741.jpg, 00:00:46, 6.42 m
 Other obstacles at joint from 4 o'clock to 11 o'clock, 75% cross-sectional area loss, Debris

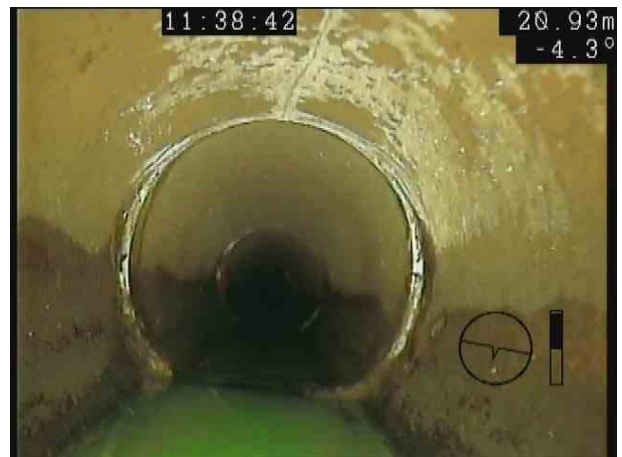
S18X_c6fce1ed-d7d8-4ed7-b6b7-ec7182af3358_20201106_154608_712.jpg, 00:01:47, 20.93 m
 Crack, longitudinal at 12 o'clock

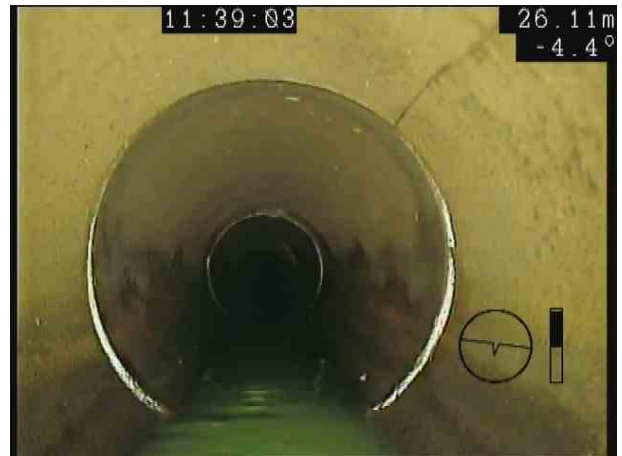
S18X_ec2350b0-acb3-445d-ae7-ac500e4601d8_20201106_154709_501.jpg, 00:02:08, 26.10 m
 Crack, longitudinal at 1 o'clock

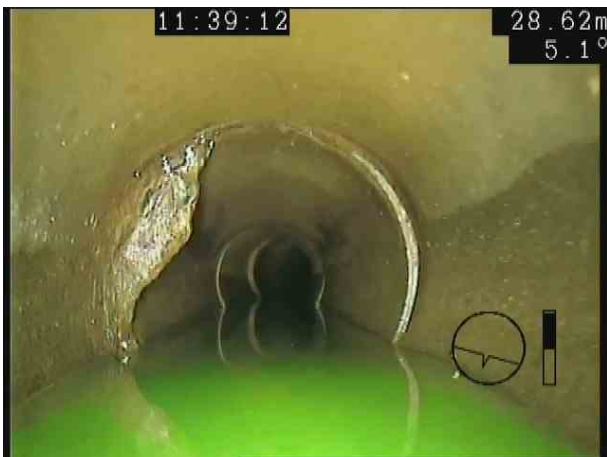
S18X_8242c4da-7854-46b3-a97c-adc9b7c6de9e_20201106_154743_651.jpg, 00:02:17, 28.62 m
 Attached deposits, encrustation at joint from 8 o'clock to 12 o'clock, 15% cross-sectional area loss

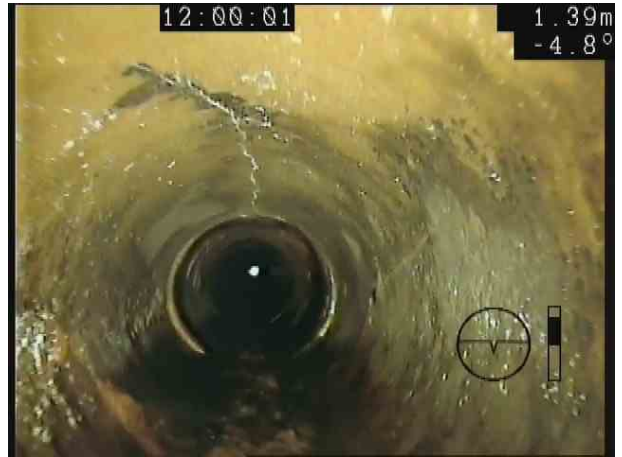
S19X_a582841d-2717-4ddd-89bc-d7c19de28dfe_20201110_111119_456.jpg, 00:00:23, 1.46 m
Crack, longitudinal at 12 o'clock

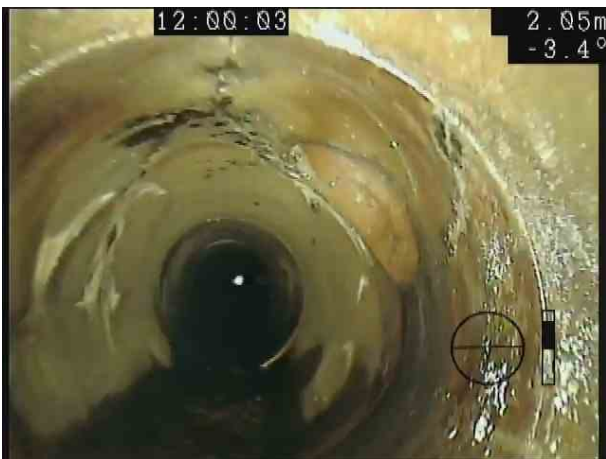
S19X_e79285c3-b780-4a96-bc4c-98708fa75e17_20201110_11301_659.jpg, 00:00:26, 2.13 m
Crack, circumferential from 12 o'clock to 1 o'clock

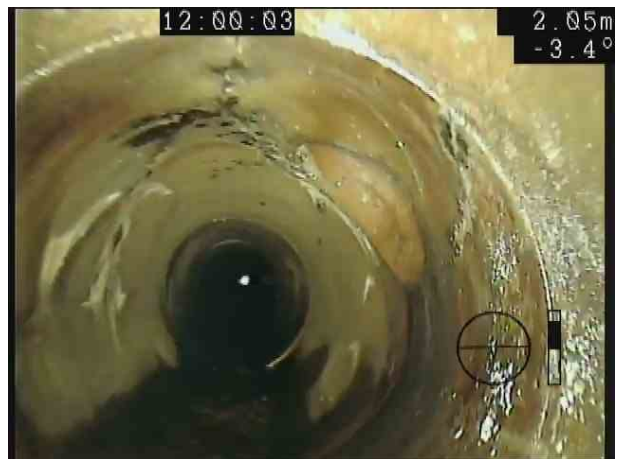
S19X_50f21c81-9d70-4eae-a7b6-a64339ea3148_20201110_111243_796.jpg, 00:00:26, 2.13 m
Crack, circumferential from 9 o'clock to 12 o'clock

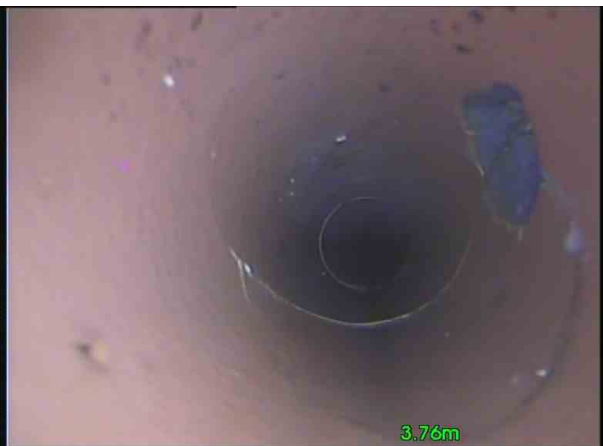
F28X_4930d5ab-3d21-47b6-8a81-1e0fb8b79434_20201106_161234_367.jpg, 00:00:33, 3.76 m
 Crack, circumferential from 3 o'clock to 8 o'clock

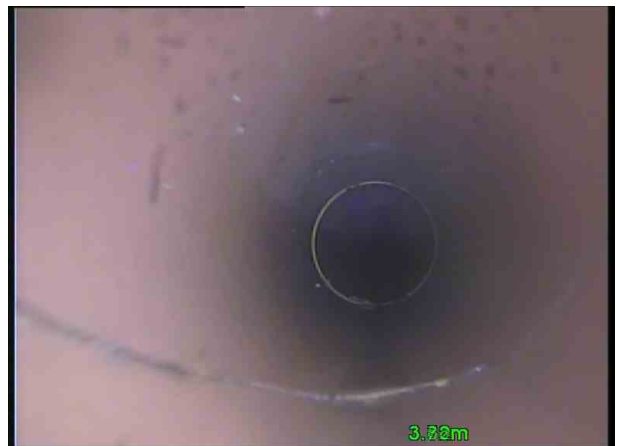
F28X_afa23ae4-bfbc-4ce7-974f-cb345fcd6a97_20201106_161301_053.jpg, 00:00:36, 3.82 m
 Fracture, circumferential from 3 o'clock to 8 o'clock

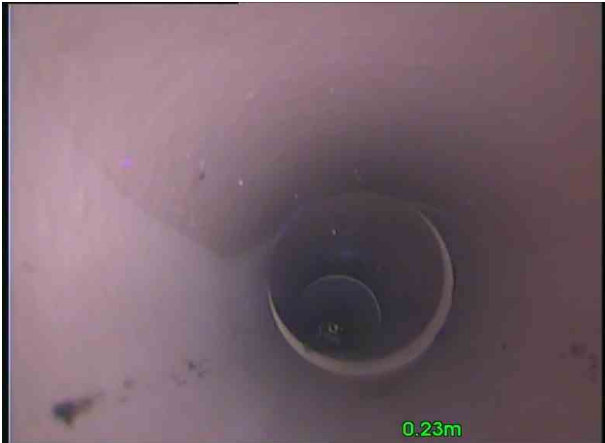
End O
 LineX_8bf572d9-1073-4fd8-8079-dd29252b1eb8_20201109_1
 01306_920.jpg, 00:00:15, 0.23 m
 Crack, longitudinal at 2 o'clock

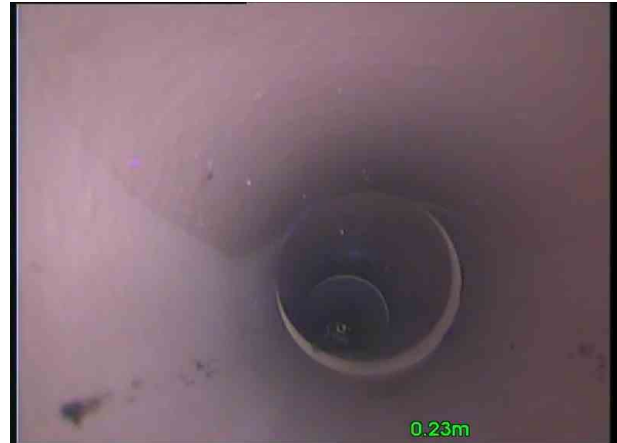
End O
 LineX_21e96b31-7273-4a78-96a6-e1f5af0f99a1_20201109_1
 01245_296.jpg, 00:00:15, 0.23 m
 Crack, longitudinal at 10 o'clock

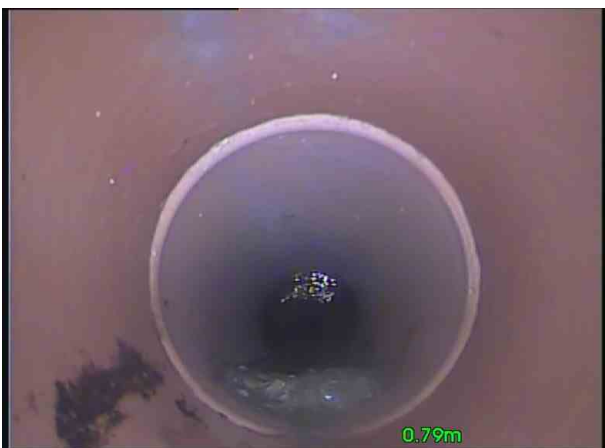
End O
 LineX_ccacb8fa-e7d4-4bdc-9e3b-3f455fe38f59_20201109_10
 1405_971.jpg, 00:00:18, 0.80 m
 Settled deposits, fine, 10% cross-sectional area loss

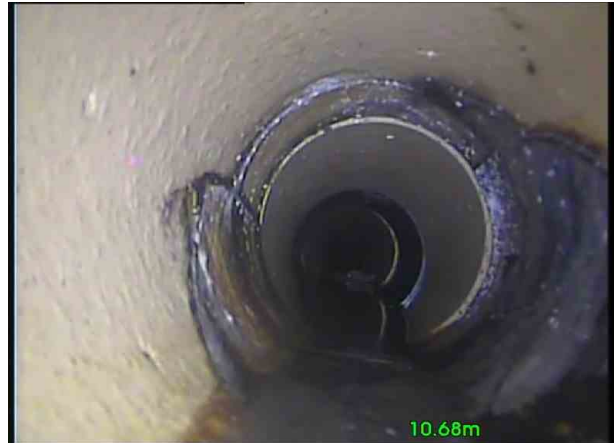
Branch
 X_850a770d-c978-44c7-a3e8-d8c418f00e17_20201109_1619
 25_070.jpg, 00:01:09, 10.76 m
 Fracture, multiple at joint from 7 o'clock to 3 o'clock

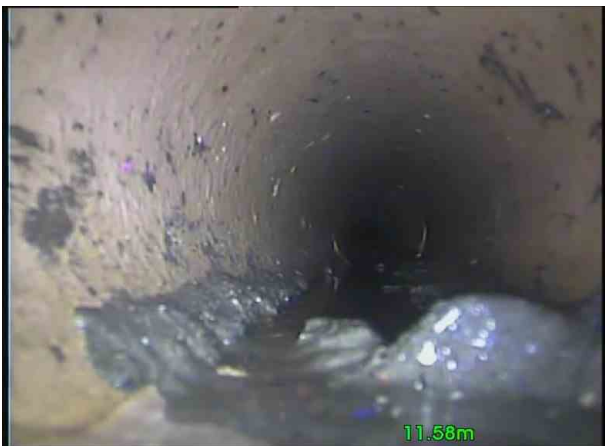
Branch
 X_34783183-e1db-459b-9ac4-04b6f3f610e5_20201109_1621
 17_969.jpg, 00:01:23, 11.60 m
 Settled deposits, fine, 10% cross-sectional area loss

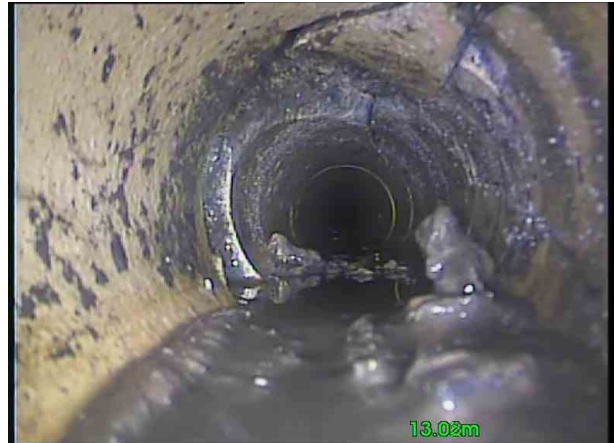
Branch
 X_327269f3-6905-4e12-9e0b-4040eaa99063_20201109_162
 153_785.jpg, 00:01:32, 13.06 m
 Broken pipe from 11 o'clock to 4 o'clock

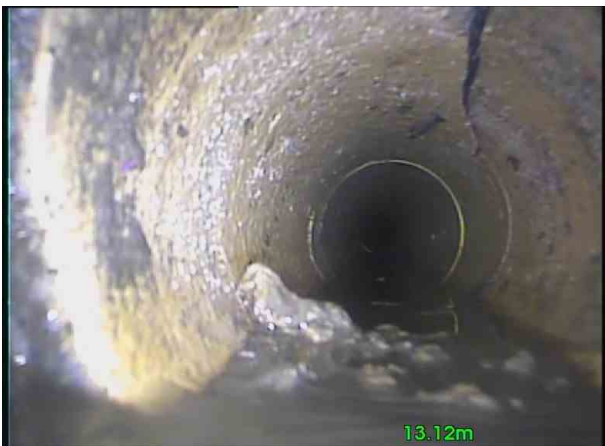
Branch
 X_47092d3a-271a-4efd-9c9e-2d220a38e735_20201109_1622
 57_426.jpg, 00:01:38, 13.12 m
 Fracture, longitudinal at 1 o'clock

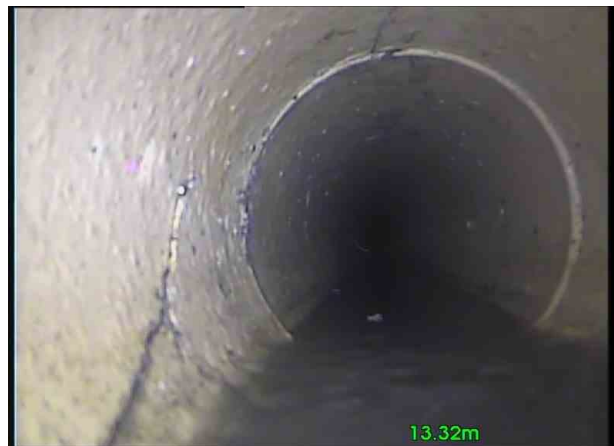
Branch
 X_48819294-8f4c-43f7-b0f2-0d3f8680d79c_20201109_16231
 9_761.jpg, 00:01:40, 13.32 m
 Crack, circumferential from 7 o'clock to 9 o'clock

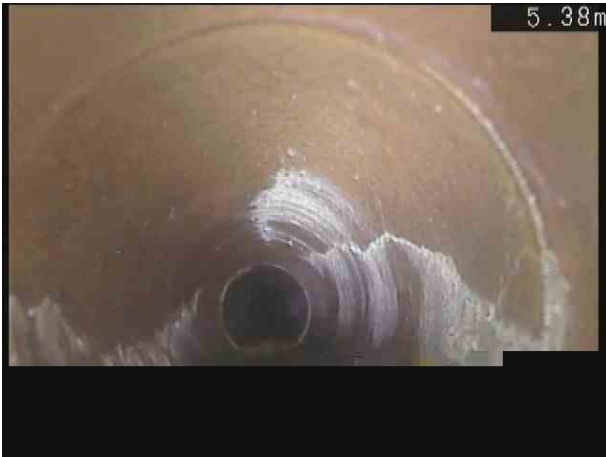
F4X_321b57aa-8ffa-44c2-a497-fbb46036c044_20201109_164307_742.jpg, 00:00:32, 5.50 m
 Crack, longitudinal at 3 o'clock

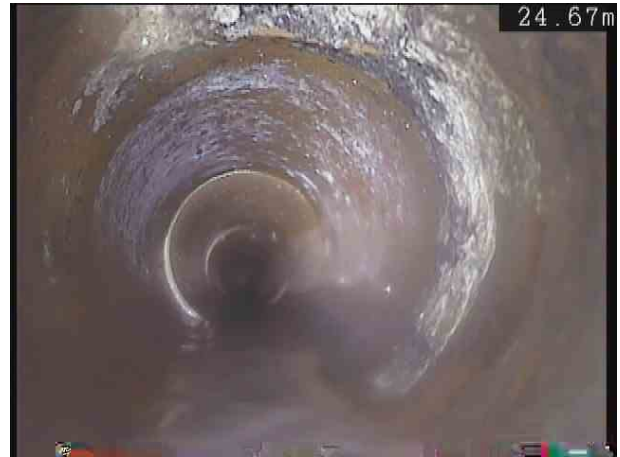
F4X_6191a1bc-4c17-4ad2-8297-9aab1560f653_20201109_165602_771.jpg, 00:02:18, 24.78 m
 Attached deposits, grease from 1 o'clock to 5 o'clock, 5% cross-sectional area loss

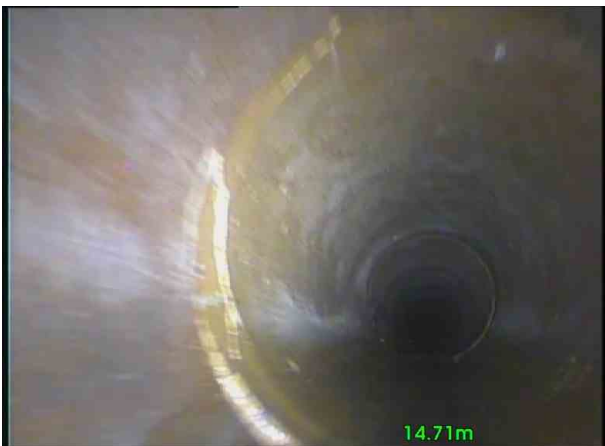
C9X_69511520-c31d-45ca-8d9e-f23c6cc42670_20201110_105248_896.jpg, 00:01:29, 14.70 m
 Crack, circumferential at joint from 8 o'clock to 11 o'clock
