PROJECT  
Whitworth High School  
Whitworth  
Rochdale

DRAWING TITLE  
PAS 128 Utility Survey

Project: **WHITWORTH COMMUNITY HIGH SCHOOL**

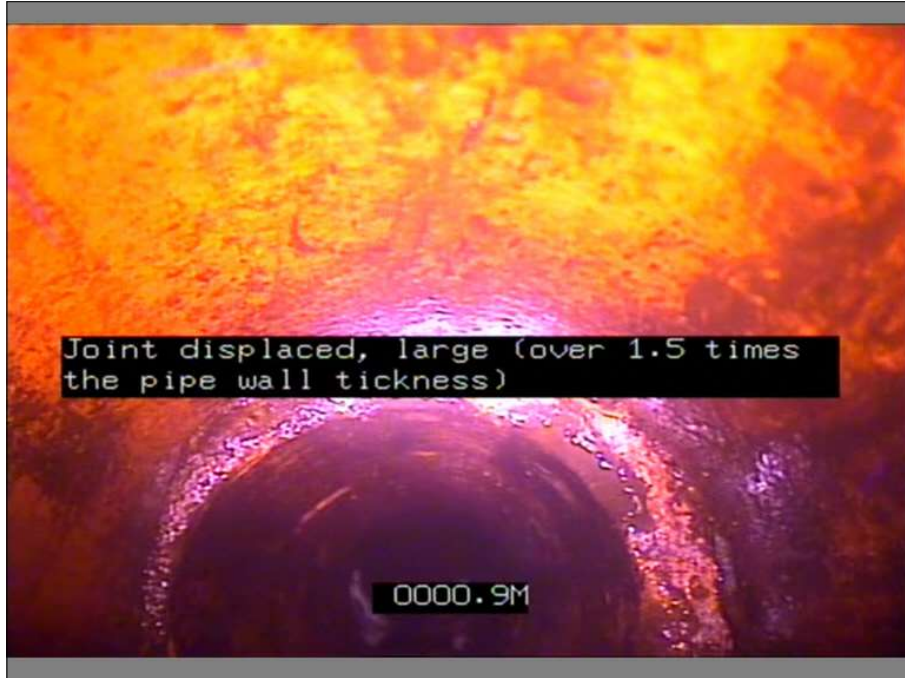
Photo: 1\_2A, MPEG #: 220321\_1, 00:00:50  
0.9m, Joint displaced, large (over 1.5 times the pipe wall tickness)

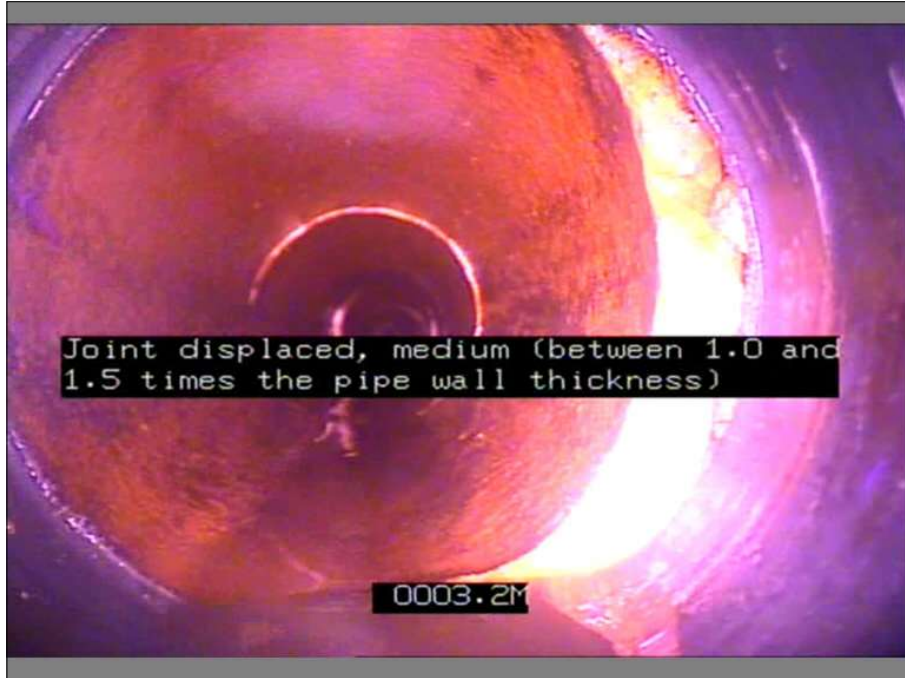
Photo: 2\_2A, MPEG #: 220321\_1, 00:00:30  
3.2m, Joint displaced, medium (between 1.0 and 1.5 times the pipe wall thickness)

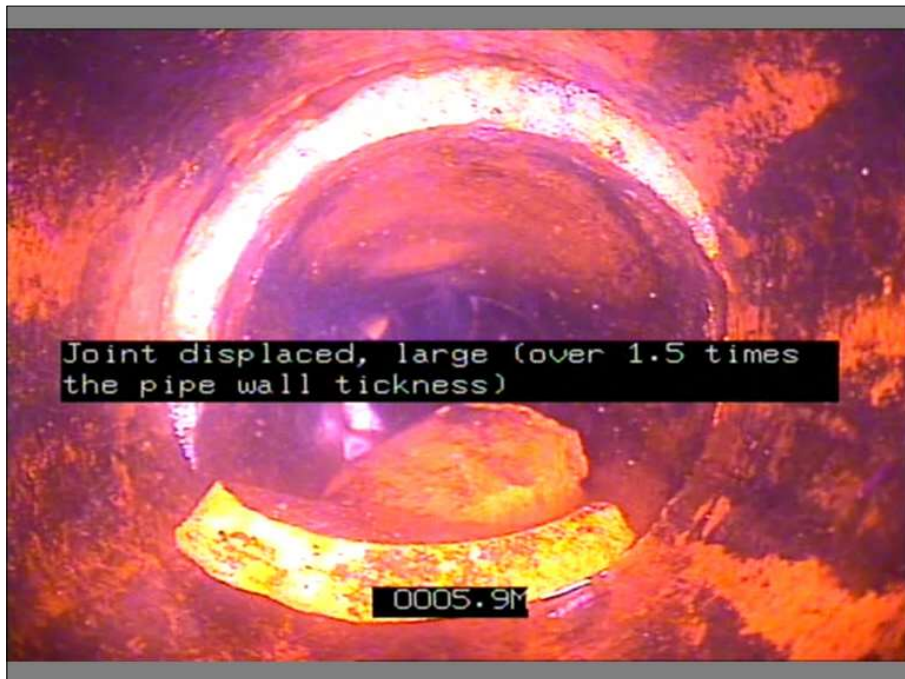
Photo: 2\_4A, MPEG #: 220321\_1, 00:01:06  
5.9m, Joint displaced, large (over 1.5 times the pipe wall thickness)

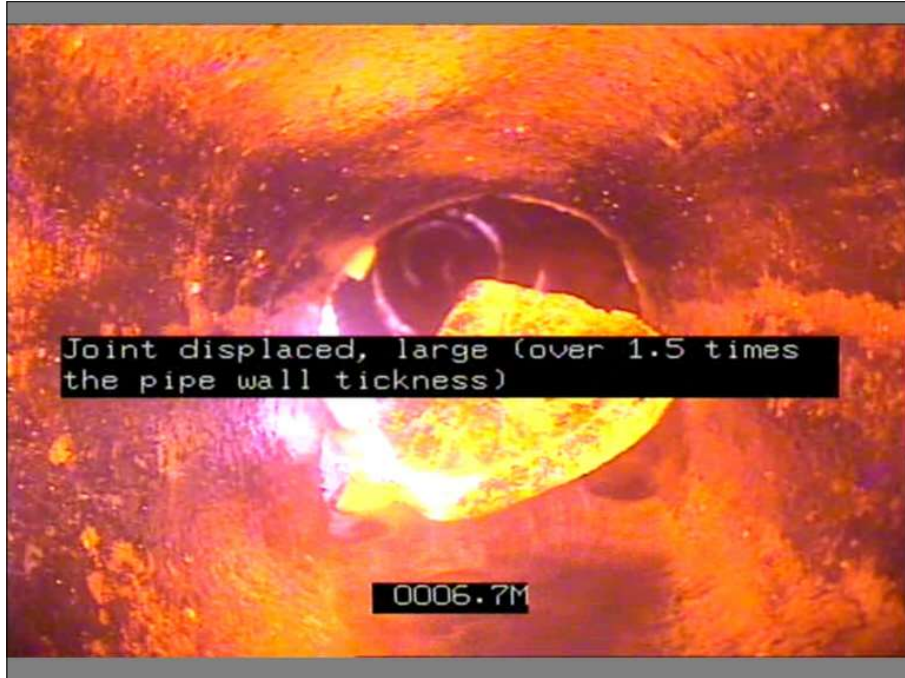
Photo: 2\_6A, MPEG #: 220321\_1, 00:01:22  
6.7m, Joint displaced, large (over 1.5 times the pipe wall tickness)

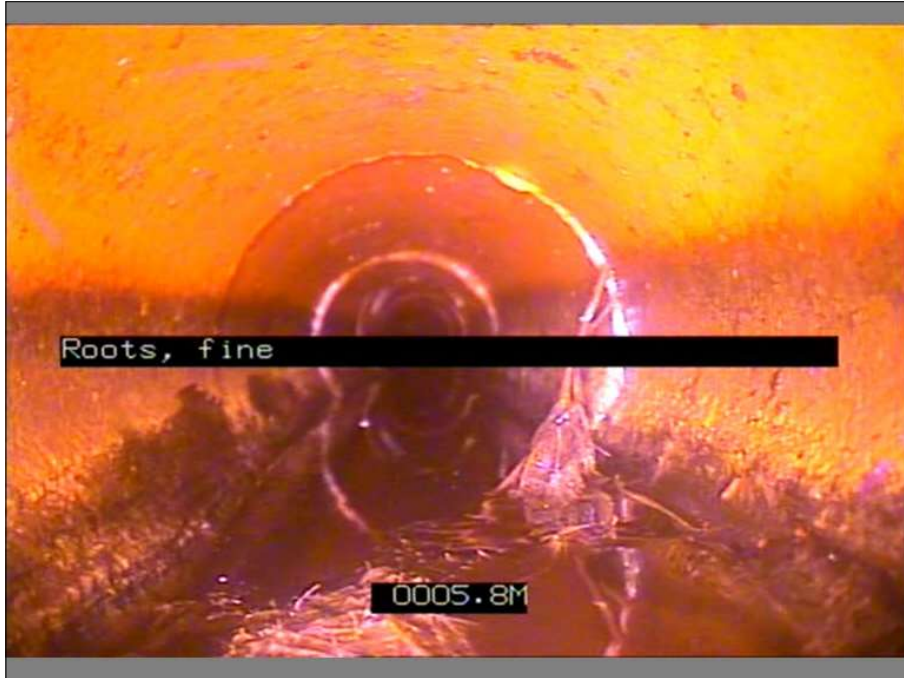
Photo: 3\_2A, MPEG #: 220321\_1, 00:00:45  
5.8m, Roots, fine

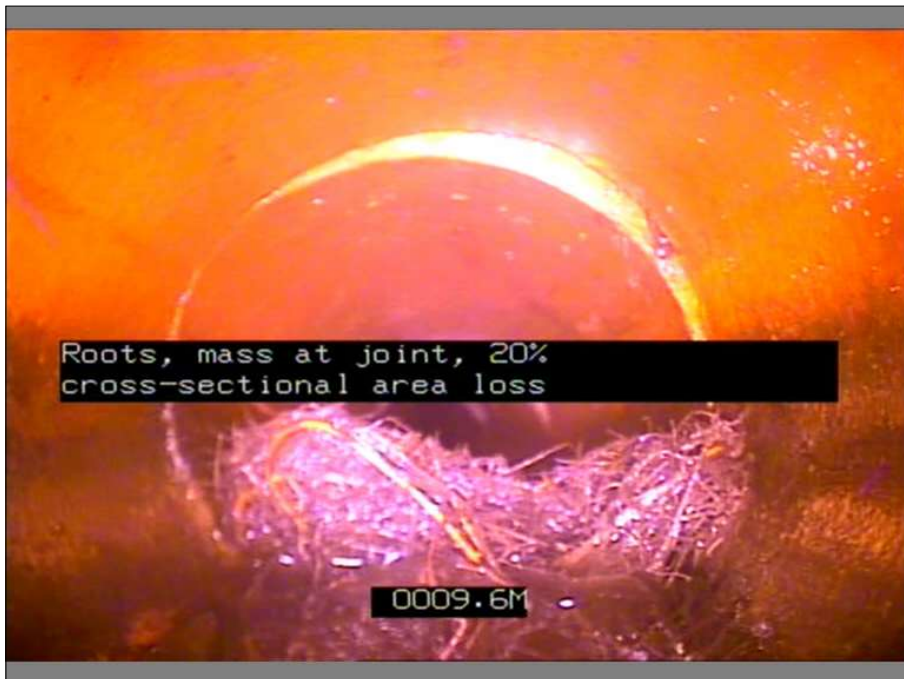
Photo: 3\_3A, MPEG #: 220321\_1, 00:01:26  
9.6m, Roots, mass at joint, 20% cross-sectional area loss

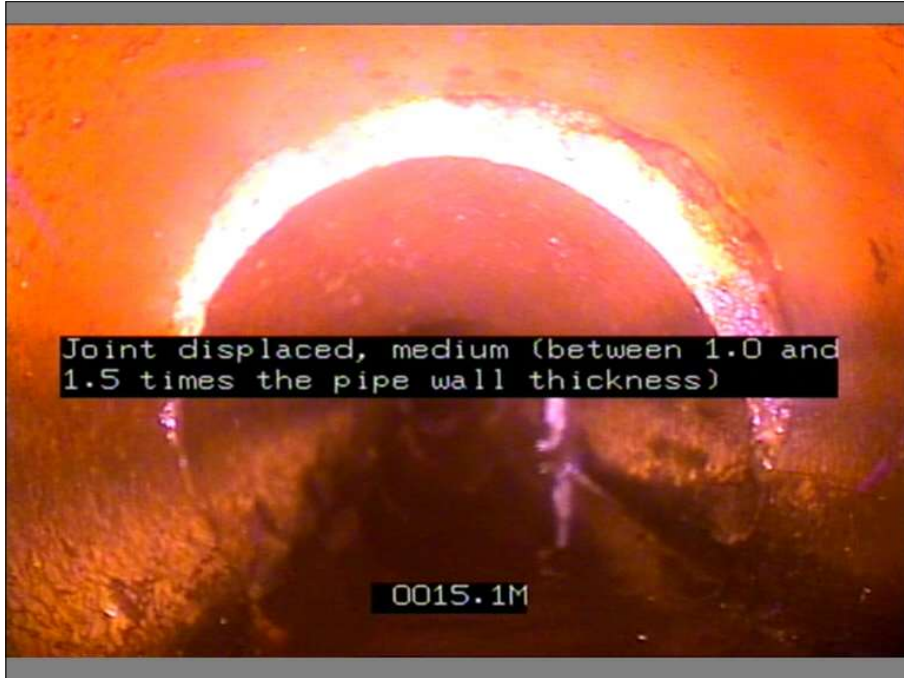
Photo: 3\_4A, MPEG #: 220321\_1, 00:02:04  
15.1m, Joint displaced, medium (between 1.0 and 1.5 times the pipe wall thickness)

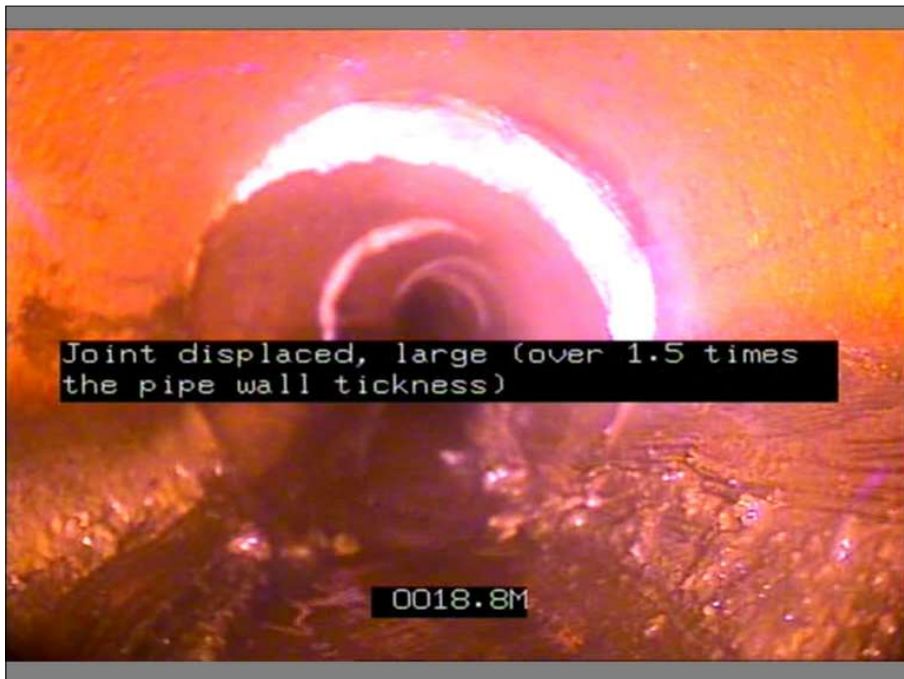
Photo: 3\_5A, MPEG #: 220321\_1, 00:02:27  
18.8m, Joint displaced, large (over 1.5 times the pipe wall thickness)

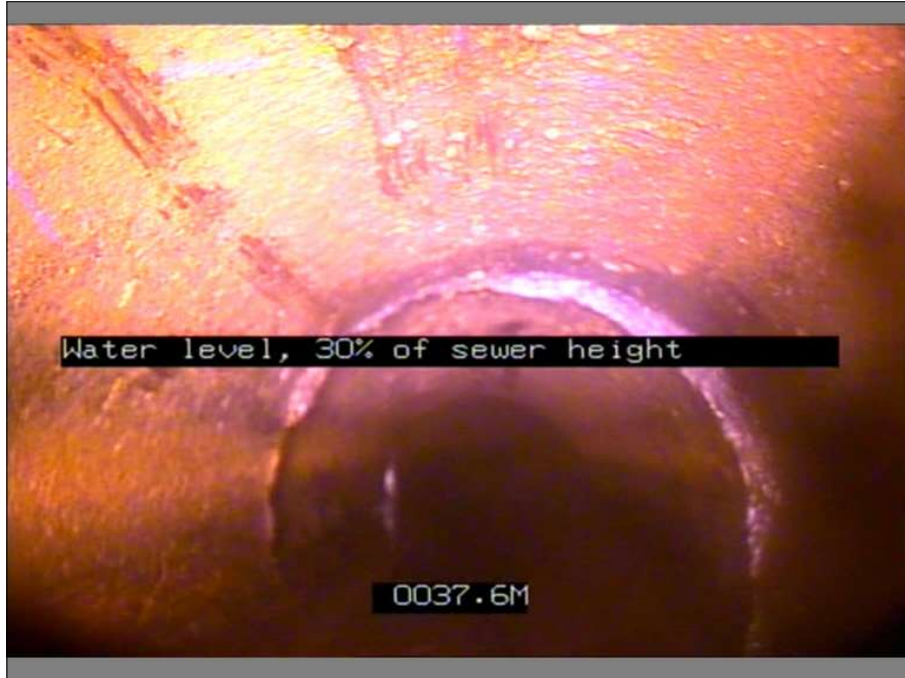
Photo: 3\_6A, MPEG #: 220321\_1, 00:04:13  
37.6m, Water level, 30% of sewer height

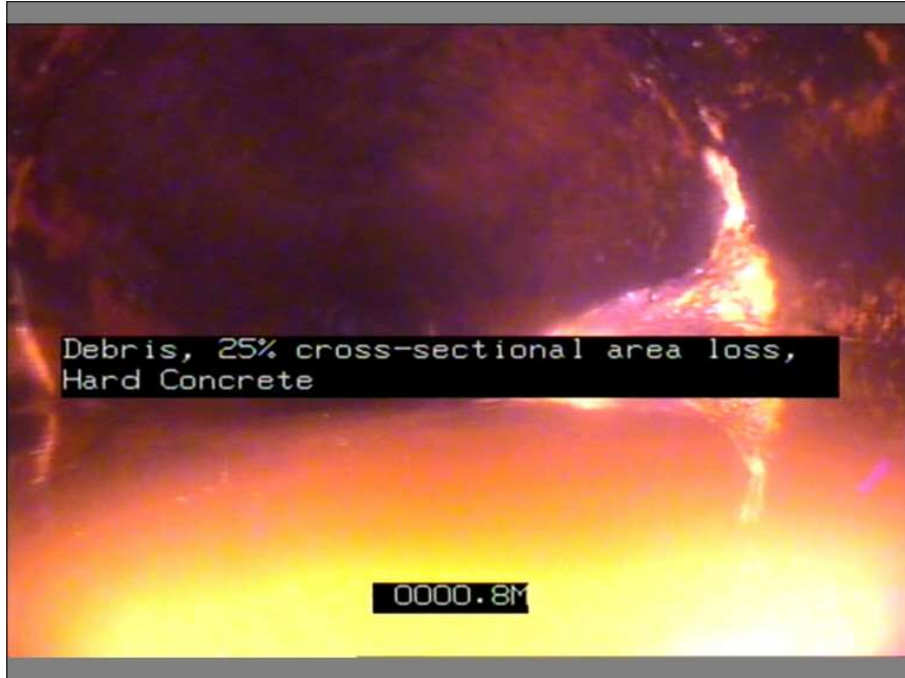
Photo: 9\_2A, MPEG #: 220321\_1, 00:00:39  
0.8m, Debris, 25% cross-sectional area loss

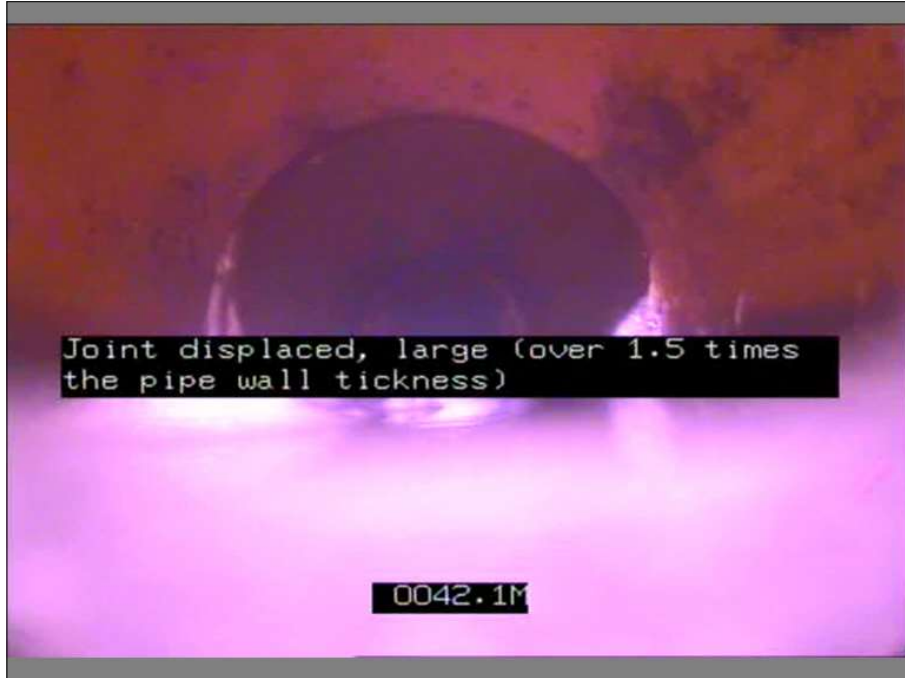
Photo: 10\_2A, MPEG #: 220321\_1, 00:05:22  
42.1m, Joint displaced, large (over 1.5 times the pipe wall tickness)

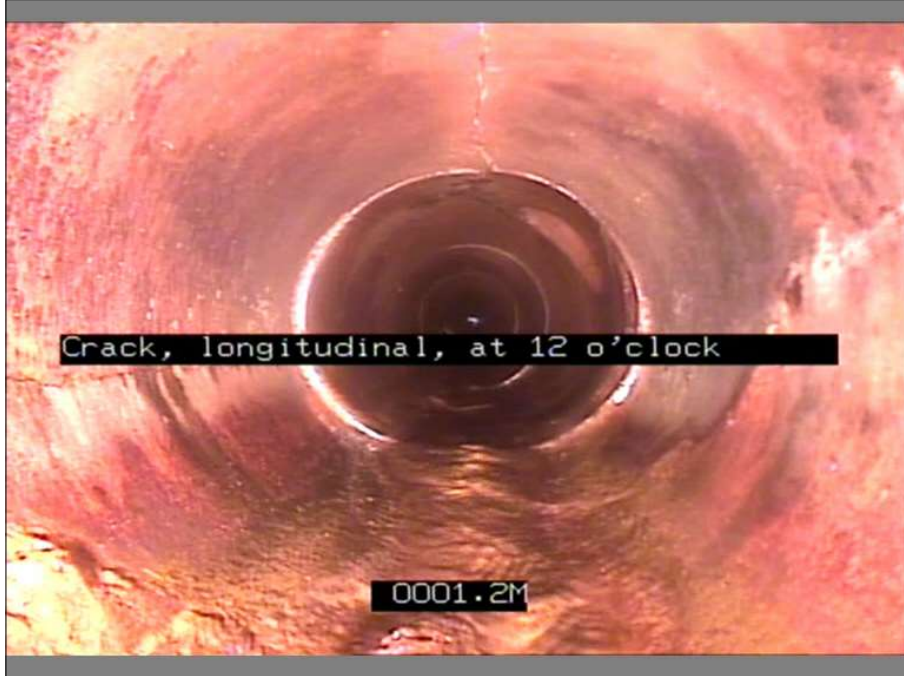
Photo: 11\_2A, MPEG #: 220321\_1, 00:00:32  
1.2m, Crack, longitudinal, at 12 o'clock

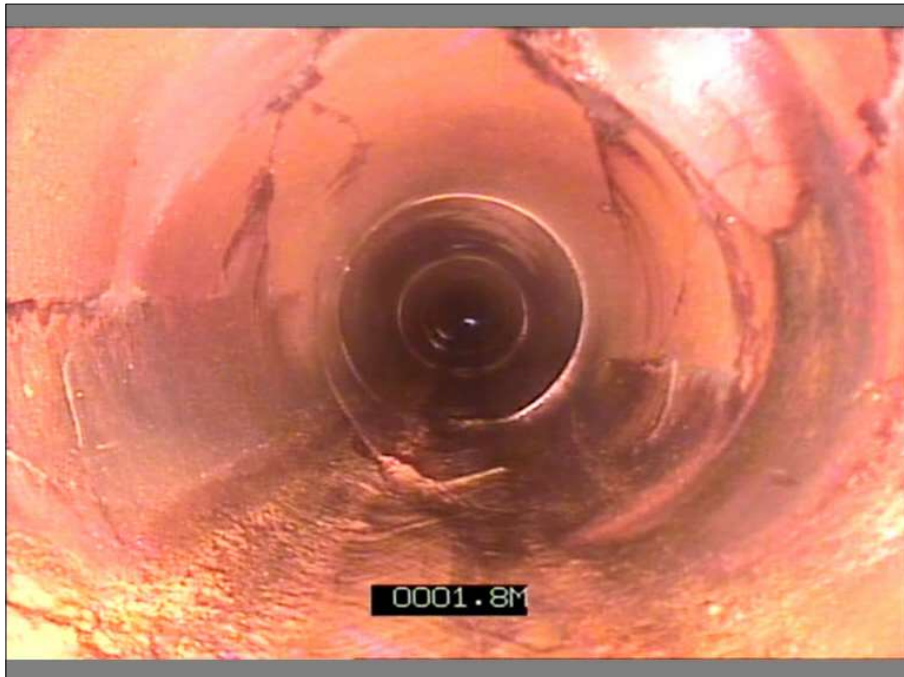
Photo: 11\_4A, MPEG #: 220321\_1, 00:00:48  
1.8m, Cracks, multiple, from 12 to 12 o'clock

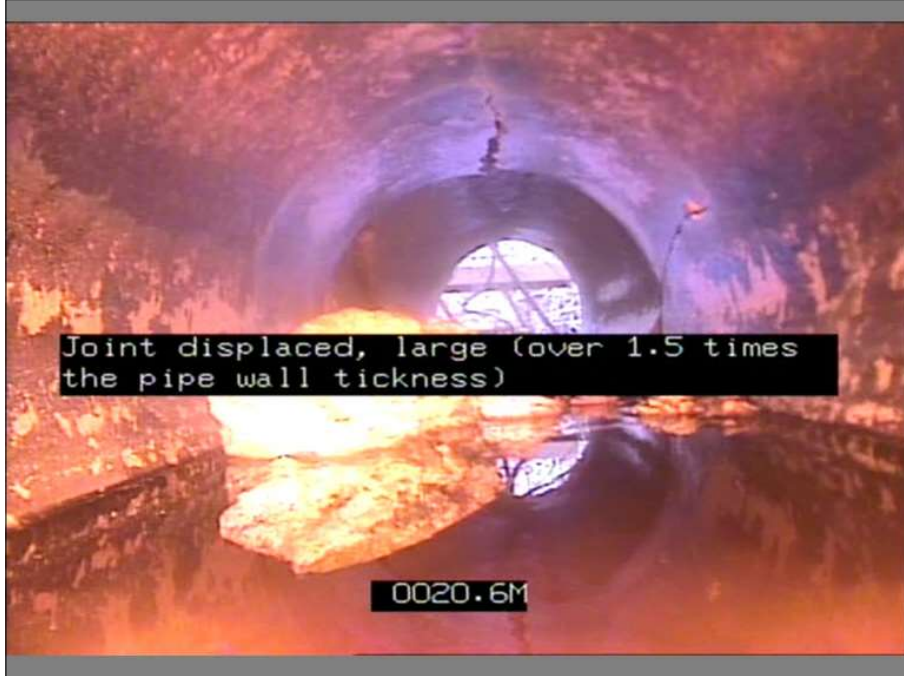
Photo: 11\_5A, MPEG #: 220321\_1, 00:02:41  
20.6m, Joint displaced, large (over 1.5 times the pipe wall tickness)

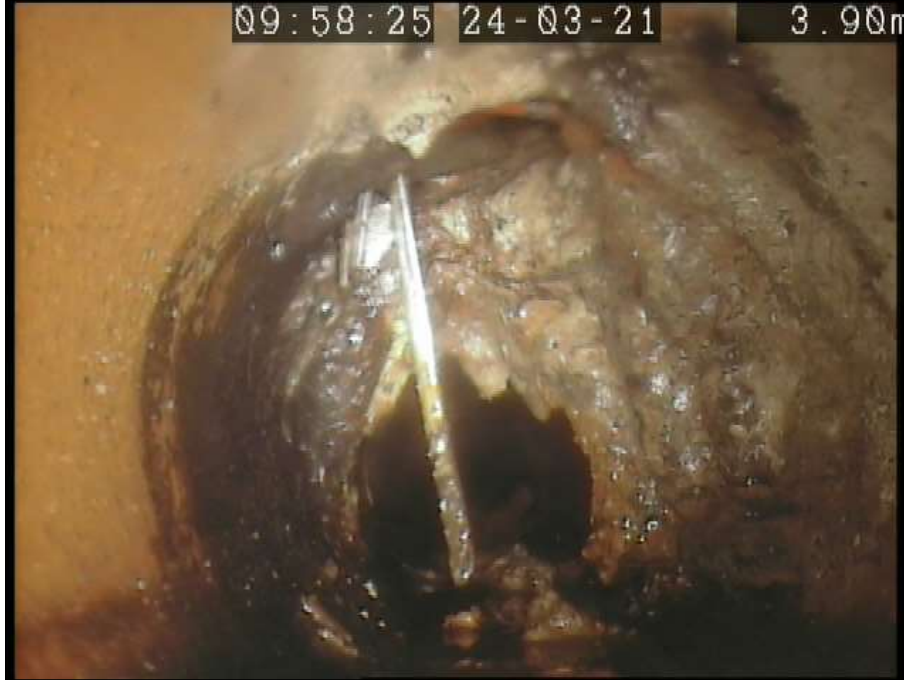
Photo: 21\_2A, MPEG #: 220321\_1, 00:00:28  
3.9m, Encrustation, heavy, from 12 to 12 o'clock, 50% cross-sectional area loss

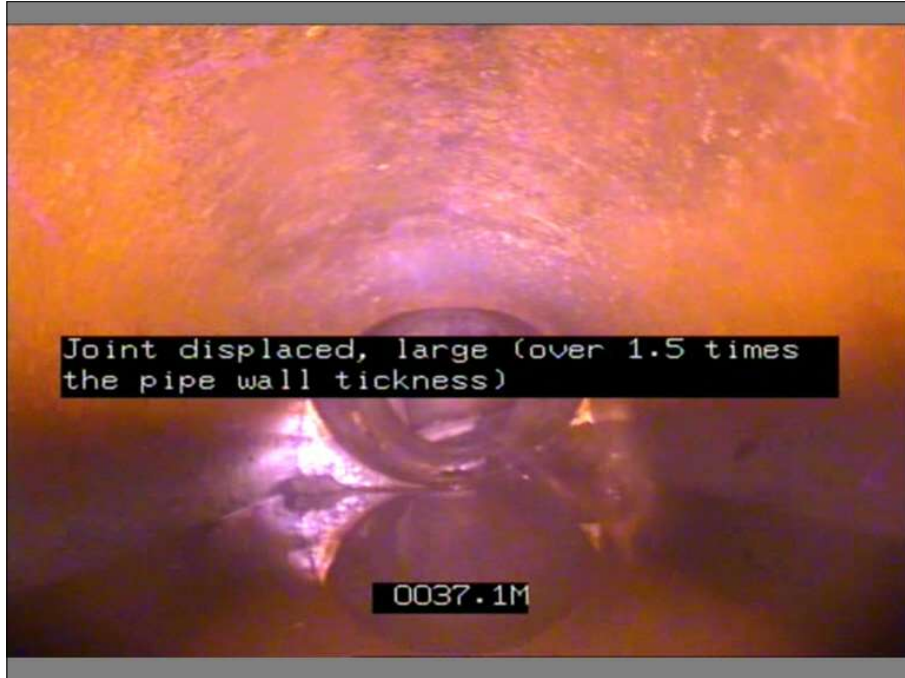
Photo: 29\_7A, MPEG #: 220321\_1, 00:02:32  
37.1m, Joint displaced, large (over 1.5 times the pipe wall tickness)
