**BAMBURGH RESEARCH PROJECT**  
**TRIAL TRENCH EVALUATION**  
**AND HISTORIC BUILDING INVESTIGATION**  
**LORD CREWE ARMS HOTEL**  
**BLANCHLAND**  
**NORTHUMBERLAND**

**ARCHAEOLOGICAL TRIAL TRENCHING AND BUILDING**  
**INVESTIGATION REPORT**

Compiled on behalf of The Lord Crewe's Charity by the Bamburgh Research Project: Commercial Projects Section

BRP 20/03b

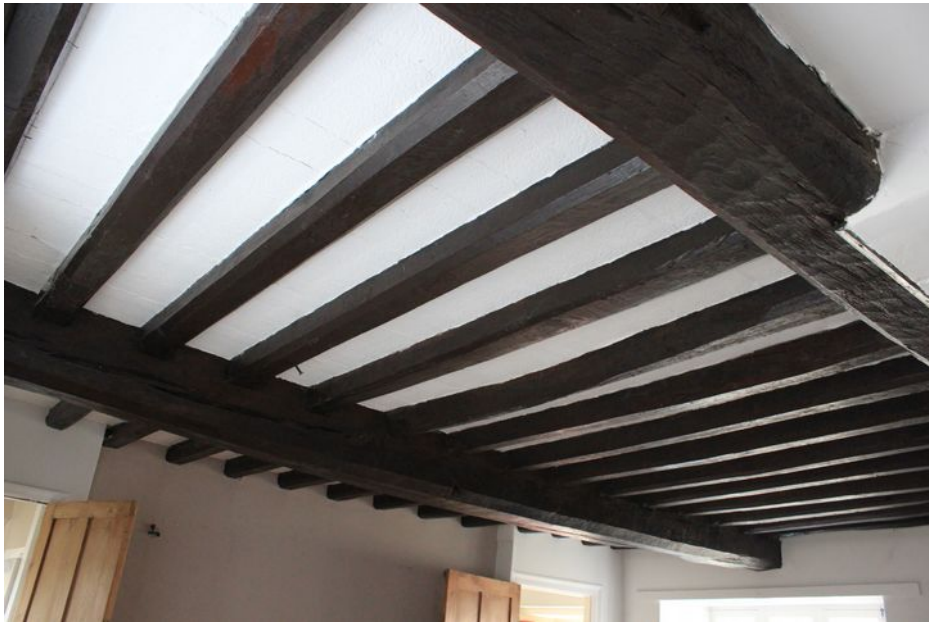
3.1.3 Room B has a very different ceiling structure with very large timber tie beams extending between the walls with smaller, but still substantial joists extending at

right angles to the beams. The tie beams are octagonally shaped and show the clear sign of having been trimmed to shape using axe or adze and therefore seem almost certainly to be of medieval or early post-medieval date. The joists are smaller and less obviously adze trimmed, but are certainly not of a uniform size and do not appear to be machine cut and therefore are likely of some historic significance. Care taken to avoid any substantive impact on the tie beams and joists of the ceiling of Room B during the refurbishment (Plate 1).

*Plate 1: Ceiling structure of Room B, looking south-west*

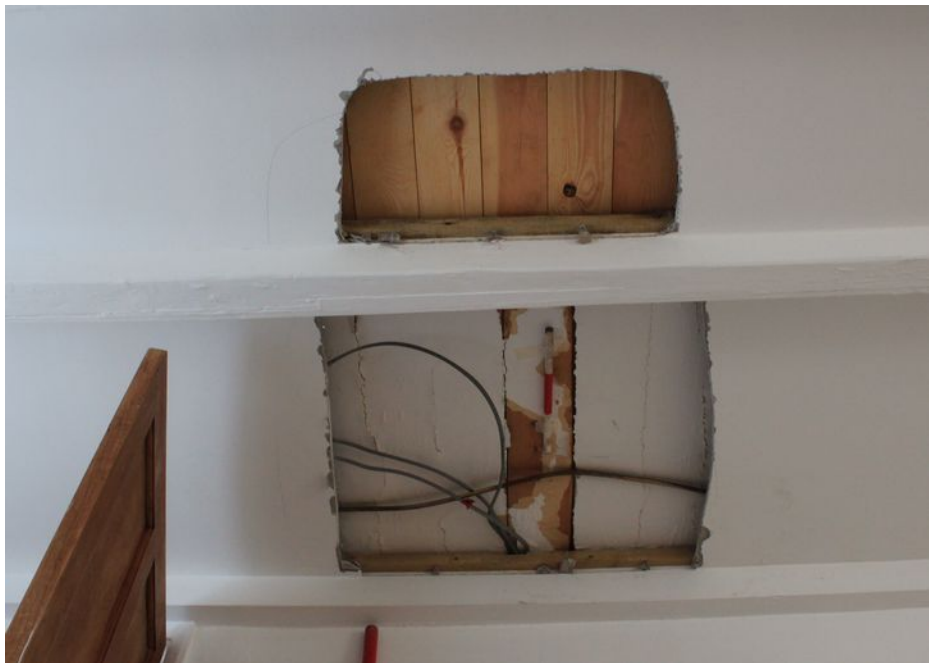
- 3.2.1 A spiral stair case is to pass through the ceiling to allow access from Room A on the ground floor to Room D on the first floor. The type of stair selected requires no fixing to the ceiling of Room D so the impact is only on the ceiling of Room A and the floor boards of Room D. All of the supporting timber for the Room A ceiling, as described earlier, are of modern appearance as are the floor boards where seen by the removal of the ceiling plasterboard from below and the stripping back of the carpet above (Plates 2 and 3).

*Plate 2: Area of ceiling to be impacted by the insertion of the spiral stair with plasterboard removed showing timber and floor boards to be modern, looking south*

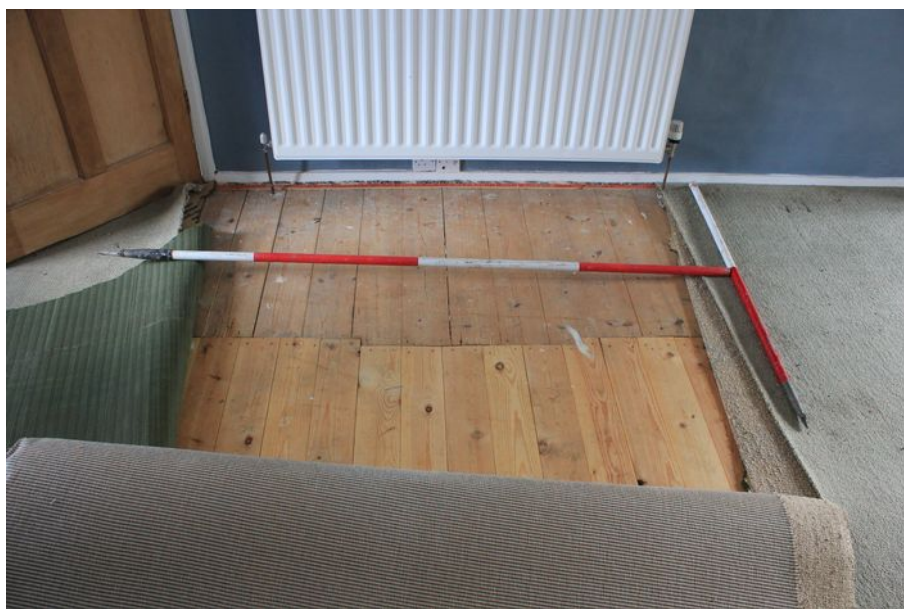
Plate 3: Floor boards in Room D to be impacted by insertion of spiral stair showing two groups of modern boards, facing south

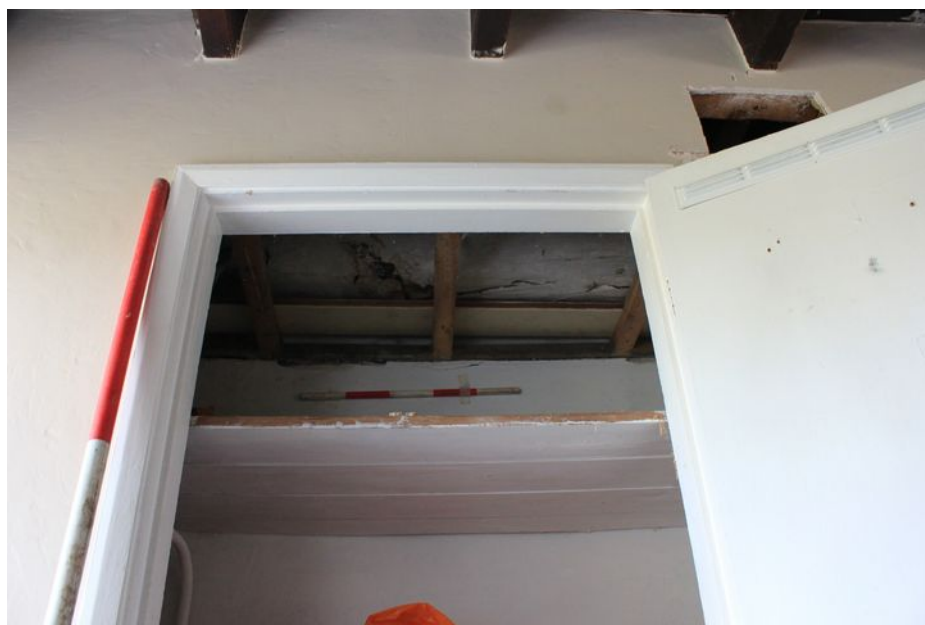
3.3.1 A substantial timber beam was known to be present to the west of the fireplace in the south wall of Room C. A cupboard obscured the same area to the east of the fireplace where the installation of an *en-suite* bathroom was proposed. As the beam was very substantial and showed axe or adze dressing of a similar kind to that seen in the ceiling of Room B and was likely also of medieval or early post-medieval date it was important to identify if the beam was actually present there. Consequently the plaster board false ceiling within the cupboard and a small section of the plasterboard wall to the side of the cupboard was removed to allow for this. The timber beam was seen to be present across the full extent of the alcove and to be of similarly early date to that seen within the alcove to the west. It will be important therefore to preserve this beam *in situ*.

Plate 4: The old timber beam revealed above the plasterboard false ceiling within the cupboard, facing south

- 5.0.5 A substantial timber beam of likely medieval, or possibly early post-medial date is present above the false ceiling within the cupboard to the east of the fireplace in Room C. Consideration will need to be made to how it is safely preserved during the installation of the new *en suite* within Room C.

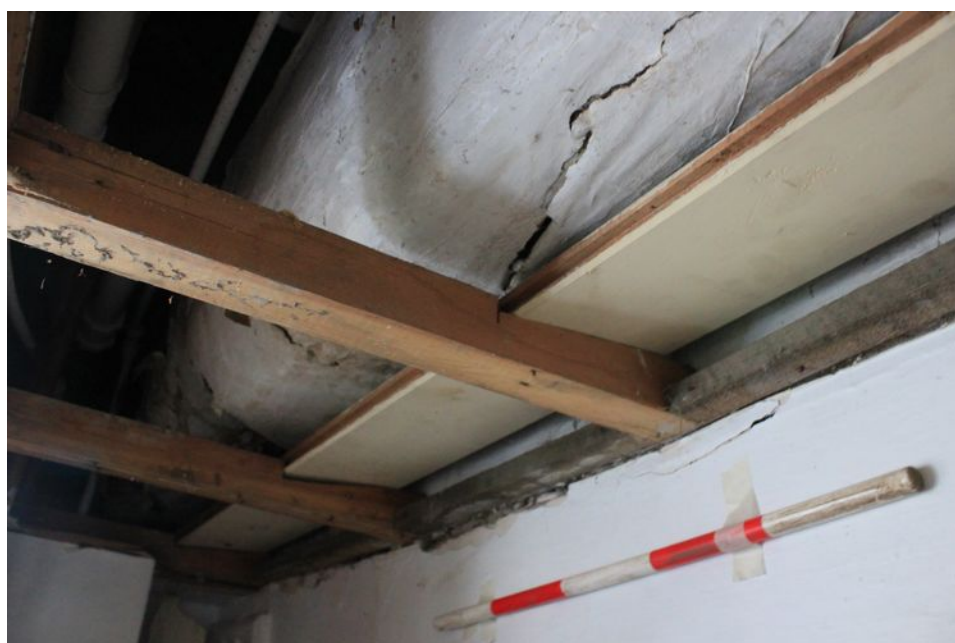
Plate 5: The timber beam extending eastwards to the external wall, facing east

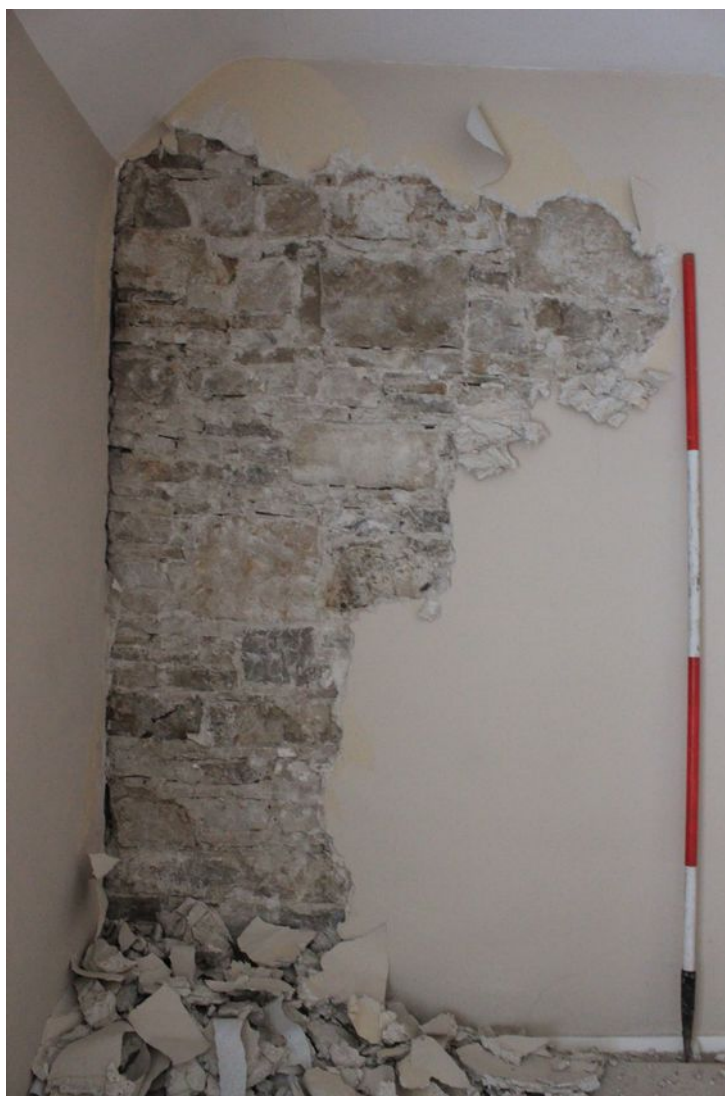
- 3.4.2 The stripped area of plaster revealed a wall of irregularly coursed sandstone blocks of very variable size, from larger squared blocks, likely to be re-used from early structures, to small rubble fragments. No obvious medieval elements are present within the wall structure other than the potential for the re-use of individual blocks. In addition it was seen to butt against the external wall down its full length and therefore appears to be a later insert and not contemporary to the original build phase. Examination of the wall within the cupboard on the other side of the wall was consistent with the above.

*Plate 6: Area of wall within Room E to be recessed to allow for a new wardrobe, facing north*

- 5.0.6 The area of wall between Rooms D and E that is to be reduced is not an original part of the building's structure as it is butt jointed to the external wall and constructed from a very mixed fabric.

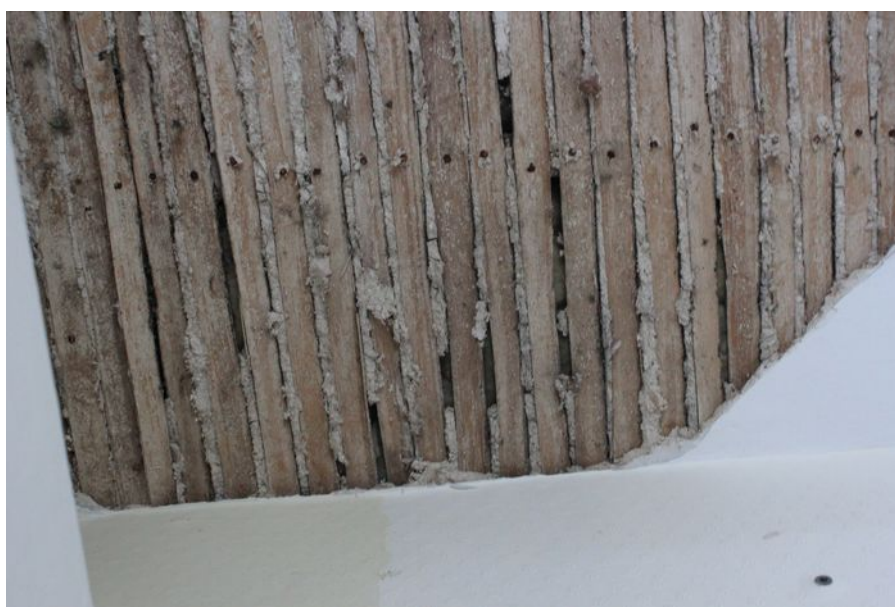
updates to services, fire safety, ventilation and lighting to the first floor as well and all of this work has the potential to impact on the first floor ceiling. Inspection of the ceilings of the first floor shows some of the tie beams and roof timbers, that are clearly part of an old roof structure do extend below the ceiling level into the rooms. Impact on these should clearly be avoided where at all possible. The general ceiling area is of a uniform smooth surface, however, in one area within the hallway at the top of the stairs to the side of Room E some of this modern plasterboard has fallen to reveal small timber laths and traces of older plaster beneath it. This appears to represent an earlier ceiling later covered but there is no indication that this earlier ceiling material is of particularly great age (Plate 7).

*Plate 7: Earlier laths and plaster seen beneath the modern plaster board, hall ceiling first floor, facing west*

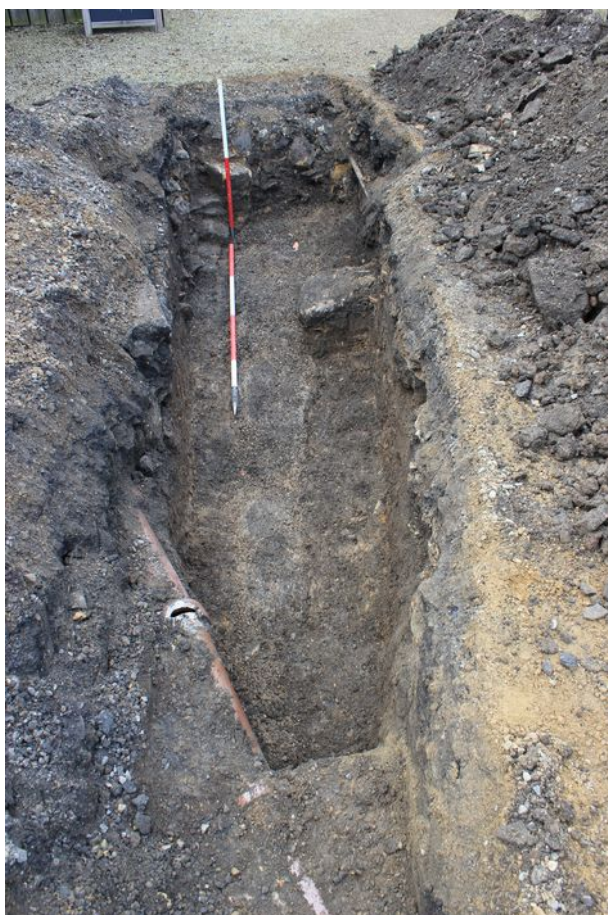
4.1.1 Subsoil (**119**) that comprised a medium yellow-brown silty clay was seen at the base if the trench 1.13m below ground level (236.72m OD). A very disturbed sandstone wall (**111**) was present cut into subsoil in the south-west corner of the trench. It survives partially intact, disturbed by a number of features but appears to have been constructed on a rubble foundation on which square cut dressed sandstone blocks had been laid. It was silt bonded and may have been partially robbed. It survived up

to 0.4m in height and was sealed by a soil layer (**110**), a stony very dark brown clay silt over which a less stony layer of grey-brown silty clay was present (**109**), further covered by a thin layer of dark near black silt (**106**). This was in turn cut by a pit (**104**) that contained a layer of sandstone rubble (**103**) and a medium yellow-brown sandy silt (**102**) (Figure 5 and Plates 8 and 9).

- 4.1.2 The trench contained three service trenches. The largest of these (**114**) extended along the trench on an east to west alignment and contained a gravel fill (**113**) and had truncated wall **111**. This was cut on its north side by a further service trench (**116**) that contained a narrow metal pipe and also cut at the east end of the trench by a service cut (**108**) for a soil pipe that extended across the trench on a south-east to north-west alignment. The services were sealed by topsoil (**101**), two paving slabs (**105**) and this in turn sealed by gravel (**100**) that formed the hard standing in the area.

Plate 8: Trench 1 showing the fragmentary stone wall at the far end of the trench and the service cuts, facing west

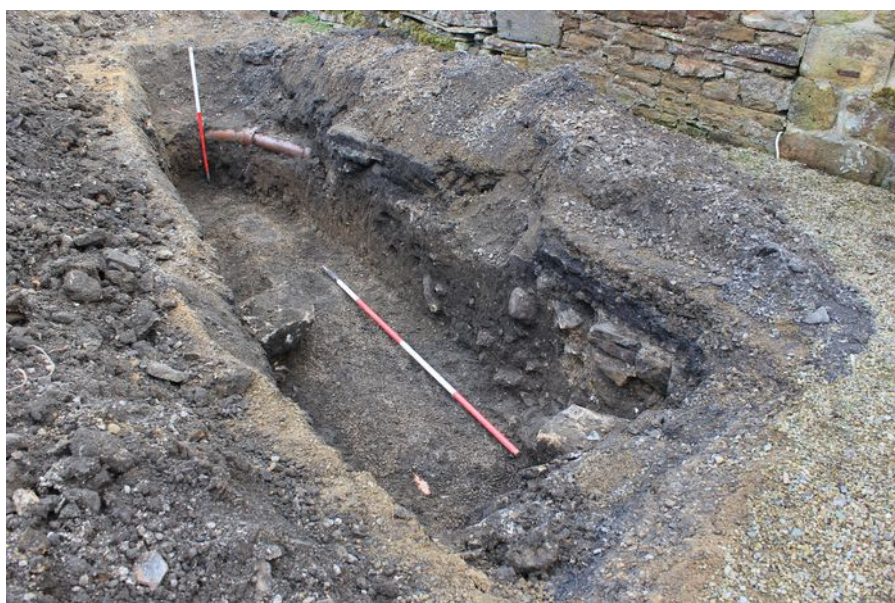
Plate 9: Trench 1 showing the fragmentary stone wall truncated by the service trench and rubble filled pit, facing south-east

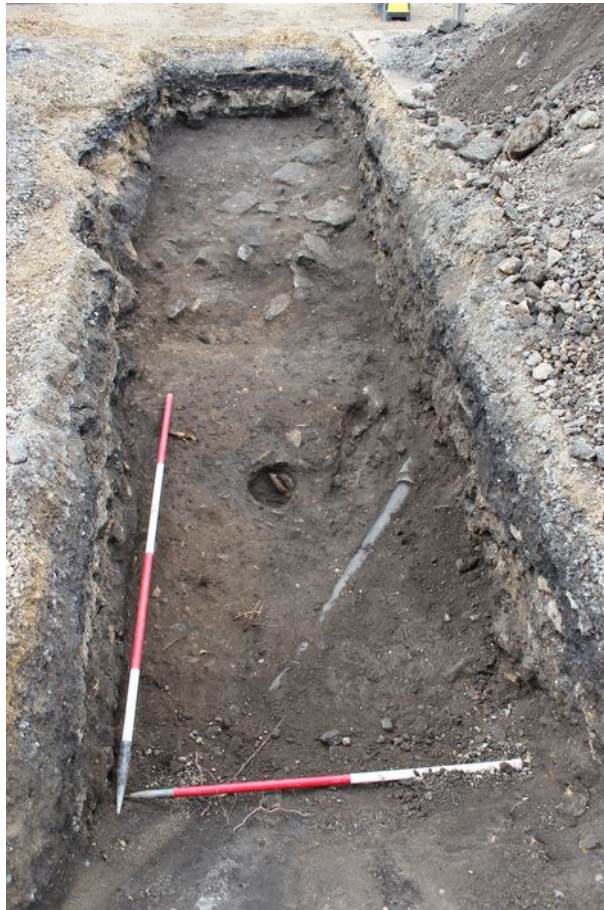
- 4.2.1 Subsoil (**215**) was seen at the base of the trench and comprised a red-brown silty clay with some stones. It lay between 0.7m and 1.0m below ground level (232.32m and 232.04m OD) and was cut by a stone wall (**210**) at the west end of the trench that may have been contained within a rather ephemeral shallow cut (**212**). The wall survived only one course high, was formed from two faces of square cut medium sized sandstone blocks with a rubble core. It was silt bonded and was disturbed at the south end where it appeared to have been robbed out as it did not extend to the section (Figure 5 and Plate 10).

- 4.2.2 The wall and subsoil was sealed by a layer (**209**) of dark grey-brown stony sandy silt which in turn was covered by a grey-brown sandy silt with pebbles (**208**). At the east end of the trench these layers were overlain by a stony dark silt layer (**207**) and a stony mortar spread (**206**) and a dark grey-brown stony layer (**205**) that also contained a substantial mortar content. Both layers had the appearance of being derived from demolition rather than being in any way structural. In addition a number of masonry blocks within the west end of these layers, and the central part of the section, are in the correct place to represent rubble from the robbing of wall **210**. Two mortar layers (**204** and **203**), separated by a thin silt lens were present in the east part of the trench sealing layer **208**. It was unclear if these layers represent a crudely laid mortar surface or a dump deposit. They were sealed by a layer of very dark grey-brown silt (**202**) with a substantial stone content. The trench was covered by a pebble surface (**200**) laid on a thin silt layer (**201**).

*Plate 10: Trench 2 showing the partially surviving stone wall and intrusive service, facing north-west*

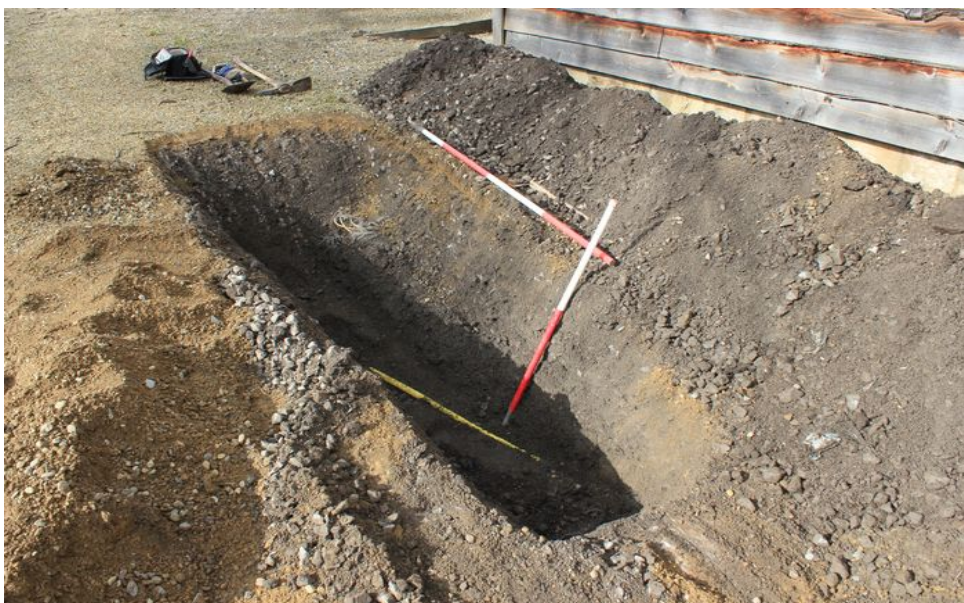
*Plate 11: Trench 3 containing made-up ground and modern service, facing north-west*

- 4.3.1 Trench 3 revealed the presence of a service pipe within its cut (**303**) that appeared to be cut into a made-up ground (**301**). The service pipe was sealed by the pebble hard standing layer (**300**) that formed the ground surface (Figure 5 and Plate 11).

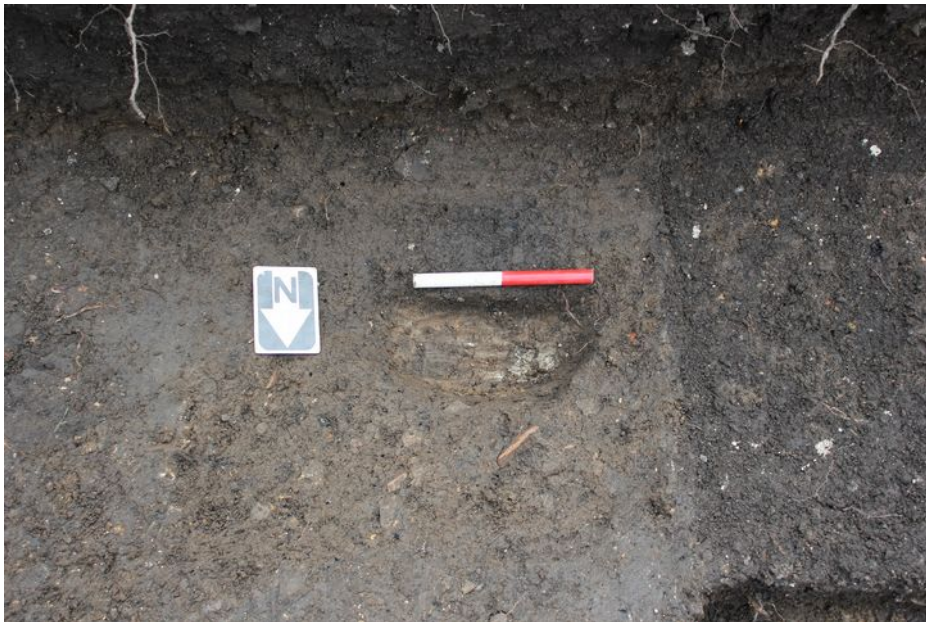
*Plate 13: Trench 5 showing the small feature (504) and service cut (502), facing south*

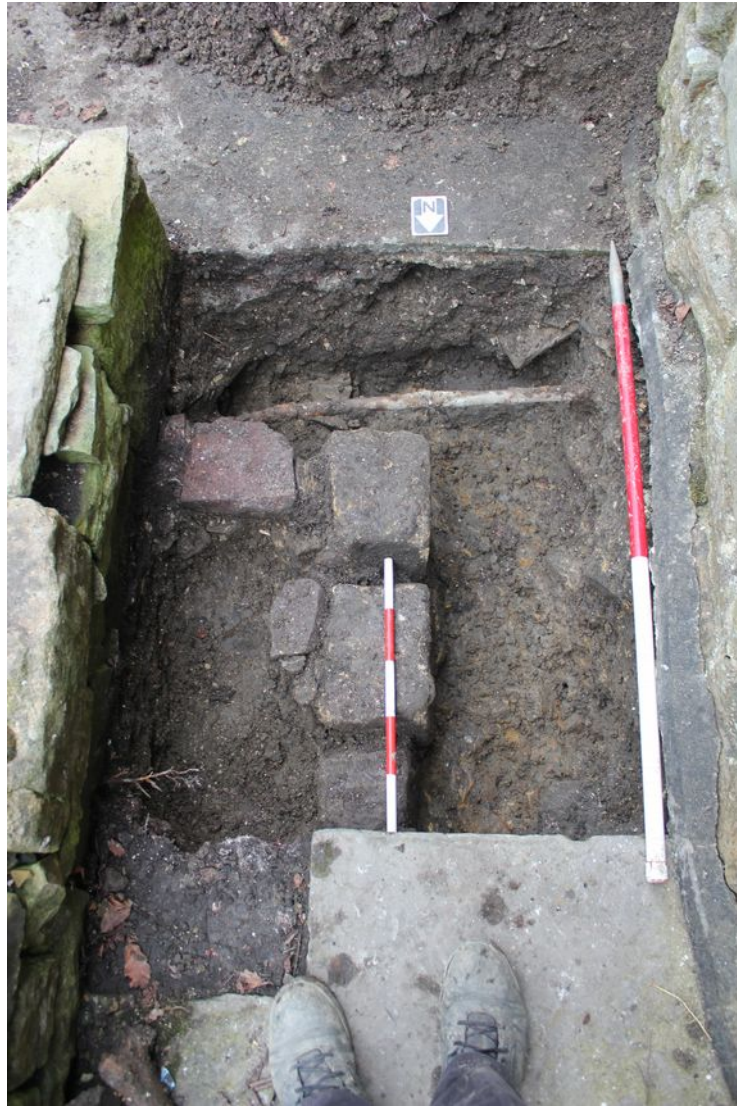
- 4.6.1 Subsoil (**606**) was seen at the base of the trench 0.45m below ground level and was the same yellow-brown clay with some stone seen in Trenches 4 and 5. A single course, and single thickness, stone right-angled linear (**602**) that may have been a very crude wall was seen on a north to south alignment set on the subsoil and covered by a soil layer (**601**), a dark grey-brown silt with some clay and stone content. The feature was of unknown date but had the appearance of being a garden feature. At the south end of the trench two or three small split sandstone flags (**603**) were seen to lie on the subsoil to the south of the wall. A water service pipe (cut **604** and fill **605**) had been cut in at the south end of the trench above the level of the slabs. The trench was covered by pavement slabs (**600**) that formed the ground surface (Figure 5 and Plate 14).

*Plate 14: Trench 6 showing the stub wall (602), facing south*
