BUILDING CONDITION SURVEY

The former Eagles Inn Cressage Shropshire SY5 6DE

Client: Mr Joe Nugent: Brownshore Management Ltd

Date of inspection: 29/10/2019

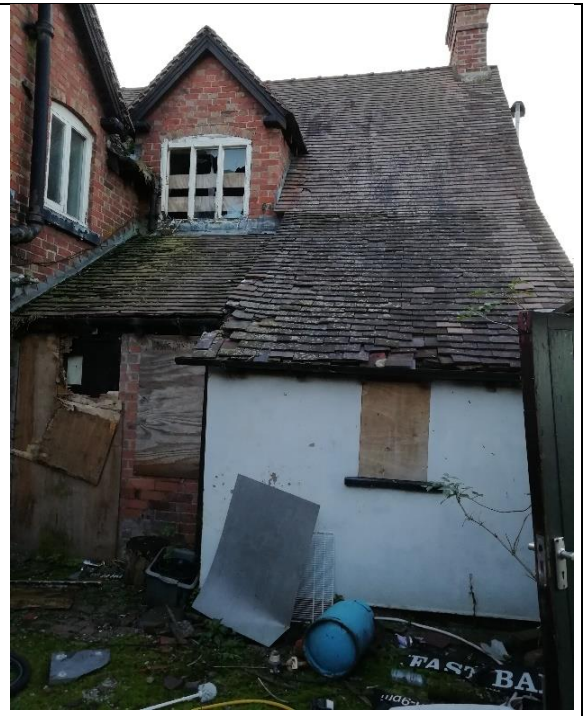
few localised areas to lower levels that will require some repair work towards the rear of the property. There did appear to be some deflection to the ridge line probably as a result of settlement or structural alterations over the centuries. The valleys are mostly tiled except for the western lead valley that could not be inspected from above but did appear to be functioning as intended shedding water onto the west entrance canopy and into guttering. The building abutments between stages of development also appeared to be functioning as intended and in reasonable condition.

3.4 Rainwater goods: The guttering is a miss-match of differing forms of cast iron and plastic with hoppers and running outlets in various locations around the building. As it was not raining at time of inspection the adequate disposal of rainwater could not be determined however, guttering is an often-overlooked important maintenance item and they should always be clear from debris. The cast iron elements of the guttering tended to be in a reasonable condition, however, may need attention within the near future. Some parts of the plastic guttering were missing and will need repaired or replaced.

Repairs to roof and gutters required.

7.2 Externally: The property is vacant therefore subject to vandalism and may require further security measures in place. It would be wise to address all issues of water ingress and clear rainwater gullies and repair gutters or roof tiles to prevent the water penetration until the property is brought back into habitation

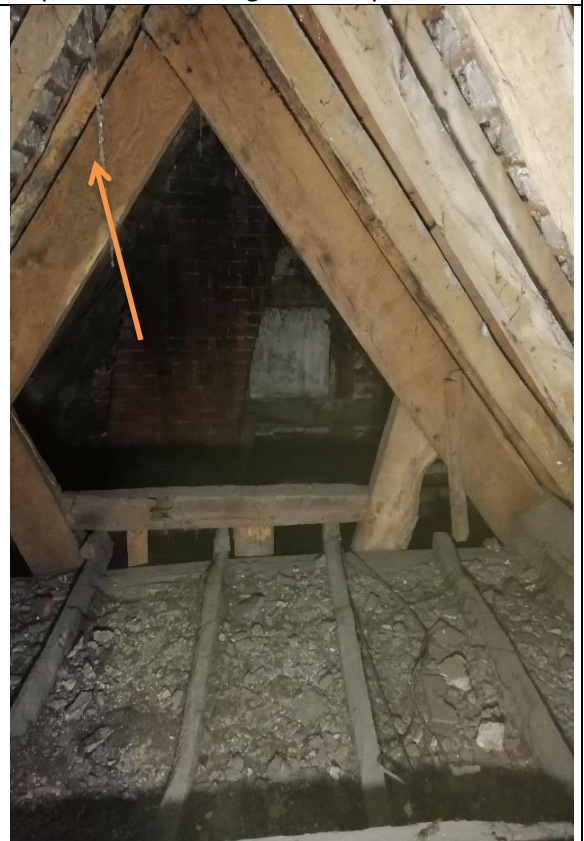
Typical Tudor style frame 17th century

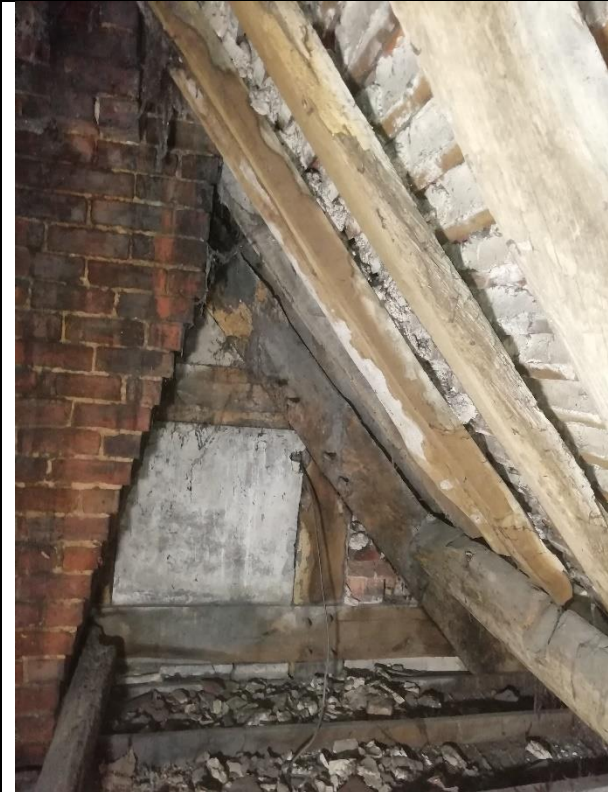
Chimney built later in front of Tudor frame.

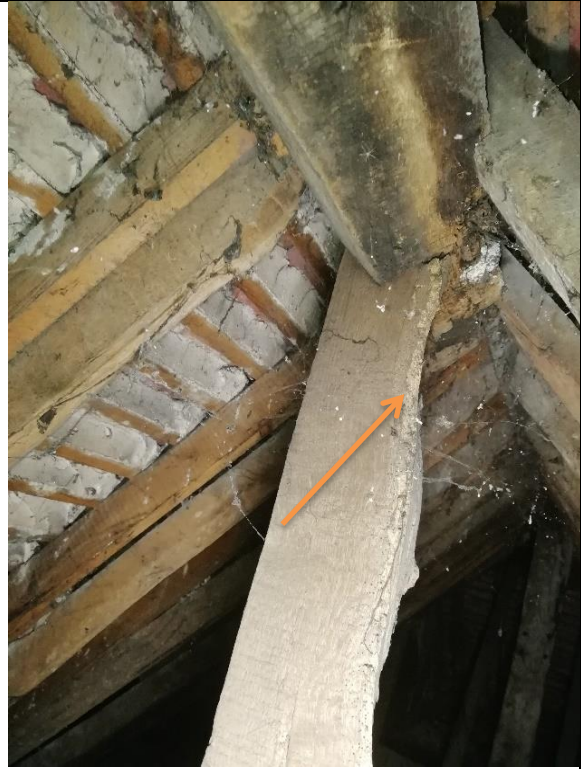
Evidence of beetle infestation and rot.

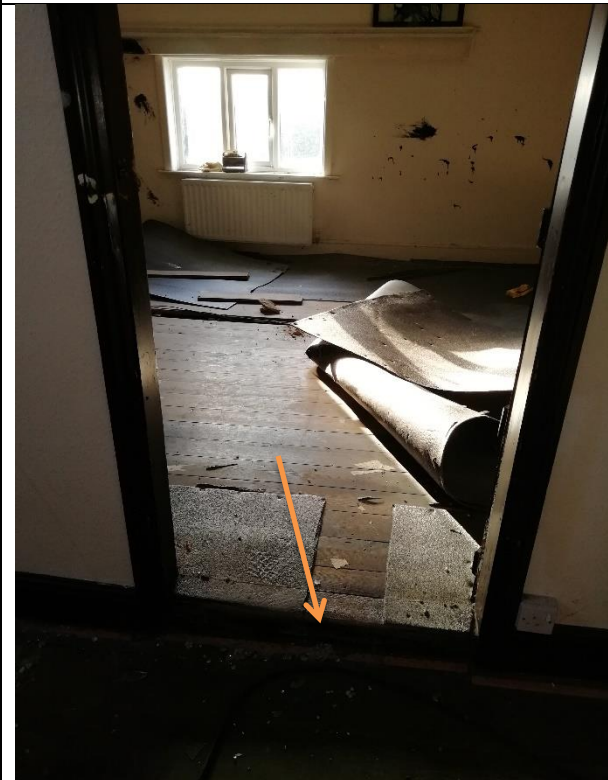
Floor evened up by overlaid joists and flooring

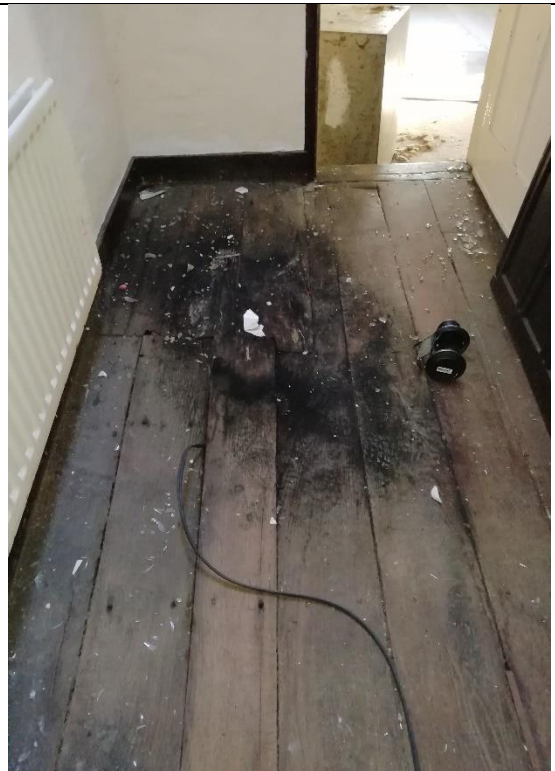
- 3.9 External windows and doors.** Generally, the doors are of a modern timber mortice and tenon construction in poor condition with panels and glass panes broken and boarded up. The windows are either modern Upvc double glazed in poor condition or single glazed casement windows from a slightly earlier period in poor condition with broken panes of glass and boarded up on the ground floor. There is a couple of roof lights one Velux style in reasonable condition and another timber frame where the glazing has slipped allowing the elements into the building and causing water damage to the floor below.

Damage to floor from open skylight.

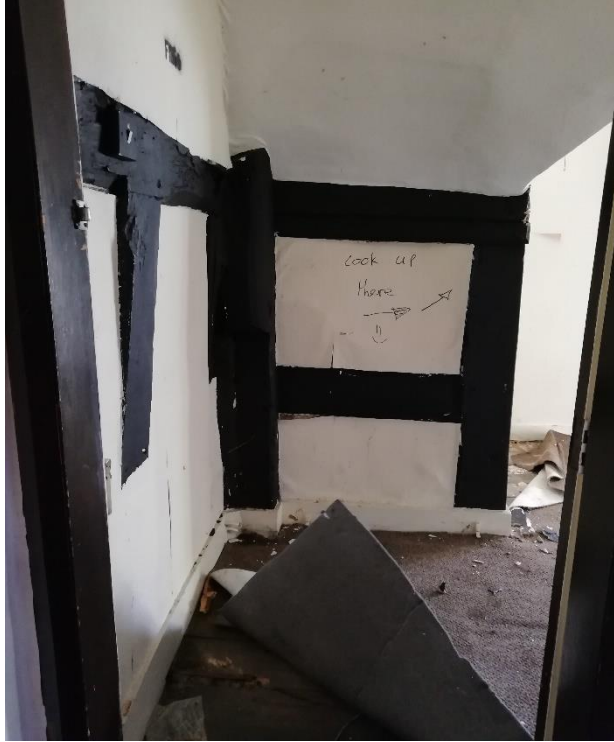
Timber frame painted black

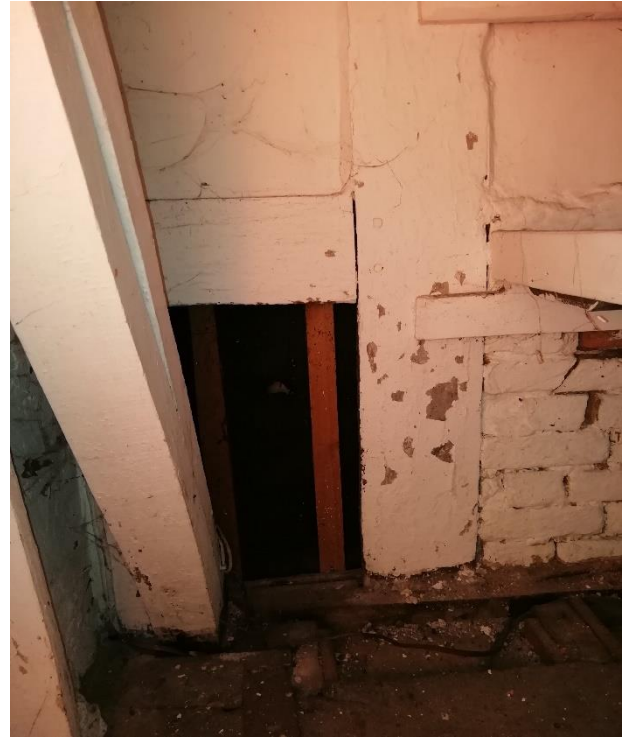
Frame brick infill. Felt and battens.

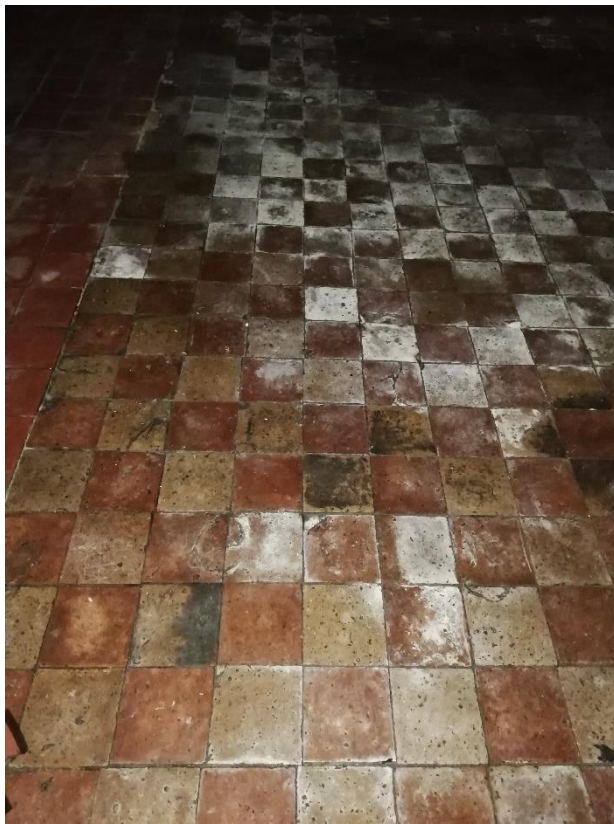
Bar floor tiles possibly historic.

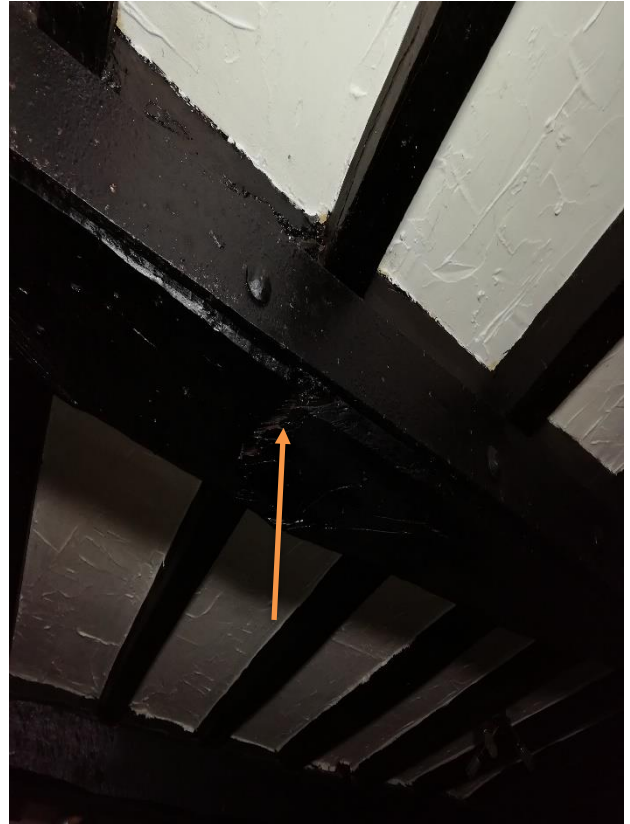
4.5 First floor: These floors are of a traditional timber central beam and half lap joist arrangement with lathe and plaster infills between joists to the older parts of the building. The floorboards give an indication to age as they are irregular oak planks of different widths and butted together and in good condition. The earlier Victorian extensions although not investigated usually 8x2 inch joists or similar size spanning from wall to wall with tongue and groove flooring. Some floors to rooms have been overlaid with more flooring it is assumed to level up a floor to provide functionality. The floors are of different levels, uneven up to 150mm in height and in one specific area where the bar area central beam has split and centrally deflected raising the beam end bearing on the spine supporting wall resulting in the the room difficult to be habitable. Further invasive investigation is necessary to determine loading paths and causes for settlement to assess whether the deflection is historical or still active as the bar area beam and others have been repaired or strengthened.

Fracture and steel plate repair to beam.

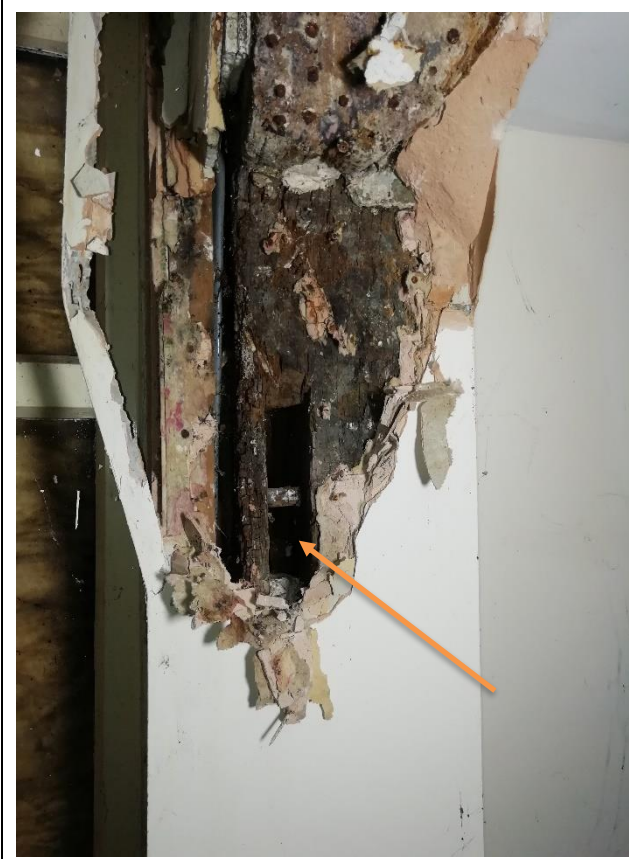
load will need attention very soon. There is evidence of structural tying members removed from the timber uprights above the cellar that require more investigation yet suggest works have been carried out in the past that have had a detrimental effect on the stability of the building. The condition of this floor is critical and to stop the spread of dry rot needs immediate attention or methods to temporary support the floor and provide ventilation in attempt to halt the progress of any rot in the timbers or structure.

Timber upright with horizontal tie removed

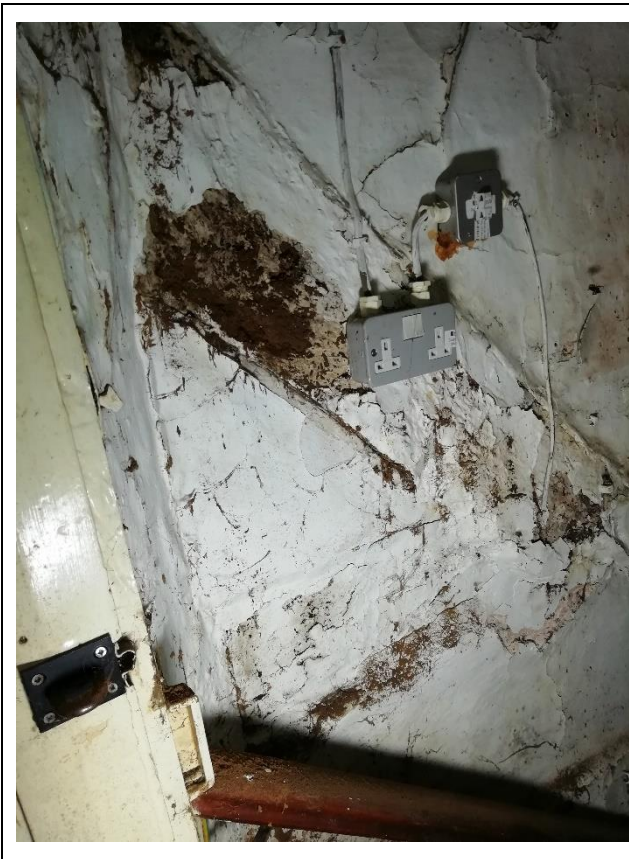
4.6 Ground floor: Most of the floors are of a solid construction of concrete or similar. The bar area has a square tiled floor that may have historical value and require further investigation. The only timber structure floor is above the cellar area and in serious condition is failing and unsafe. The floor was covered in carpet and not inspected above as an area has collapsed and in the interests of safety avoided. The underside of the floor was inspected from the cellar area and evidence of dry rot, wet rot and beetle infestation and deflection were found in many areas to the beams and joists. A cellar thermometer reading indicated a room temperature of 10 degrees Celsius and if accurate with a combination of dampness in the cellar provides perfect conditions for dry rot as evidence suggests. There is evidence of supporting timber uprights and diagonal support leading into the cellar stair that are starting to suffer from rot and if these carry

Timber frame to cellar stairs with rot.

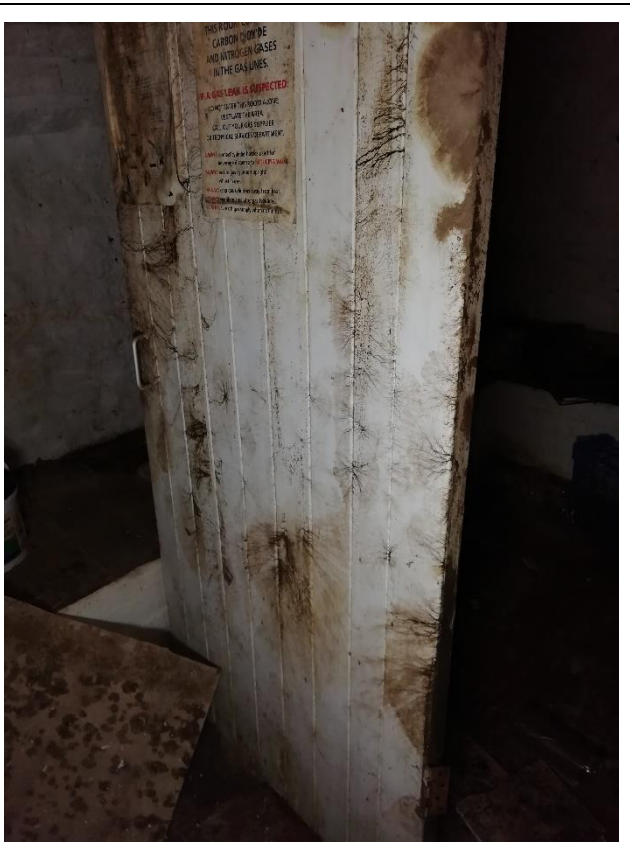
4.7 Internal joinery and staircase: The joinery is in a satisfactory condition overall to the 1st floor with some possibly original doors, frames and architrave remaining. The bedroom doors are difficult to close and require adjusting or investigation (as previously mentioned item 4.5). The turning staircase has a low balustrade handrail and many of the spindles removed or vandalised causing a hazard. However, is in reasonable condition and may be original from the Georgian or Victorian latter extension. The staircase to the cellar is in reasonable condition, however being close to areas of dry rot are susceptible to attack.

Evidence of dry rot fungus.
