BUILDING CONDITION SURVEY

The former Eagles Inn Cressage Shropshire SY5 6DE

Client: Mr Joe Nugent: Brownshore Management Ltd

Date of inspection: 29/10/2019

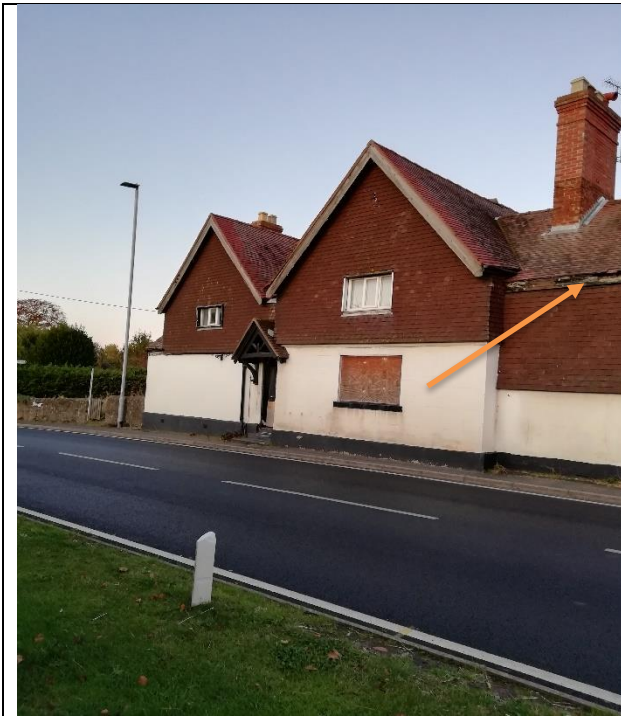
3.3 Fascia boards, sarking felt and roof ventilation: The timber fascia boards where present are of different sizes and require decorating/renewal especially at the southern end of the West front elevation as the rafters can be seen that will allow birds etc to nest. The barge boards to the gable ends appeared to be in reasonable condition but require decoration. There was no evidence of sarking felt therefore roof void ventilation is provided by small gaps between the roof tiles as evident by the rood space inspection.

Gutter fascia damage requires attention.

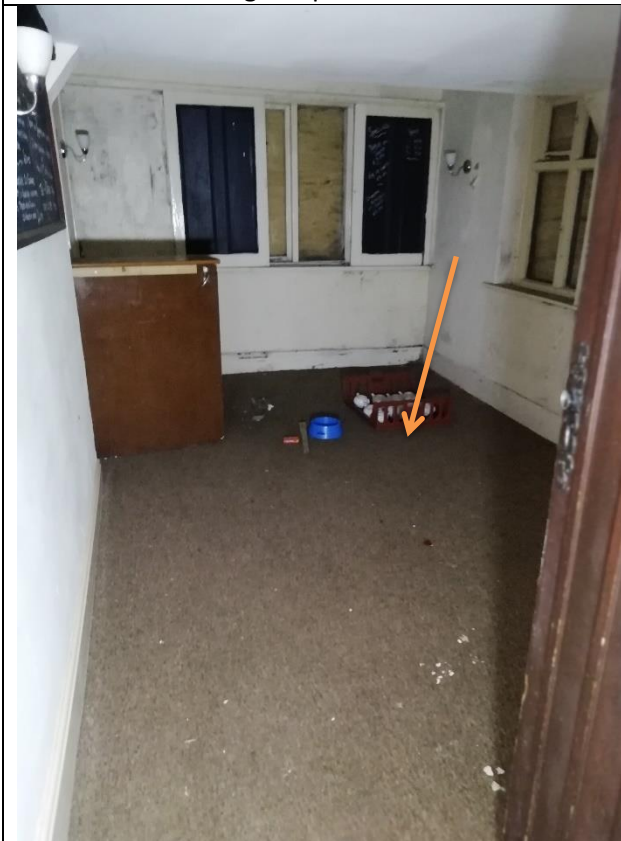
4.6 Ground floor: Most of the floors are of a solid construction of concrete or similar. The bar area has a square tiled floor that may have historical value and require further investigation. The only timber structure floor is above the cellar area and in serious condition is failing and unsafe. The floor was covered in carpet and not inspected above as an area has collapsed and in the interests of safety avoided. The underside of the floor was inspected from the cellar area and evidence of dry rot, wet rot and beetle infestation and deflection were found in many areas to the beams and joists. A cellar thermometer reading indicated a room temperature of 10 degrees Celsius and if accurate with a combination of dampness in the cellar provides perfect conditions for dry rot as evidence suggests. There is evidence of supporting timber uprights and diagonal support leading into the cellar stair that are starting to suffer from rot and if these carry

load will need attention very soon. There is evidence of structural tying members removed from the timber uprights above the cellar that require more investigation yet suggest works have been carried out in the past that have had a detrimental effect on the stability of the building. The condition of this floor is critical and to stop the spread of dry rot needs immediate attention or methods to temporary support the floor and provide ventilation in attempt to halt the progress of any rot in the timbers or structure.

Area above cellar, starting to fail.

7.1 Structural: The survey has highlighted major structural defects that requires further investigation, inspection and temporary supporting to the cellar areas and deflected beams to the ground floor area that affect the first-floor area. Structural investigation is required and methods to address the areas highlighted in the report.

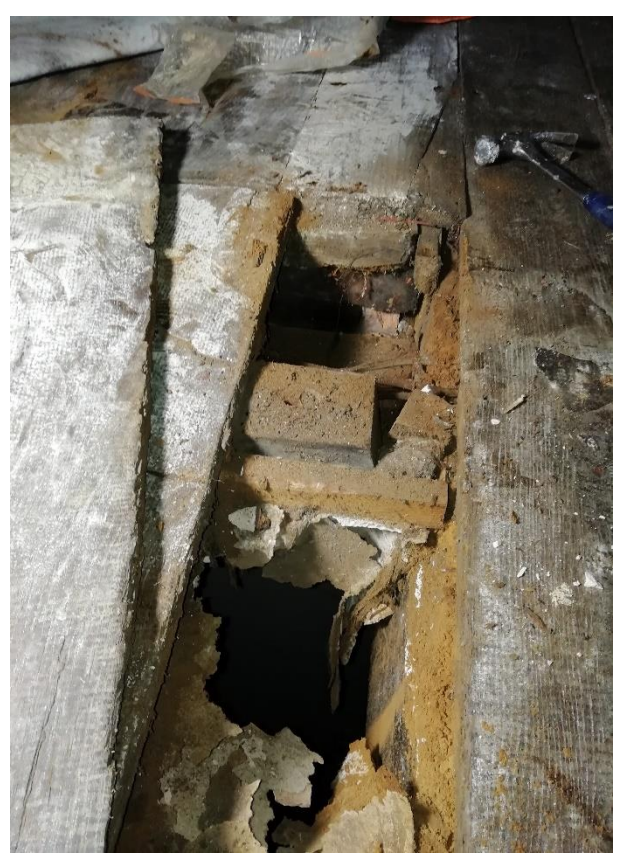
Oak floorboard lifted above deflected beam
