Revised
Arboricultural Appraisal Report

Subsidence Damage Investigation at:

59 Pearson Park
 Hull
 HU5 2TQ

CLIENT:	Crawford & Company
CLIENT REF:	SU1903936
MWA REF:	SUB200127-6652Rev01
MWA CONSULTANT:	John Graham B.Sc. Hons PhD
REPORT DATE:	20/02/2020
REVISED REPORT DATE:	08/07/2020

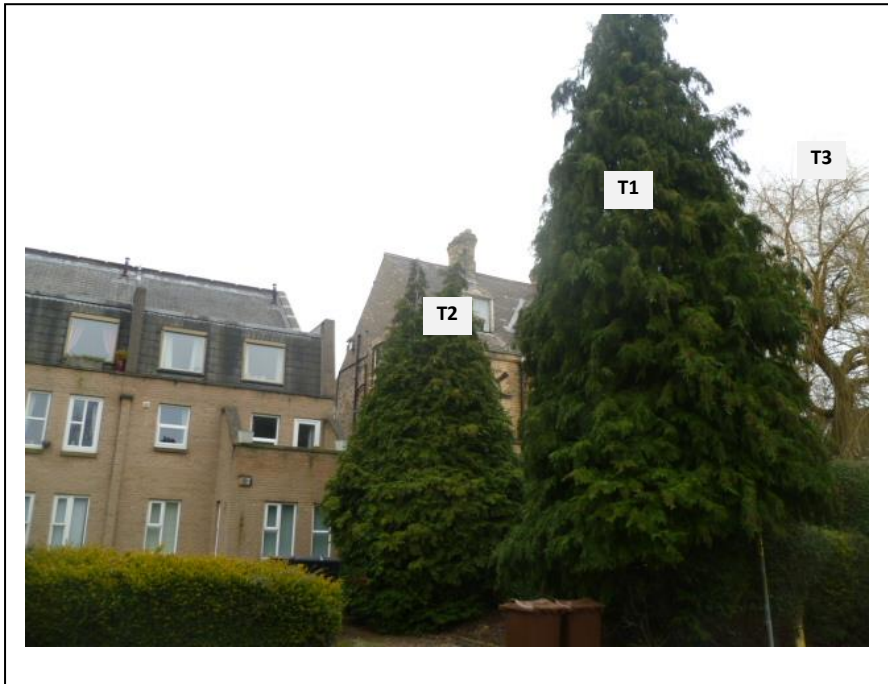
Based on the technical reports currently available, engineering opinion and our own site assessment we conclude the damage is consistent with shrinkage of the clay subsoil related to moisture abstraction by vegetation. Having considered the information currently available, it is our opinion that T2, T3, T4 and S1 are the principal cause of or are materially contributing to the current subsidence damage.

View of T1, T2 and T3.

If an arboricultural solution is to be implemented to mitigate the influence of the implicated trees/vegetation we recommend that T2, T3, T4 and S1 are removed. Other vegetation recorded presents a potential future risk to building stability and management is therefore recommended.

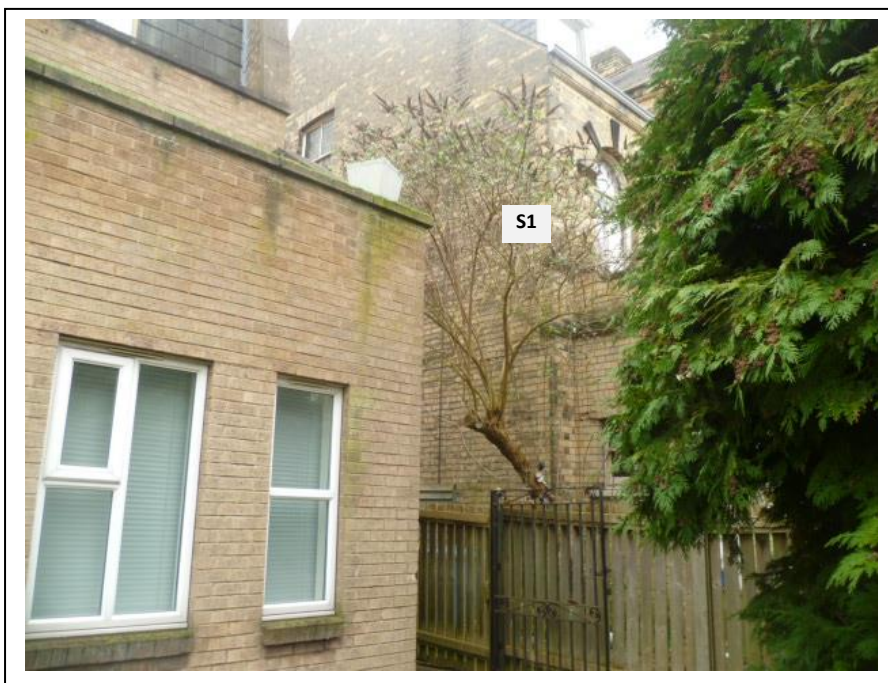
View of S1

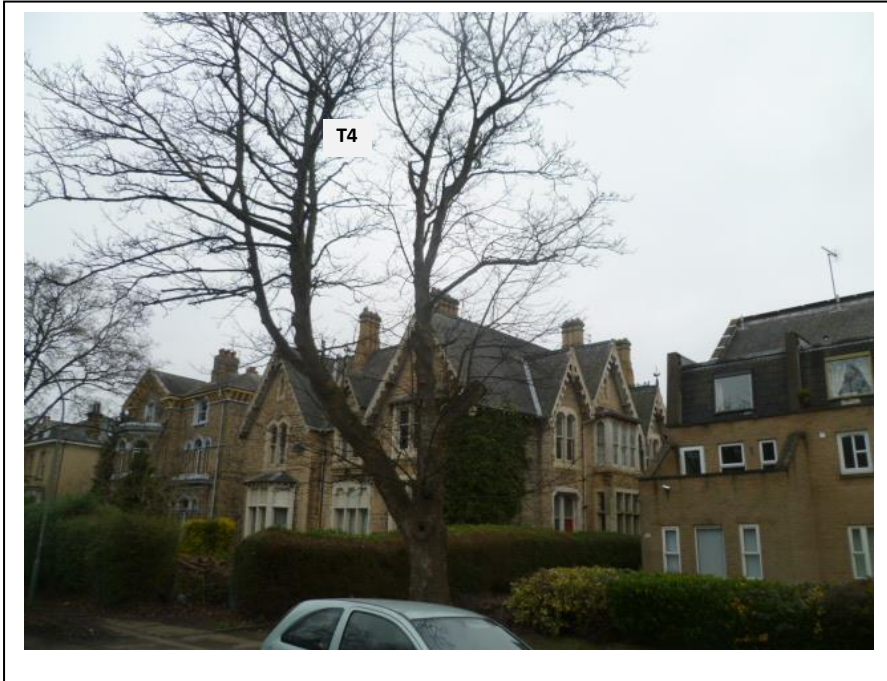
Roots were observed to a depth of 500mm bgl in TP/BH1 and recovered samples have been positively identified (using anatomical analysis) as *Acer* (Maple), the origin of which will be T4 (Sycamore – Maple). Roots were observed to a depth of 1,000 and 1,500mm bgl in TP/BH2 and recovered samples have been positively identified as Cupressaceae (Cypress) and Salicaceae (Willow family), the origin of which will be T2 (Cypress) and T3 (Weeping Willow) respectively, confirming the influence of T2, T3 and T4 on the soils below the foundations. Irrespective of the identification of recovered root samples, the roots of S1 are also likely to be present below foundation level in proximity to the area of movement/damage and influencing soil moisture and volumes.

View of T4

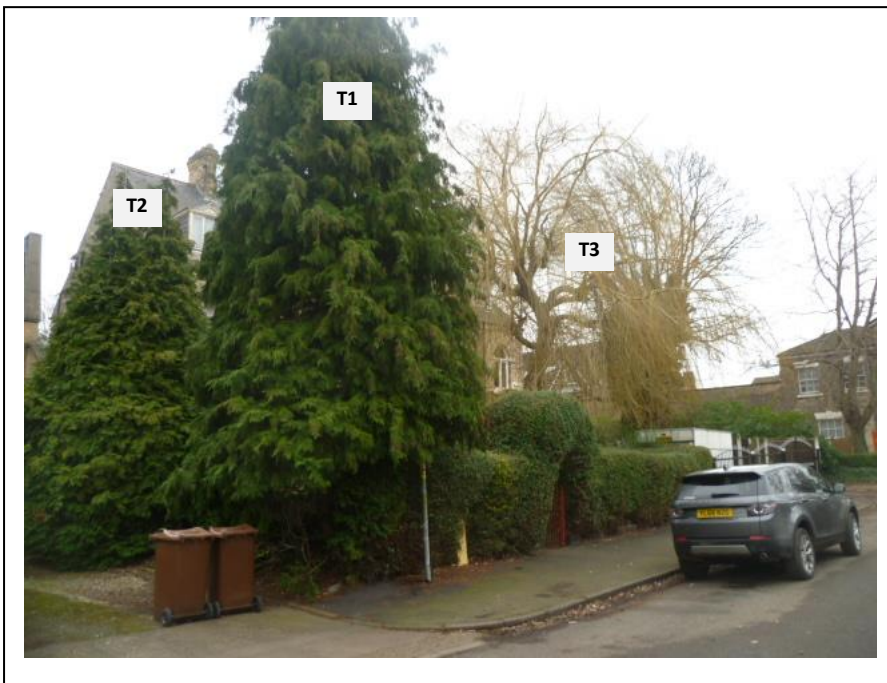
View of T1, T2 and T3
