TECHNICAL REPORT ON A SUBSIDENCE CLAIM

Crawford Reference: SU1903936

████████████████████
**59 Pearson Park
Hull
HU5 2TQ**

DATE 11th October 2019

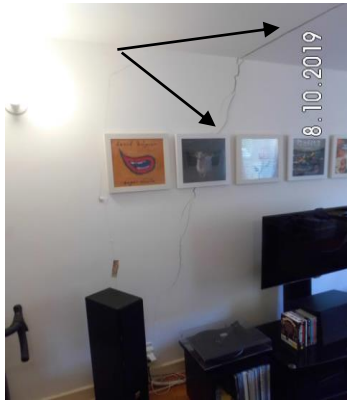
Flat 4 – Vertical Crack in Lounge

Main damage affects the lounge walls and ceiling; with cracks up to 15mm wide.
There is a minor crack to the bedroom wall; mirroring that of the lounge.

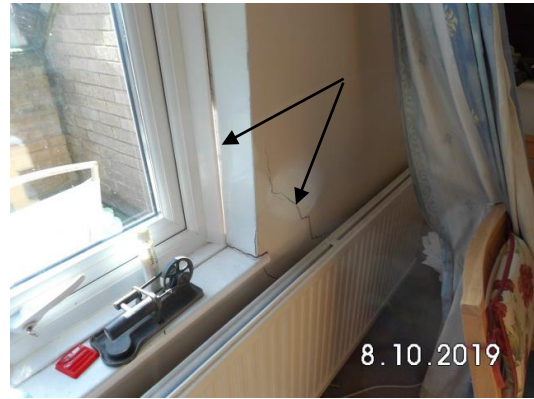
Flat 10 – Diagonal Crack to Lounge

Main damage affects the lounge window wall; with visible daylight to the window frame. The uPVC door to balcony area is out of alignment with variable sized cracking.
The master bedroom above the lounge shows hairline cracking around the window head.

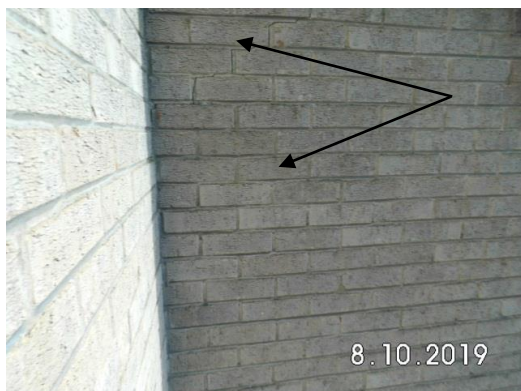
Stepped diagonal cracks above and below windows up to 20mm wide.
Stepped diagonal cracks to external masonry up to 20mm wide.

Flat 4 – Side Wall Stepped Cracking

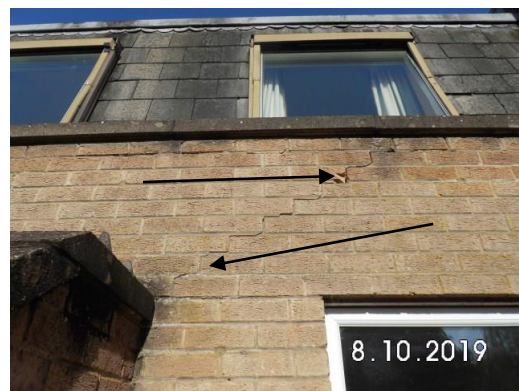
Flat 10 – Stepped Cracking

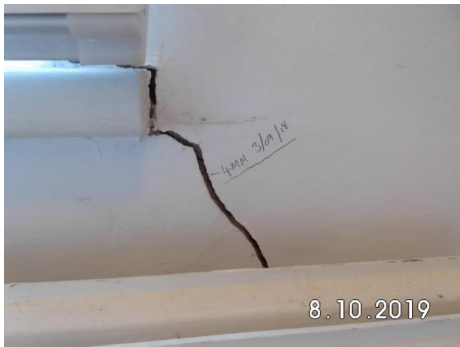
Flat 4 Lounge – Diagonal Crack to Sill

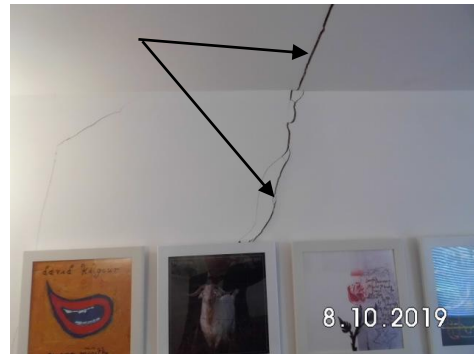
Flat 4 Lounge – Wall/Ceiling Crack

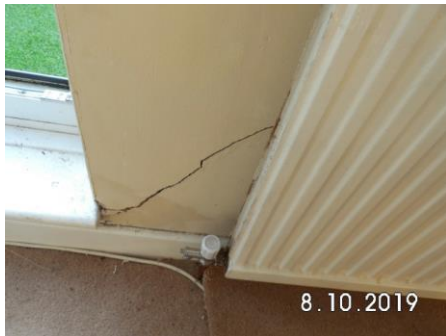
Flat 10 Lounge – Diagonal Crack at uPVC Door

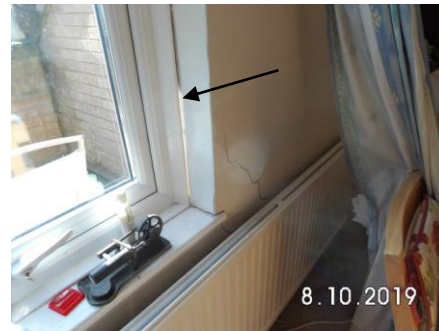
Flat 10 Lounge – Daylight to Window Frame

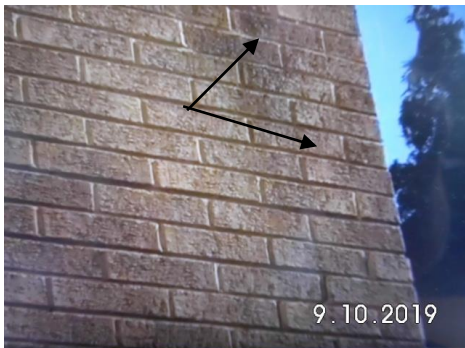
Side Elevation – Stepped Masonry Cracks

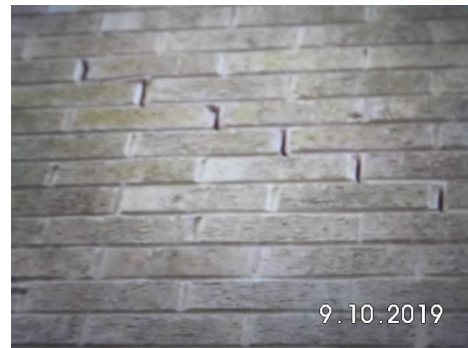
Right Side Gable Elevation – Stepped Cracks

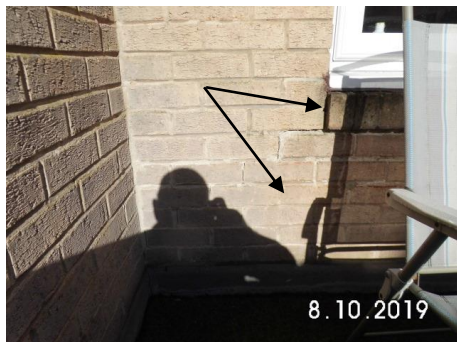
Flat 4 Side Wall – Stepped Cracks

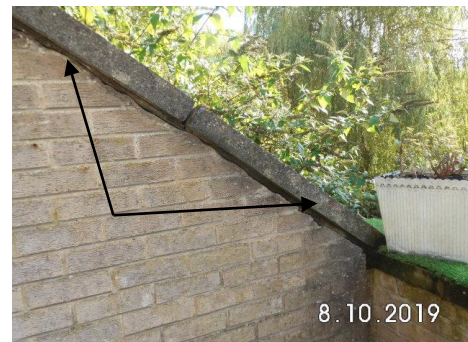
Flat 10 Balcony – Displaced Copings
