ADDENDUM TECHNICAL REPORT

Crawford Reference: SU1903936

59 Pearson Park
Hull
HU5 2TQ

SUBSIDENCE CLAIM

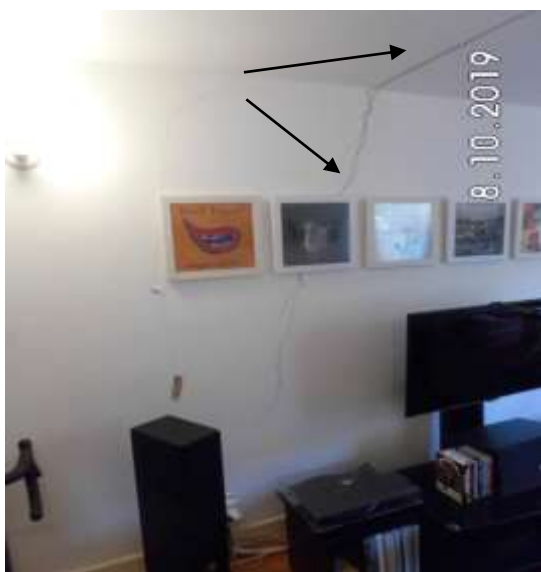
Vertical tapering cracks to masonry walls up to 15mm wide.

Flat 4 – Vertical Crack in Lounge

- Main damage affects the lounge walls and ceiling; with cracks up to 15mm wide.
- There is a minor crack to the bedroom wall; mirroring that of the lounge.

If an arboricultural solution is to be implemented to mitigate the influence of the implicated trees/vegetation we recommend that **T2, T3, T4 and S1** are removed.

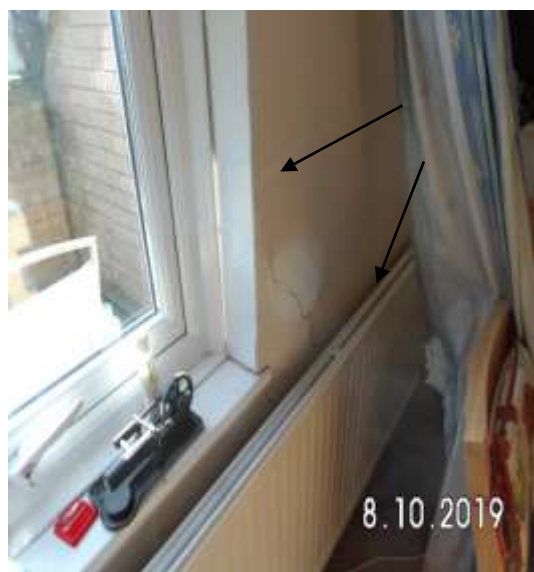
Stepped diagonal cracks sited either side of windows up to 15mm wide.

Flat 10 – Diagonal Crack to Lounge

- Main damage affects the lounge window wall; with visible daylight to the window frame. The uPVC door to balcony area is out of alignment with variable sized cracking.
- The master bedroom above the lounge shows hairline cracking around the window head.

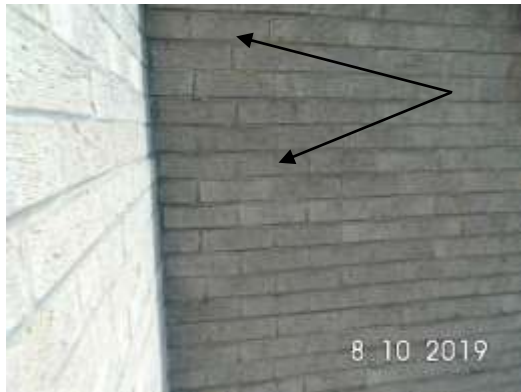
Flat 4 – Side Wall Stepped Cracking

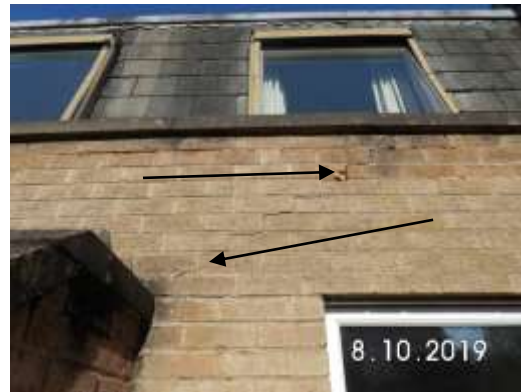
Flat 10 – Stepped Cracking
