Site Investigation Report

99216.1.USI

Auger were commissioned by Crawford & Co to undertake a site investigation and CCTV inspection of the underground drainage within the area of concern at the property.

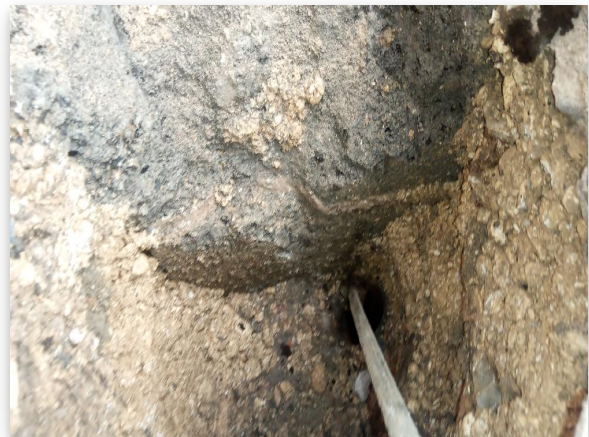
Fig 1.2: Trial Hole 1 Footing

Location: Front LHS of extension

| Depth (m) | Symbolic Log | Strata Description | Insitu Tests | | Soil Sample | Root Sample |
|---|---|---|---|--|---|---|
| 0.5 | | Moist very stiff Brown sandy fine to medium gravelly silty CLAY | 102kpa | | Soil @ 0.5m | Root @ 0.5m |
| 1.0 | | Moist stiff Brown silty CLAY □ | 98kpa | | Soil @ 1m | |
| 1.5 | | Moist stiff Brown silty CLAY □ | 50kpa | | Soil @ 1.5m | |
| 2.0 | | Damp stiff Brown sandy fine to medium gravelly silty CLAY | 52kpa | | Soil @ 2m | |
| 2.5 | | Damp stiff Brown sandy fine to medium gravelly silty CLAY | 60kpa | | Soil @ 2.5m | |

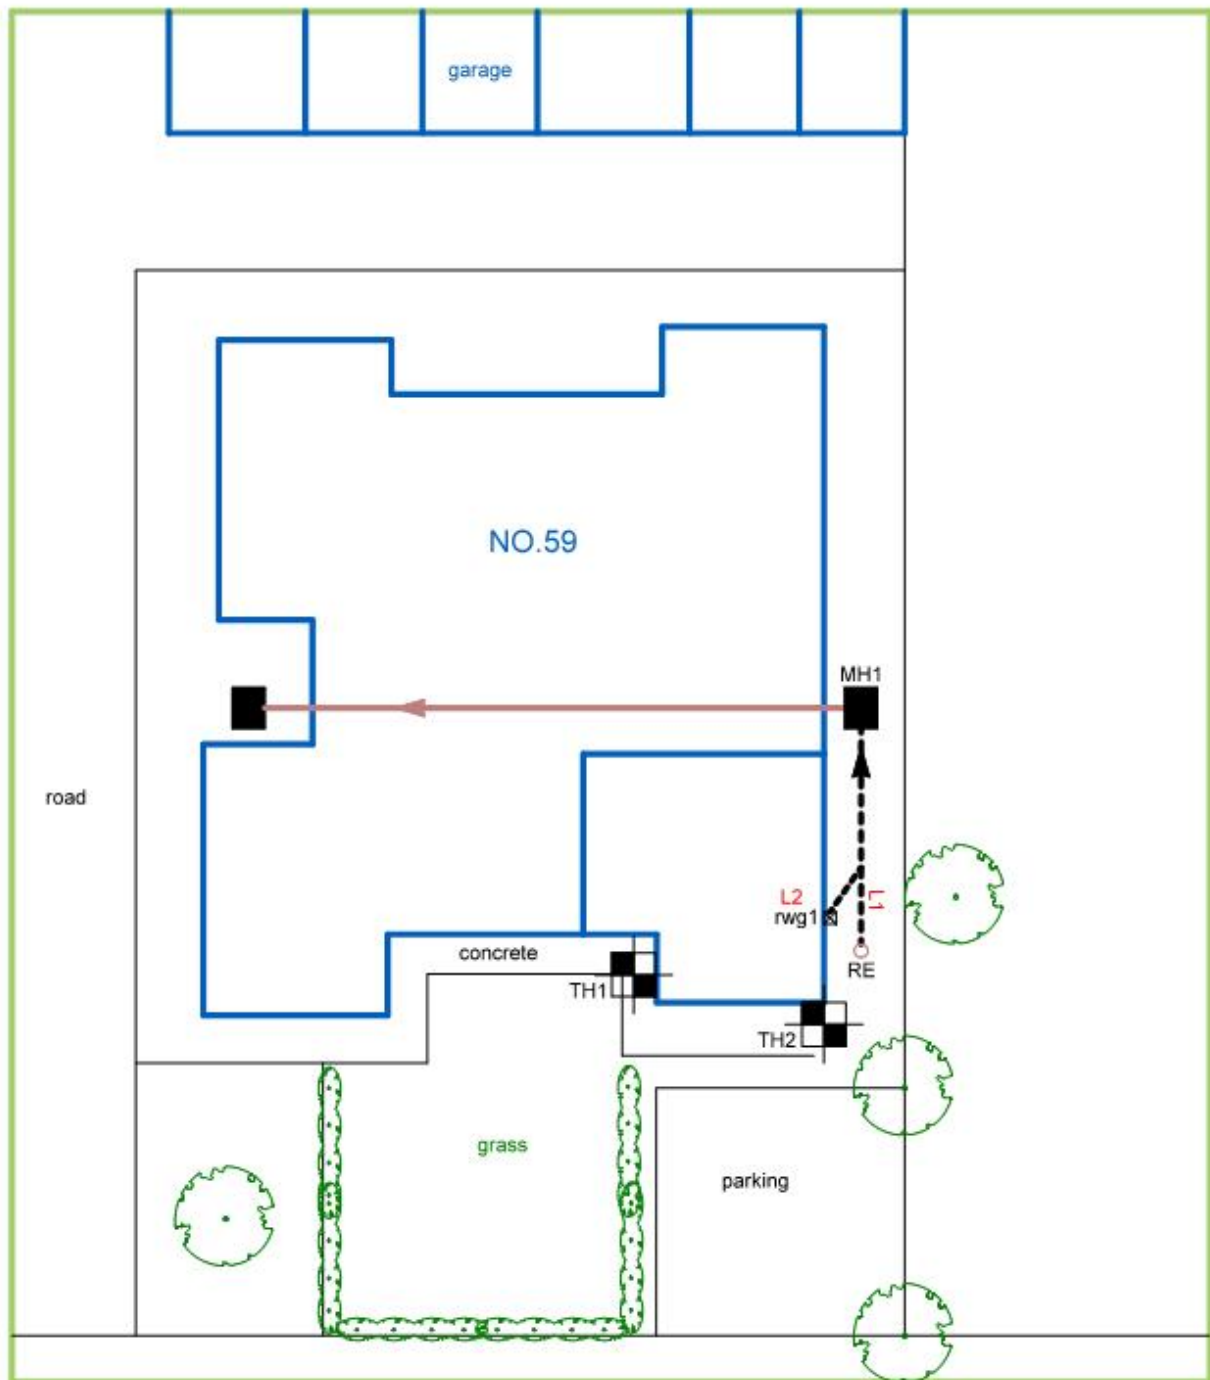
FRONT OF PROPERTY

Our survey revealed no significant defects which could be allowing water to escape in the area of concern.

No significant drainage defects were found and as such, no repairs are recommended.
