The Queen's Head Chambers.  
16 St John's Road,  
Clacton on Sea.

Heritage Statement/Report.  
2021

Prepared by J Parker MSc (Conservation of Buildings)

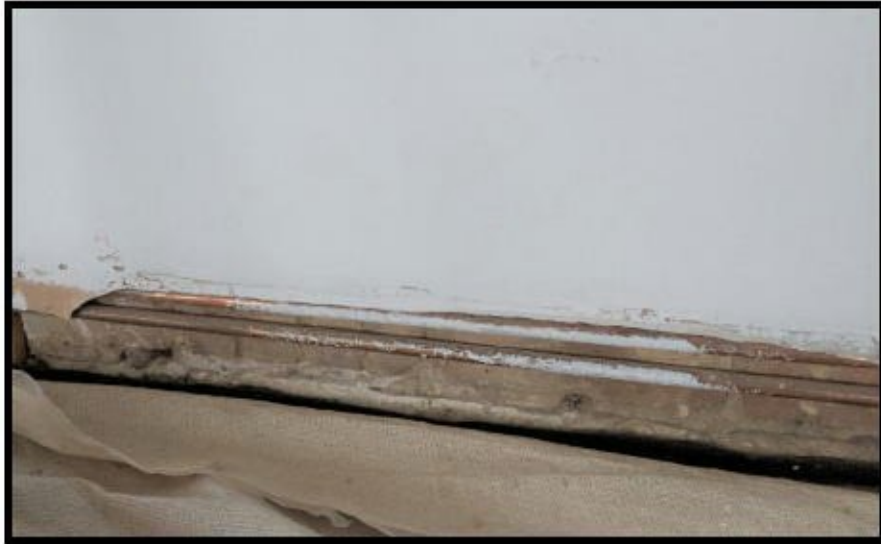
Pic 1

Whilst writing this report an earlier picture taken by one of the trades involved in the works came to light. This picture confirms this section of wall is C20 9" brickwork next to the C19 red brick fireplace and chimney.

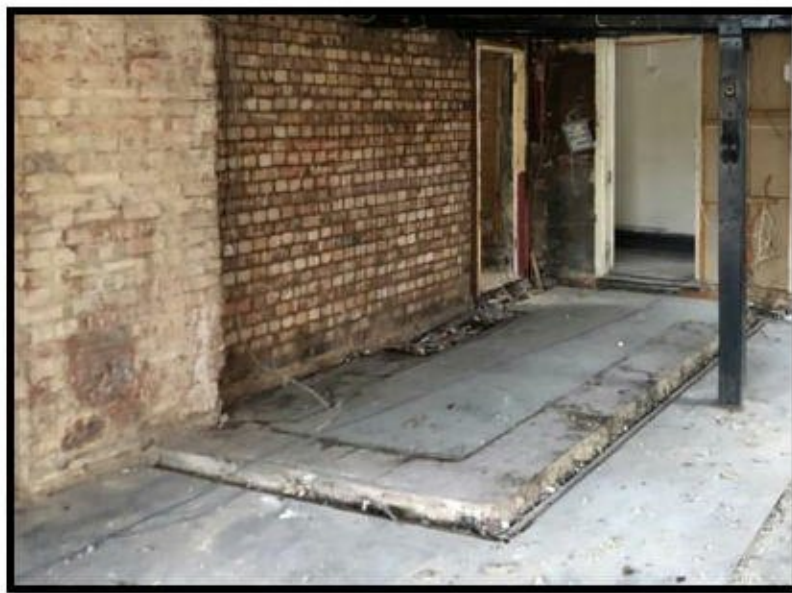
This also confirms the concrete floor and supporting post is set in the concrete.

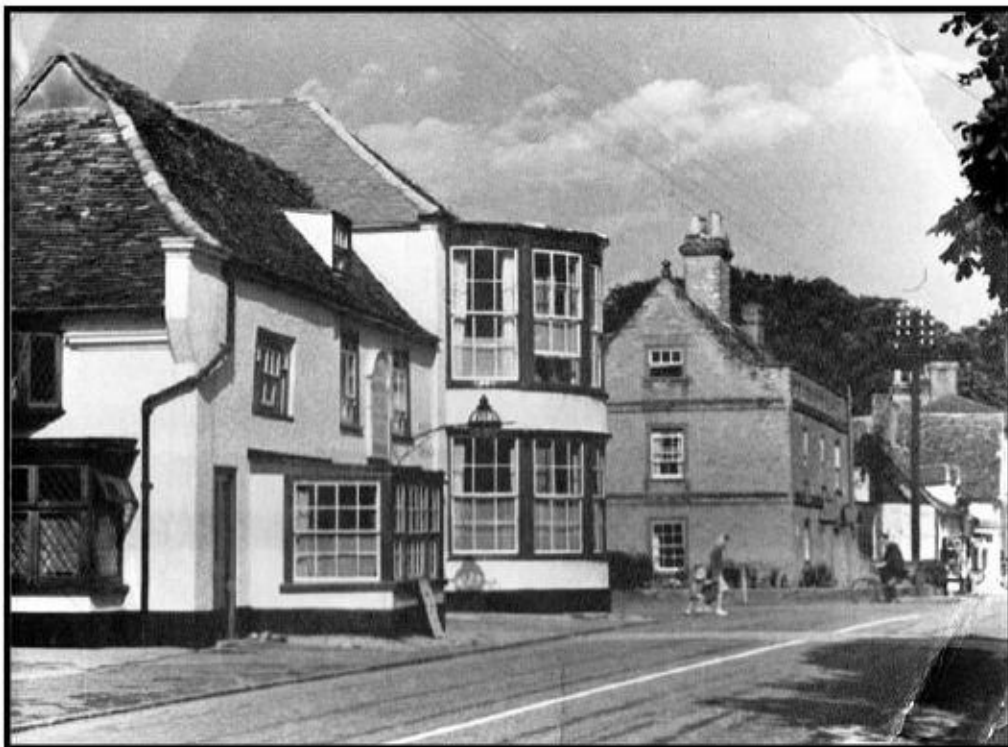
1930's. The first-floor wall bows out in the picture as it does currently.

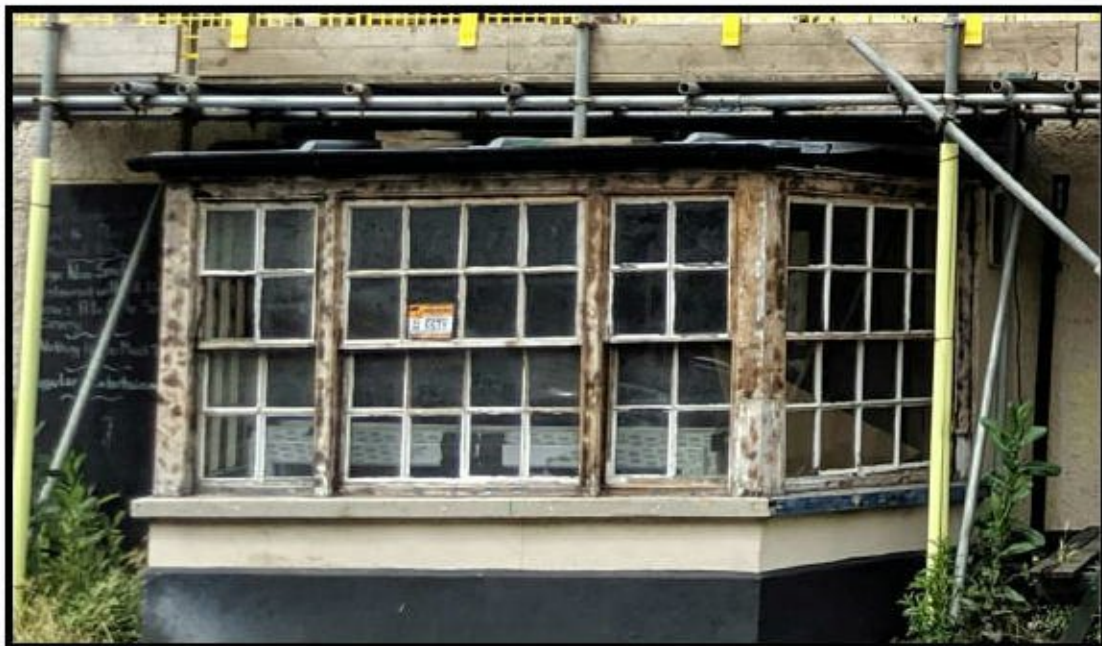
The sashes are in overall acceptable condition, with the exception of some poor replacement glazing and a few missing glazing bars. The bottom rails are in workable

condition which is usually the site of decay. There is no evidence of sash weights or any of the expected iron monger associated with a traditional sash window. They will need sympathetic repairs to the joinery and glazing materials including putty that has failed, prior to decoration. The exterior cills show signs of previous repairs that are in need of attention.

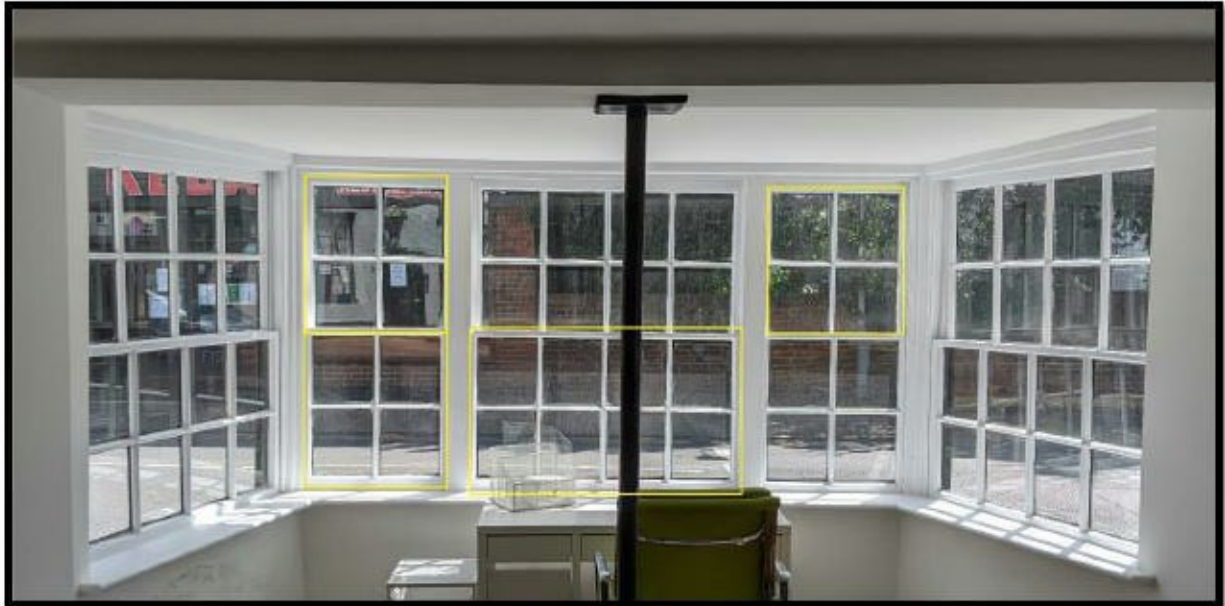
The 4 sashes boxed in yellow appear to be older than the others, having a finer profile typically from C18 to early C19 (HE G&G 2011 page 104). See comparison below.

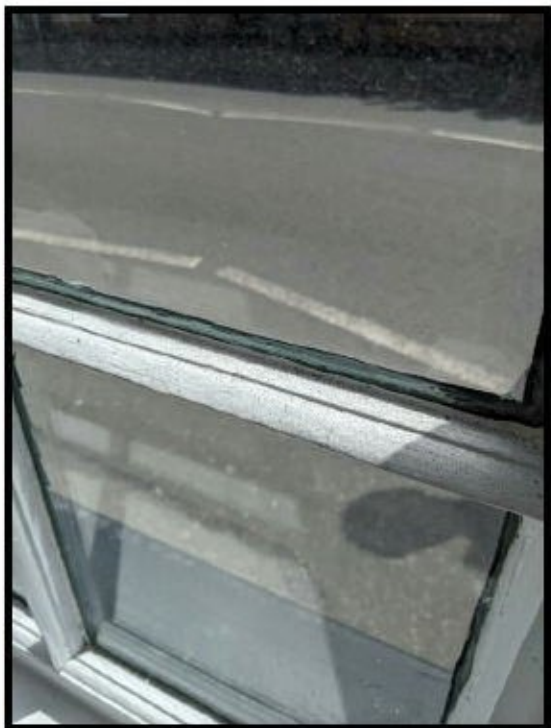
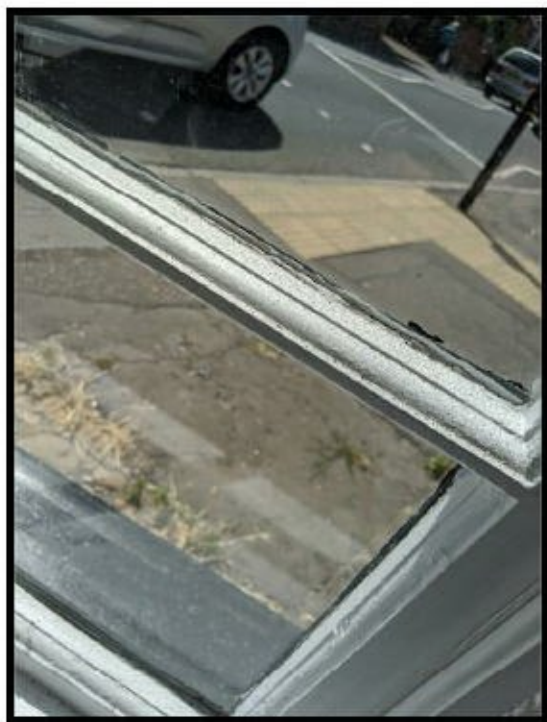
The left hand picture shows the early C18 to C19 ovolo profile on the maked sashes, the 2<sup>nd</sup> picture shows the profile of the remaining sashes that are heavier C20 profiles that allow for heavier glass.

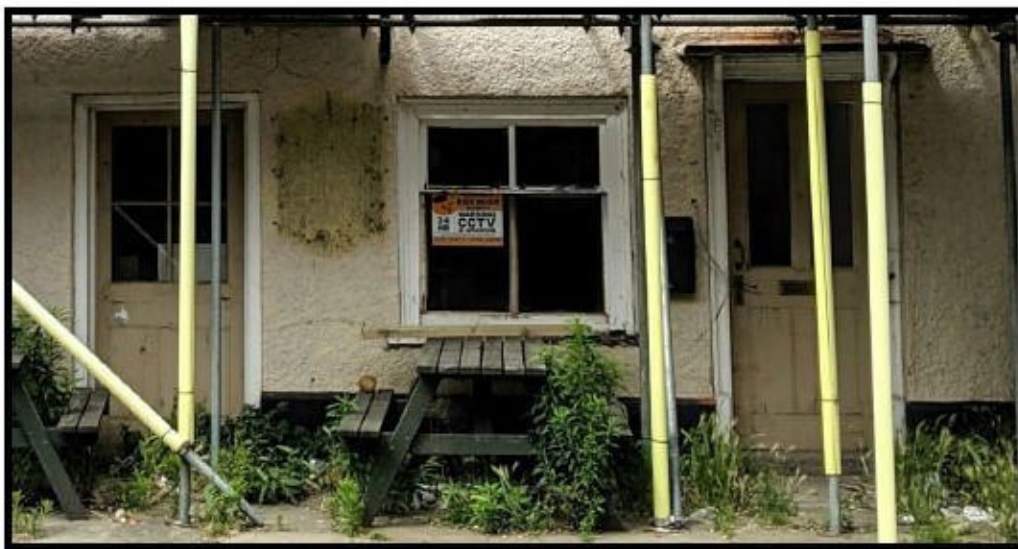
The left-hand doorway in the above picture accesses the bar area and is in overall acceptable condition, though would benefit from redecoration. There are minor areas of decay at the base of the glazed section of the door that will need minor attention prior to redecoration.

The right-hand door and frame are in similar condition with only minor repairs and decoration required.

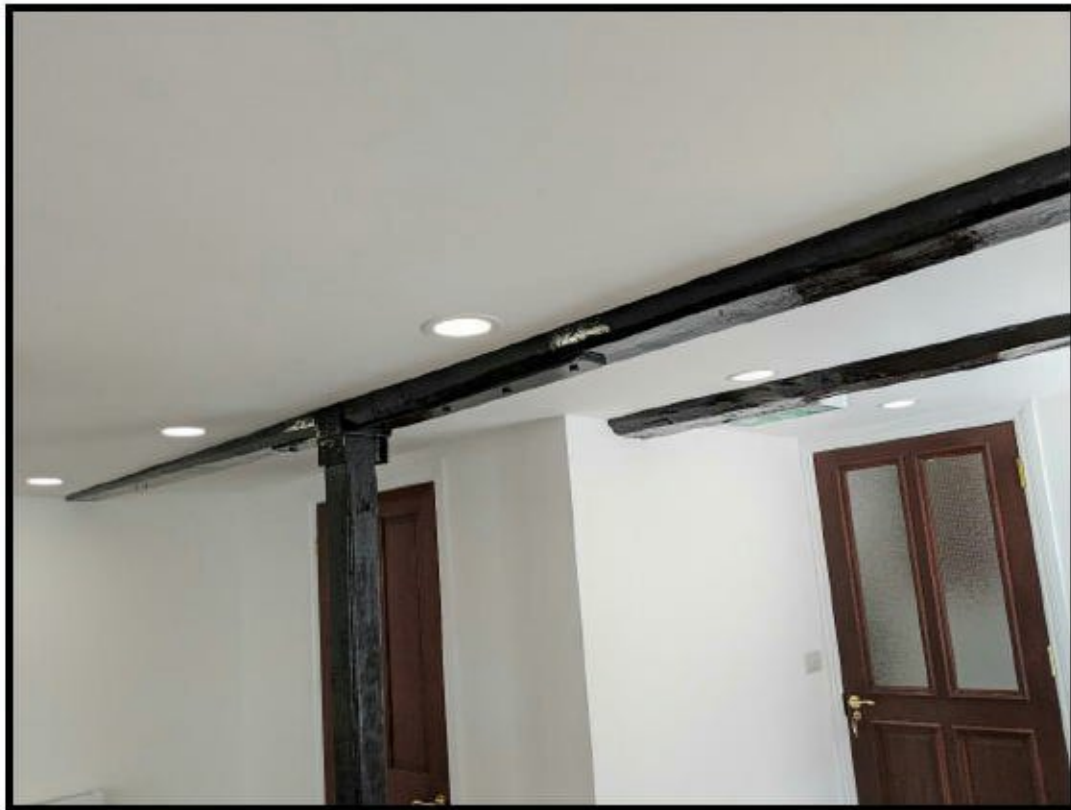
An additional support has previously been added below a tie beam that is only chamfered on one side, this would indicate that it may have been originally intended to be at the end of a room. There is a large metal strap on the underside of this beam from a previous repair. In addition, there is a C20 mild steel bracket/collar atop the support post. The lower post is screwed into the bracket. The base of the post sits on the concrete slab floor. The bracket is fixed to the beam with single screws on either face of the beam.

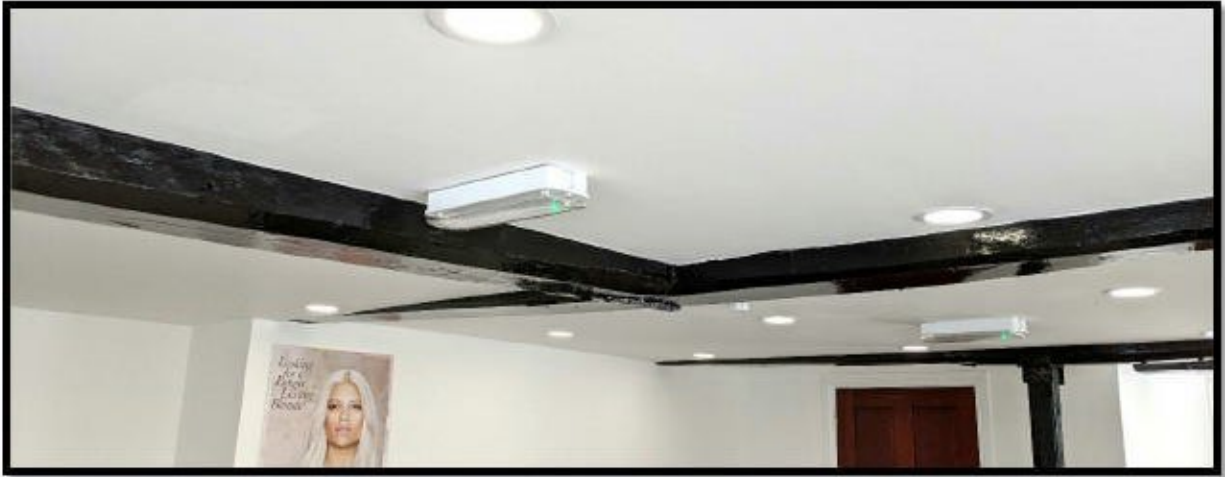
Here we see the tie beam to the right at the narrower area of the building with the bridging beam joining it in the middle. There is an old iron bracket beneath the joint. Above this tie beam is the wall separating bedroom 1 and the kitchen. Once again these beams are chamfered. There do not appear to be any mortices, yet faint machining marks are visible.

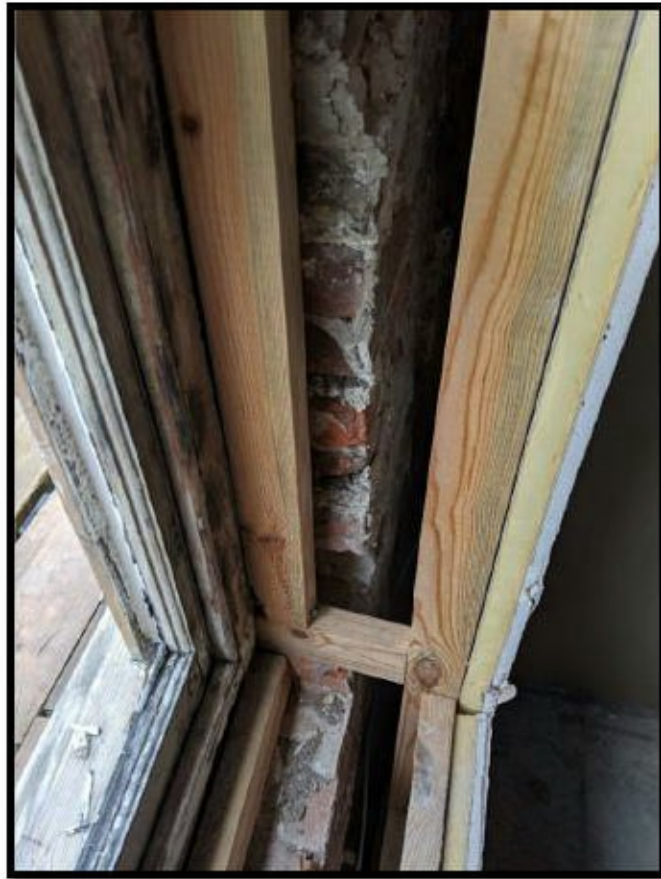
Pic 5

This shows the front of the building is built in a mix of stock and soft red 9" brickwork, confirming the timber frame in this section of the building has been replaced. The brickwork is built with a lime mortar suggesting it is pre, or early C20 construction.

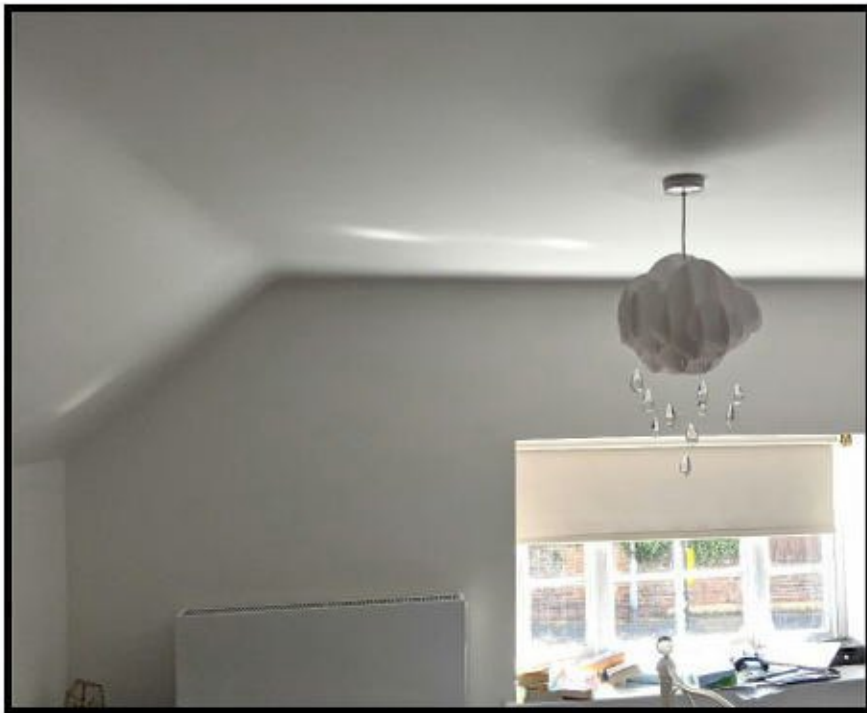
This picture also shows the C20 sash window. The window is in fair condition with the sash cords still connected. It will require re-decoration.

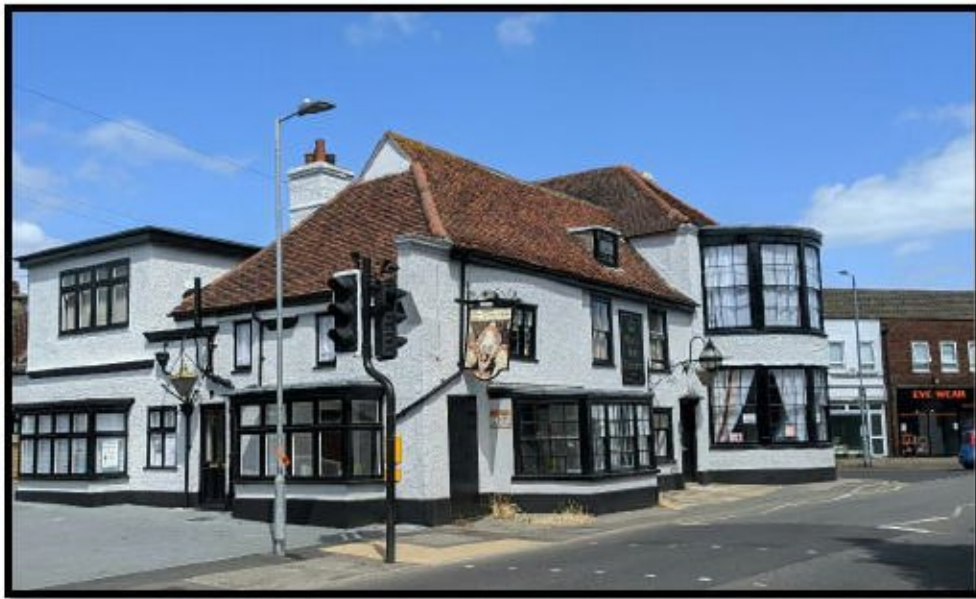
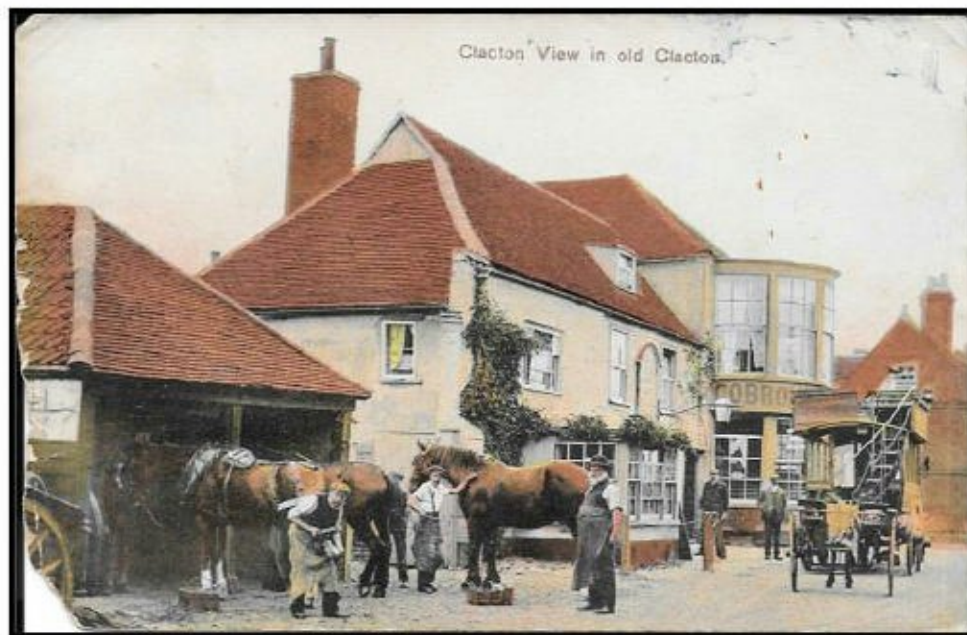
These windows replaced the C20 oriel windows and reference the casements from the 1903 picture.

The horizontal glazing bar is missing. The overall aesthetic would be improved if the glazing bar were to be reintroduced. Beyond that the profile of the casement and frame appear to be almost identical in size.

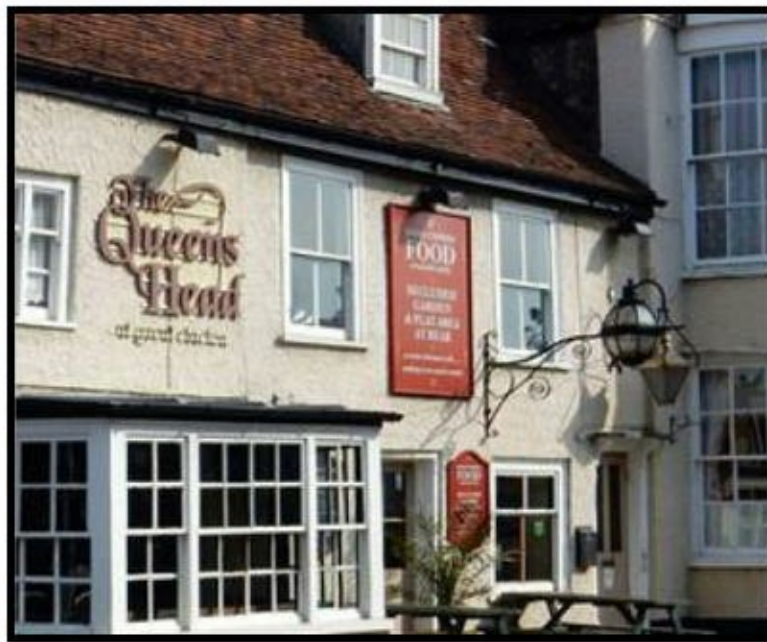
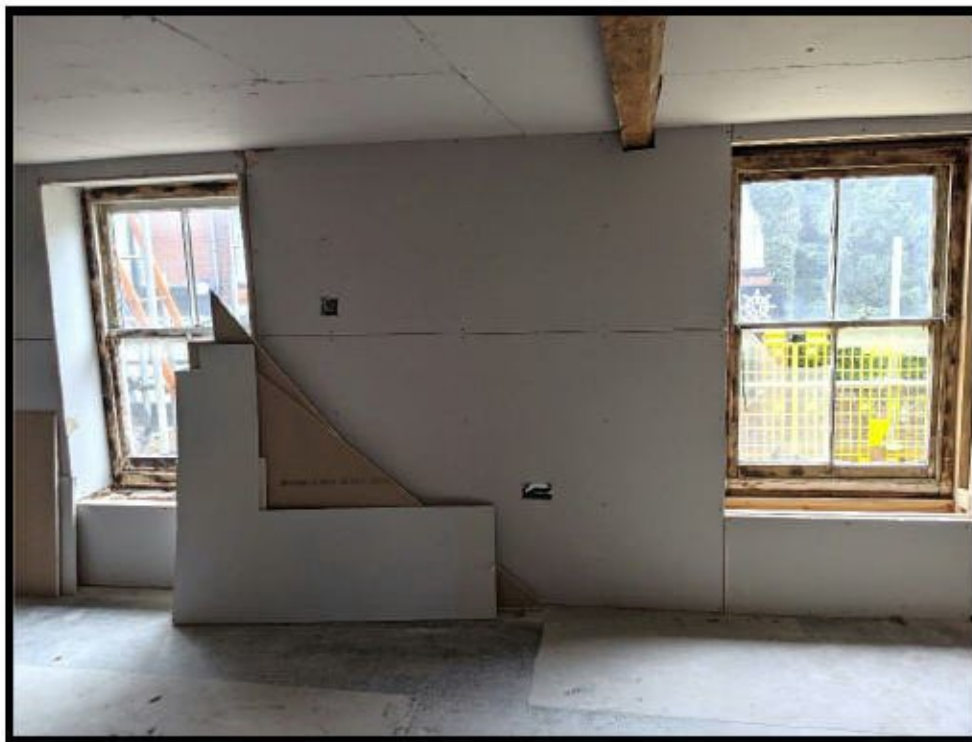
Pics 9 & 10

The horns at the bottom of the top sash confirm these windows as Victorian rather than adapted earlier items. The frames and sashes are in good condition. The sash cords have snapped therefore these will need to be repaired. Some of the glass is broken and needs to be replaced. Care should be taken with the thickness of the new glass or the additional weight of thicker modern glass will have an adverse effect on the function of the sash weights.

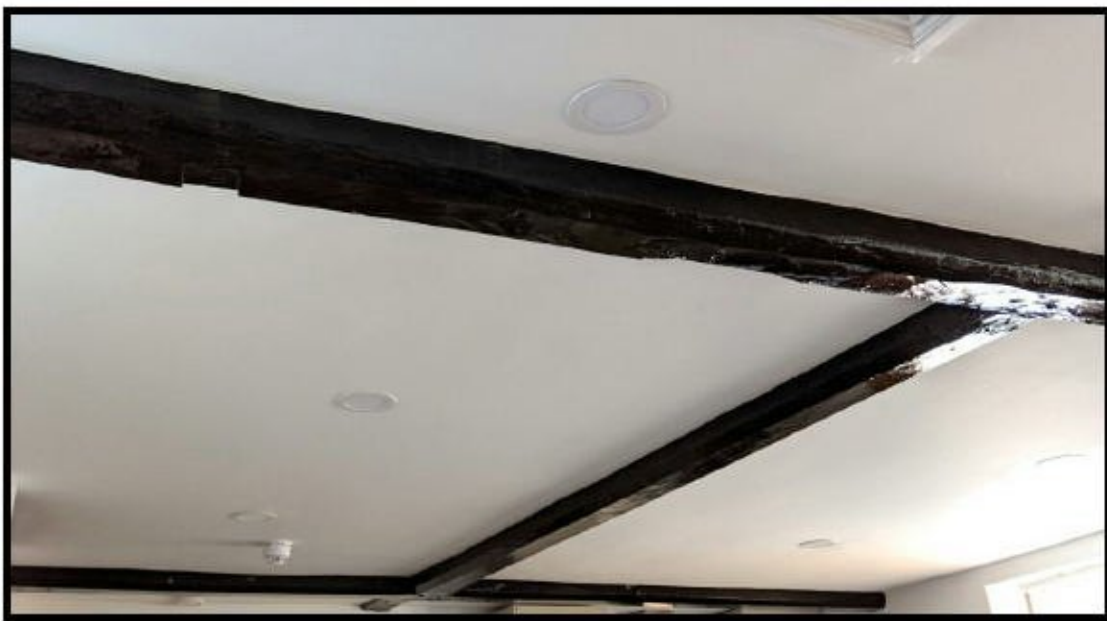
Pic 11

The tie beam at the far end of the building, where it joins the taller section is either a replacement or the original building continued further towards North road as there are no signs of previous mortices.

In addition, both sides of the beam have been chamfered. The small section of bridging beam the other side of the main room has also either been reduced or replaced.

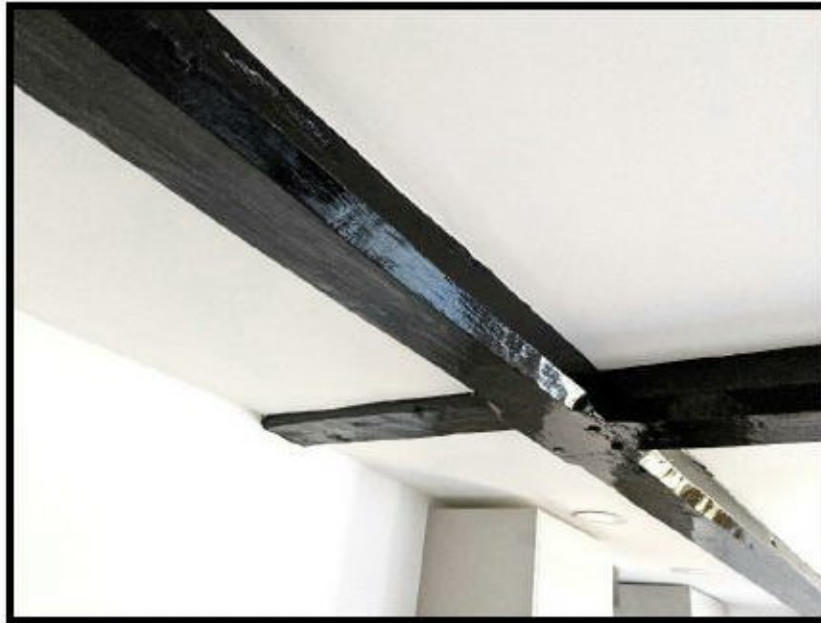
Pic 12

The position of the reduced bridging beam may indicate a later adaptation following the removal of a previous chimney. Similarly, it may be a low budget fix installed when Section 2 of the building was constructed.

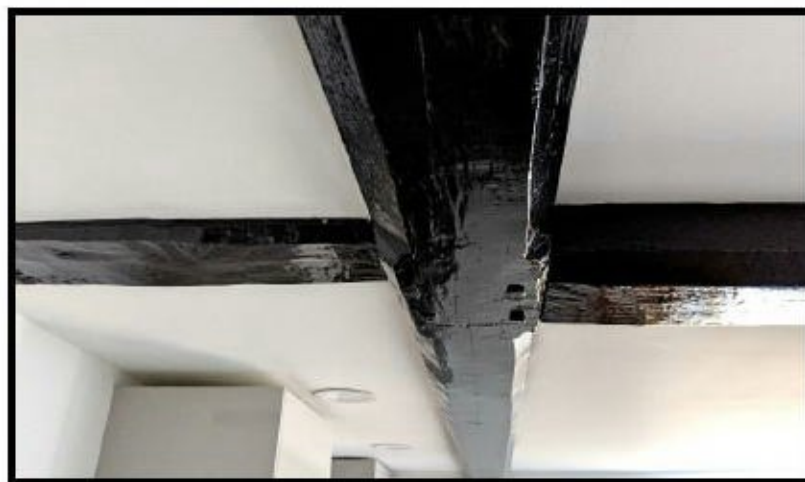
The pegs at the junction of the bridging and tie beams may be a later addition as they appear to have been installed from underneath the beam rather than traditionally from above. This could have been a later repair to secure the joint without lifting the flooring in the loft room as there are no visible pegs at the other end of the bridging beam just indentations further suggesting this was originally fixed from above.

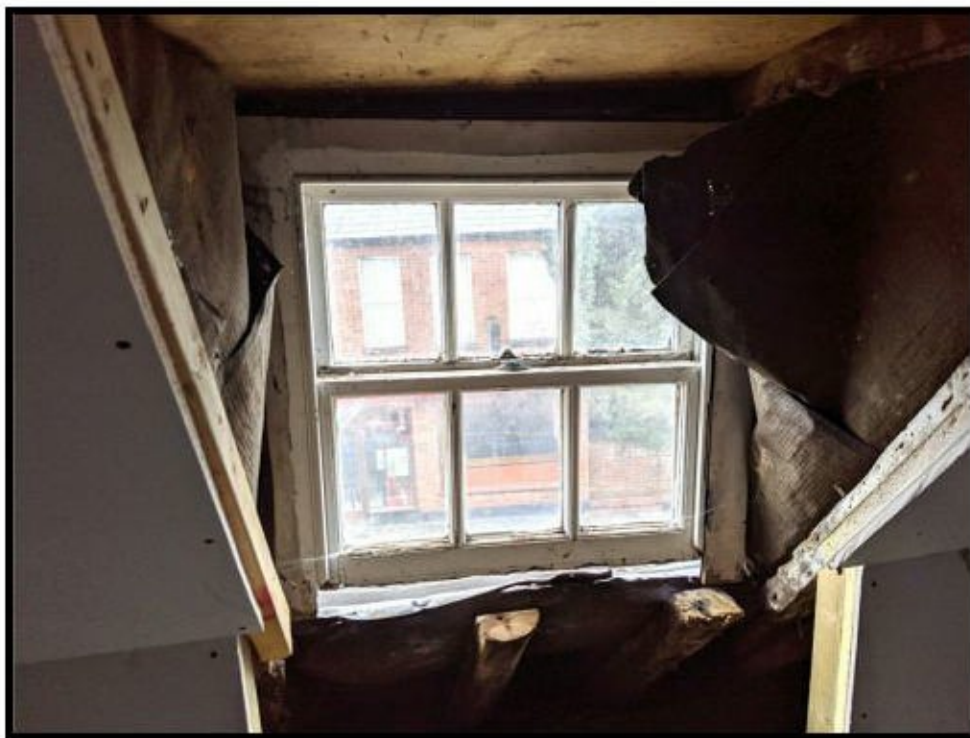
The dorma window is another C20 sash in need of repair. The cills are missing and will need replacement with new items made from joinery grade softwood with a minimum of 20 rings to the section inch. A new base rail and staff bead will need to be fitted to the frame with additional repairs the bottom rail of the lower sash.

The opening formed in the roof for the dorma is inadequate.

The rust marks on the cut rafters suggest a window board was nailed directly onto the rafters offering very little structural support, requiring the tile battens to bear the weight of the roof below and the dorma window.

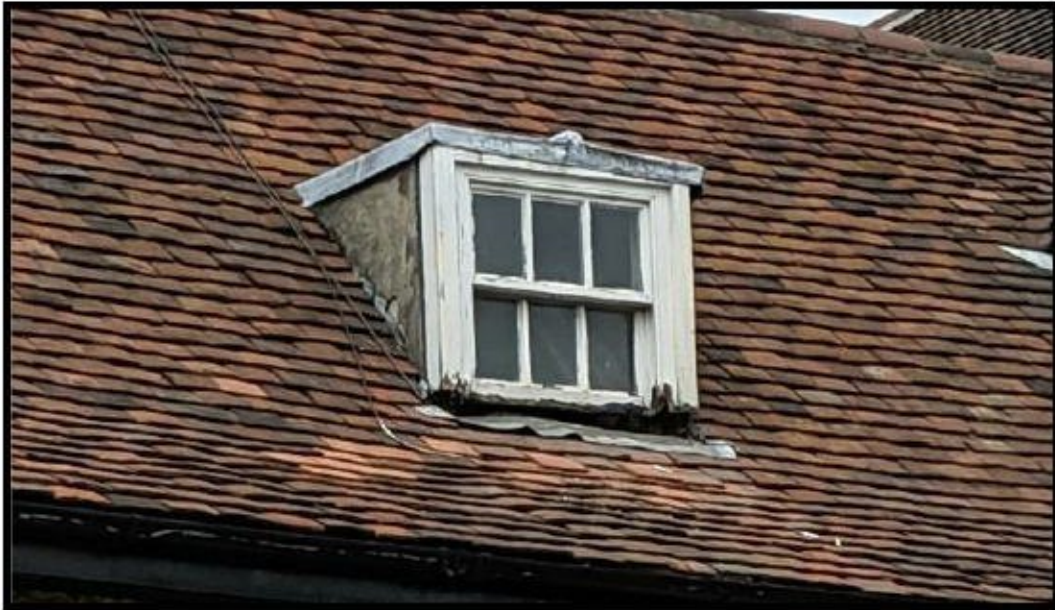
The exterior view confirms the level of decay to the lower section of the window. It also confirms the plywood ceiling is the entire structure of the flat roof with just a mop stick moulding for the jointing of the lead roof covering.

The exterior cheeks are rendered, there appears to be a small area in need of repair. Comparing the sizes internally and externally the window is the structural element supporting the plywood roof and cheeks of the dormer.

The dormer would clearly benefit from the addition of timber studwork supporting walls behind the plywood sections supported by the additional rafters previously recommended.

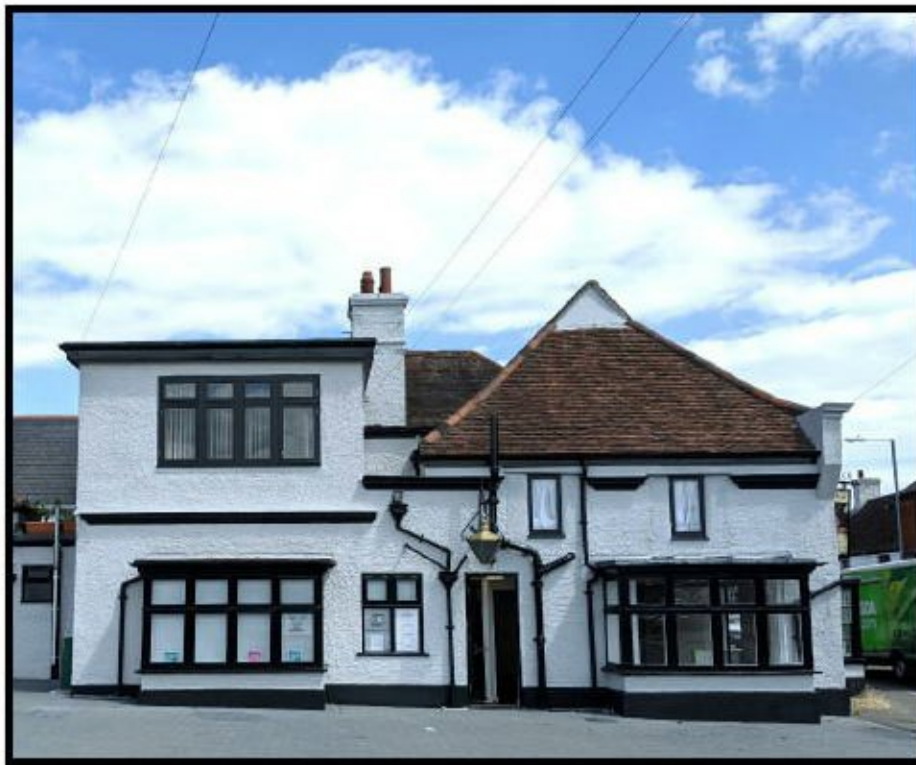
The pitch of the roof is shallower than is to be expected being below 45 degrees at the rear and slightly shallower to the front. Traditionally in Essex roofs are taller, reportedly due to the abundance of timber and the improved view of the plain tiles. Historic England or English Heritage as it was at the time of publishing state, *many writers have commented that for most traditional buildings a pitch greater than 47 degrees with a pitch between 55-60 degrees is optimum.*

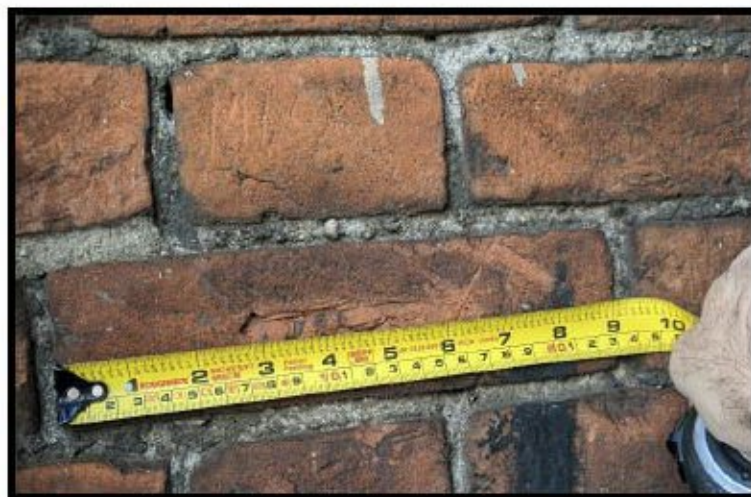
The 9-inch Imperial face brick built in a Flemish bond with lime mortar suggests C19 construction. The wall is in good condition partly due to the protection of its shielded position protected by the neighbouring building.

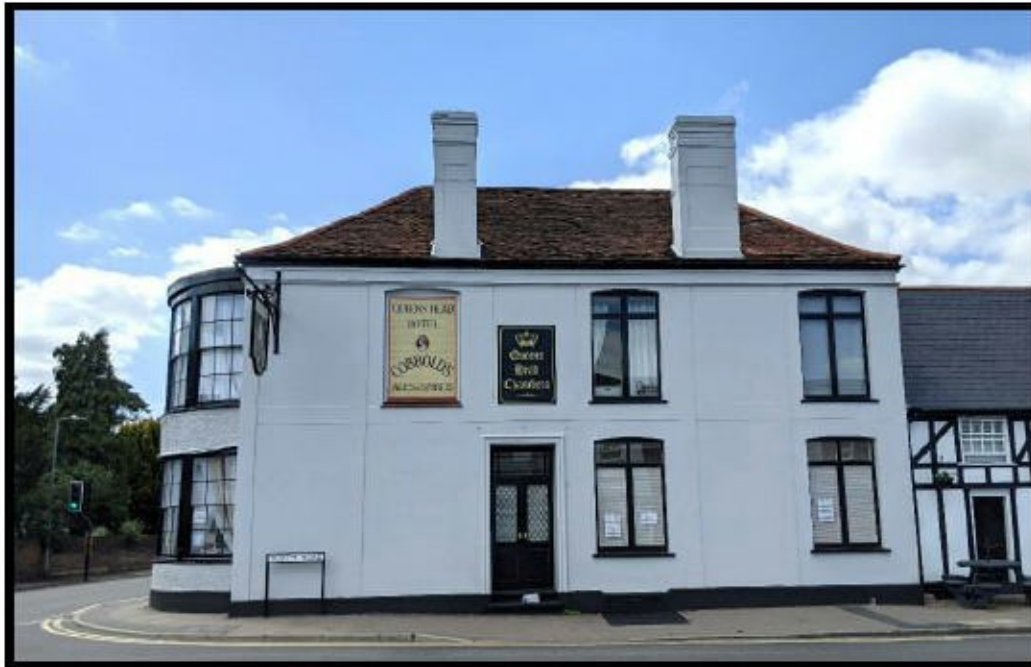
The current casement windows replaced previous 5 panel casements that were in even less keeping with the building. The current window design is reported to be influenced by Building regulation requirements relating to fire.

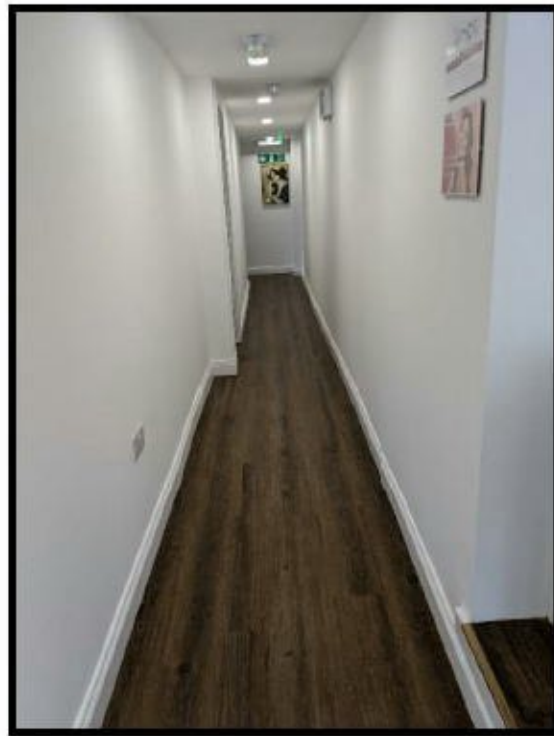
The wall to the right of the picture has had additional cladding consisting of a secondary stud wall, insulated and plasterboarded to comply with Building regulations relating to fire and insulation. This resulted from the wall being old, machined timber studwork.

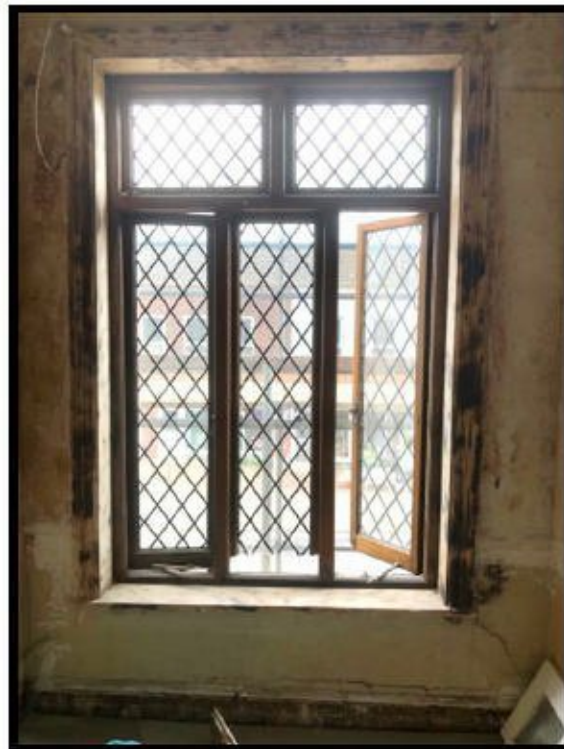
This picture is from the 1<sup>st</sup> floor, the windows on the ground floor were identical.

An odd design of window not in keeping with the building with stick-on imitation leaded lights. The bottom rails show signs of decay.

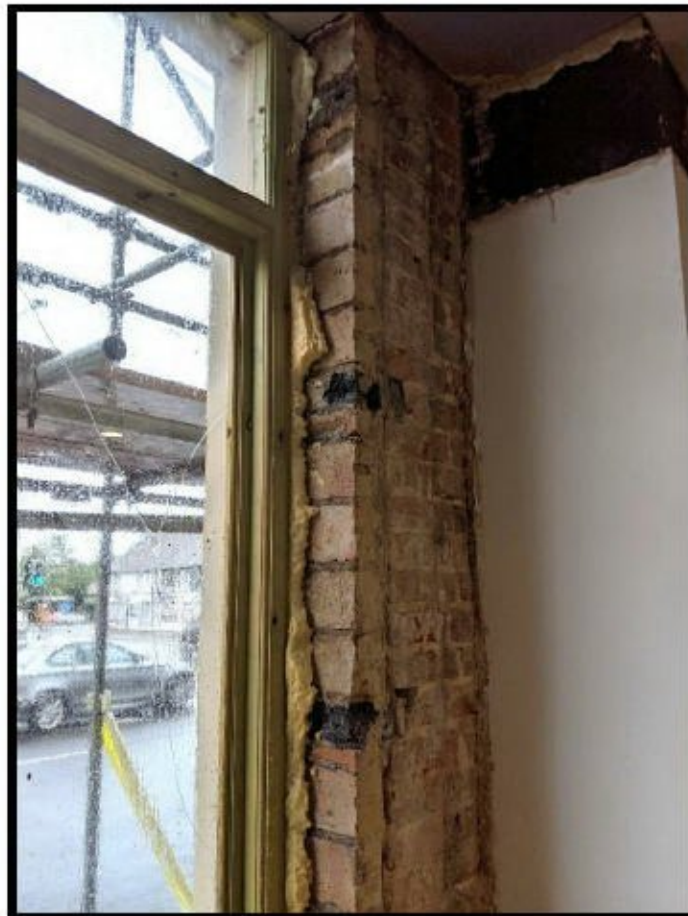
The picture shows previous adaptation of the opening with C20 brickwork reducing the size of the aperture. Judging by the exterior pargetting design this adaptation was carried out at the same time as the rendering. The picture on the previous page shows the original width of the window still present in the relief the sign resides in. The Fletton bricks and clinker blocks with cut nails in, confirm a C20 adaptation.

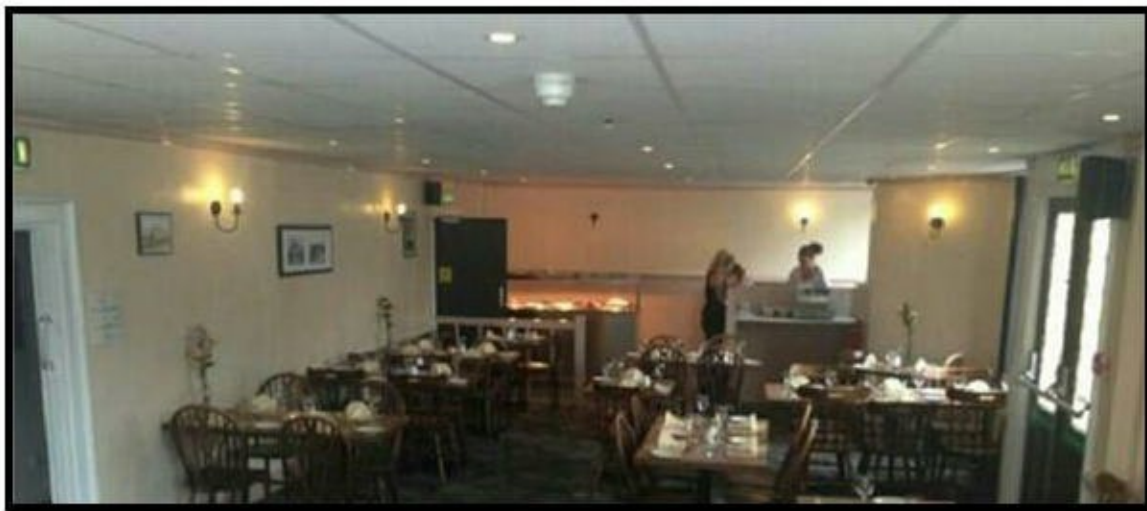
A replacement suspended ceiling has been installed to provide access for services.

Above the new ceiling is the original lath and plaster item with sign of previous damage caused by the installation of the earlier suspended ceiling. Agreement with the TDC's conservation consultant to reduce the ceiling to its current layout has resulted in the configuration in the picture on the next page.
