19<sup>th</sup> May 2021

Cherry and Maples at Wilderhope House

## **Boundary retaining wall, Wilderhope House**

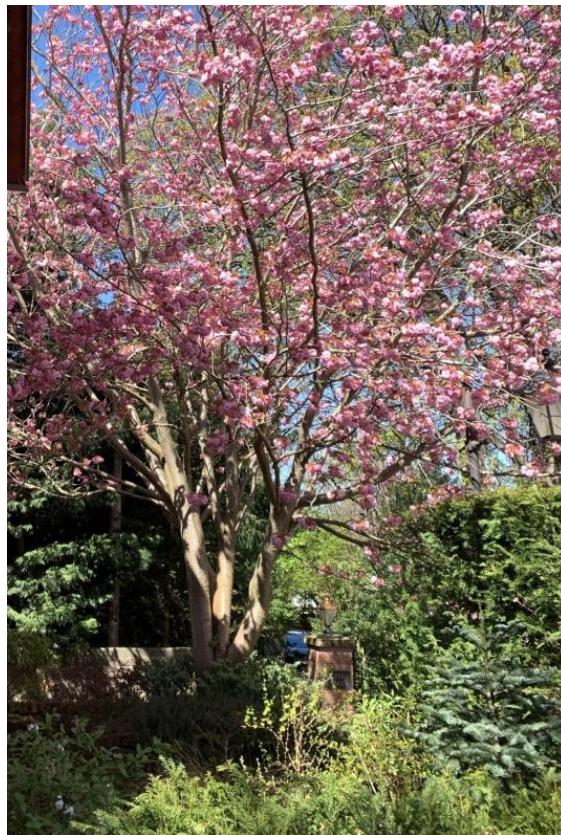
T1 is a Cherry located on top of a retaining wall on the northern corner of your property and a drive serving a neighbouring house. The tree is a large Cherry with 3 stems emanating from near ground level. The tree overhangs the corner of the house and has a wide spreading form. The retaining wall the tree sits upon has been surveyed by a civil engineer who has confirmed the wall is in such a condition that demolition and rebuilding is required to prevent the wall from collapsing. I have appended his comments at Fig 5.

Fig 2 T1 Cherry to Fall

The removal and replacement of the wall would make the retention of the tree unsustainable. Excavation works as indicated in the appended email from the engineer indicates that these would be extensive, and retention of the tree would be unlikely. I concur with this and agree it would be a reasonable option to remove the tree given its location, species and potential future life expectancy.

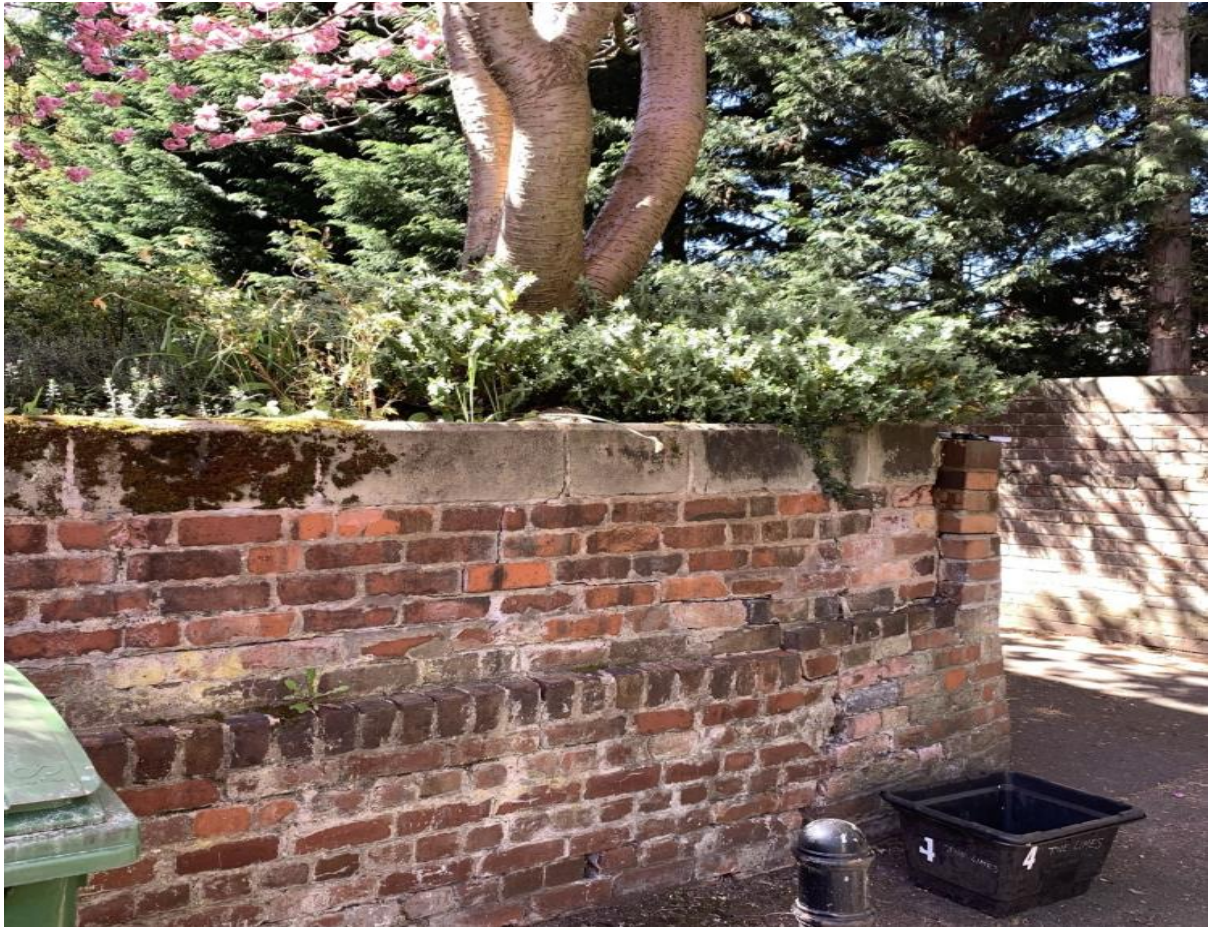
Fig 3 Wall Damage

Very significant exposed roots (200mm approx diameter) are noted at the upper ground level, these being partially constrained by the wall construction. Deeper root growth has resulted in significant damage and distortion to the exposed faces of the wall which, as a result, now exhibit a considerable outward lean as well as more localised areas of bulging and fractured / loosened brickwork. Full thickness cracking of the brickwork is evident at a number of positions with discontinuities of alignment occurring at the positions of the cracking. Whilst the damage appears more critical along the neighbour's driveway, both lengths of wall are now considered to be at risk of local or total collapse.

There is no doubt that the significant damage noted to the retaining wall, both along the Pountney Gardens elevation and down the neighbour's access has occurred as a result of root growth from this tree. The damage and distortion is such that stability of both lengths of the wall may only be restored by rebuilding of the affected lengths. It is understood that you are loathe to lose the tree and that, being subject to a tree preservation order and being in a conservation area makes the retention of the tree a priority if at all feasible.

In its current condition, the wall must be considered to be structurally unsound and liable to collapse without warning. High wind loading could easily provide the necessary trigger for collapse with this possibility increasing whilst the tree is in full leaf. Given the position of the tree, it could potentially fall in any direction although it would appear that falling into the highway or into your neighbour's drive would be the most likely scenario. In our opinion and in the interests of public safety, urgent attention is required to avoid total failure of the wall and consequent collapse of the entire tree. We would therefore recommend that the tree is removed as a matter of urgency allowing reconstruction of the retaining wall to be completed in a safe manner.

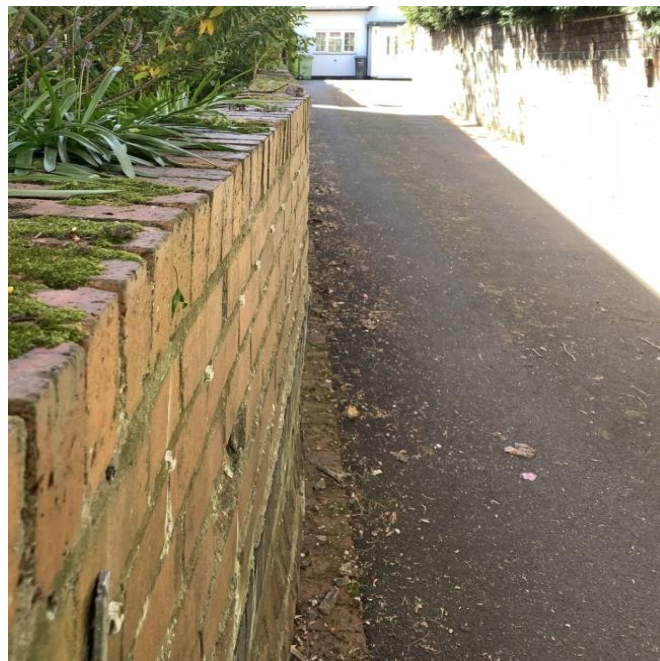
Fig 4 Wall disturbance looking towards neighbouring property

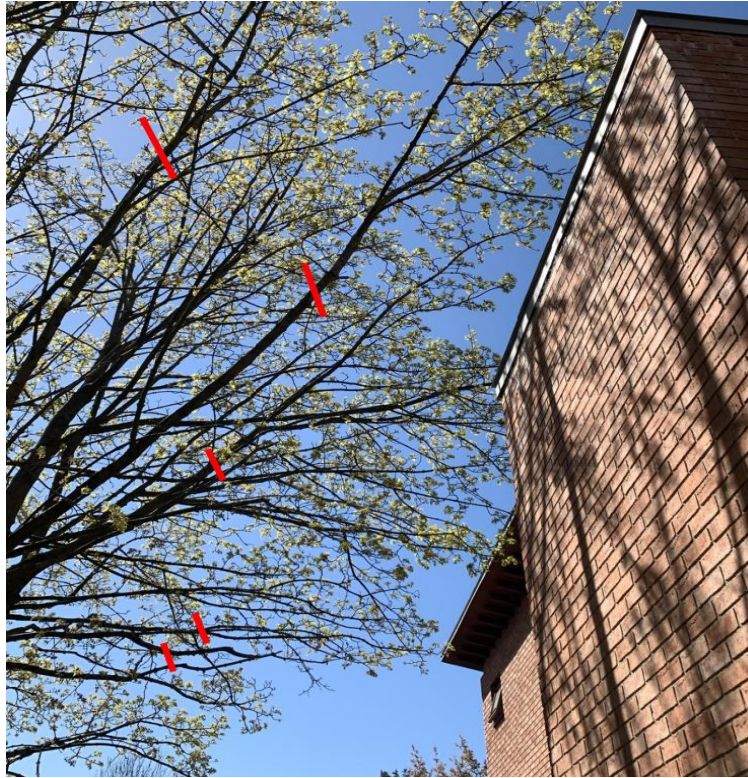
There are two Norway Maples located to the south east of your property. Both trees overhang the roof space of the house. Pruning works to alleviate direct contact between the house and the trees is required to prevent damage occurring because of this contact.

Fig 6 T1 Branches suggested for removal, final cuts to be no more than 100mm  
T2 to be pruned in a similar manner
