ASBESTOS MANAGEMENT SURVEY REPORT
Of
THE PADDOCKS
HONILEY ROAD
BEAUSALE
WARWICKSHIRE
CV35 7NX

REPORT REFERENCE: S2069

Site: The Paddocks
Honiley Road
Beausale
Warwickshire
CV35 7NX

Client	Mr Adam Hicken	Survey Ref	S2069
Survey Type	Management Survey	Survey Date	17/08/2020
Site Address	The Paddocks, Honiley Road, Beausale, Warwickshire, CV35 7NX	Surveyor	Sul Ibrahim
		Report Date	25/08/2020

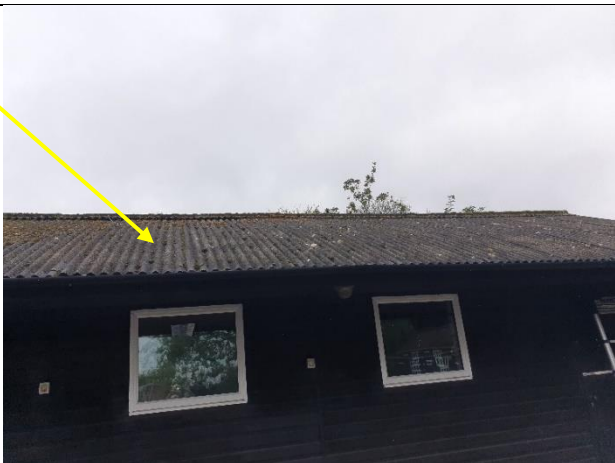
Ref. No.	S2069/01	Building	Building 1	
Floor/Room	External			
Position	Roof

Material Type	Cement			
Level of Identification	Sampled			
Asbestos Type	Chrysotile			
Extent	40m ²			
Accessibility	Unlikely to be disturbed			
Comments	The roof to Building 1 was sampled and analysis confirmed the presence of asbestos. The cement roof was in a good condition.			
Product Type	1	Asbestos Score	1	
Actions	Condition	1	MA Score	4
Monitor and manage See 8.2	Surface Treatment	1	MRA	Very Low

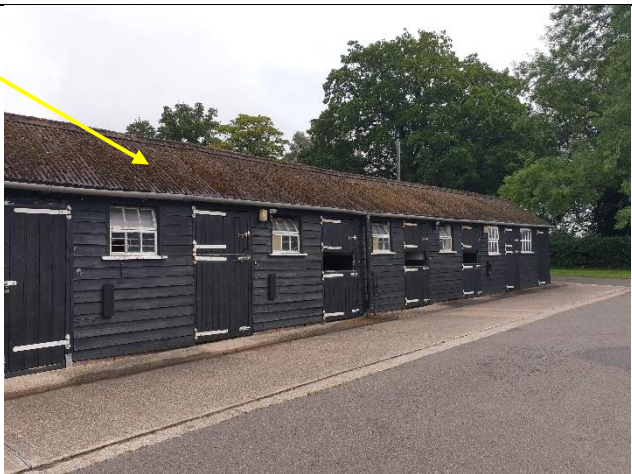
Ref. No.	S2069/03	Building	Building 2		
Floor/Room	External				
Position	Roof

Material Type	Cement				
Level of Identification	Sampled				
Asbestos Type	Chrysotile				
Extent	200m ²				
Accessibility	Unlikely to be disturbed				
Comments	The roof to Building 2 was sampled and analysis confirmed the presence of asbestos. The cement roof was in a good condition.				
	Product Type	1	Asbestos Score	1	
Actions	Condition	1	MA Score	4	
Monitor and manage See 8.2	Surface Treatment	1	MRA	Very Low

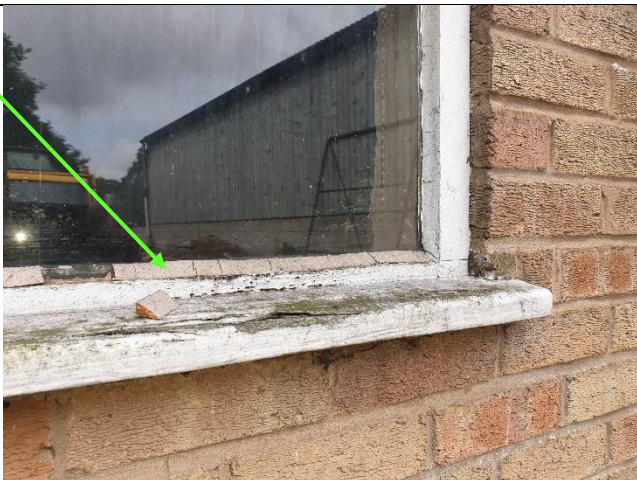
Ref. No.	S2069/04	Building	Building 2		
Floor/Room	External				
Position	Windows

Material Type	Putty				
Level of Identification	Sampled				
Asbestos Type	No asbestos detected				
Extent	Not Applicable				
Accessibility	Not applicable				
Comments	This material was slightly damaged, however it was negative for the presence of asbestos.				
	Product Type	NA	Asbestos Score	NA	
Actions	Condition	NA	MA Score	NA	
None	Surface Treatment	NA	MRA	None

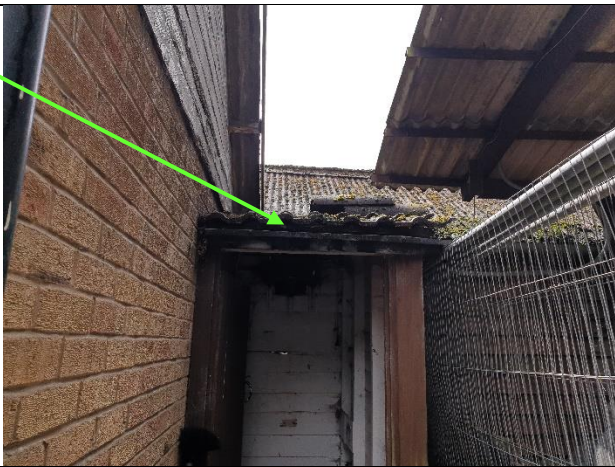
Ref. No.	S2069/05	Building	Building 2		
Floor/Room	External				
Position	Roof

Material Type	Bitumen Felt				
Level of Identification	Sampled				
Asbestos Type	No asbestos detected				
Extent	Not Applicable				
Accessibility	Not applicable				
Comments					
	Product Type	NA	Asbestos Score	NA	
Actions	Condition	NA	MA Score	NA	
None	Surface Treatment	NA	MRA	None

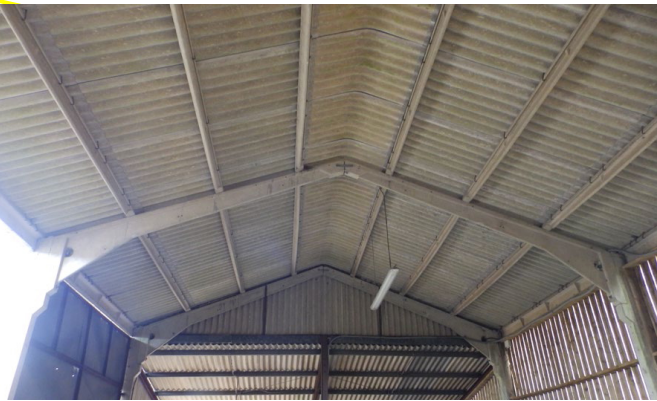
Ref. No.	S2069/06	Building	Building 3		
Floor/Room	External				
Position	Roof & Wall

Material Type	Cement				
Level of Identification	Sampled				
Asbestos Type	Chrysotile				
Extent	350m ²				
Accessibility	Unlikely to be disturbed				
Comments	The roof & wall to Building 3 was sampled and analysis confirmed the presence of asbestos. The cement roof & wall were in a good condition.				
	Product Type	1	Asbestos Score	1	
Actions	Condition	1	MA Score	1	
Monitor and manage See 8.2	Surface Treatment	1	MRA	Very Low

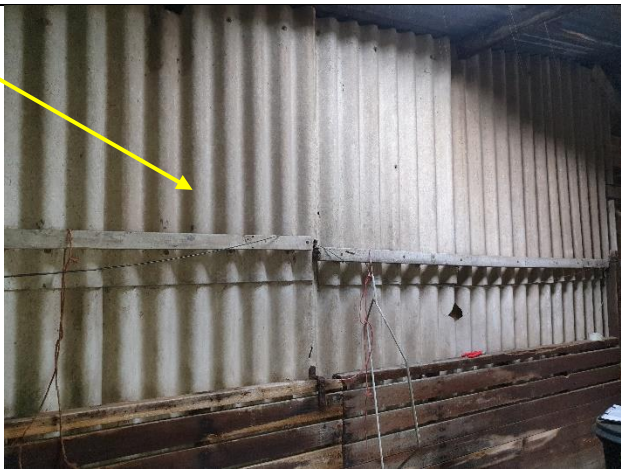
Ref. No.	S2069/06A	Building	Building 6	
Floor/Room	Internal Store Area			
Position	Wall

Material Type	Cement			
Level of Identification	Strongly Presumed			
Asbestos Type	Chrysotile			
Extent	20m ²			
Accessibility	Occasionally likely to be disturbed			
Comments	Strongly presumed to be similar to S2069/06. The cement wall was in a good condition.			
	Product Type	1	Asbestos Score	1
Actions	Condition	1	MA Score	4
Monitor and manage See 8.2	Surface Treatment	1	MRA	Very Low

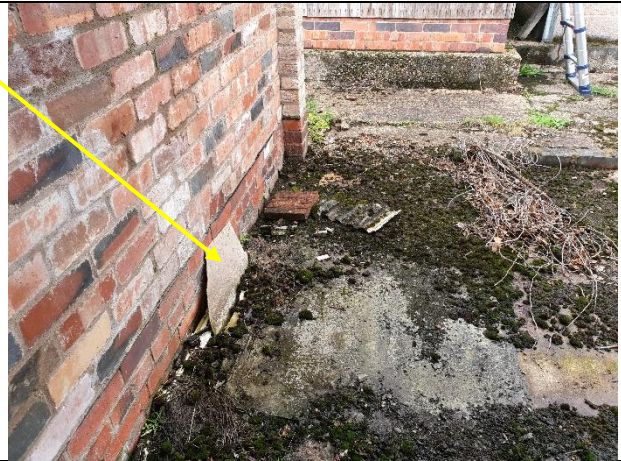
Ref. No.	S2069/06B	Building	Building 6	
Floor/Room	Internal Store Area			
Position	Floor

Material Type	Cement Debris			
Level of Identification	Strongly Presumed			
Asbestos Type	Chrysotile			
Extent	As Found			
Accessibility	Occasionally likely to be disturbed			
Comments	Strongly presumed to be similar to S2069/06. Cement debris was identified in various areas throughout the site.			
	Product Type	1	Asbestos Score	1
Actions	Condition	2	MA Score	5
Remove See 8.1	Surface Treatment	1	MRA	Low

There was cement debris identified in various locations throughout the site. Ideally, this material should be removed. This is not a licensed activity but the Control of Asbestos Regulations 2012 and Hazardous Waste Regulations 2005 must be followed. For further information please see <http://www.hse.gov.uk/asbestos/essentials/>.

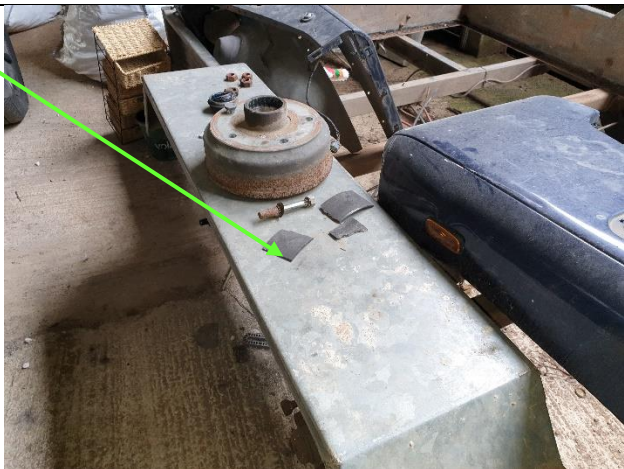
Ref. No.	S2069/07	Building	Building 3			
Floor/Room	Main Barn Area					
Position	Floor & Table

Material Type	Composite Debris					
Level of Identification	Sampled					
Asbestos Type	No asbestos detected					
Extent	Not Applicable					
Accessibility	Not applicable					
Comments						
	Product Type				NA	Asbestos Score
Actions	Condition	NA	MA Score	NA		
None	Surface Treatment	NA	MRA	None

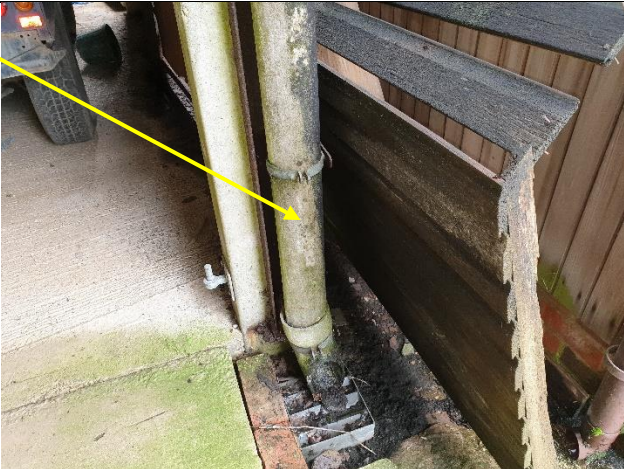
Ref. No.	S2069/08	Building	Building 3			
Floor/Room	External					
Position	Gutters/Downpipes

Material Type	Cement					
Level of Identification	Sampled					
Asbestos Type	Chrysotile					
Extent	30LM					
Accessibility	Occasionally likely to be disturbed					
Comments	The cement gutters and downpipes were in a fair condition.					
	Product Type				1	Asbestos Score
Actions	Condition	1	MA Score	4		
Monitor and manage See 8.2	Surface Treatment	1	MRA	Very Low

The cement walls, roofs, gutters and downpipes were in a good condition and can remain in situ. If these materials are likely to be significantly disturbed, they should be removed under controlled conditions and disposed of in accordance with Hazardous Waste Regulations (2005). This is not a licensed activity but the Control of Asbestos Regulations (2012) must still be adhered to. For further guidance on removal please see <http://www.hse.gov.uk/asbestos/essentials/>.

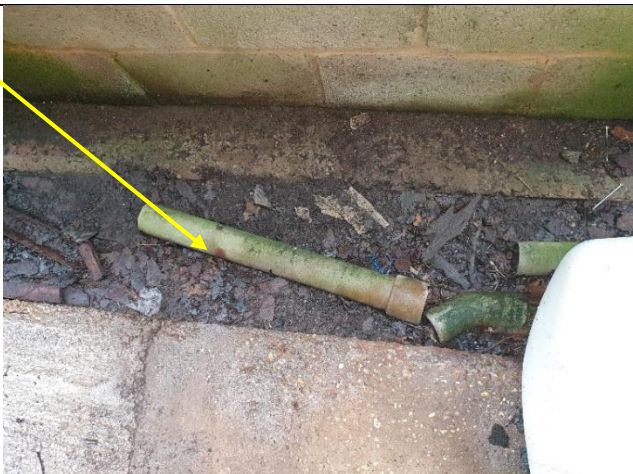
Ref. No.	S2069/08A	Building	Building 3			
Floor/Room	Main Barn Area					
Position	Floor

Material Type	Cement Debris					
Level of Identification	Strongly Presumed					
Asbestos Type	Chrysotile					
Extent	As Found					
Accessibility	Occasionally likely to be disturbed					
Comments	Strongly presumed to be similar to S2069/08. Cement debris was identified to the floor. There is likely to be cement debris throughout the site due to the vast quantity of cement present.					
Actions	Remove	See 8.1	Product Type	1	Asbestos Score	1
			Condition	2	MA Score	5
			Surface Treatment	1	MRA	Low

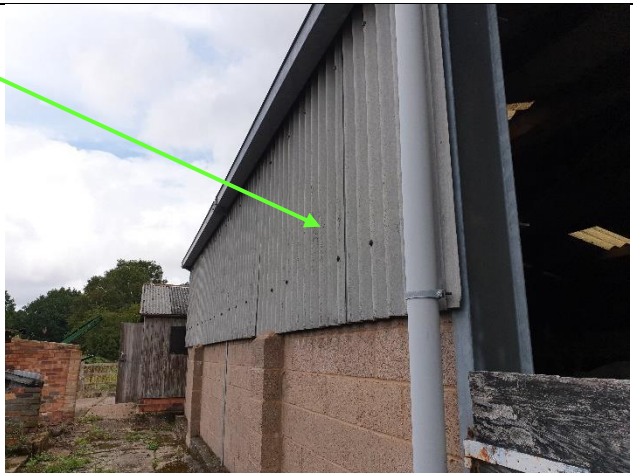
Ref. No.	S2069/09	Building	Building 4			
Floor/Room	External					
Position	Wall

Material Type	Cement					
Level of Identification	Sampled					
Asbestos Type	No asbestos detected					
Extent	Not Applicable					
Accessibility	Not applicable					
Comments	The cement sheets that were tested were modern non-asbestos cement.					
Actions	None	See 8.3	Product Type	NA	Asbestos Score	NA
			Condition	NA	MA Score	NA
			Surface Treatment	NA	MRA	None

Some cement materials tested negative for the presence of asbestos. These may be modern replacements for previous asbestos containing cement sheets, which can be replaced due to excessive damage. The cement sheets tested were negative, however there may be a combination of both positive and negative cement products present. The above recommendation (8.2) should be adhered to.

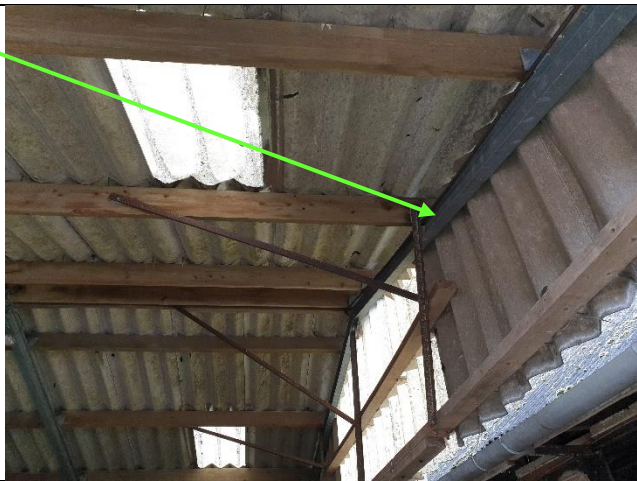
Ref. No.	S2069/10	Building	Building 4		
Floor/Room	External				
Position	Roof & Wall

Material Type	Cement				
Level of Identification	Sampled				
Asbestos Type	No asbestos detected				
Extent	Not Applicable				
Accessibility	Not applicable				
Comments					
					Product Type
Actions		Condition	NA	MA Score	NA
	None See 8.3	Surface Treatment	NA	MRA	None

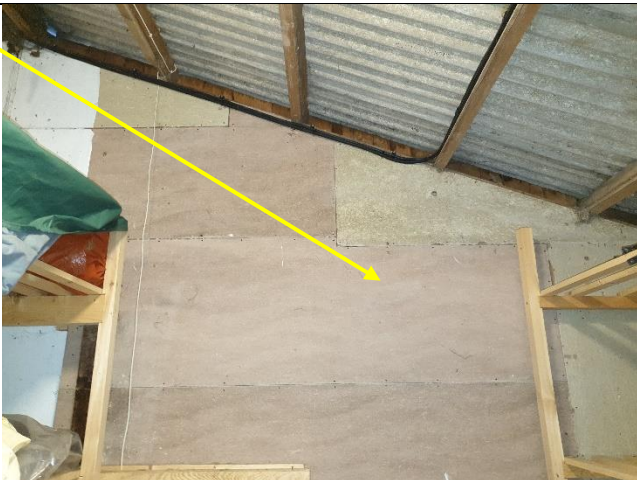
Ref. No.	S2069/11	Building	Building 5		
Floor/Room	G/01 – Store				
Position	Wall Panels to Rear

Material Type	Cement				
Level of Identification	Sampled				
Asbestos Type	Chrysotile				
Extent	5m ²				
Accessibility	Easily disturbed				
Comments					
	Cement Panels to the rear of Building 5 tested positive for the presence of asbestos.				Product Type
Actions		Condition	1	MA Score	NA
	Monitor and manage See 8.2	Surface Treatment	1	MRA	Very Low

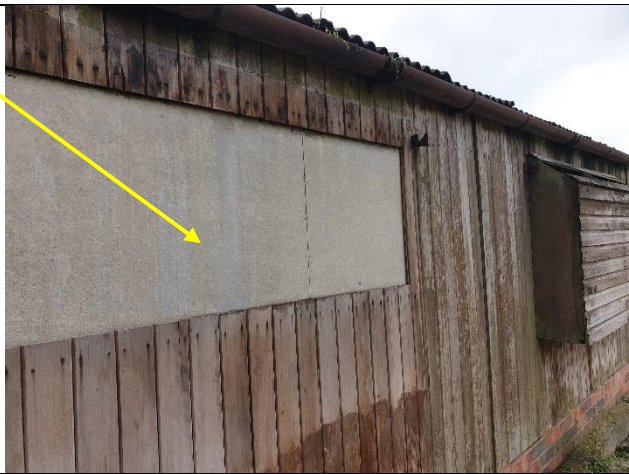
Ref. No.	S2069/11A	Building	Building 5	
Floor/Room	External			
Position	Wall

Material Type	Cement			
Level of Identification	Strongly Presumed			
Asbestos Type	Chrysotile			
Extent	2m ²			
Accessibility	Occasionally likely to be disturbed			
Comments	Strongly presumed to be similar to S2069/11. Cement panel was visually identified to the exterior. This material may be present behind the timber cladding.			
	Product Type	1	Asbestos Score	1
Actions	Condition	0	MA Score	3
Monitor and manage See 8.2	Surface Treatment	1	MRA	Very Low

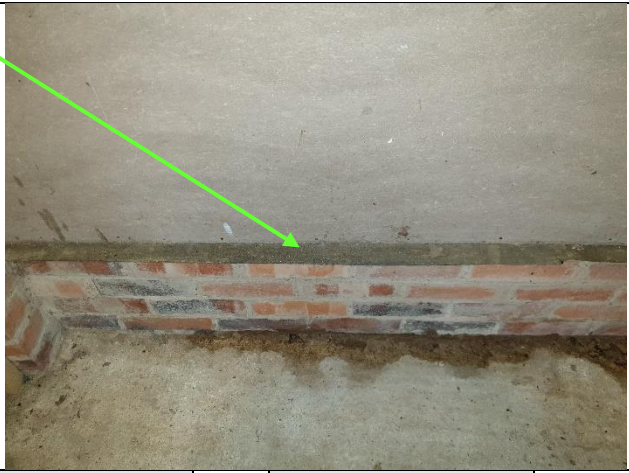
Ref. No.	S2069/12	Building	Building 5	
Floor/Room	G/01 - Store			
Position	Wall

Material Type	Bitumen Felt			
Level of Identification	Sampled			
Asbestos Type	No asbestos detected			
Extent	Not Applicable			
Accessibility	Not applicable			
Comments				
	Product Type	NA	Asbestos Score	NA
Actions	Condition	NA	MA Score	NA
None	Surface Treatment	NA	MRA	None

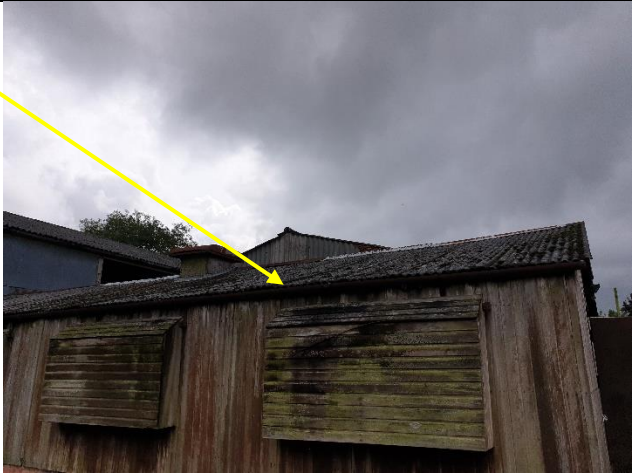
Ref. No.	S2069/13	Building	Building 5	
Floor/Room	External			
Position	Roof

Material Type	Cement			
Level of Identification	Sampled			
Asbestos Type	Chrysotile			
Extent	70m ²			
Accessibility	Unlikely to be disturbed			
Comments	The cement roof was sampled and analysis confirmed the presence of asbestos.			
	Product Type	1	Asbestos Score	1
Actions	Condition	1	MA Score	4
Monitor and manage See 8.2	Surface Treatment	1	MRA	Very Low

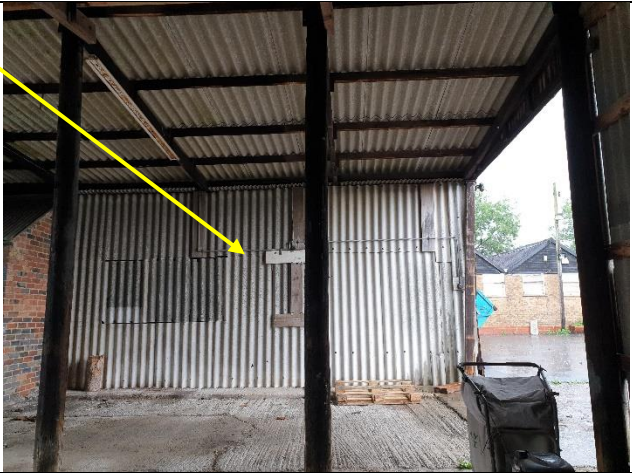
Ref. No.	S2069/13A	Building	Building 6	
Floor/Room	External Barn			
Position	Roof & Wall

Material Type	Cement			
Level of Identification	Strongly Presumed			
Asbestos Type	Chrysotile			
Extent	200m ²			
Accessibility	Occasionally likely to be disturbed			
Comments	Strongly presumed to be similar to S2069/13. The cement roof and wall were in a good condition.			
	Product Type	1	Asbestos Score	1
Actions	Condition	1	MA Score	4
Monitor and manage See 8.2	Surface Treatment	1	MRA	Very Low

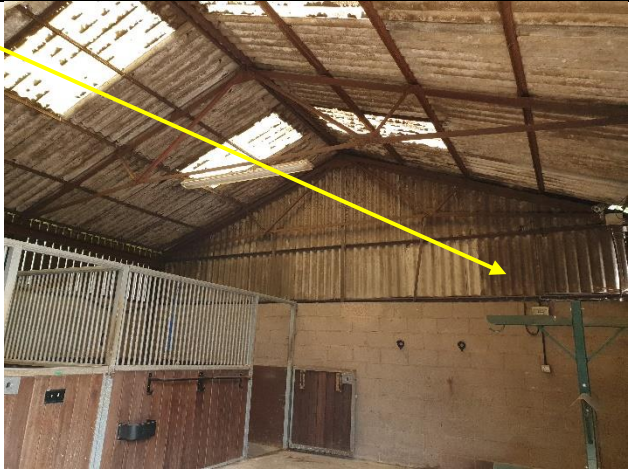
Ref. No.	S2069/13B	Building	Building 7	
Floor/Room	External Barn			
Position	Roof & Wall

Material Type	Cement			
Level of Identification	Strongly Presumed			
Asbestos Type	Chrysotile			
Extent	200m ²			
Accessibility	Occasionally likely to be disturbed			
Comments	Strongly presumed to be similar to S2069/13. The cement roof and wall were in a good condition.			
	Product Type	1	Asbestos Score	1
Actions	Condition	1	MA Score	4
Monitor and manage See 8.2	Surface Treatment	1	MRA	Very Low

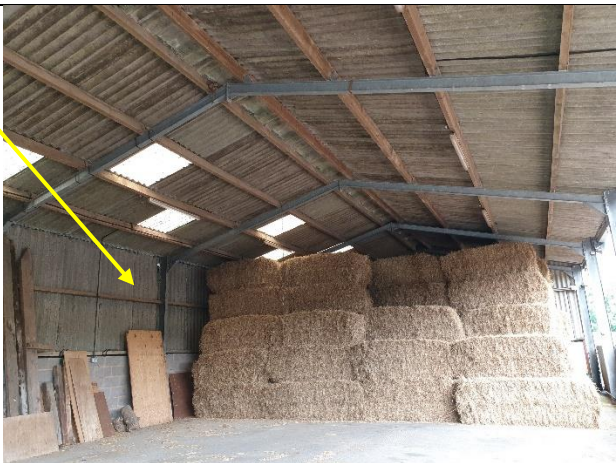
Ref. No.	S2069/13C	Building	Building 8	
Floor/Room	External Barn & Stalls			
Position	Roof & Wall

Material Type	Cement			
Level of Identification	Strongly Presumed			
Asbestos Type	Chrysotile			
Extent	500m ²			
Accessibility	Occasionally likely to be disturbed			
Comments	Strongly presumed to be similar to S2069/13. The cement roof and wall to the main barn and rear stalls. were in a good condition			
	Product Type	1	Asbestos Score	1
Actions	Condition	1	MA Score	4
Monitor and manage See 8.2	Surface Treatment	1	MRA	Very Low
