PHILOSOPHICAL APPROACH

SEB5 EXTERNAL WORKS:

SEB5: PROPOSED EXTERNAL ELEVATION
SCALE 1:10 @ A0

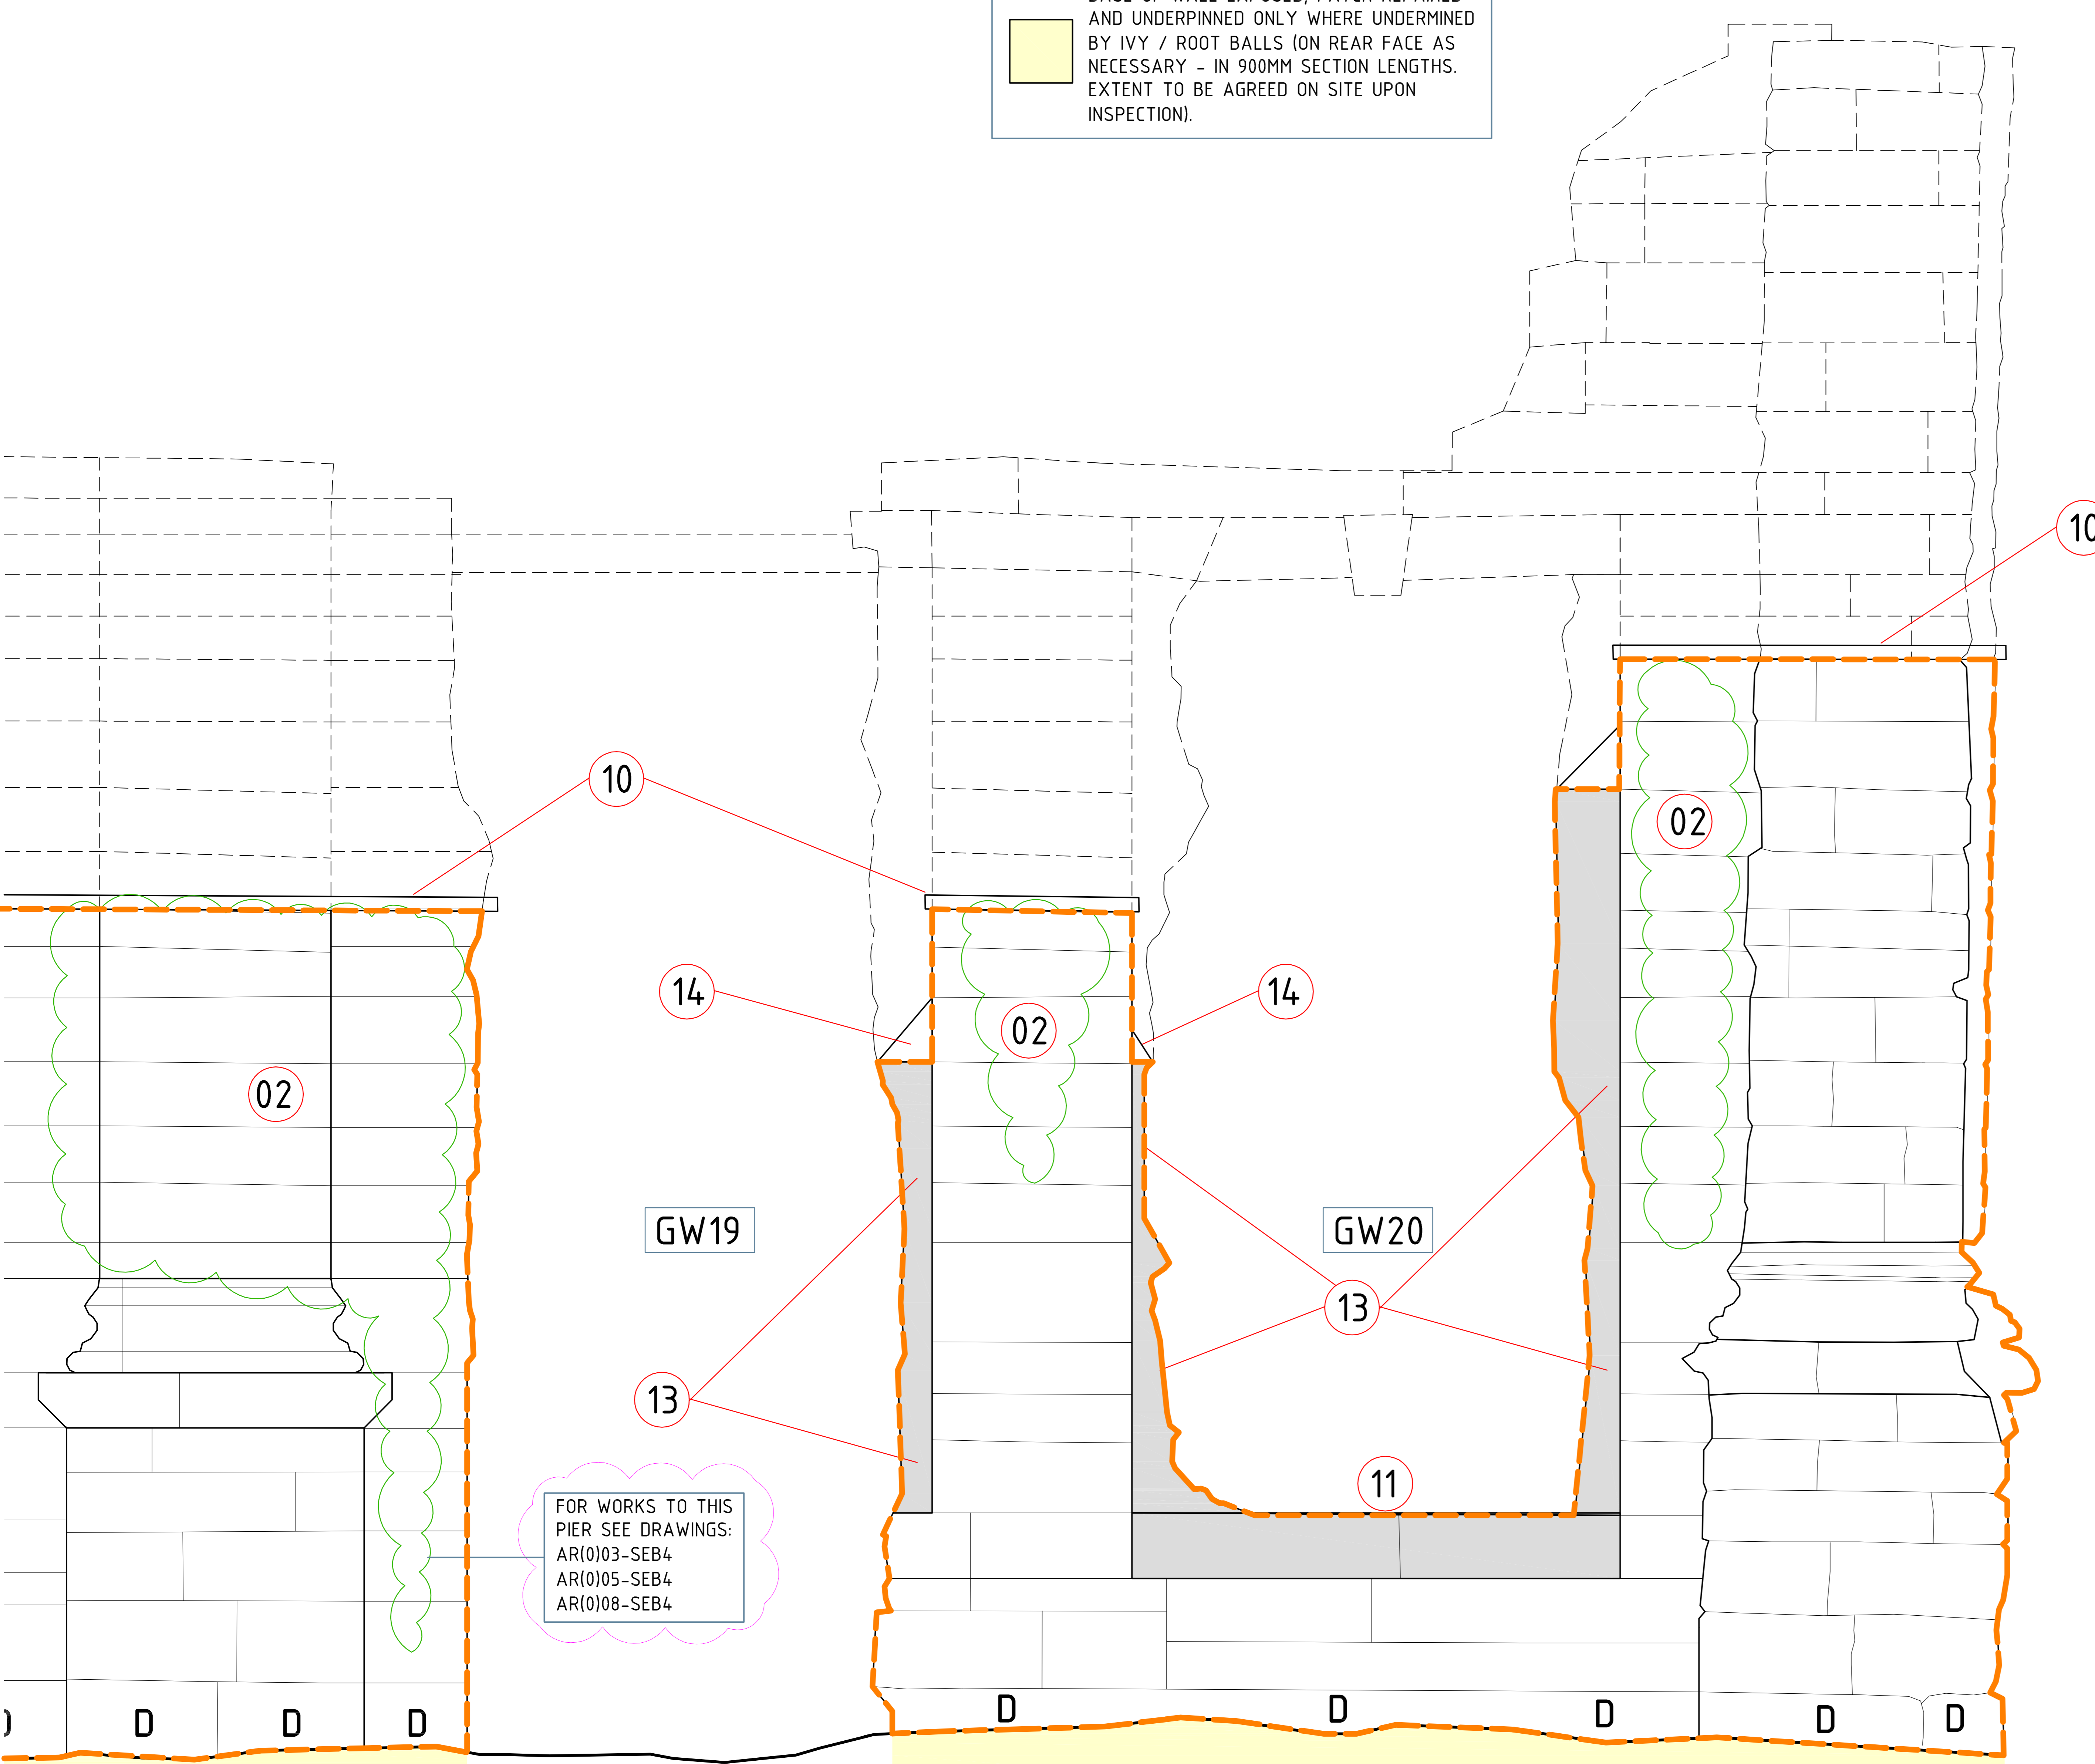
THIS FAÇADE HAS SUFFERED FROM EXTENSIVE UNCONTROLLED COLLAPSE OVER THE YEARS AND THE STRUCTURAL INTEGRITY OF THE REMAINING ELEMENTS IS SIGNIFICANTLY COMPROMISED. ON THE BASIS THAT REPRESENTATIVE SAMPLES OF THE VARIOUS BUILDING ELEMENTS ARE PRESERVED ELSEWHERE IT IS PROPOSED THAT MISSING OR COLLAPSED SECTIONS ARE NOT REINSTATED AND UNSTABLE REMNANTS ARE REMOVED. THE EXISTING MASONRY WILL BE REDUCED IN HEIGHT TO A LOGICAL POINT WHERE IT IS MORE STRUCTURALLY VIABLE AND CAN BE WEATHERED EFFECTIVELY IN ORDER THAT DECAY AND FURTHER COLLAPSE CAN BE ARRESTED AND THE RUIN CONSOLIDATED. STONES TAKEN DOWN WILL BE LEFT ON SITE ADJACENT TO WHERE THEY CAME FROM. A PHOTOGRAPHIC RECORD IS TO BE MADE OF THE STRUCTURE AS IT CURRENTLY STANDS PRIOR TO DISMANTLING.

- 01 GENERALLY REMOVE ALL REMNANTS OF VEGETATION.
- 02 AREA OBSCURED BY REMAINING VEGETATION AND SCAFFOLD PLANKS. ASSUME CATEGORY B REPAIR REQUIRED.
- 03 CARRY OUT CATEGORY B REPAIRS - LIGHTLY DRESS EXISTING STONES IN-SITU

- 04 CARRY OUT CATEGORY C REPAIRS - REPAIR DAMAGED OR HEAVILY ERODED STONES USING REINFORCED SSTONE REPAIR SYSTEM AS REQUIRED, SEE NBS.
- 05 CARRY OUT CATEGORY D REPAIRS - CUT OUT STONES CONSIDERED TO BE TOO BADLY DAMAGED OR ERODED FOR REPAIR AND REPLACE WITH NEW TO ORIGINAL PROFILE. REPLACE MISSING STONES WITH NEW TO MATCH ORIGINAL PROFILE.

- 06 NOT ON THIS DRAWING.
- 07 GENERALLY REPOINT ELEVATION WITH LIME MORTAR.
- 08 INSTALL NEW STONES TO FORM NEW WINDOW SURROUND TO MATCH ORIGINAL.
- 09 STONEMWORK BELOW CILL BUILT BACK UP OFF EXISTING FOOTING USING RECLAIMED STONE OR NEW TO MATCH THE EXISTING.

- 10 NEW CAPPING OF LEAD CLAD PAVING SLABS INSTALLED IN ACCORDANCE WITH DRAWING AR(0)08 SEB5.
- 11 EXISTING STONE AND BRICK INFILL REMOVED TO ALLOW CILLS TO BE INSTALLED. ENSURE MOISTURE PROTECTION TO WALL BELOW IS ACHIEVED.

- 12 HOLES IN STONE ASSUMED TO HAVE BEEN WHERE RAINWATER GOODS WERE FIXED FILLED
- 13 CAREFULLY REMOVE AND REINSTATE AFTER A LIGHT DRESSING ORIGINAL WINDOW SURROUND STONES. EMPLOY STAINLESS STEEL CRAMPS , DOWELS AND HELICAL FIXINGS TO SECURE STONES IN PLACE.

- A: NO WORK REQUIRED
- B: STONE RE-DRESSED IN SITU - NBS CLAUSES C41X / 450 - 458
- C: STONE LOCALLY REPAIRED - NBS CLAUSES C41X / 510 - 692
- D: STONE REPLACED WITH NEW - NBS CLAUSES C41X / 310 - 420

STONEMWORK TO BE GENERALLY REPOINTED IN ACCORDANCE WITH THE SPECIFICATION NBS CLAUSES C41X / 810 - 860

- GW19 GROUND FLOOR WINDOW 19
- GW20 GROUND FLOOR WINDOW 20
- BASE OF WALL EXPOSED, PATCH REPAIRED AND UNDERPINNED ONLY WHERE UNDERMINED BY IVY / ROOT BALLS (ON REAR FACE AS NECESSARY - IN 900MM SECTION LENGTHS. EXTENT TO BE AGREED ON SITE UPON INSPECTION).

- 14 INSTALL LIME MORTAR BENCHING TO IMPROVE WATER RUN OFF

ALL STONES TO BE NUMBERED AND CATALOGUED PRIOR TO PIER BEING CAREFULLY TAKEN DOWN TO GROUND LEVEL. PIER TO BE RECONSTRUCTED TO DATUM AS DRAWING AR(0)05 SEB5 USING SALVAGED STONES DEEMED ACCEPTABLE FOR RE-USE (WITH RE-DRESSING) IN ORIGINAL UN-DISPLACED POSITIONS. STONES CONSIDERED TO BE TOO BADLY DAMAGED OR ERODED FOR REPAIR REPLACED WITH NEW TO ORIGINAL PROFILE.
