SEB5: PROPOSED INTERNAL ELEVATION
 SCALE 1:10 @ A0

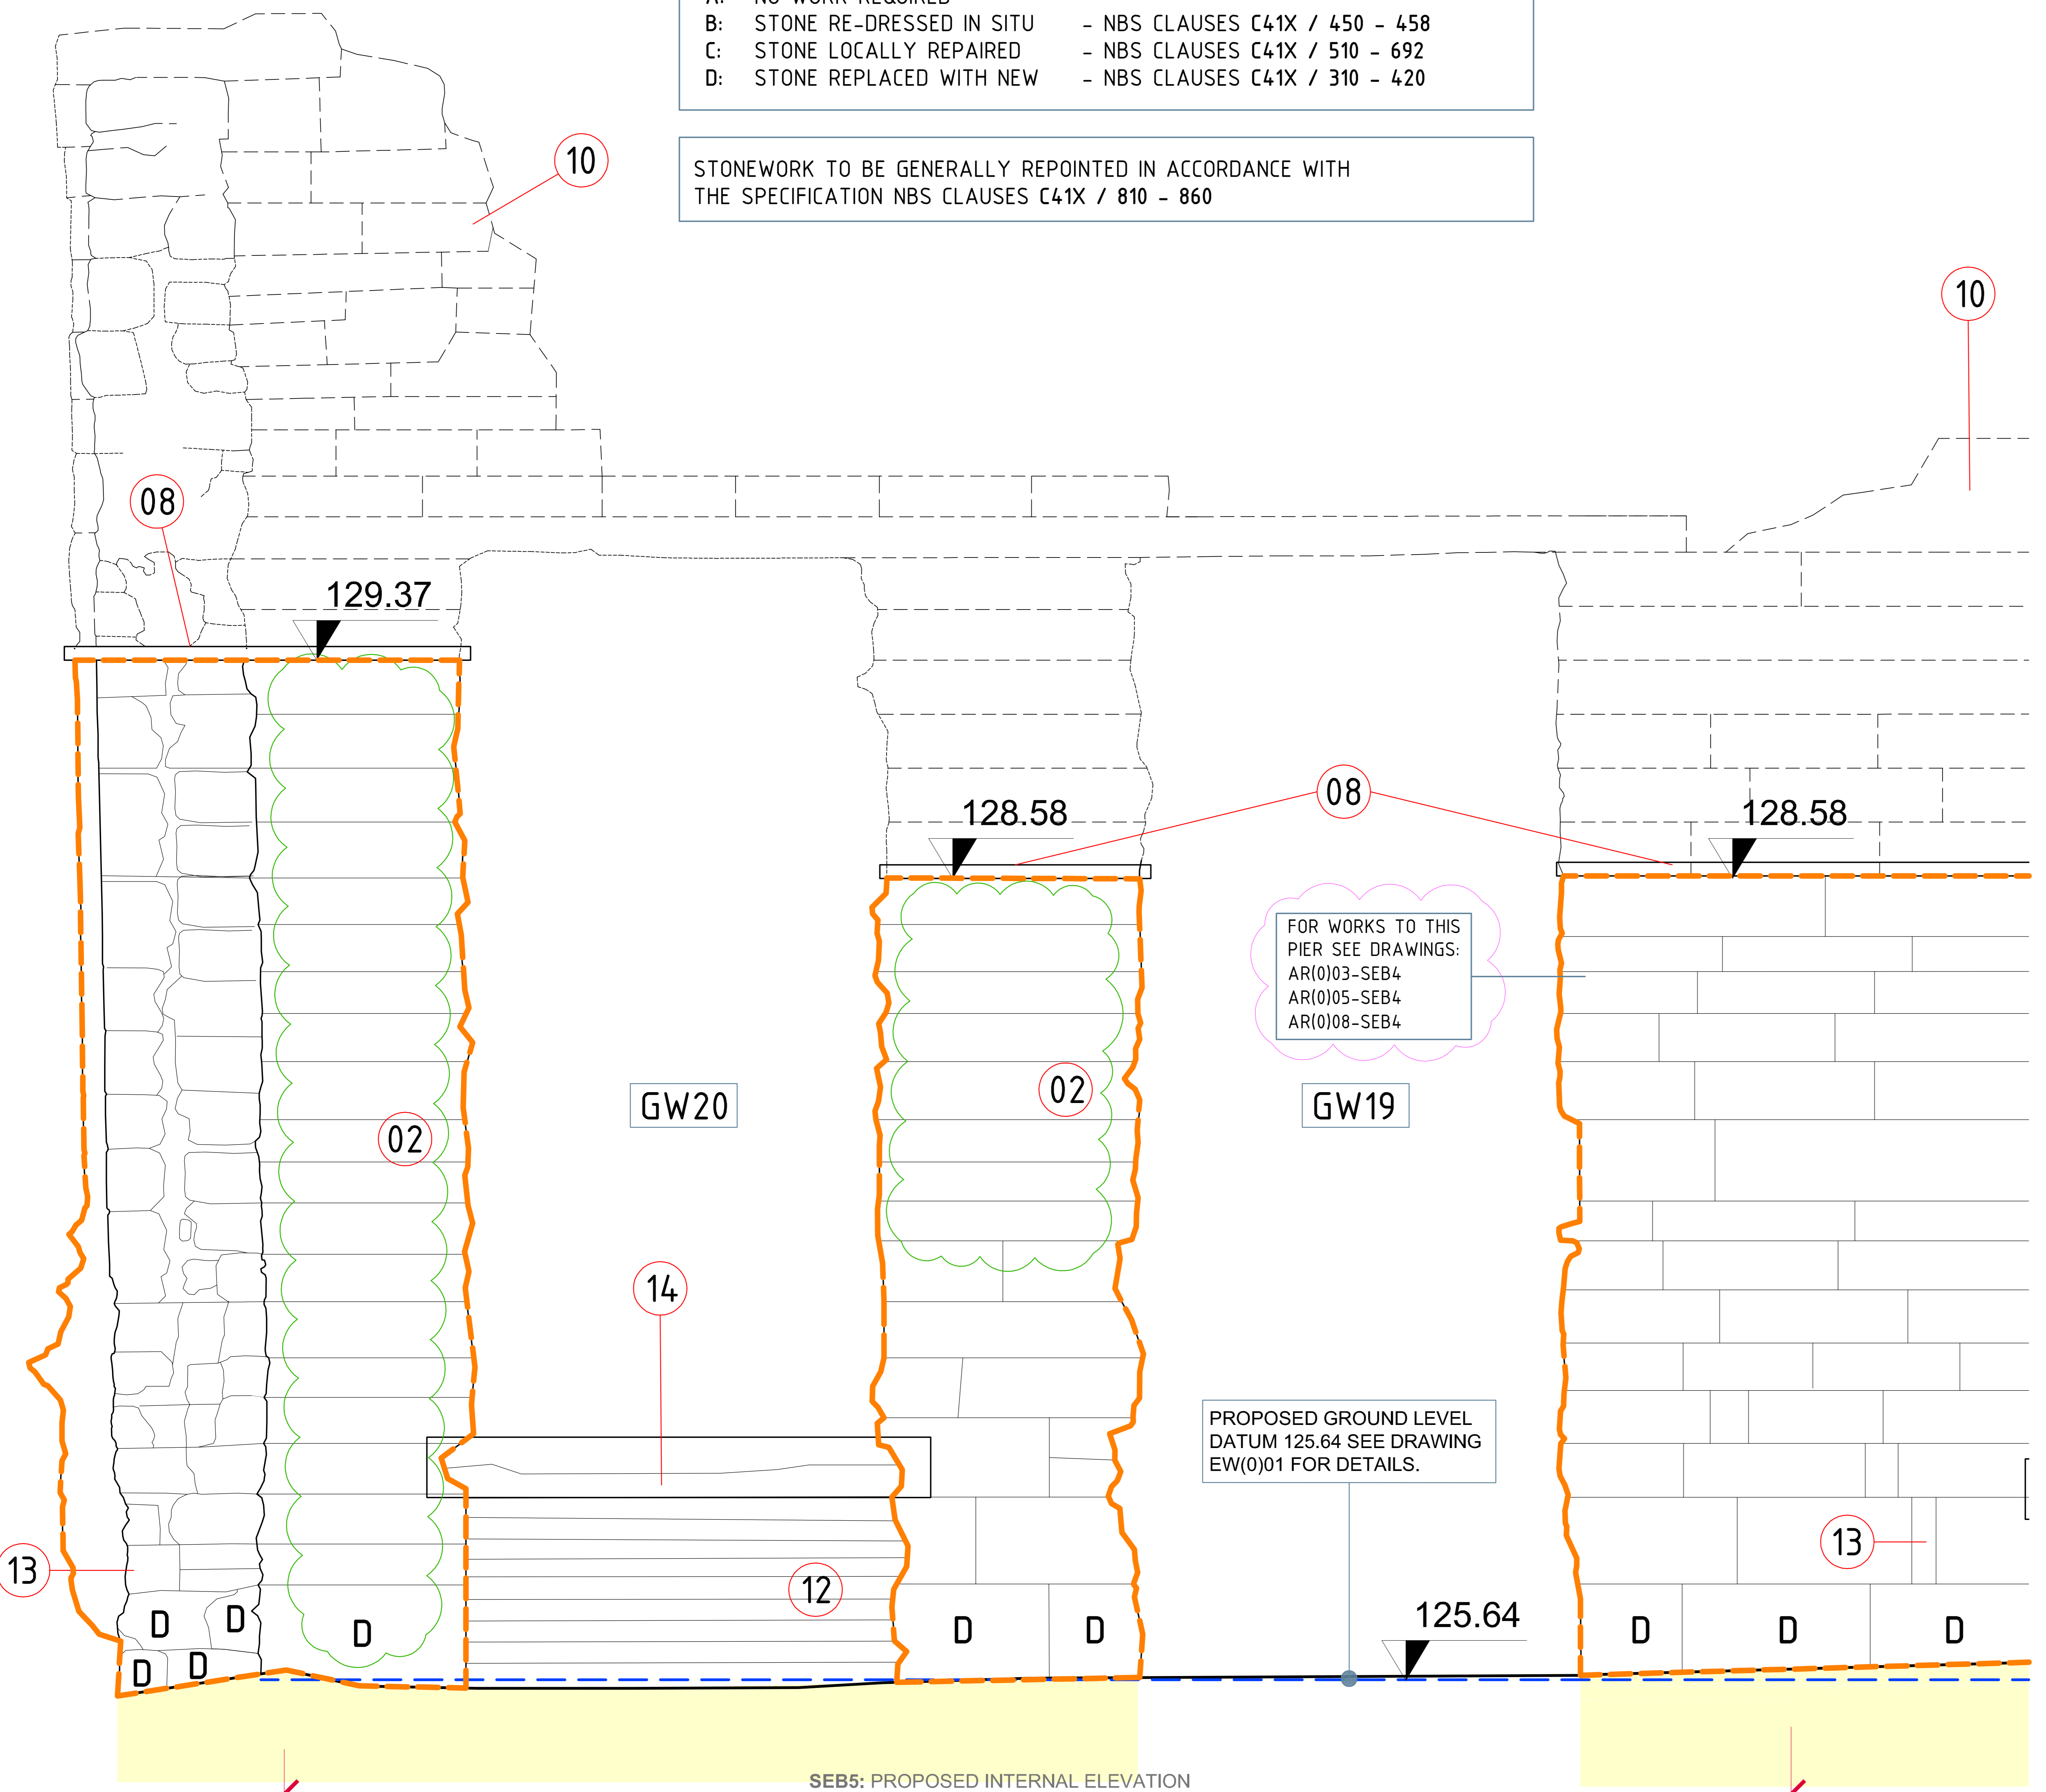
THIS FAÇADE HAS SUFFERED FROM EXTENSIVE UNCONTROLLED COLLAPSE OVER THE YEARS AND THE STRUCTURAL INTEGRITY OF THE REMAINING ELEMENTS IS SIGNIFICANTLY COMPROMISED. ON THE BASIS THAT REPRESENTATIVE SAMPLES OF THE VARIOUS BUILDING ELEMENTS ARE PRESERVED ELSEWHERE IT IS PROPOSED THAT MISSING OR COLLAPSED SECTIONS ARE NOT REINSTATED AND UNSTABLE REMNANTS ARE REMOVED. THE EXISTING MASONRY WILL BE REDUCED IN HEIGHT TO A LOGICAL POINT WHERE IT IS MORE STRUCTURALLY VIABLE AND CAN BE WEATHERED EFFECTIVELY IN ORDER THAT DECAY AND FURTHER COLLAPSE CAN BE ARRESTED AND THE RUIN CONSOLIDATED. STONES TAKEN DOWN WILL BE LEFT ON SITE ADJACENT TO WHERE THEY CAME FROM. A PHOTOGRAPHIC RECORD IS TO BE MADE OF THE STRUCTURE AS IT CURRENTLY STANDS PRIOR TO DISMANTLING.

- SEB5 INTERNAL WORKS:**
- 01 GENERALLY REMOVE ALL REMNANTS OF VEGETATION.
 - 02 AREA OBSCURED BY REMAINING VEGETATION AND SCAFFOLD PLANKS. ASSUME CATEGORY B REPAIR REQUIRED.

BASE OF WALL EXPOSED, PATCH REPAIRED AND UNDERPINNED ONLY WHERE UNDERMINED BY IVY / ROOT BALLS (ON REAR FACE AS NECESSARY - IN 900MM SECTION LENGTHS. EXTENT TO BE AGREED ON SITE UPON INSPECTION).

- 03 CARRY OUT CATEGORY B REPAIRS - LIGHTLY DRESS EXISTING STONES IN-SITU
 - 04 CARRY OUT CATEGORY C REPAIRS - REPAIR DAMAGED OR HEAVILY ERODED STONES USING REINFORCED STONE REPAIR SYSTEM AS REQUIRED, SEE NBS.

- 05 CARRY OUT CATEGORY D REPAIRS - CUT OUT STONES CONSIDERED TO BE TOO BADLY DAMAGED OR ERODED FOR REPAIR AND REPLACE WITH NEW TO ORIGINAL PROFILE. REPLACE MISSING STONES WITH NEW TO MATCH ORIGINAL PROFILE.

- 06 GENERALLY REPOINT ELEVATION WITH LIME MORTAR.
 - 07 CAREFULLY REMOVE AND REINSTATE AFTER A LIGHT DRESSING ORIGINAL WINDOW SURROUND STONES. EMPLOY STAINLESS STEEL CRAMPS, DOWELS AND HELICAL FIXINGS TO SECURE STONES IN PLACE.

- 08 NEW CAPPING OF LEAD CLAD PAVING SLABS INSTALLED IN ACCORDANCE WITH DRAWING AR(0)08 SEB5
 - 09 HOLES IN STONE ASSUMED TO HAVE BEEN WHERE RAINWATER GOODS WERE FIXED FILLED.

- 10 STONES REMOVED PERMANENTLY.
 - 11 IRONWORK REMNANTS TO BE REMOVED.
 - 12 BRICK INFILL CHECKED FOR SOUNDNESS. ANY HEAVILY ERODED OR DISINTEGRATING BRICKS CUT OUT AND REPLACED. UNDAAMAGED AND LIGHTLY DAMAGED BRICKS DRESSED AND REPOINTED AS REQUIRED.

- 13 BRICK PATCHES REPLACED WITH NEW STONEMWORK TO MATCH EXISTING PROFILES.
 - 14 NEW STONE CILL INSTALLED TO MATCH EXISTING. ENSURE TOP OF WALL BELOW IS FULLY PROTECTED FROM MOISTURE PENETRATION.

- 15 BRICKWORK IN VERY POOR CONDITION REMOVED. BRICKWORK BELOW CILL REBUILT IN NEW APPROVED BRICK TO LEVEL SUITABLE FOR SUPPORTING CILL.
 - 16 GENERALLY REMOVE ALL REDUNDANT IRONWORK AND FILL HOLES LEFT WITH LIME MORTAR FOR SMALL HOLES. DISCUSS REPAIR METHOD FOR LARGER AREAS OF DAMAGE WITH ARCHITECT.

ALL STONES TO BE NUMBERED AND CATALOGUED PRIOR TO PIER BEING CAREFULLY TAKEN DOWN TO GROUND LEVEL. PIER TO BE RECONSTRUCTED TO DATUM SHOWN USING SALVAGED STONES DEEMED ACCEPTABLE FOR RE-USE (WITH RE-DRESSING) IN ORIGINAL UN-DISPLACED POSITIONS. STONES CONSIDERED TO BE TOO BADLY DAMAGED OR ERODED FOR REPAIR REPLACED WITH NEW TO ORIGINAL PROFILE.
