Affinity
Design & Management Ltd
RIBA
Studio 20
Roslyn Works
36 Uttometer Road
Longton
Stoke on Trent
ST3 1PQ
Telephone - 01782 319956
Email - info@affinitydm.co.uk
Project:
HMP HEWELL RUIN REPAIRS
Project No:
17059
Drawing Reference
AR(0)05 - SEB3
Revision
B
Drawn by
MBS/cv
Scale
1:10@A0
Date
NOV 20

SEB3: PROPOSED INTERNAL ELEVATION
SCALE 1:10 @ A0

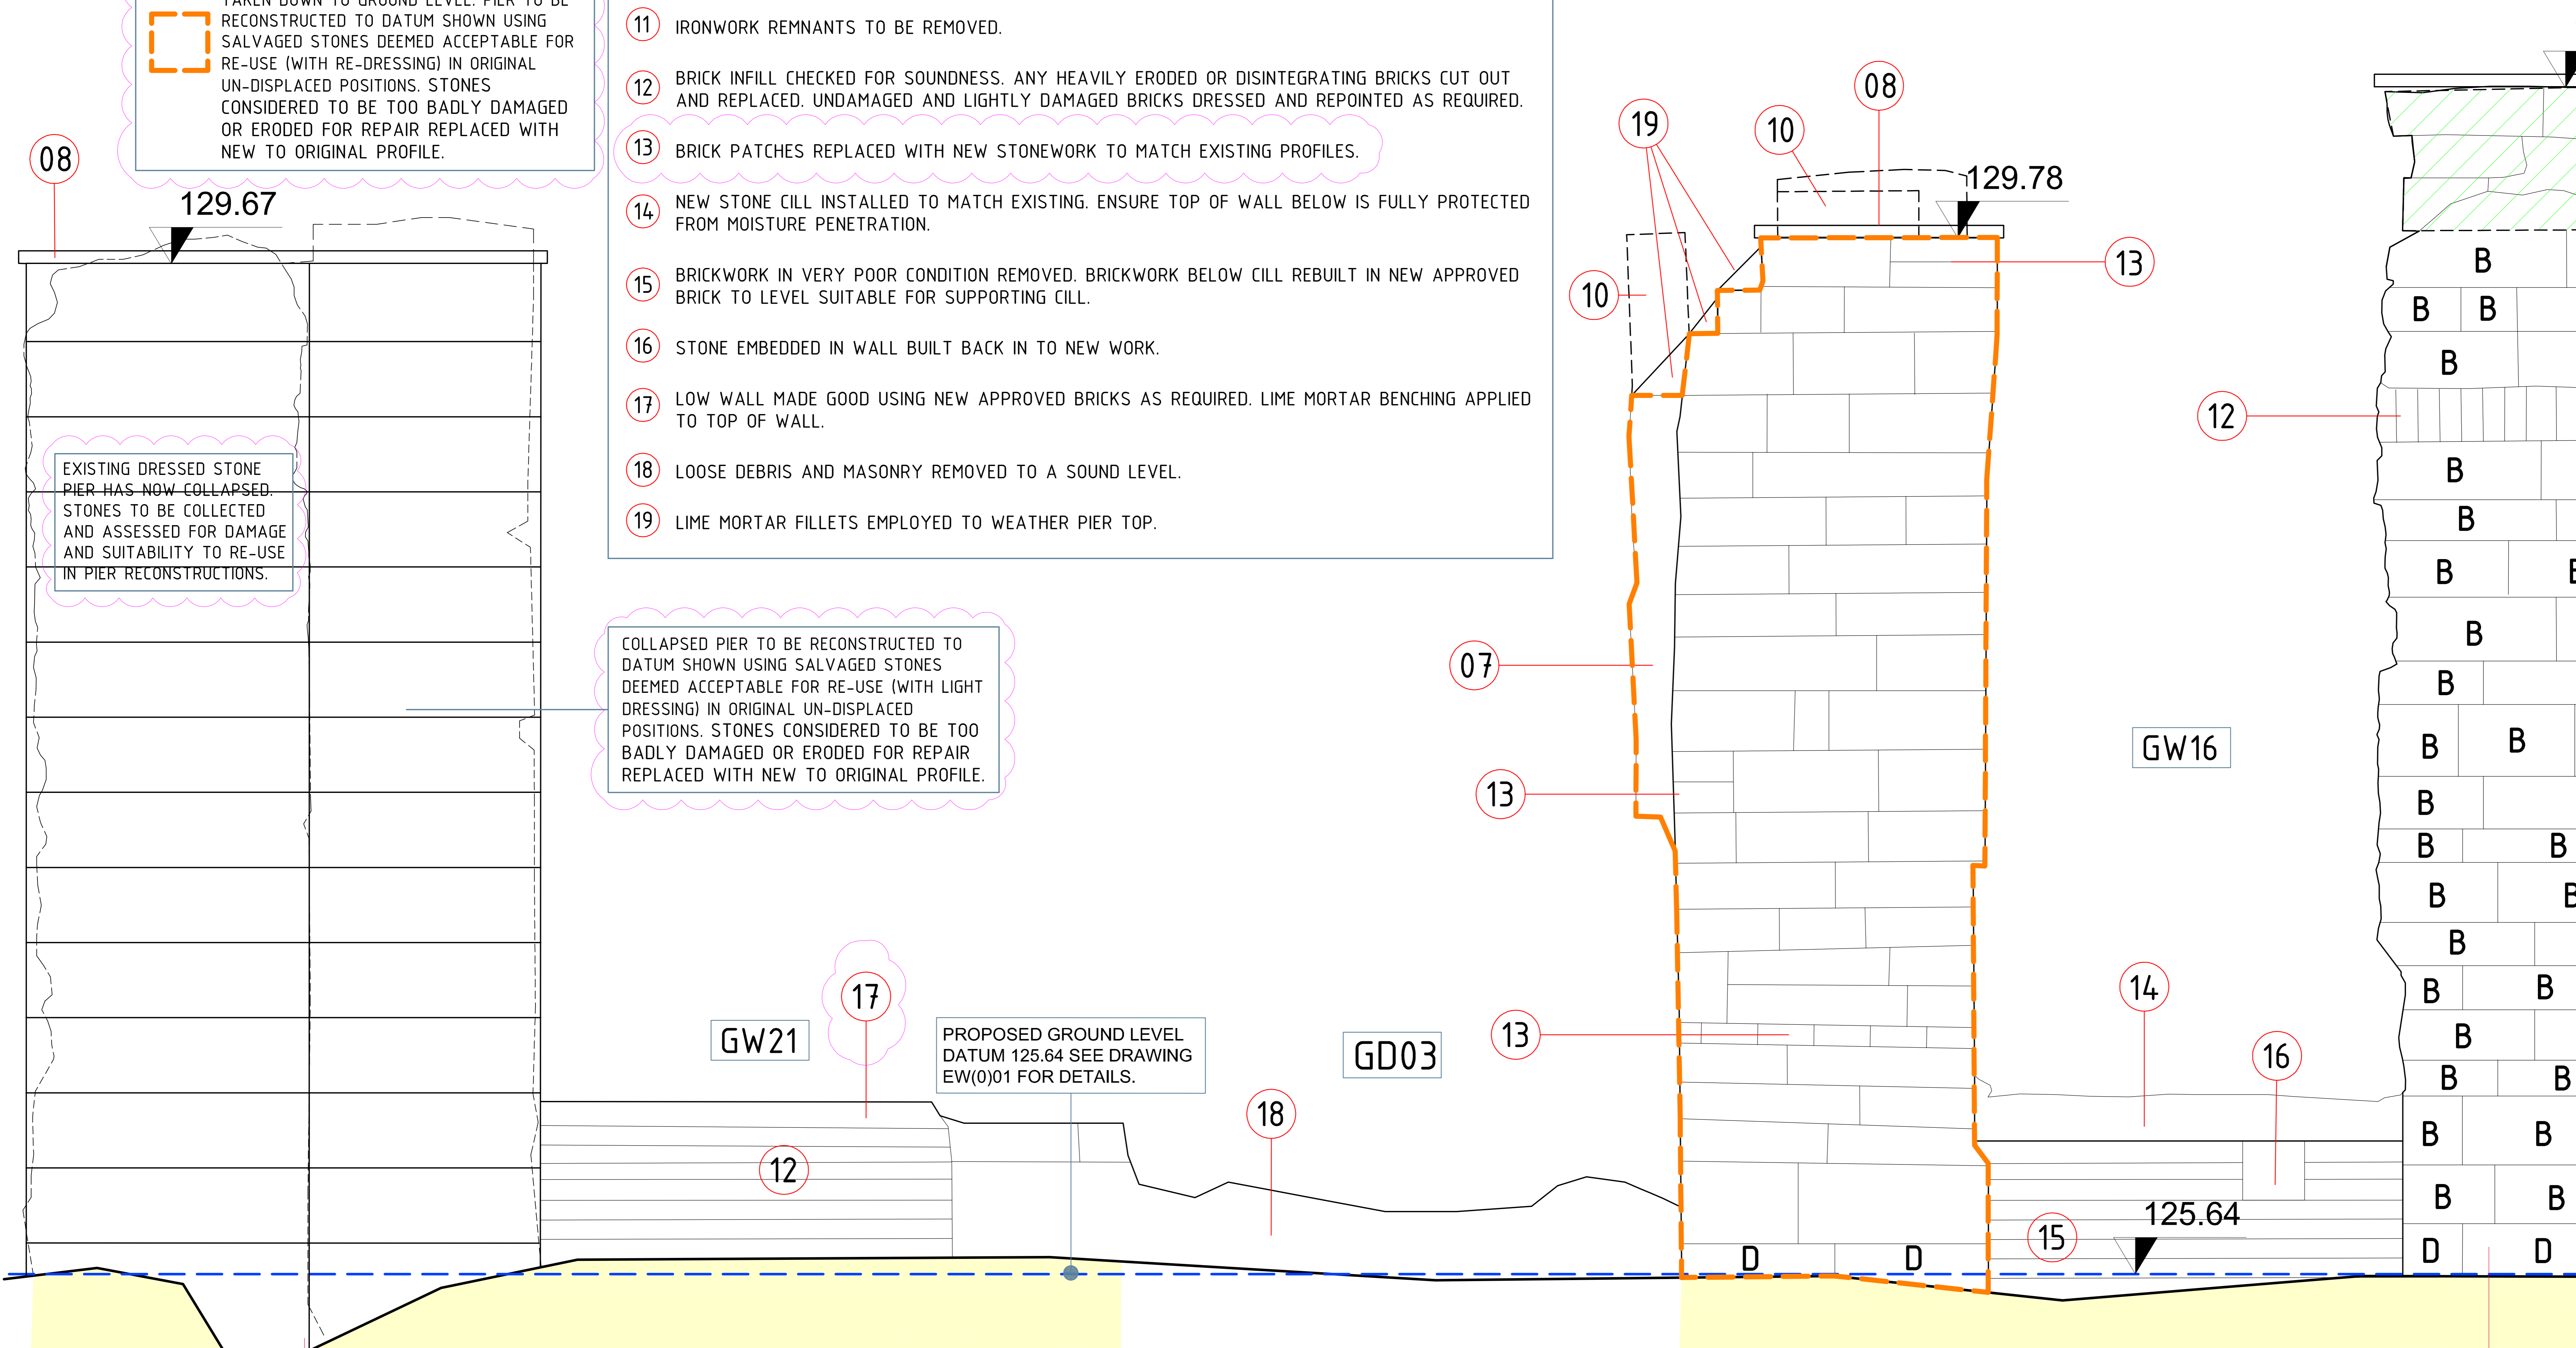
THIS FAÇADE HAS SUFFERED FROM EXTENSIVE UNCONTROLLED COLLAPSE OVER THE YEARS AND THE STRUCTURAL INTEGRITY OF THE REMAINING ELEMENTS IS SIGNIFICANTLY COMPROMISED. ON THE BASIS THAT REPRESENTATIVE SAMPLES OF THE VARIOUS BUILDING ELEMENTS ARE PRESERVED ELSEWHERE IT IS PROPOSED THAT MISSING OR COLLAPSED SECTIONS ARE NOT REINSTATED AND UNSTABLE REMNANTS ARE REMOVED. THE EXISTING MASONRY WILL BE REDUCED IN HEIGHT TO A LOGICAL POINT WHERE IT IS MORE STRUCTURALLY VIABLE AND CAN BE WEATHERED EFFECTIVELY IN ORDER THAT DECAY AND FURTHER COLLAPSE CAN BE ARRESTED AND THE RUIN CONSOLIDATED. STONES TAKEN DOWN WILL BE LEFT ON SITE ADJACENT TO WHERE THEY CAME FROM. A PHOTOGRAPHIC RECORD IS TO BE MADE OF THE STRUCTURE AS IT CURRENTLY STANDS PRIOR TO DISMANTLING.

BASE OF WALL EXPOSED, PATCH REPAIRED AND UNDERPINNED ONLY WHERE UNDERMINED BY IVY / ROOT BALLS (ON REAR FACE AS NECESSARY - IN 900MM SECTION LENGTHS. EXTENT TO BE AGREED ON SITE UPON INSPECTION).

ALL STONES TO BE NUMBERED AND CATALOGUED PRIOR TO PIER BEING CAREFULLY TAKEN DOWN TO GROUND LEVEL. PIER TO BE RECONSTRUCTED TO DATUM SHOWN USING SALVAGED STONES DEEMED ACCEPTABLE FOR RE-USE (WITH RE-DRESSING) IN ORIGINAL UN-DISPLACED POSITIONS. STONES CONSIDERED TO BE TOO BADLY DAMAGED OR ERODED FOR REPAIR REPLACED WITH NEW TO ORIGINAL PROFILE.

- 01 GENERALLY REMOVE ALL REMNANTS OF VEGETATION.
- 02 AREA OBSCURED BY REMAINING VEGETATION AND SCAFFOLD PLANKS. ASSUME CATEGORY B REPAIR REQUIRED.
- 03 CARRY OUT CATEGORY B REPAIRS - LIGHTLY DRESS EXISTING STONES IN-SITU

- 04 CARRY OUT CATEGORY C REPAIRS - REPAIR DAMAGED OR HEAVILY ERODED STONES USING REINFORCED STONE REPAIR SYSTEM AS REQUIRED, SEE NBS.
- 05 CARRY OUT CATEGORY D REPAIRS - CUT OUT STONES CONSIDERED TO BE TOO BADLY DAMAGED OR ERODED FOR REPAIR AND REPLACE WITH NEW TO ORIGINAL PROFILE. REPLACE MISSING STONES WITH NEW TO MATCH ORIGINAL PROFILE.

- 06 GENERALLY REPOINT ELEVATION WITH LIME MORTAR.
- 07 CAREFULLY REMOVE AND REINSTATE AFTER A LIGHT DRESSING ORIGINAL WINDOW SURROUND STONES. EMPLOY STAINLESS STEEL CRAMPS, DOWELS AND HELICAL FIXINGS TO SECURE STONES IN PLACE.

- 08 NEW CAPPING OF LEAD CLAD PAVING SLABS INSTALLED IN ACCORDANCE WITH DRAWING AR(0)08 SEB3
- 09 NOT ON THIS DRAWING..
- 10 STONES REMOVED PERMANENTLY.
- 11 IRONWORK REMNANTS TO BE REMOVED.

- 12 BRICK INFILL CHECKED FOR SOUNDNESS. ANY HEAVILY ERODED OR DISINTEGRATING BRICKS CUT OUT AND REPLACED. UNDAUNTED AND LIGHTLY DAMAGED BRICKS DRESSED AND REPOINTED AS REQUIRED.

- 13 BRICK PATCHES REPLACED WITH NEW STONEMWORK TO MATCH EXISTING PROFILES.
- 14 NEW STONE CILL INSTALLED TO MATCH EXISTING. ENSURE TOP OF WALL BELOW IS FULLY PROTECTED FROM MOISTURE PENETRATION.

- 15 BRICKWORK IN VERY POOR CONDITION REMOVED. BRICKWORK BELOW CILL REBUILT IN NEW APPROVED BRICK TO LEVEL SUITABLE FOR SUPPORTING CILL.
- 16 STONE EMBEDDED IN WALL BUILT BACK IN TO NEW WORK.

- 17 LOW WALL MADE GOOD USING NEW APPROVED BRICKS AS REQUIRED. LIME MORTAR BENCHING APPLIED TO TOP OF WALL.
- 18 LOOSE DEBRIS AND MASONRY REMOVED TO A SOUND LEVEL.

- 19 LIME MORTAR FILLETS EMPLOYED TO WEATHER PIER TOP.

COLLAPSED PIER TO BE RECONSTRUCTED TO DATUM SHOWN USING SALVAGED STONES DEEMED ACCEPTABLE FOR RE-USE (WITH LIGHT DRESSING) IN ORIGINAL UN-DISPLACED POSITIONS. STONES CONSIDERED TO BE TOO BADLY DAMAGED OR ERODED FOR REPAIR REPLACED WITH NEW TO ORIGINAL PROFILE.
