EXISTING SEB5 CORNER RETURN
SCALE 1:20 @ A0

PROPOSED SEB5 CORNER RETURN
SCALE 1:10 @ A0

SEB5 CORNER RETURN WORKS:

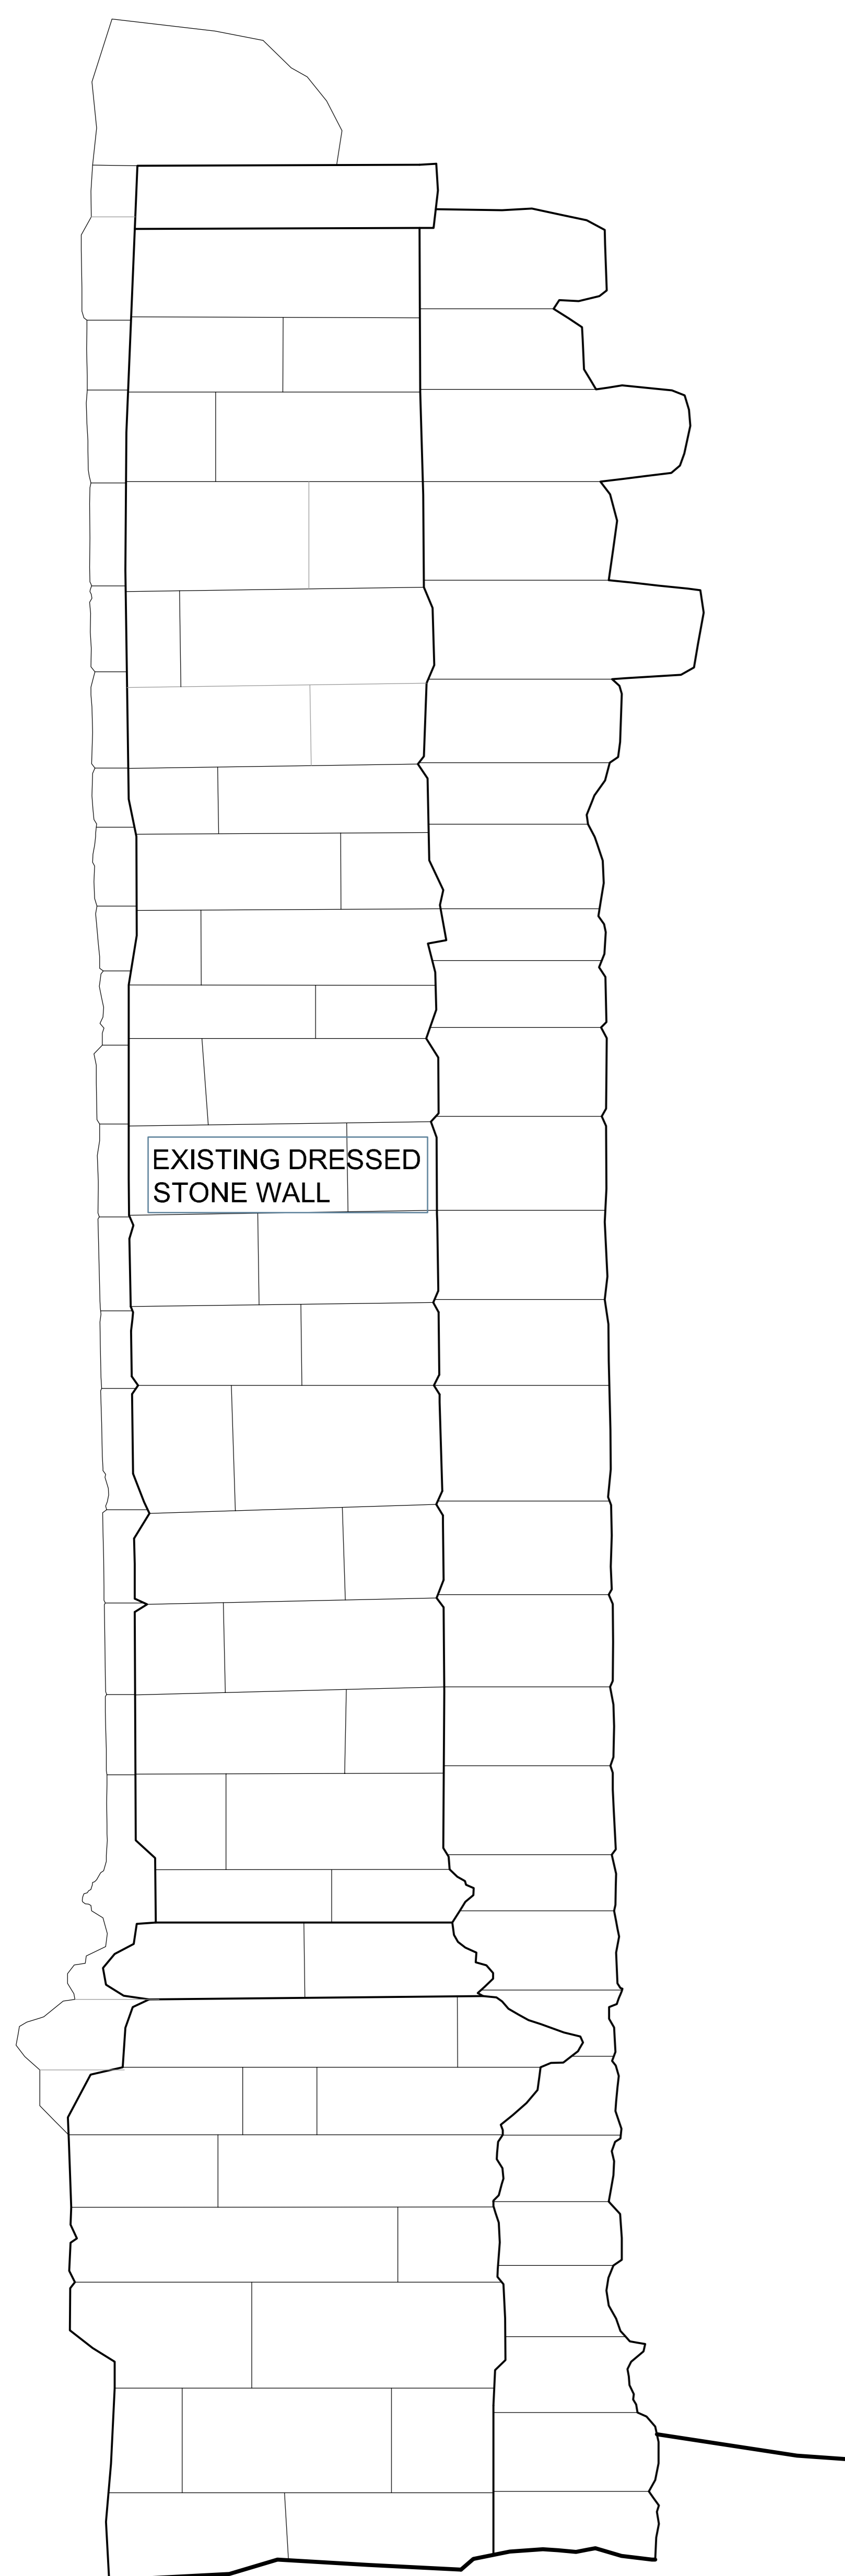
THIS FAÇADE HAS SUFFERED FROM EXTENSIVE UNCONTROLLED COLLAPSE OVER THE YEARS AND THE STRUCTURAL INTEGRITY OF THE REMAINING ELEMENTS IS SIGNIFICANTLY COMPROMISED. ON THE BASIS THAT REPRESENTATIVE SAMPLES OF THE VARIOUS BUILDING ELEMENTS ARE PRESERVED ELSEWHERE IT IS PROPOSED THAT MISSING OR COLLAPSED SECTIONS ARE NOT REINSTATED AND UNSTABLE REMNANTS ARE REMOVED. THE EXISTING MASONRY WILL BE REDUCED IN HEIGHT TO A LOGICAL POINT WHERE IT IS MORE STRUCTURALLY VIABLE AND CAN BE WEATHERED EFFECTIVELY IN ORDER THAT DECAY AND FURTHER COLLAPSE CAN BE ARRESTED AND THE RUIN CONSOLIDATED. STONES TAKEN DOWN WILL BE LEFT ON SITE ADJACENT TO WHERE THEY CAME FROM. A PHOTOGRAPHIC RECORD IS TO BE MADE OF THE STRUCTURE AS IT CURRENTLY STANDS PRIOR TO DISMANTLING.

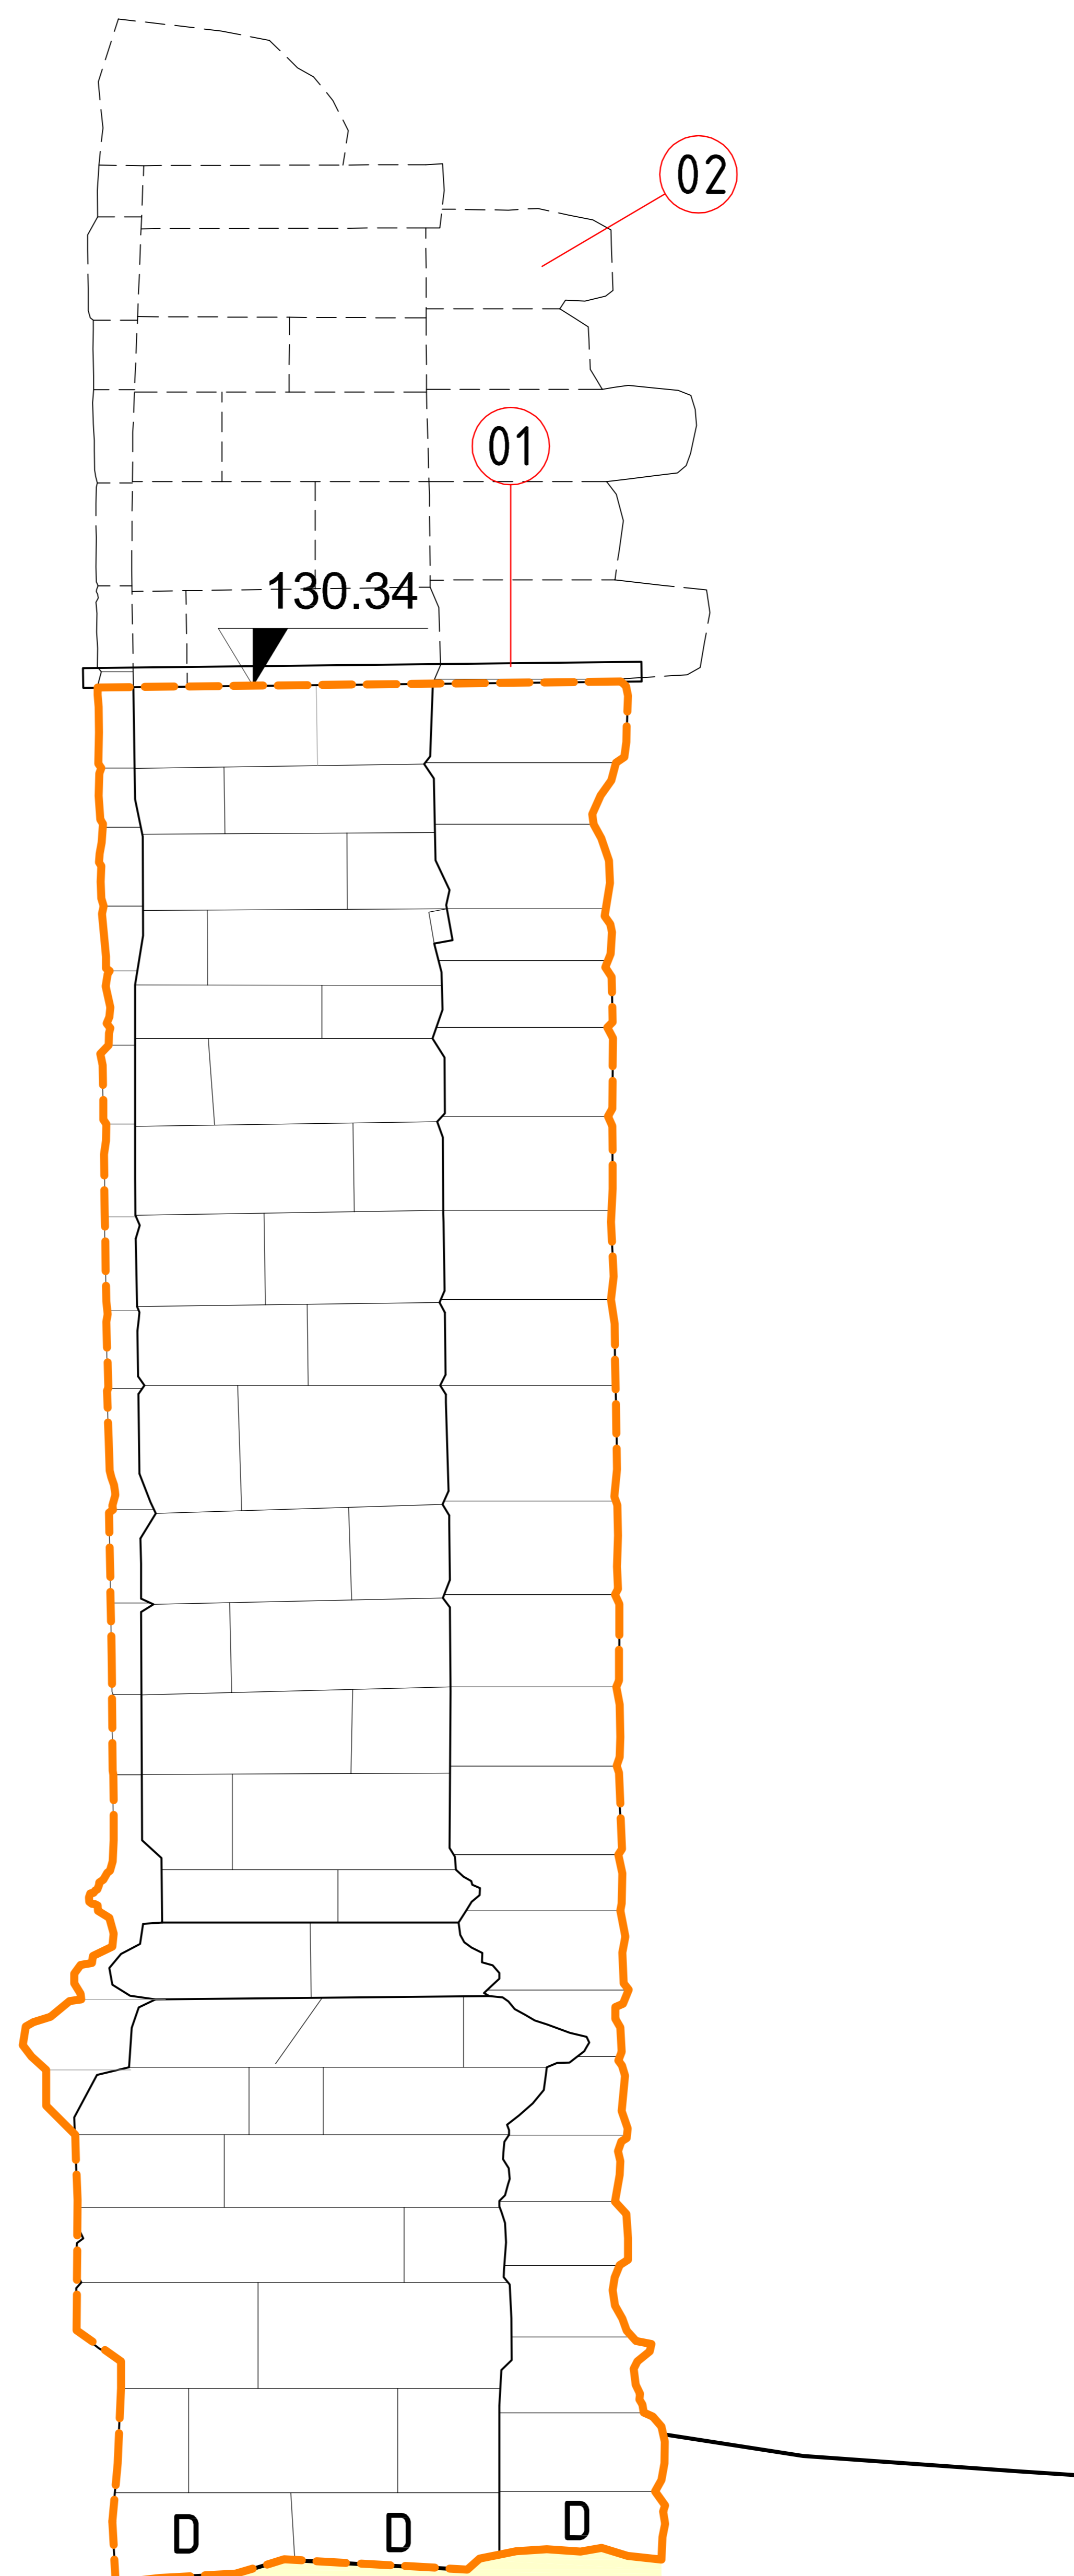
BASE OF WALL EXPOSED, PATCH REPAIRED AND UNDERPINNED ONLY WHERE UNDERMINED BY IVY / ROOT BALLS (ON REAR FACE AS NECESSARY - IN 900MM SECTION LENGTHS. EXTENT TO BE AGREED ON SITE UPON INSPECTION).

STONEMWORK TO BE GENERALLY REPOINTED IN ACCORDANCE WITH THE SPECIFICATION NBS CLAUSES C41X / 810 - 860

- 01 NEW CAPPING OF LEAD CLAD PAVING SLABS INSTALLED IN ACCORDANCE WITH DRAWING AR(0)08 SEB5
- 02 STONES REMOVED PERMANENTLY.

ALL STONES TO BE NUMBERED AND CATALOGUED PRIOR TO PIER BEING CAREFULLY TAKEN DOWN TO GROUND LEVEL. PIER TO BE RECONSTRUCTED TO DATUM SHOWN USING SALVAGED STONES DEEMED ACCEPTABLE FOR RE-USE (WITH RE-DRESSING) IN ORIGINAL UN-DISPLACED POSITIONS. STONES CONSIDERED TO BE TOO BADLY DAMAGED OR ERODED FOR REPAIR REPLACED WITH NEW TO ORIGINAL PROFILE.
