PHILOSOPHICAL APPROACH

SEB4: PROPOSED EXTERNAL ELEVATION
SCALE 1:10 @ A0

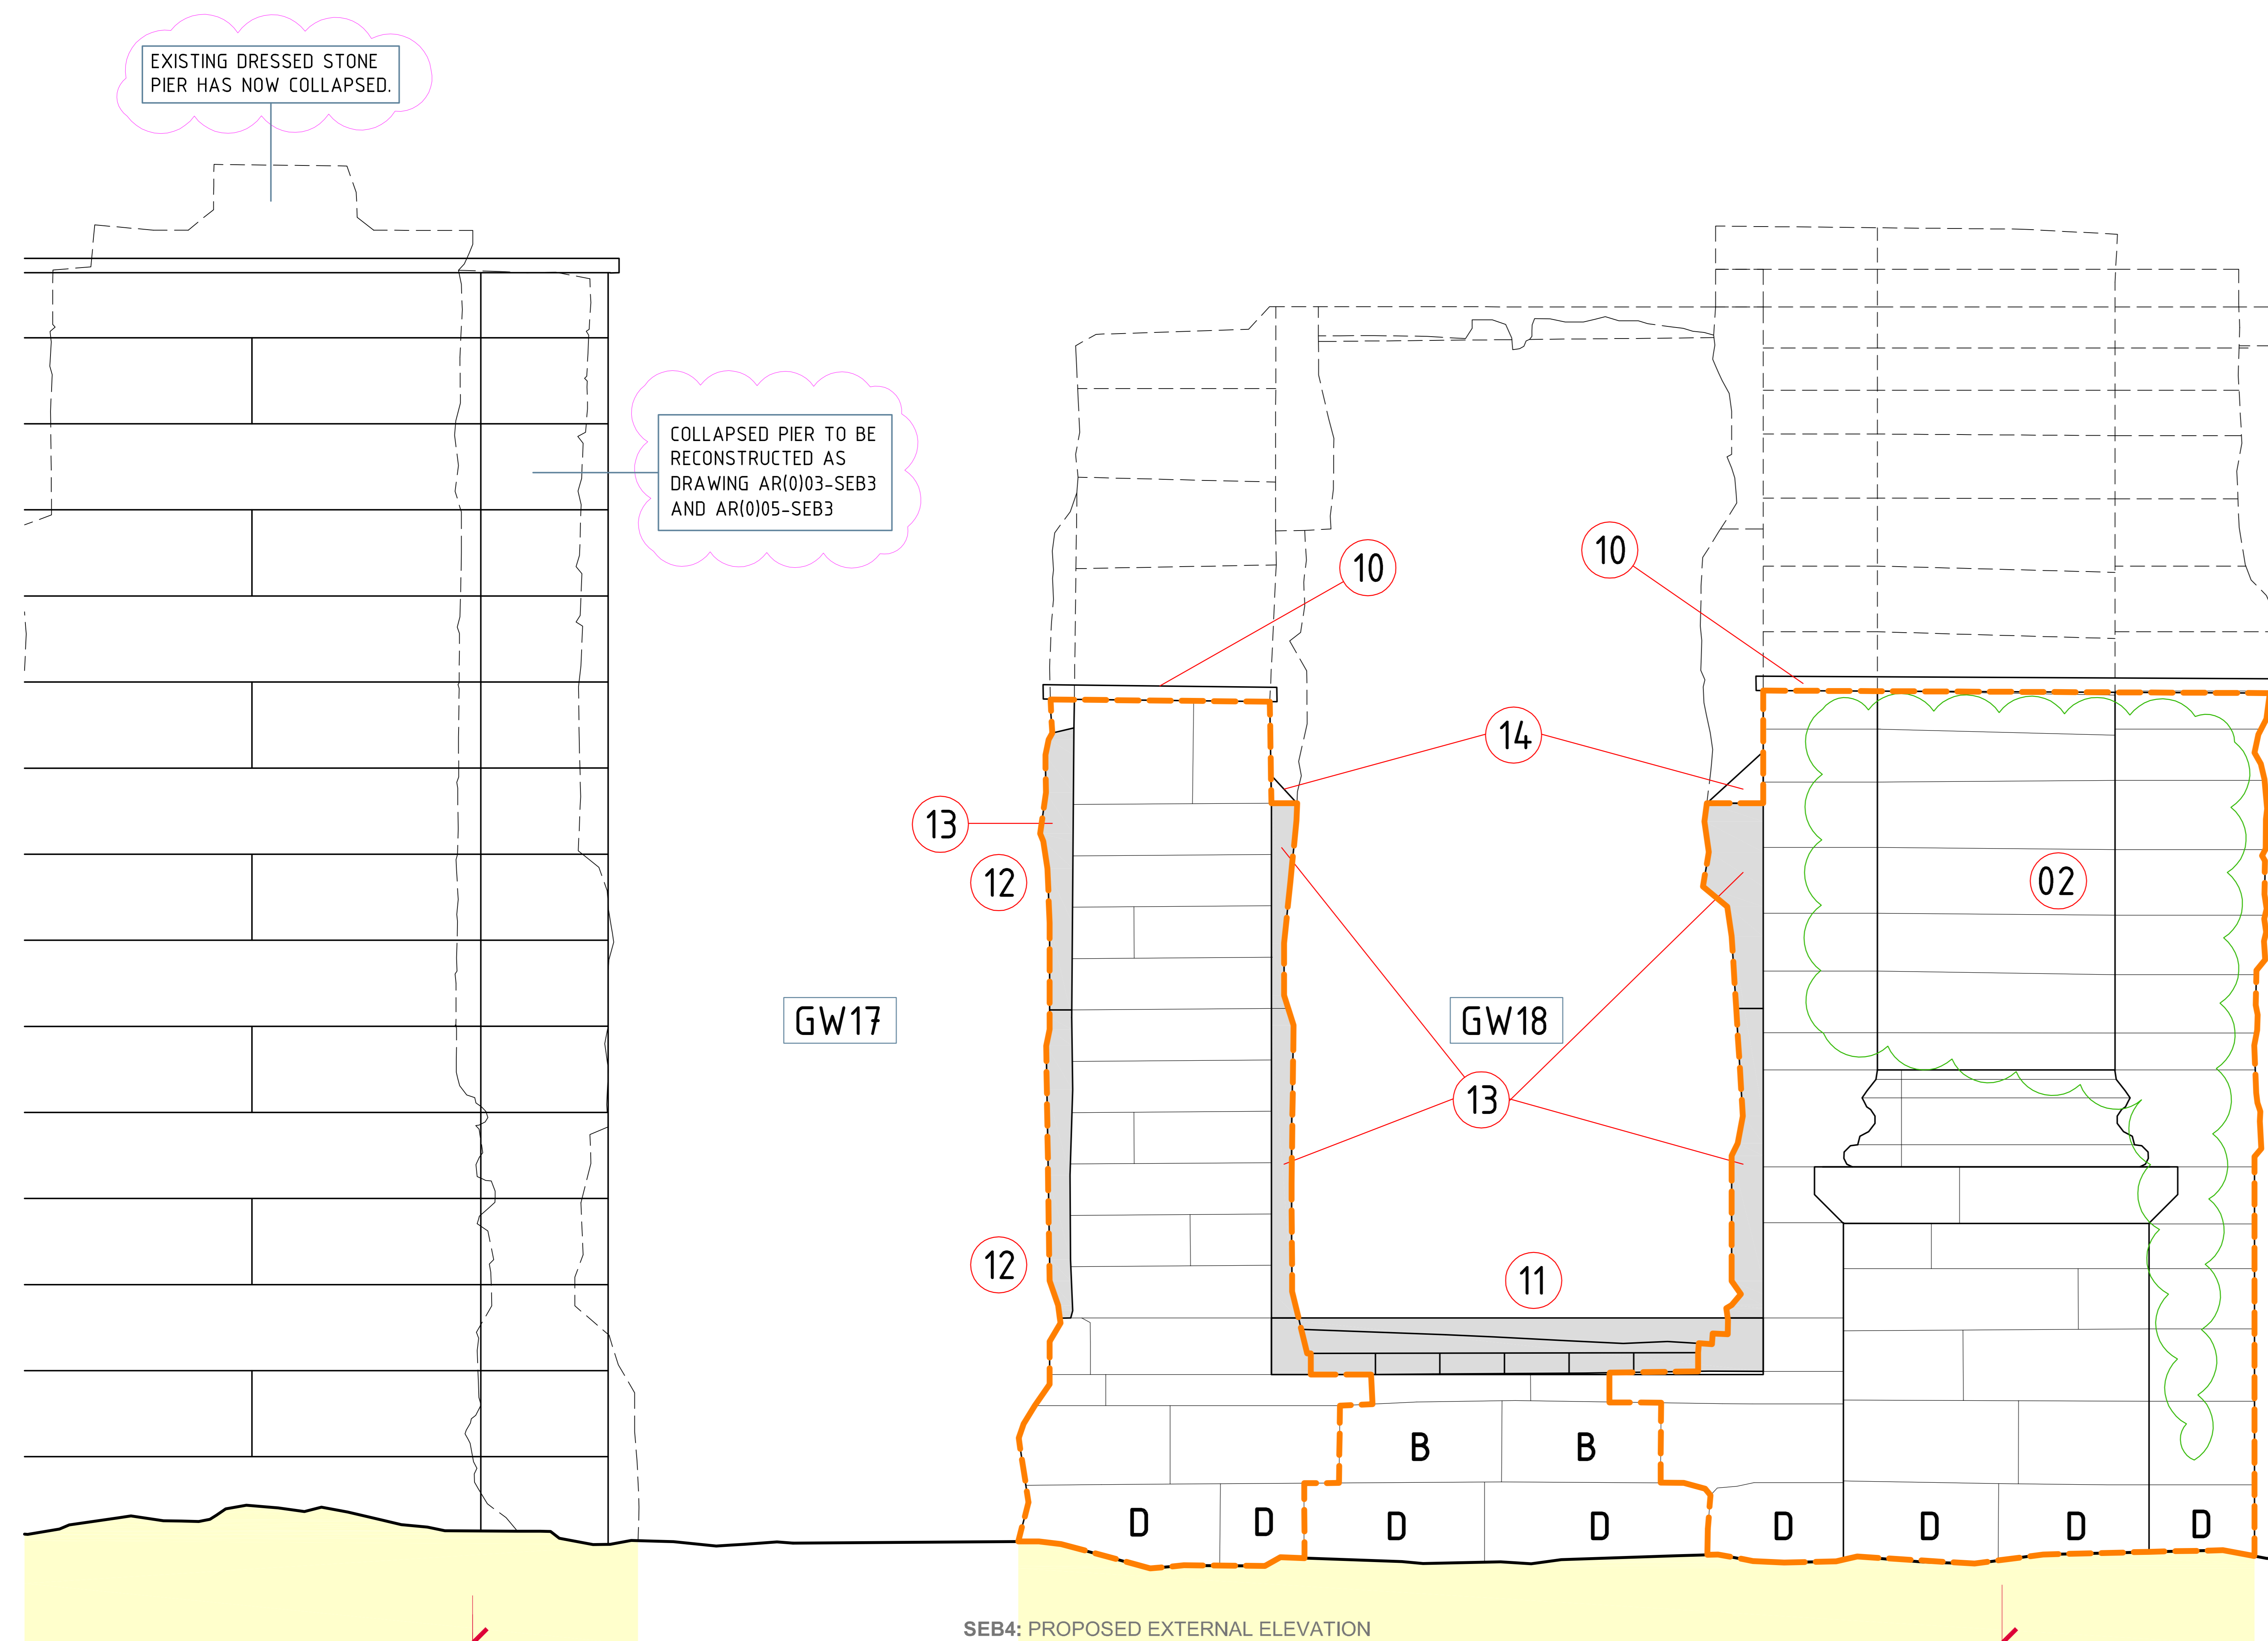
THIS FAÇADE HAS SUFFERED FROM EXTENSIVE UNCONTROLLED COLLAPSE OVER THE YEARS AND THE STRUCTURAL INTEGRITY OF THE REMAINING ELEMENTS IS SIGNIFICANTLY COMPROMISED. ON THE BASIS THAT REPRESENTATIVE SAMPLES OF THE VARIOUS BUILDING ELEMENTS ARE PRESERVED ELSEWHERE IT IS PROPOSED THAT MISSING OR COLLAPSED SECTIONS ARE NOT REINSTATED AND UNSTABLE REMNANTS ARE REMOVED. THE EXISTING MASONRY WILL BE REDUCED IN HEIGHT TO A LOGICAL POINT WHERE IT IS MORE STRUCTURALLY VIABLE AND CAN BE WEATHERED EFFECTIVELY IN ORDER THAT DECAY AND FURTHER COLLAPSE CAN BE ARRESTED AND THE RUIN CONSOLIDATED. STONES TAKEN DOWN WILL BE LEFT ON SITE ADJACENT TO WHERE THEY CAME FROM. A PHOTOGRAPHIC RECORD IS TO BE MADE OF THE STRUCTURE AS IT CURRENTLY STANDS PRIOR TO DISMANTLING.

EXISTING DRESSED STONE PIER HAS NOW COLLAPSED.

- 01 GENERALLY REMOVE ALL REMNANTS OF VEGETATION.
- 02 AREA OBSCURED BY REMAINING VEGETATION AND SCAFFOLD PLANKS. ASSUME CATEGORY B REPAIR REQUIRED.
- 03 CARRY OUT CATEGORY B REPAIRS - LIGHTLY DRESS EXISTING STONES IN-SITU

- GW17 GROUND FLOOR WINDOW 17
- GW18 GROUND FLOOR WINDOW 18
- BASE OF WALL EXPOSED, PATCH REPAIRED AND UNDERPINNED ONLY WHERE UNDERMINED BY IVY / ROOT BALLS (ON REAR FACE AS NECESSARY - IN 900MM SECTION LENGTHS. EXTENT TO BE AGREED ON SITE UPON INSPECTION).

COLLAPSED PIER TO BE RECONSTRUCTED AS DRAWING AR(0)03-SEB3 AND AR(0)05-SEB3

- 04 CARRY OUT CATEGORY C REPAIRS - REPAIR DAMAGED OR HEAVILY ERODED STONES USING REINFORCED SSTONE REPAIR SYSTEM AS REQUIRED, SEE NBS.
- 05 CARRY OUT CATEGORY D REPAIRS - CUT OUT STONES CONSIDERED TO BE TOO BADLY DAMAGED OR ERODED FOR REPAIR AND REPLACE WITH NEW TO ORIGINAL PROFILE. REPLACE MISSING STONES WITH NEW TO MATCH ORIGINAL PROFILE.

- 06 NOT ON THIS DRAWING.
- 07 GENERALLY REPOINT ELEVATION WITH LIME MORTAR.
- 08 INSTALL NEW STONES TO FORM NEW WINDOW SURROUND TO MATCH ORIGINAL.
- 09 STONEMWORK BELOW CILL BUILT BACK UP OFF EXISTING FOOTING USING RECLAIMED STONE OR NEW TO MATCH THE EXISTING.

- 10 NEW CAPPING OF LEAD CLAD PAVING SLABS INSTALLED IN ACCORDANCE WITH DRAWING AR(0)08 SEB4.
- 11 EXISTING STONE AND BRICK INFILL REMOVED TO ALLOW CILLS TO BE INSTALLED. ENSURE MOISTURE PROTECTION TO WALL BELOW IS ACHIEVED.

- 12 HOLES IN STONE ASSUMED TO HAVE BEEN WHERE RAINWATER GOODS WERE FIXED FILLED
- 13 CAREFULLY REMOVE AND REINSTATE AFTER A LIGHT DRESSING ORIGINAL WINDOW SURROUND STONES. EMPLOY STAINLESS STEEL CRAMPS , DOWELS AND HELICAL FIXINGS TO SECURE STONES IN PLACE.

- 14 INSTALL LIME MORTAR BENCHING TO IMPROVE WATER RUN OFF

ALL STONES TO BE NUMBERED AND CATALOGUED PRIOR TO PIER BEING CAREFULLY TAKEN DOWN TO GROUND LEVEL. PIER TO BE RECONSTRUCTED TO DATUM AS DRAWING AR(0)05 SEB4 USING SALVAGED STONES DEEMED ACCEPTABLE FOR RE-USE (WITH RE-DRESSING) IN ORIGINAL UN-DISPLACED POSITIONS. STONES CONSIDERED TO BE TOO BADLY DAMAGED OR ERODED FOR REPAIR REPLACED WITH NEW TO ORIGINAL PROFILE.
