PHILOSOPHICAL APPROACH

SEB3: PROPOSED EXTERNAL ELEVATION
 SCALE 1:10 @ A0

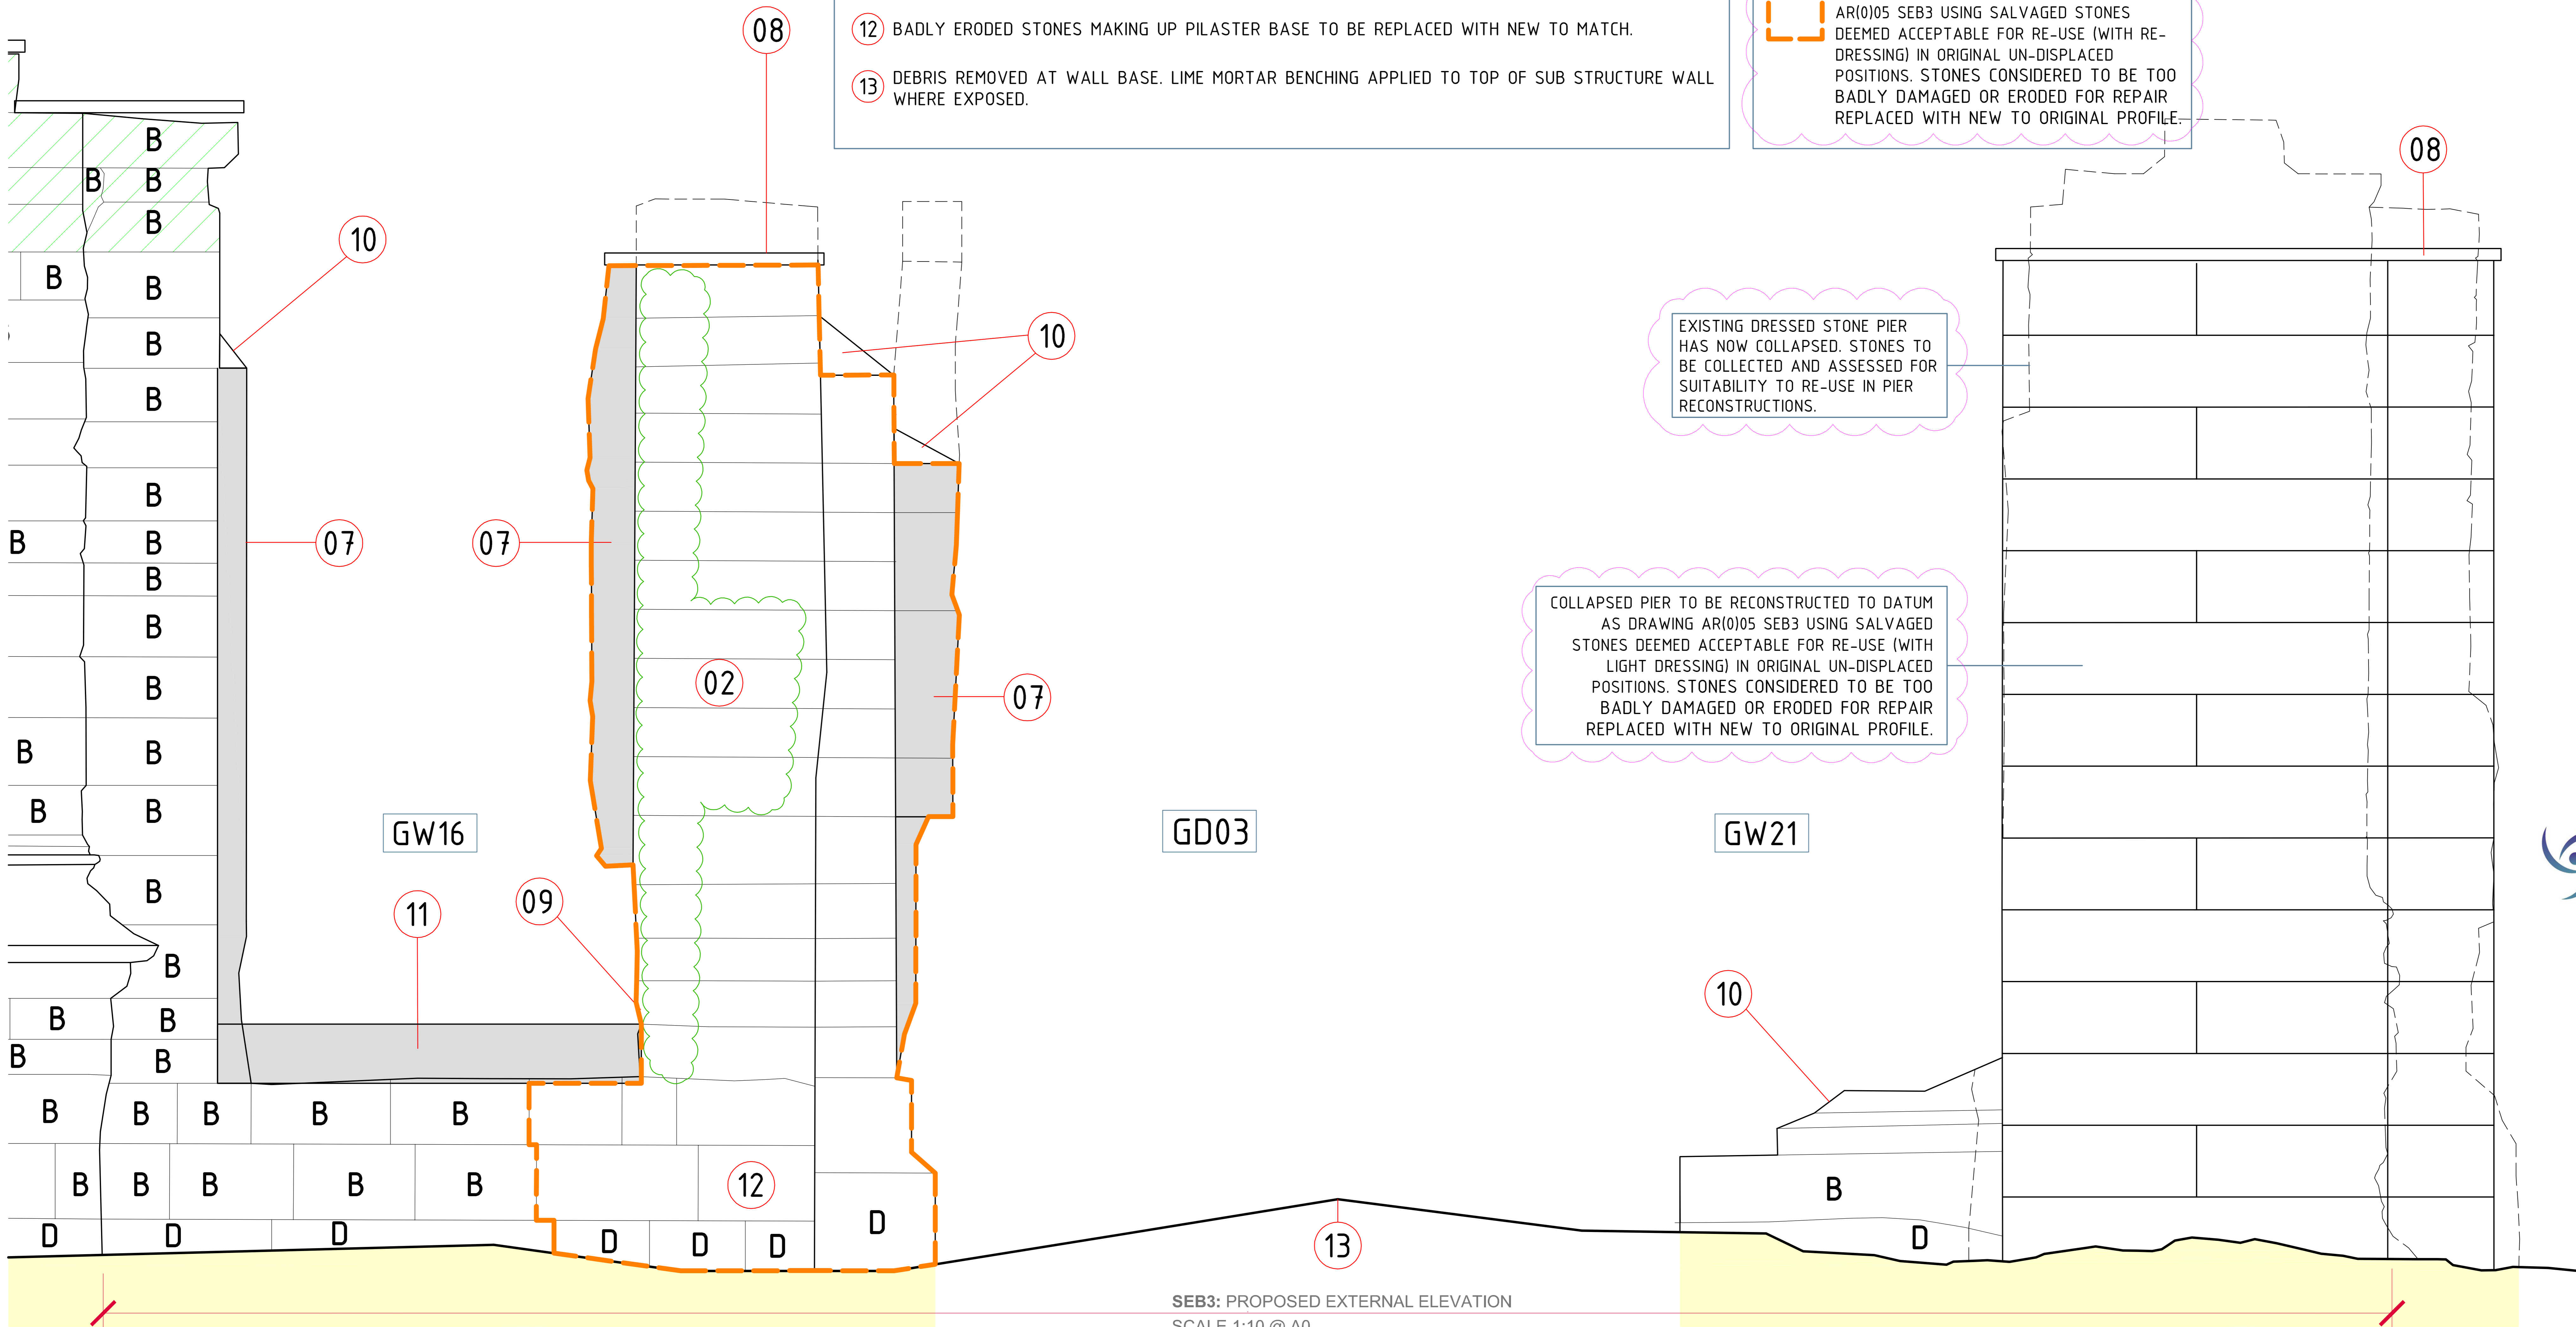
THIS FAÇADE HAS SUFFERED FROM EXTENSIVE UNCONTROLLED COLLAPSE OVER THE YEARS AND THE STRUCTURAL INTEGRITY OF THE REMAINING ELEMENTS IS SIGNIFICANTLY COMPROMISED. ON THE BASIS THAT REPRESENTATIVE SAMPLES OF THE VARIOUS BUILDING ELEMENTS ARE PRESERVED ELSEWHERE IT IS PROPOSED THAT MISSING OR COLLAPSED SECTIONS ARE NOT REINSTATED AND UNSTABLE REMNANTS ARE REMOVED. THE EXISTING MASONRY WILL BE REDUCED IN HEIGHT TO A LOGICAL POINT WHERE IT IS MORE STRUCTURALLY VIABLE AND CAN BE WEATHERED EFFECTIVELY IN ORDER THAT DECAY AND FURTHER COLLAPSE CAN BE ARRESTED AND THE RUIN CONSOLIDATED. STONES TAKEN DOWN WILL BE LEFT ON SITE ADJACENT TO WHERE THEY CAME FROM. A PHOTOGRAPHIC RECORD IS TO BE MADE OF THE STRUCTURE AS IT CURRENTLY STANDS PRIOR TO DISMANTLING.

- 01 GENERALLY REMOVE ALL REMNANTS OF VEGETATION.
- 02 AREA OBSCURED BY REMAINING VEGETATION AND SCAFFOLD PLANKS.
- 03 CARRY OUT CATEGORY B REPAIRS - LIGHTLY DRESS EXISTING STONES IN-SITU

- 12 BADLY ERODED STONES MAKING UP PILASTER BASE TO BE REPLACED WITH NEW TO MATCH.
- 13 DEBRIS REMOVED AT WALL BASE. LIME MORTAR BENCHING APPLIED TO TOP OF SUB STRUCTURE WALL WHERE EXPOSED.

EXISTING DRESSED STONE PIER HAS NOW COLLAPSED. STONES TO BE COLLECTED AND ASSESSED FOR SUITABILITY TO RE-USE IN PIER RECONSTRUCTIONS.

- 04 CARRY OUT CATEGORY C REPAIRS - REPAIR DAMAGED OR HEAVILY ERODED STONES USING REINFORCED STONE REPAIR SYSTEM AS REQUIRED SEE NBS
- 05 CARRY OUT CATEGORY D REPAIRS - CUT OUT STONES CONSIDERED TO BE TOO BADLY DAMAGED OR ERODED FOR REPAIR AND REPLACE WITH NEW TO ORIGINAL PROFILE. REPLACE MISSING STONES WITH NEW TO MATCH ORIGINAL PROFILE.

- 06 GENERALLY REPOINT ELEVATION WITH LIME MORTAR.
- 07 CAREFULLY REMOVE AND REINSTATE AFTER A LIGHT DRESSING ORIGINAL WINDOW SURROUND STONES. EMPLOY STAINLESS STEEL CRAMPS, DOWELS AND HELICAL FIXINGS TO SECURE STONES IN PLACE.

- 08 NEW CAPPING OF LEAD CLAD PAVING SLABS INSTALLED IN ACCORDANCE WITH DRAWING AR(0)08 SEB3
- 09 HOLES IN STONE ASSUMED TO HAVE BEEN WHERE RAINWATER GOODS WERE FIXED FILLED.

- 10 INSTALL LIME MORTAR BENCHING TO IMPROVE WATER RUN OFF
- 11 REMOVE REMNANTS OF ORIGINAL CILL AND INSTALL NEW TO MATCH THE ORIGINAL PROFILE AND TO PROVIDE WEATHERING TO TOP OF WALL BELOW.

BASE OF WALL EXPOSED, PATCH REPAIRED AND UNDERPINNED ONLY WHERE UNDERMINED BY IVY / ROOT BALLS (ON REAR FACE AS NECESSARY - IN 900MM SECTION LENGTHS. EXTENT TO BE AGREED ON SITE UPON INSPECTION).

ALL STONES TO BE NUMBERED AND CATALOGUED PRIOR TO PIER BEING CAREFULLY TAKEN DOWN TO GROUND LEVEL. PIER TO BE RECONSTRUCTED TO DATUM AS DRAWING AR(0)05 SEB3 USING SALVAGED STONES DEEMED ACCEPTABLE FOR RE-USE (WITH RE-DRESSING) IN ORIGINAL UN-DISPLACED POSITIONS. STONES CONSIDERED TO BE TOO BADLY DAMAGED OR ERODED FOR REPAIR REPLACED WITH NEW TO ORIGINAL PROFILE.

COLLAPSED PIER TO BE RECONSTRUCTED TO DATUM AS DRAWING AR(0)05 SEB3 USING SALVAGED STONES DEEMED ACCEPTABLE FOR RE-USE (WITH LIGHT DRESSING) IN ORIGINAL UN-DISPLACED POSITIONS. STONES CONSIDERED TO BE TOO BADLY DAMAGED OR ERODED FOR REPAIR REPLACED WITH NEW TO ORIGINAL PROFILE.
