# Brian Carr Design Ltd

17/081/dbc/300617

30 June 2017

## **Re Structural Survey of Existing Dwelling to Rear of 72 Bailgate, Lincoln**

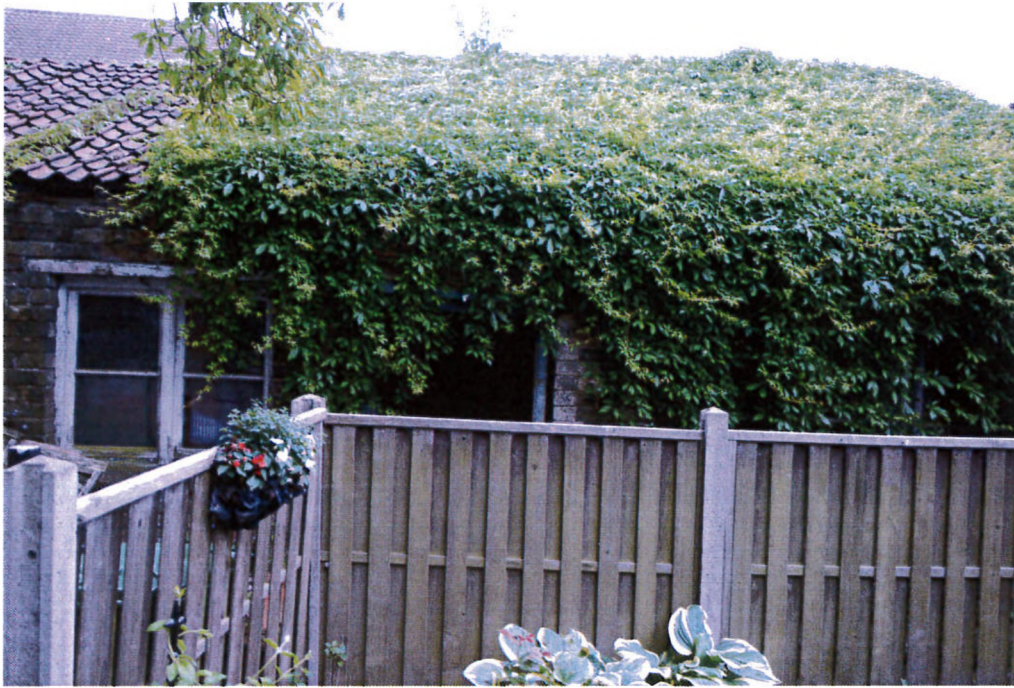
Main Front Elevation

The masonry generally on the front elevation is, to the left hand side, in a reasonable structural condition. Door and window heads are framed out with rotting timber lintels which has led to some minor distortions above and the mortar pointing is of poor quality. However the panel of masonry to the right hand side, between the central doorway and the right hand elevation, has clearly settled vertically, and also rotated outwards at its head. Vertical movement of as much as 75mm has occurred with lateral movement at the head of the wall of at least 50mm. Whilst this movement appears to be historic it is clearly very significant.

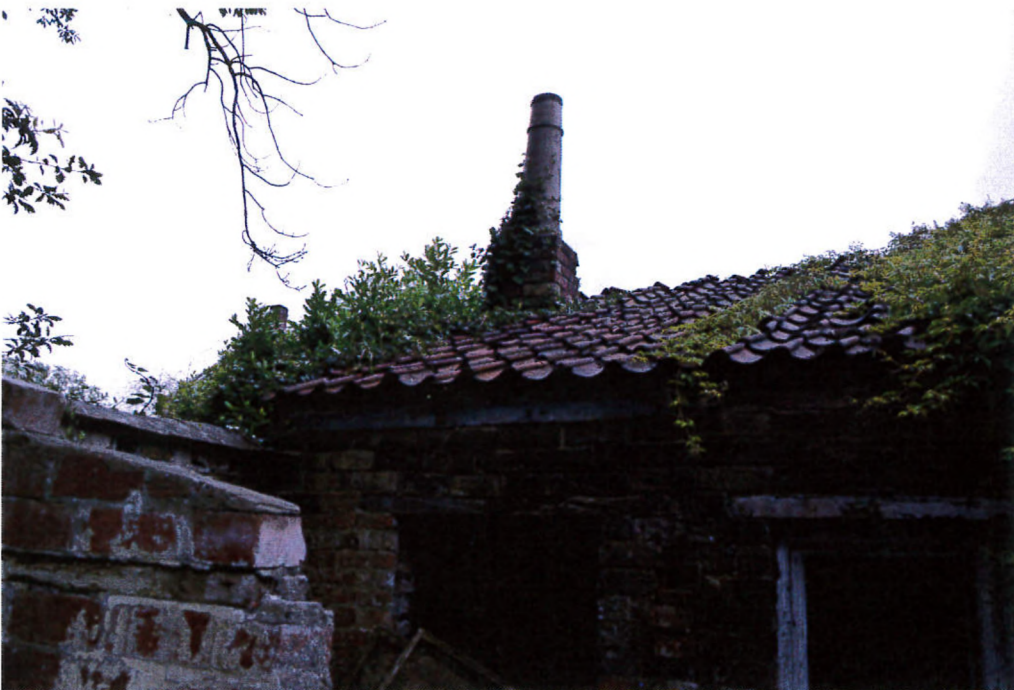
Roof from front

The roof structure is, to the right hand side completely covered in creeper growth which precludes a closer inspection. To the left, where the roof is visible, the alignment is generally satisfactory with no significant dipping along the roof slope or movement at eaves level. Whilst the projecting chimney stack appears vertical and stable the mortar pointing is poor and, as elsewhere, will require attention.

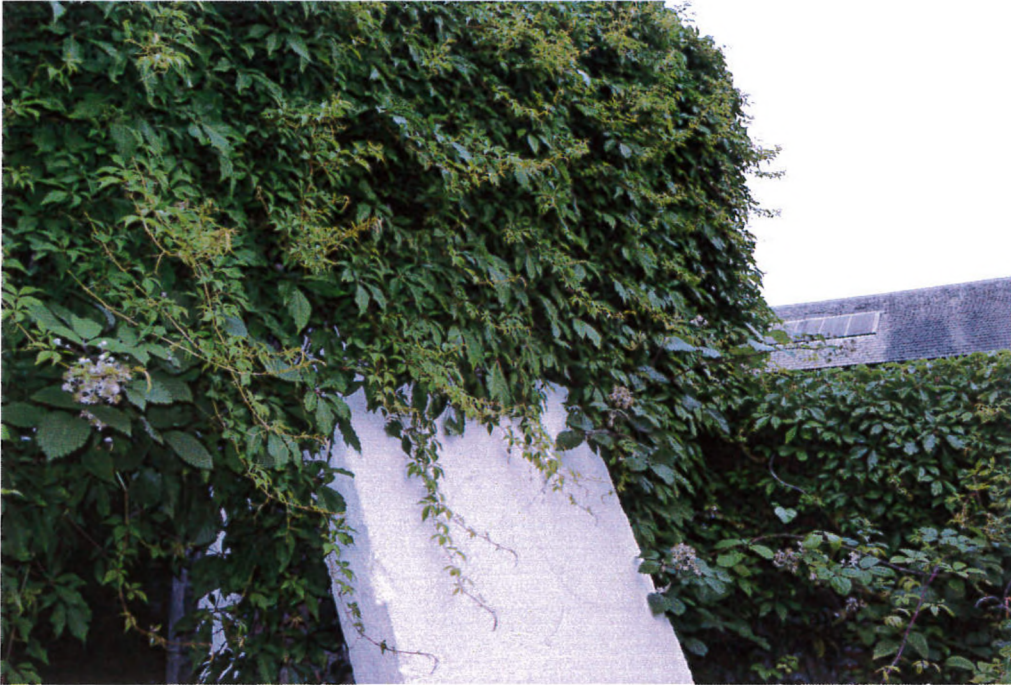
Right Hand Elevation

The right hand elevation is completely masked by this same creeper growth albeit an inspection around the doorway to the extreme front of this wall could be made. The balance of the walling appears intact and reasonably true to line and level but the brickwork to the left hand side of this opening, ie the immediate return on the front elevation, has dropped by as much as 75mm. This has resulted in localised cracking above the door head, which itself is framed out by a rotting timber lintel.

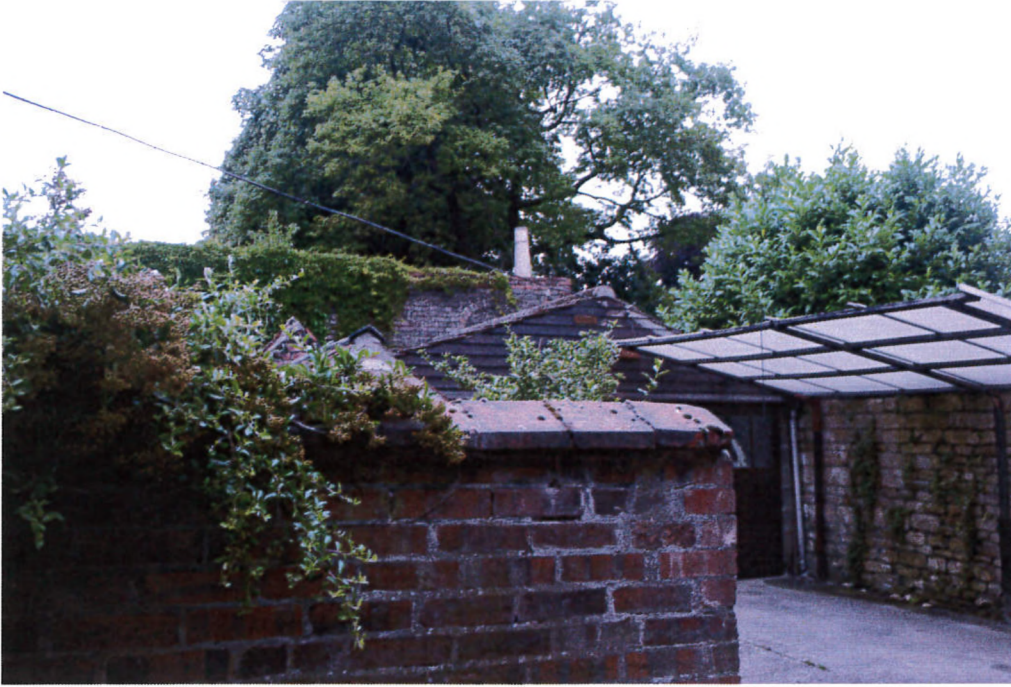
Rear Elevation

A full inspection around the perimeter of the property was not possible. The left hand wall forms the boundary to the adjacent property and access for inspection was not available at the time of our visit. The rear elevation similarly follows to boundary line and is almost entirely masked by a more recently constructed garage block on the adjacent site. Where visible the majority of the wall at higher level is masked by creeper growth but the small area of exposed masonry to the right hand side appears sound, albeit the masonry pointing to the brick courses immediately below the ridge line appears poor.

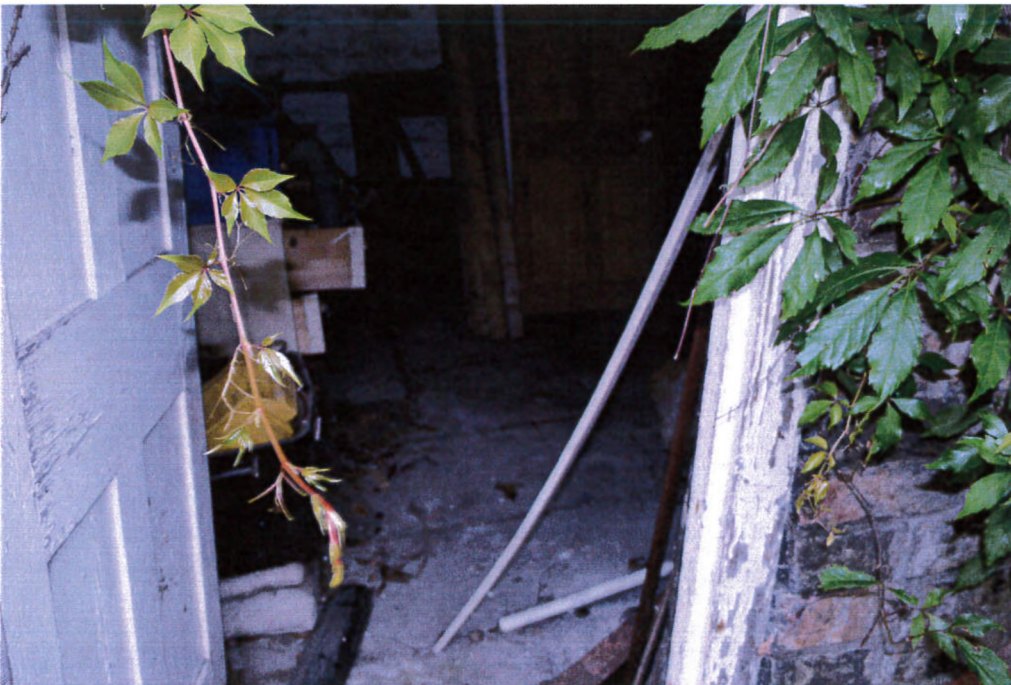
The floors comprise ground bearing pavements that will require replacement as part of any planned refurbishment. The floor within the right hand room slopes down to the front compatible with the movement to the front wall in this location.

Sloping Floor to Right Hand Room

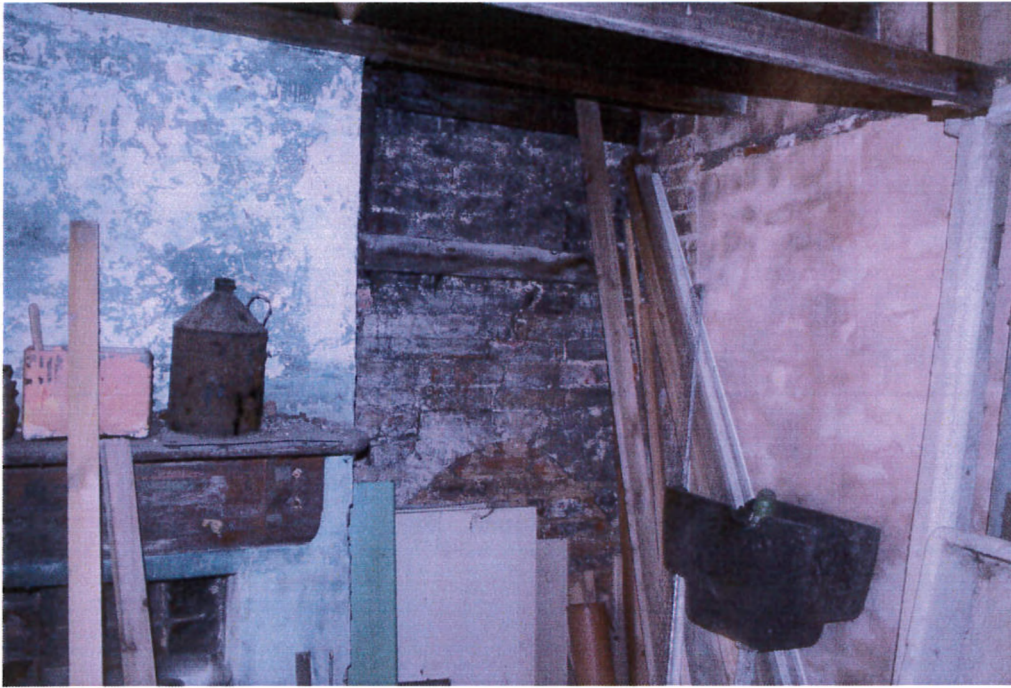
Within the left hand room the overall alignment of the rear, left and front walls is satisfactory, with the walls generally well aligned both horizontally and vertically. There is evidence of minor cracking to the rear of the left hand wall but this is not considered to be structurally significant and is clearly of some age and appears non progressive. The right hand wall, forming the division between the two rooms, has however suffered several rotational movement and settlement to the front, resultant in gaps in the brickwork at the head of the rear internal door way of over 50mm. This vertical movement at the extreme front is compatible with that to the front left hand wall.

Cracking to left wall, left hand room

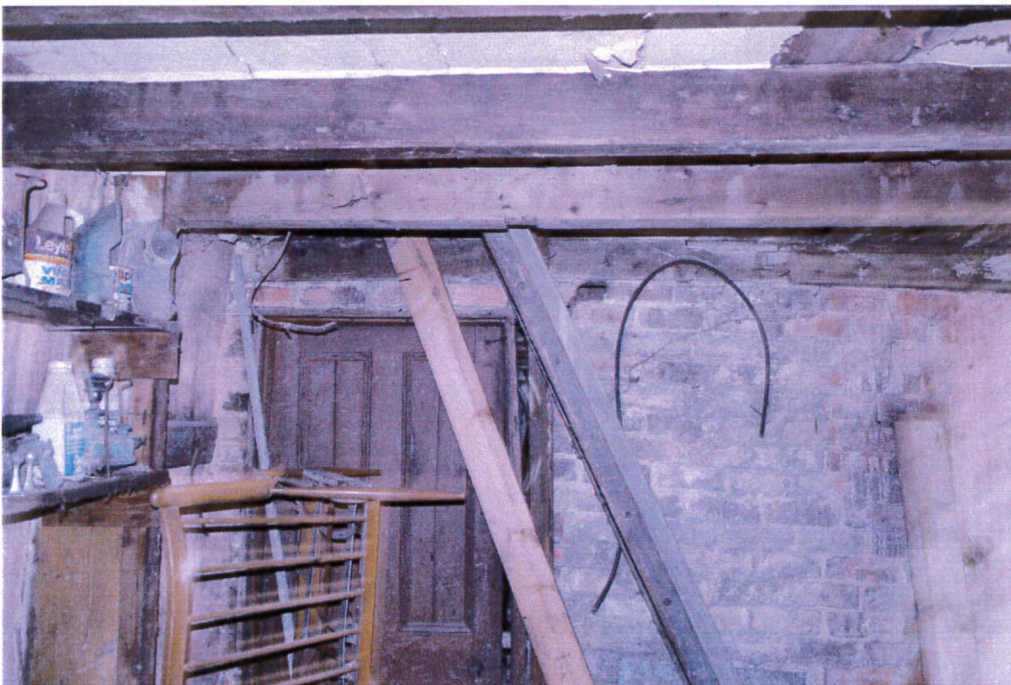
Within the right hand room the rear and rear parts of the right hand wall are well aligned horizontally and vertically. The front wall and the internal wall both however reflect the very significant movement recorded above.

Sloping internal wall in right hand room

- 1) The front right hand wall and the internal cross wall require demolition and reconstruction of a suitably designed new foundation. Ground conditions in this part of Lincoln typically comprise historic fill to some depth and hence a well-

constructed raft foundation is considered the likely solution, subject to detailed investigation and design. The likely extent and detail is included as appendix B.

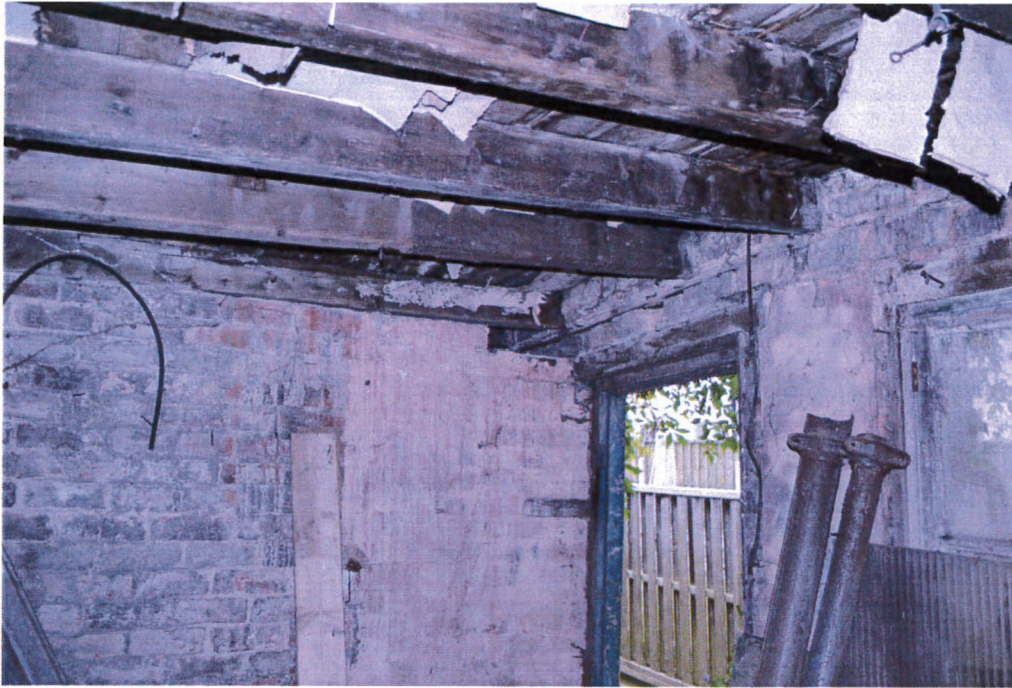
Sloping internal wall in right hand room

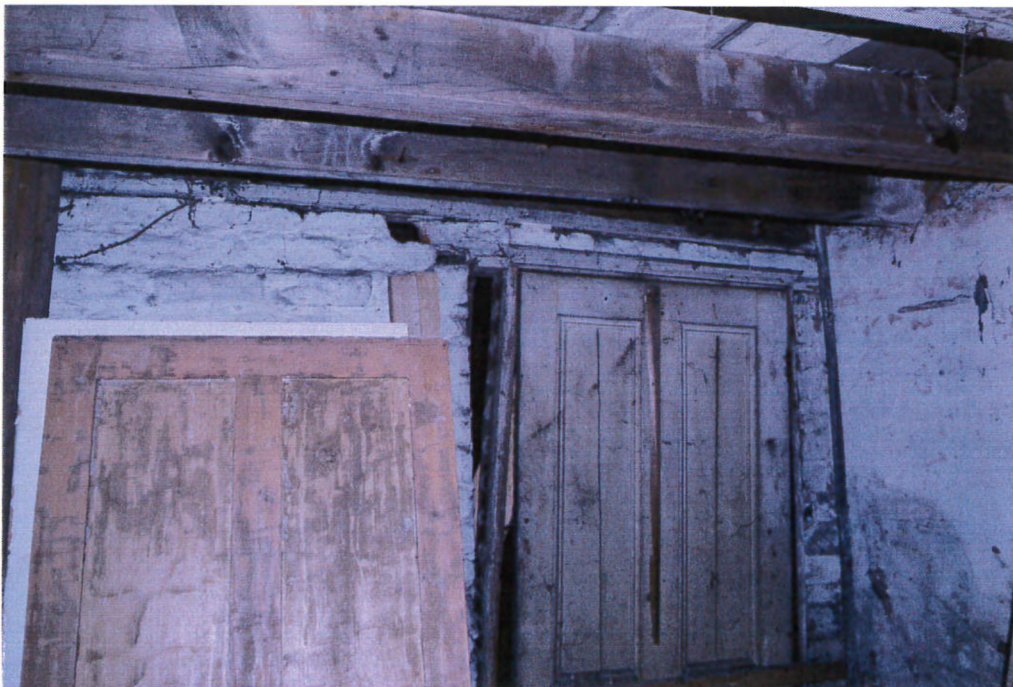
Sloping internal wall in left hand room

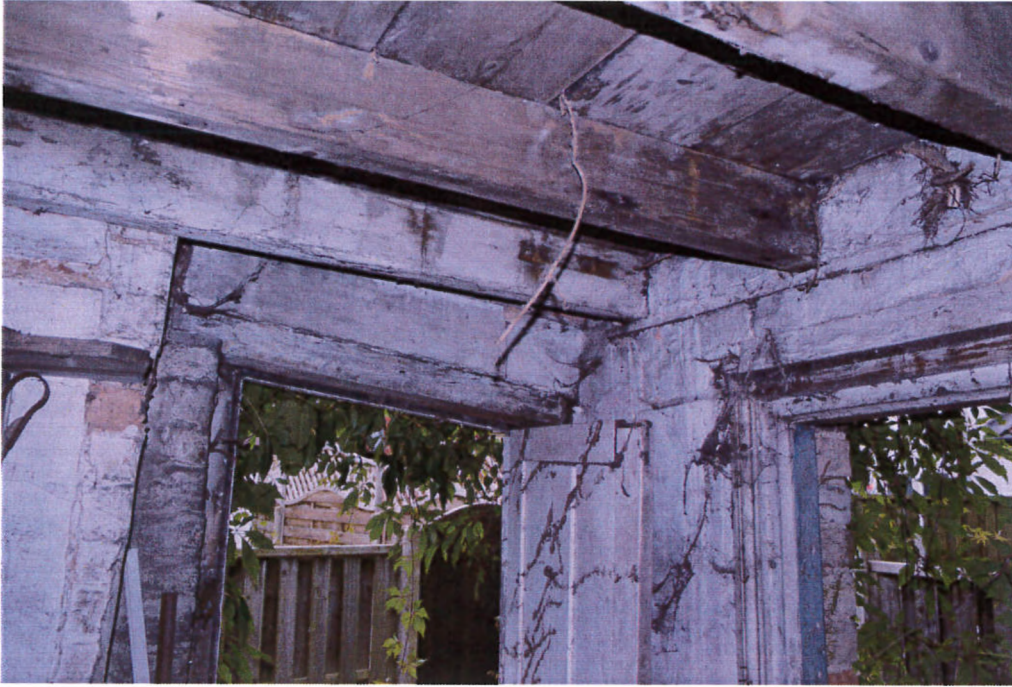
Sloping door head in right hand room

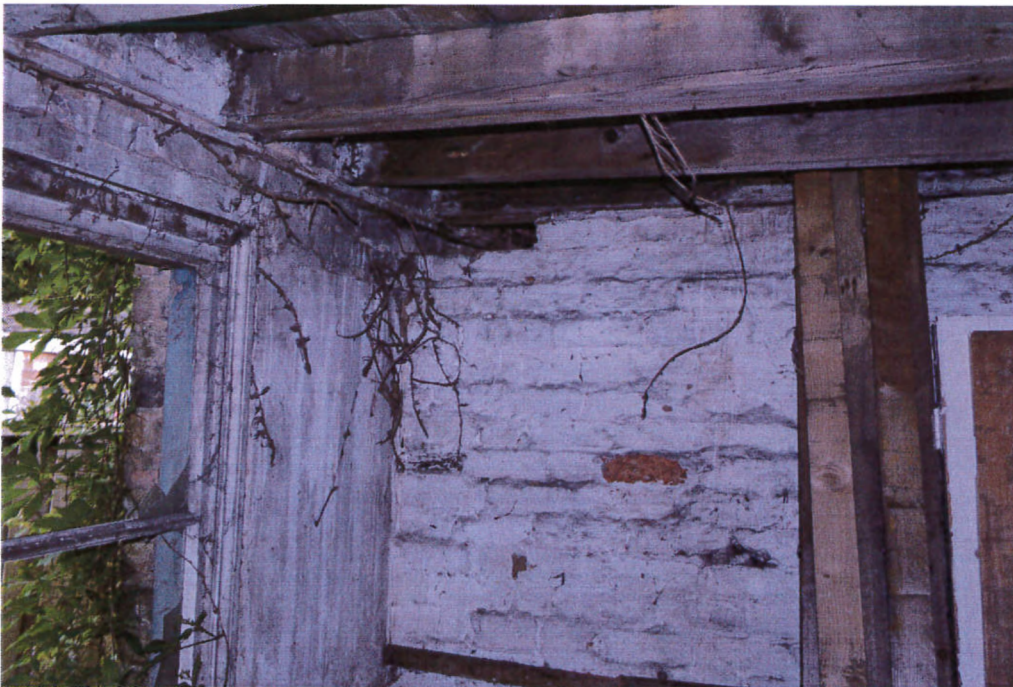
Note all internal openings are framed out with timber lintels exhibiting varying degrees of infestation/rot.

Minor timber damage in right hand room
